Europa, G-BZHS

AAIB Bulletin No: 6/2004	Ref: EW/G2003/09/29	Category: 1.3
Aircraft Type and Registration:	Europa, G-BZHS	
No & Type of Engines:	1 Rotax 912 piston engine	
Year of Manufacture:	2002	
Date & Time (UTC):	26 September 2003 at 0911 hrs	
Location:	Cambridge Airport, Cambridge	
Type of Flight:	Training	
Persons on Board:	Crew - 2	Passengers - None
Injuries:	Crew - None	Passengers - N/A
Nature of Damage:	Propeller damaged and engine shock-loaded. Further damage to main wheel tunnel	
Commander's Licence:	Commercial Pilot's Licence with Instructor rating	
Commander's Age:	74 years	
Commander's Flying Experience:	Approx 10,000 hours (of which 250 were on type)	
	Last 90 days - 80 hours	
	Last 28 days - 31 hours	
Information Source:	Aircraft Accident Report Form submitted by the commander and further enquiries by the AAIB

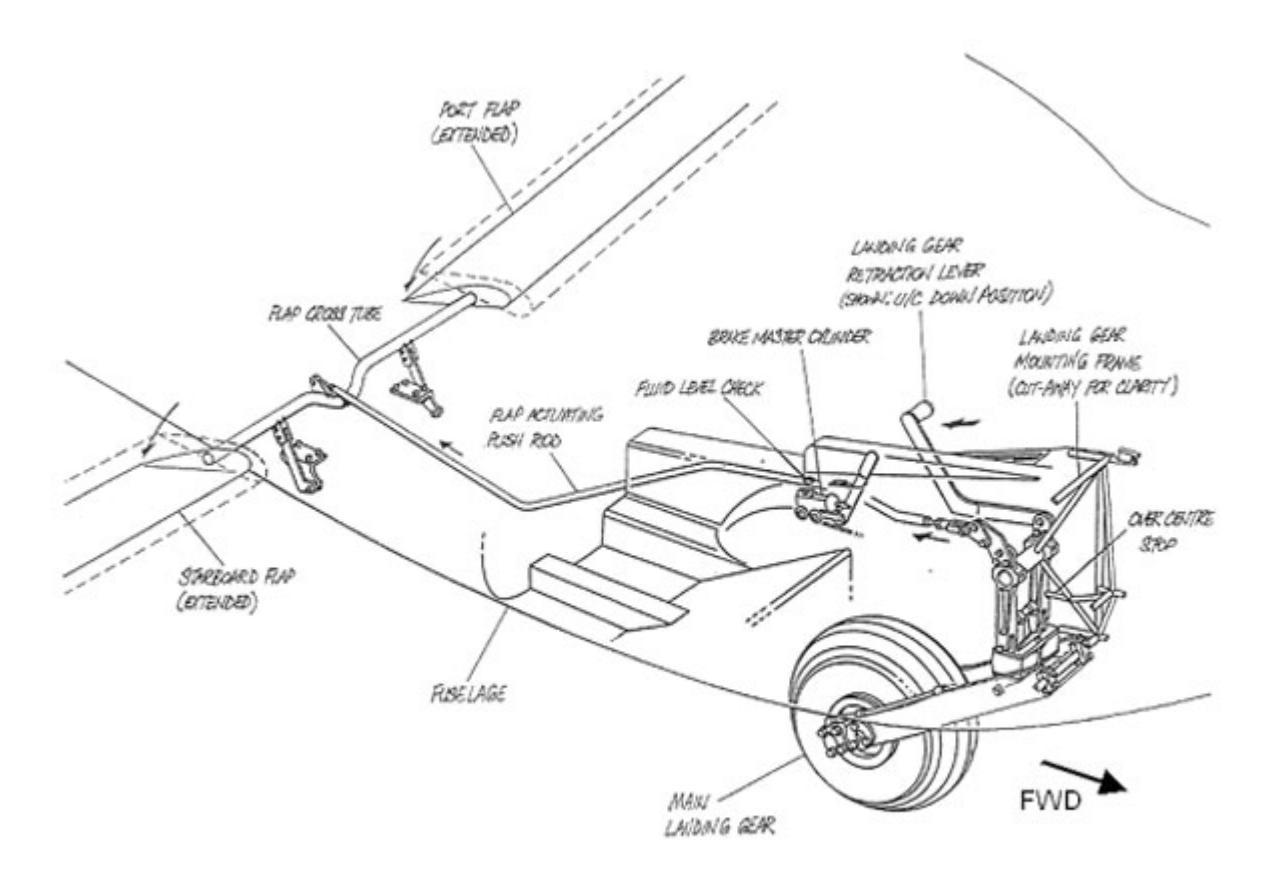
Figure 1: Flap and landing gear operating mechanism

The landing gear on this aircraft type consists of a single retractable mainwheel, two retractable outrigger wheels under the outboard sections of the wings, and a fixed tailwheel. The flaps and outrigger wheels are attached to the same linkage. The gear lever operates the mainwheel, outrigger wheels and flaps in unison. The gear lever is attached directly to the gear operating linkage which incorporates an over-centre mechanism (see Figure 1).

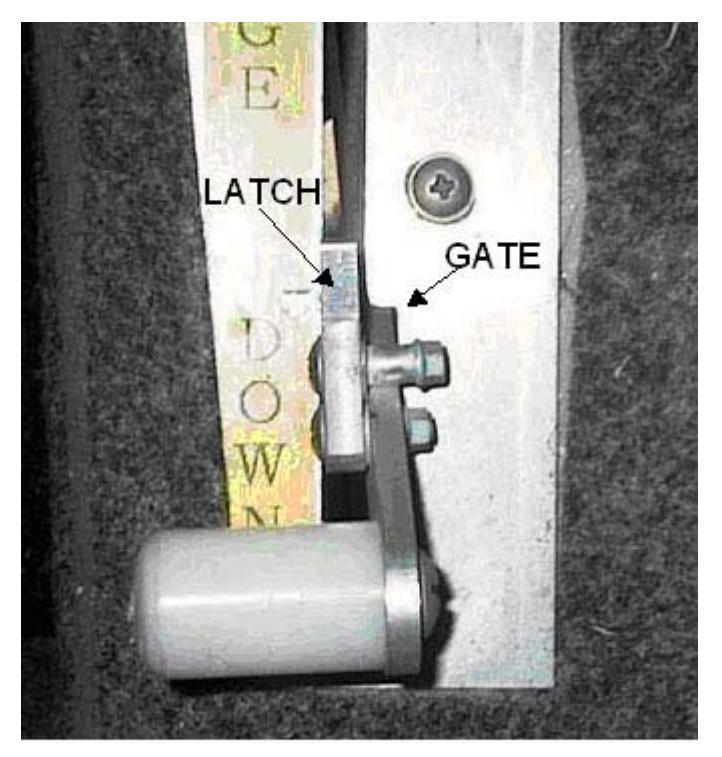
Figure 3: Top view of gear lever in down & latched position

To extend the gear the gear lever is pulled aft until it engages a gate (see Figure 3).

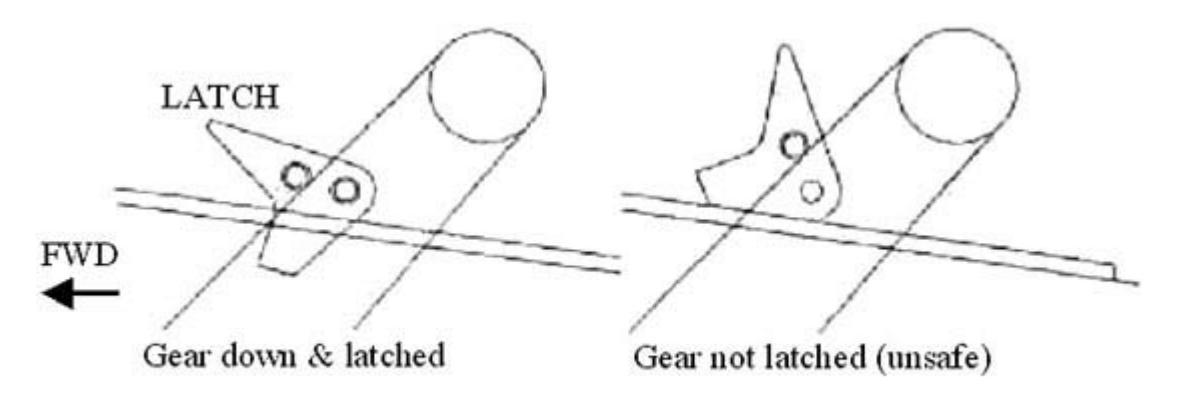
Figure 2: Gear lever latch mechanism

A safety latch is attached to the lever and is designed to rotate under its own weight into the guide slot to prevent the gear lever from inadvertently 'popping' out of the gate (see Figures 2 and 4).

A positive action is required to move the latch out of the slot, which then allows the retraction lever to be moved out of the gate.

The instructor reported that during the landing roll on another Europa aircraft he had noticed the latch bouncing up and down as the aircraft passed over undulating ground. He recommended that the latch be tightened to prevent inadvertent unlatching, but he also pointed out that the disadvantage of tightening the latch is that it will not automatically drop into place. The pilot would need to remember to push the latch down after selecting the gear lever down. One Europa pilot has installed a spring on the latch to help lock it in the down position.

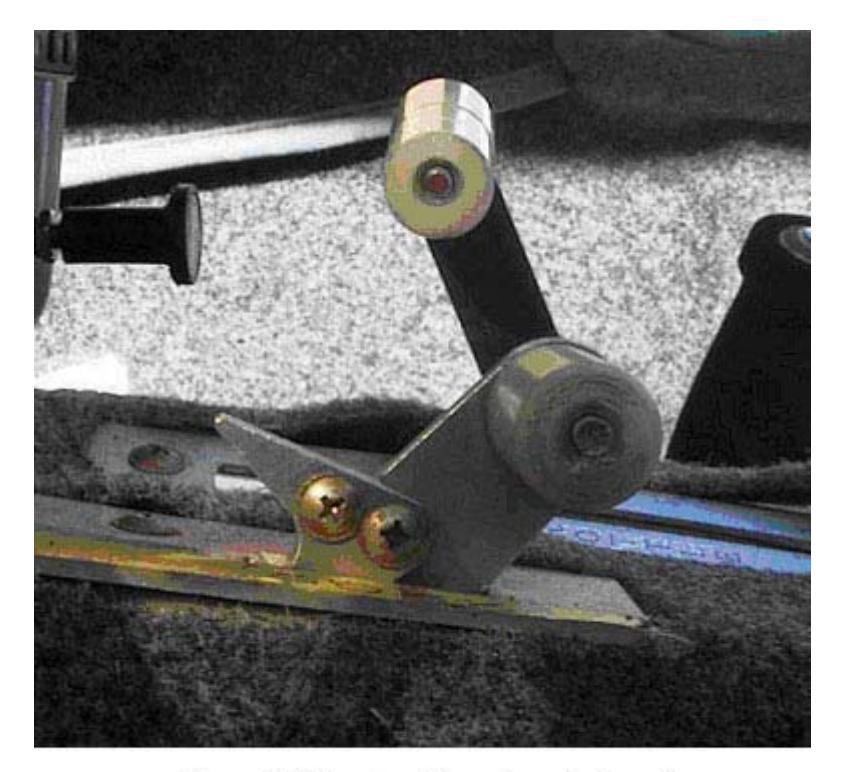
Figure 4: Side view of gear lever in down & latched position

The gear was found to operate correctly and lock down correctly. Consequently, the only way the gear could have retracted during the landing roll is for the landing gear lever to have been unlatched. Either the latch was not fully engaged in the guide slot or the latch popped up during the ground roll.
