ACCIDENT

Aircraft Type and Registration:	Diamond DA 40 D, G-ZANY	
No & Type of Engines:	1 Thielert TAE 125-01 diesel piston engine	
Year of Manufacture:	2003	
Date & Time (UTC):	30 December 2006 at 1215 hrs	
Location:	Near Southwoodham Ferrers (approximately 8 miles NW of Southend)	
Type of Flight:	Private	
Persons on Board:	Crew - 1	Passengers - 1
Injuries:	Crew - None	Passengers - None
Nature of Damage:	Damage to front of aircraft, nose gear and left wing	
Commander's Licence:	Private Pilot's Licence	
Commander's Age:	61 years	
Commander's Flying Experience:	14,455 hours (of which 232 were on type) Last 90 days - 12 hours Last 28 days - 2 hours	
Information Source:	Aircraft Accident Report Form submitted by the pilot and subsequent enquiries by the AAIB

Synopsis

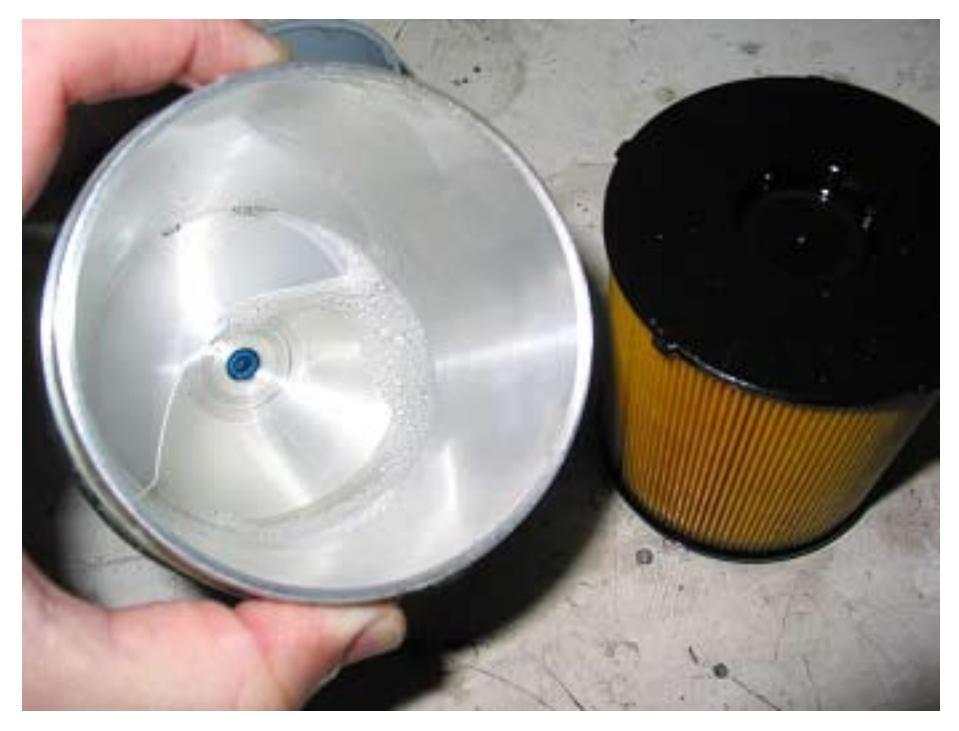
Figure 2 Fuel filter canister showing small amount of fuel present, as found

The evidence of the lack of fuel in the fuel filter canister, and the sudden drop in the actual fuel rail pressure observed in the ECU downloaded data, strongly suggests that the engine had been starved of fuel. However, despite extensive investigation, insufficient evidence was available to allow the cause of the fuel starvation to be determined with any degree of certainty, although the possibility that air entered the fuel system could not be dismissed.
