ACCIDENT
----------

Aircraft Type and Registration:	BAE Systems Jetstream 31, G-CCPW	
No & Type of Engines:	2 Garrett Airesearch TPE 331-10UGR-5164 turboprop engines	
Year of Manufacture:	1987	
Location:	Runway 26, Isle of Man Airport	
Date & Time (UTC):	8 March 2012 at 1757 hrs	
Type of Flight:	Commercial Air Transport (Passenger)	
Persons on Board:	Crew - 2	Passengers - 12
Injuries:	Crew - None	Passengers - None
Nature of Damage:	Right main landing gear yoke pintle fractured, right engine and propeller blades damaged	
Commander's Licence:	Airline Transport Pilot's Licence	
Commander's Age:	58 years	
Commander's Flying Experience:	About 6,000 hrs (of which about 1,500 hrs were on type)	
Information Source:	AAIB Field Investigation

# **Synopsis**

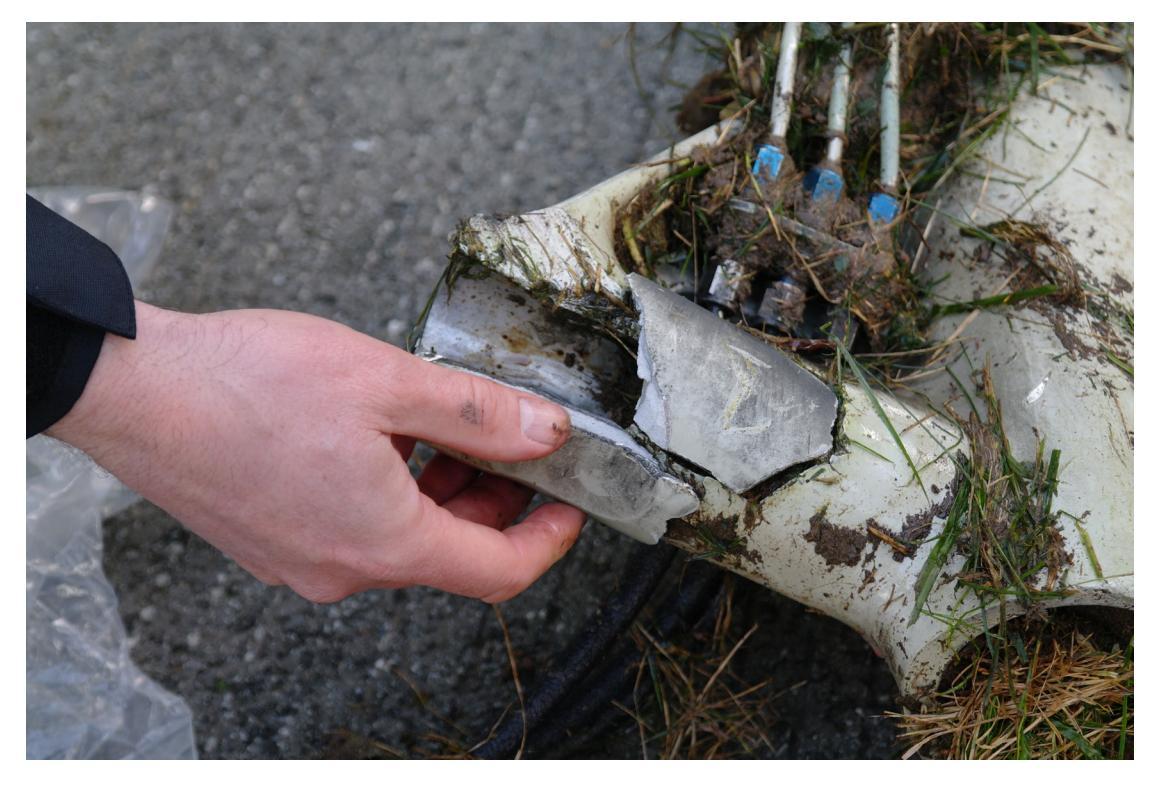
**Figure 2** Right main landing gear yoke forward pintle

The right landing gear had broken away from its trunnions as a result of a failure of the forward yoke pintle housing (refer to Figure 2). However, the landing gear remained attached to the aircraft by the radius arm (retraction jack) and hydraulic pipelines. The downlock microswitch, which is fitted to the radius arm, remained intact and when electrical power was selected ON all three green landing gear position lights illuminated.

The main landing gear is manufactured from DTD 5094 aluminium alloy, which is known to be susceptible to Stress Corrosion Cracking (SCC). The landing gear is attached to the airframe by trunnions that fit into steel spigots that are bolted to the inside of the yoke pintles. The upper surfaces of the pintles have been machined to introduce a weak link that, in the event of the landing gear being subjected to a force outside of its design limits, will fail and allow the gear to detach from the aircraft without damaging the fuel tanks. During the accident sequence the forward yoke pintle had failed with three large segments breaking away from the landing gear.

The metallurgy determined that a crack, emanating from the top edge of the forward yoke pintle, grew to approximately 120 mm before the remainder of the pintle failed in ductile overload. The first 10 mm of the crack occurred as a result of SCC and the heavy corrosion deposits indicated that this damage had been present for some time. The failure mechanism of the remainder of the crack is less clear. The patches of ductile overload and SCC, and the presence of cadmium in the crack, suggest that the crack grew over a period of time. Whilst the investigation has not yet determined how long the crack took to grow to failure, the amount of corrosion in the crack and on the steel spigots suggests that it was present during the last visual inspection carried out 11 days earlier and may have been present during the last eddy current inspection undertaken ten months earlier.

EASA AD G-003-01-86 mandates non-destructive testing and visual inspections to identify cracking in the yoke pintle housing on landing gears fitted to Jetstream 31 aircraft. As these inspection requirements did not detect the crack in the yoke pintle before it failed, the following Safety Recommendation is made to the European Aviation Safety Agency:

It is recommended that the European Aviation Safety Agency review the effectiveness of Airworthiness Directive G-003-01-86 in identifying cracks in the yoke pintle housing on landing gears fitted to Jetstream 31 aircraft.

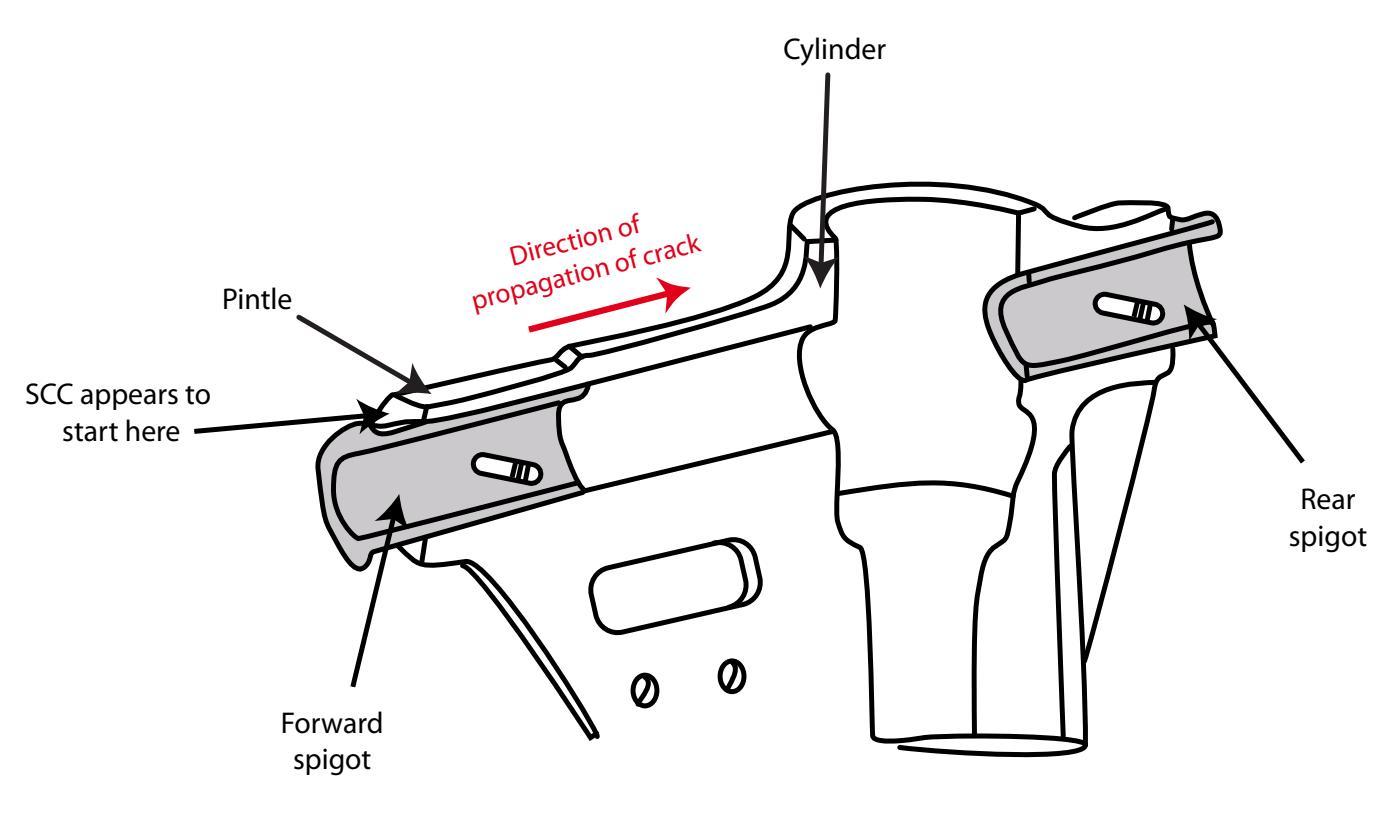
**Figure 3** Main landing gear diagram

Examination established that the failure initiated at the top outer edge of the forward yoke pintle (see Figure 3) and the crack extended along the top of the pintle for approximately 120 mm before final failure occurred. The first 10 mm of the crack was heavily corroded and lighter deposits of corrosion were found along the remainder of the crack. Scanning Electron Microscopy (SEM) of the first 10 mm of the crack showed evidence of inter-granular failure consistent with SCC. A microsection through the first 35 mm of the crack identified branching crack growth which is a characteristic of SCC. The remainder of the crack showed a combination of both ductile overload and patches of SCC. Corrosion was also found on the steel spigot. Energy-dispersive X-ray spectroscopy (EDX) of the fracture surface of the crack in the yoke pintle identified the presence of cadmium that had leached into the crack from the corroded steel spigot.
