AAIB Bulletin: 10/2012	G-BHPK	EW/C2012/01/04	
ACCIDENT			
Aircraft Type and Registration:	Piper J3C-65 Cub	Piper J3C-65 Cub, G-BHPK	
No & Type of Engines:	1 Continental Mo	1 Continental Motors Corp A65-8F piston engine	
Year of Manufacture:	1943 (Serial no:	1943 (Serial no: 12161)	
Date & Time (UTC):	28 January 2012	28 January 2012 at 1523 hrs	
Location:	Priory Farm, Tibe	Priory Farm, Tibenham, Norfolk	
Type of Flight:	Private		
Persons on Board:	Crew - 1	Others - 1	
Injuries:	Crew - None	Others - 1 (Fatal)	
Nature of Damage:	Damaged propell	Damaged propeller	
Commander's Licence:	National Private	National Private Pilot's Licence	
Commander's Age:	38 years	38 years	
Commander's Flying Experience:	370 hours (of wh Last 90 days - 4 h Last 28 days - 4 h	370 hours (of which 2 were on type) Last 90 days - 4 hours Last 28 days - 4 hours	
Information Source:	AAIB Field Inves	AAIB Field Investigation

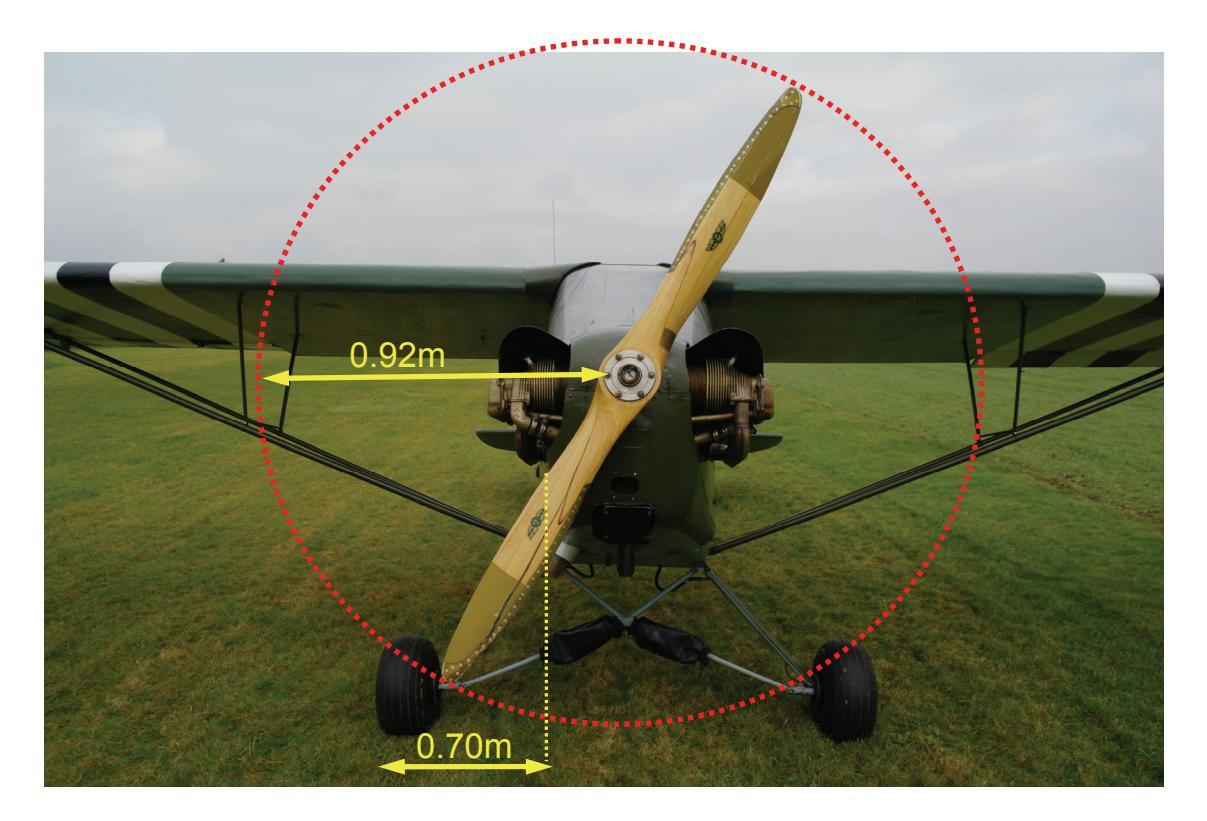
Figure 1 Aircraft front elevation

One propeller blade displayed evidence of impact damage approximately 10 cm from the tip. The impact had caused the propeller to split along the length of both blades. The coach's headset was found by the aircraft in a badly damaged condition. Later examination showed this damage to be consistent with the coach having been wearing the headset and it having been struck by the propeller. There was no other identifiable aircraft damage or defects that might have contributed to the accident.

G-BHPK had a one-piece propeller of wooden construction with a metal plate reinforced leading edge. It had a clear varnish finish and light green painted tip sections (Figure 1). The propeller has to be hand-swung in order to start the engine and when hot, the engine can be hard to restart. For this reason it is not unusual for the engine to be left running whilst people are entering or exiting the aircraft between flights. The owners of the aircraft reported that due to the low power of the engine, the wind buffet from the propeller at idle is not particularly strong.

Witness evidence indicates the coach stepped, rather than tripped or stumbled, into the path of the propeller. The evidence shows that the coach was wearing his headset; this would have reduced his ability to hear the noise of the engine and propeller. In addition, the wind buffet from the propeller at idle is reportedly not particularly strong. Whilst the propeller had tips in a different colour, the colour used might not have presented an obvious visual cue to the presence of the rotating propeller.

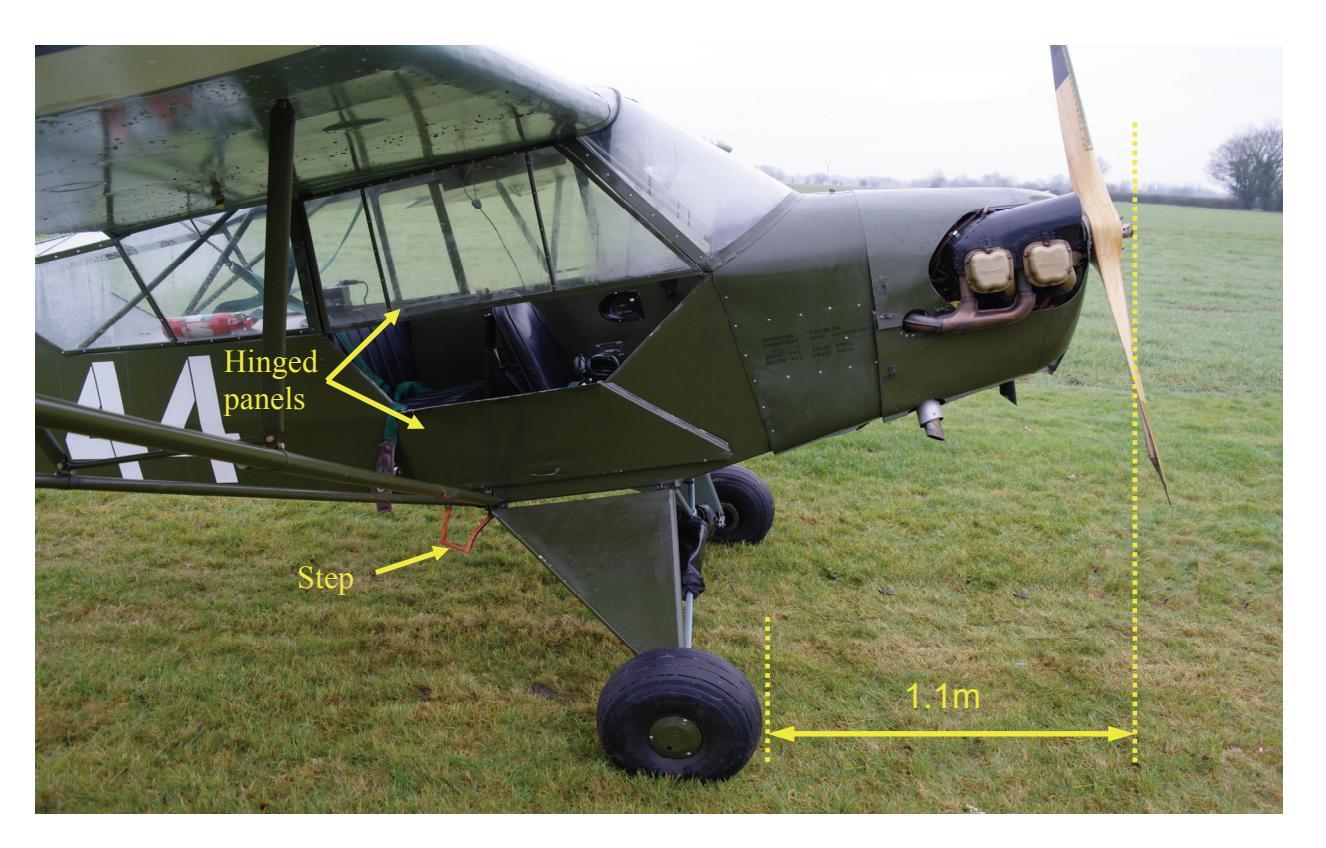
Figure 2 Aircraft side elevation

The aircraft is not equipped with a conventional door, but has two horizontally hinged panels on the right side of the fuselage; one opening upwards and one downwards, to allow access to the cockpit (Figure 2). There is a step just to the rear of where the wing struts attach to the fuselage. This step is used to assist in climbing into the aircraft. The step is awkward to use for occupants exiting from the front seat, as it is located well to the rear and is out of sight when manoeuvring backwards over the struts. The struts are not intended, nor permitted, to be used as a step. As a result, some front seat occupants find it easier to exit the aircraft by stepping out forwards onto the ground directly next to the seat, using the tyre as a step, which places them in front of the wing struts and close to the propeller.

Finally, this accident illustrates the value of the procedure used by some pilots of following a path along the edge of the wing to ensure clearance from the propeller when vacating or approaching such aircraft.
