**Air Accidents Investigation Branch**

Report on the serious incidents to

Boeing 737-81Q, registration G-XLAC on 29 December 2006

at Runway 27, Bristol International Airport

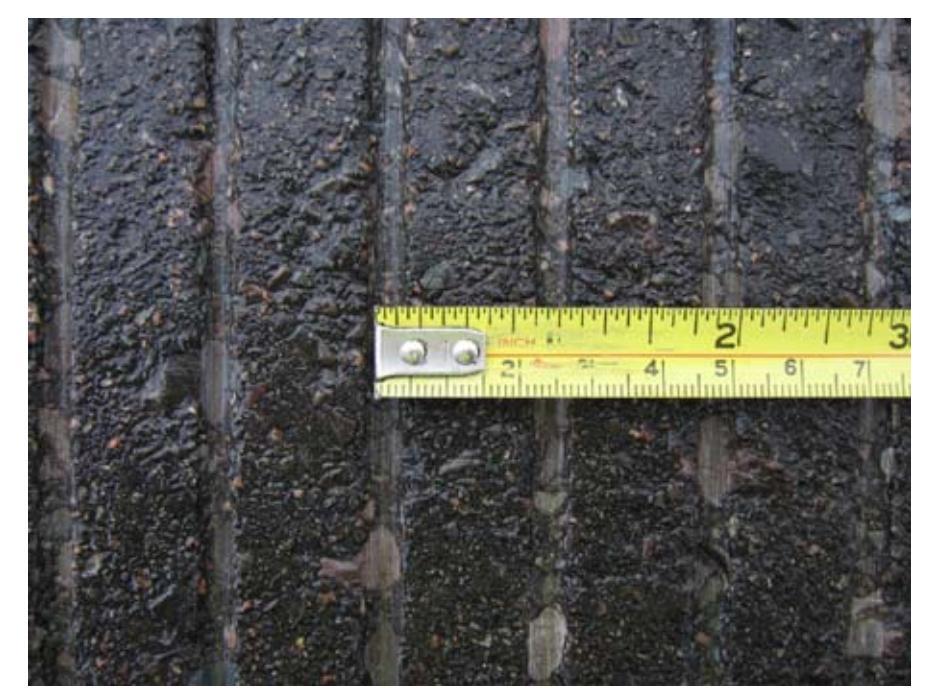
Figure 4

Section of original weathered grooved Marshal Asphalt runway surface. Grooves are 3 mm wide, 4 mm deep with 25 mm spacing (photo courtesy J. Barling)

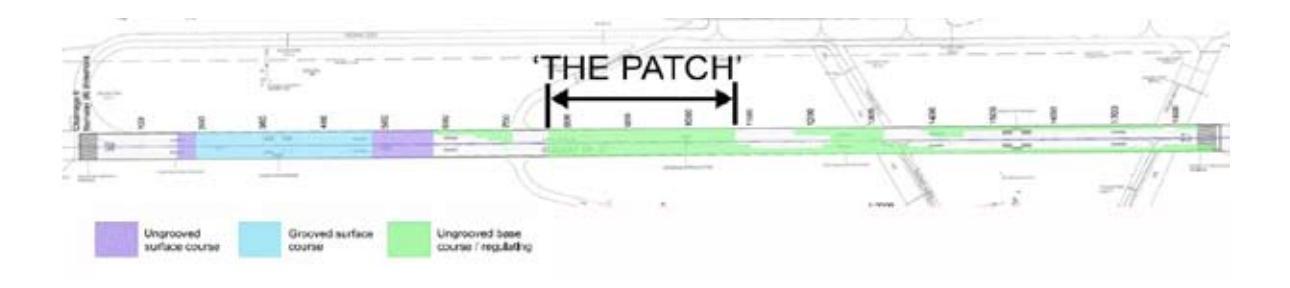
## Figure 5

The state of the runway resurfacing works between 29 December 2006 and 3 January 2007 is shown in Figure 5. The white sections in this diagram represent the original weathered runway surface consisting of grooved Marshall Asphalt (see sample in Figure 4). The green sections consist of new base course and regulating course. The purple sections consist of new surface course that has not yet been grooved. The blue section consists of new surface course that has been grooved. The green and purple sections, taken together, represent the surface area of the runway that was un-grooved.

State of runway surface between 29 December 2006 and 3 January 2007

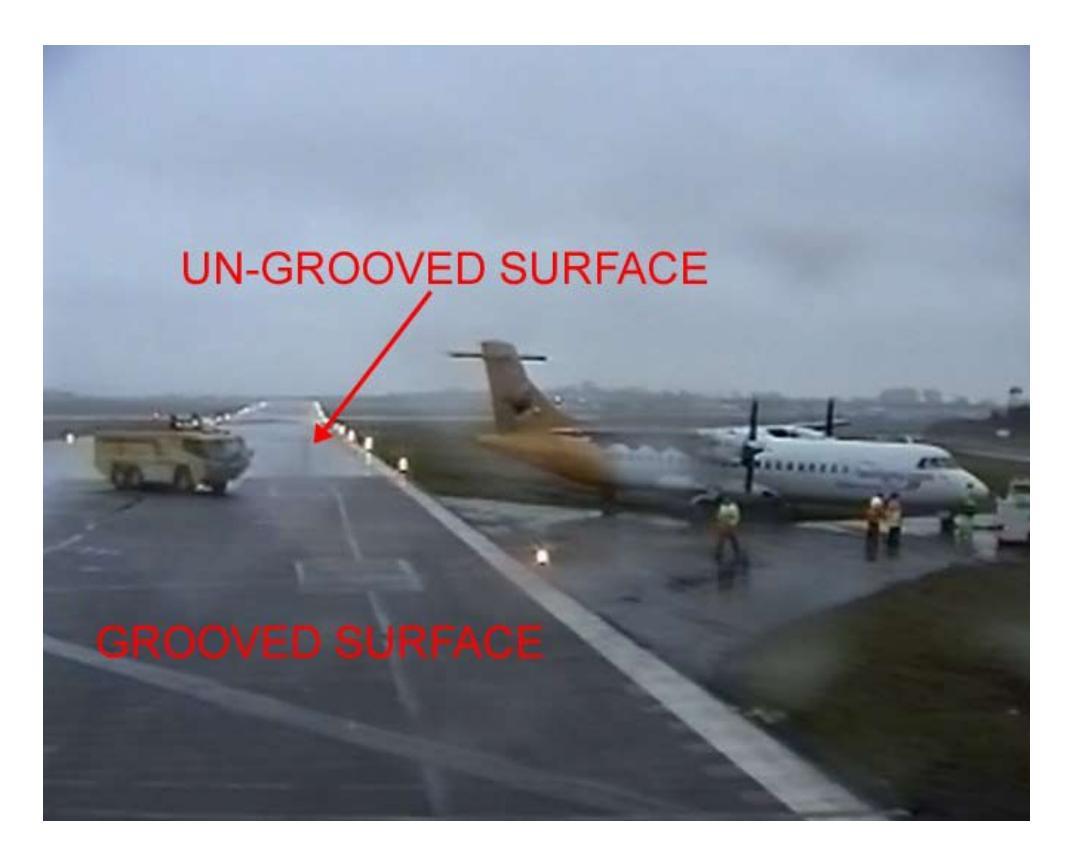
## Figure 6

The difference in water drainage capability of the grooved surface compared to the un-grooved surface is visible in Figure 6, which is a snapshot taken from the RFFS video of the incident scene shortly after G-BWDA departed the runway on 29 December 2006.

Image taken shortly after G-BWDA departed the runway, looking eastwards towards the 27 threshold

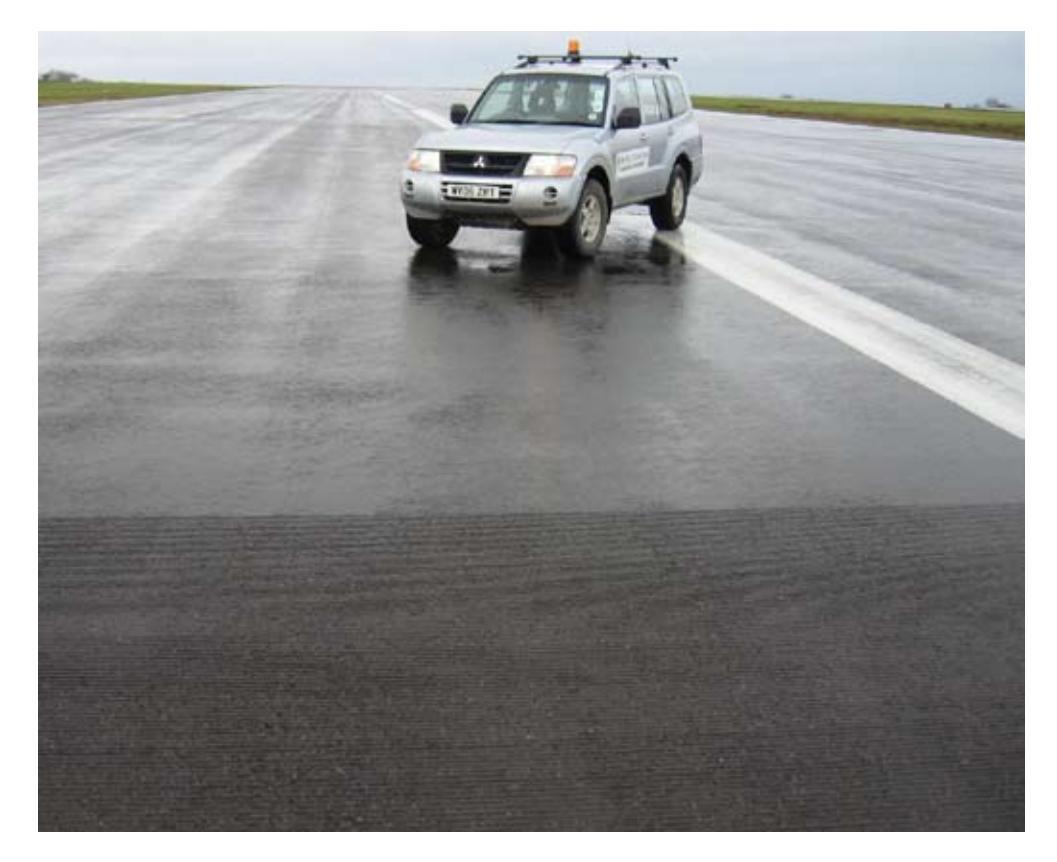
## Figure 7

Temporary grooved base course in foreground and un-grooved base course behind it. Grooves in the base course are 4 mm wide, 4 mm deep with 25 mm spacing (photo courtesy J. Barling)

Following the incidents on 29 December 2006 and 3 January 2007, the airport operator decided to improve the braking characteristics of the un-grooved base course under wet conditions. Closing the runway until the base course had been covered with surface course and then grooved was considered uneconomical. It was considered that grooving the base course might provide a temporary solution. It is not normal practice in the UK to groove base course because its more indented texture and larger aggregate size makes damage to the groove shoulders more likely following multiple landings. Therefore, on 7 January 2007 a trial area of base course 10 m long was grooved and subjected to a day of landings. An inspection the following day revealed that the grooved base course was holding up well and probably would not present a FOD (Foreign Object Damage) risk in the short term. Figure 7 shows the difference between the temporary grooved base course in the foreground and the un-grooved base course behind it.

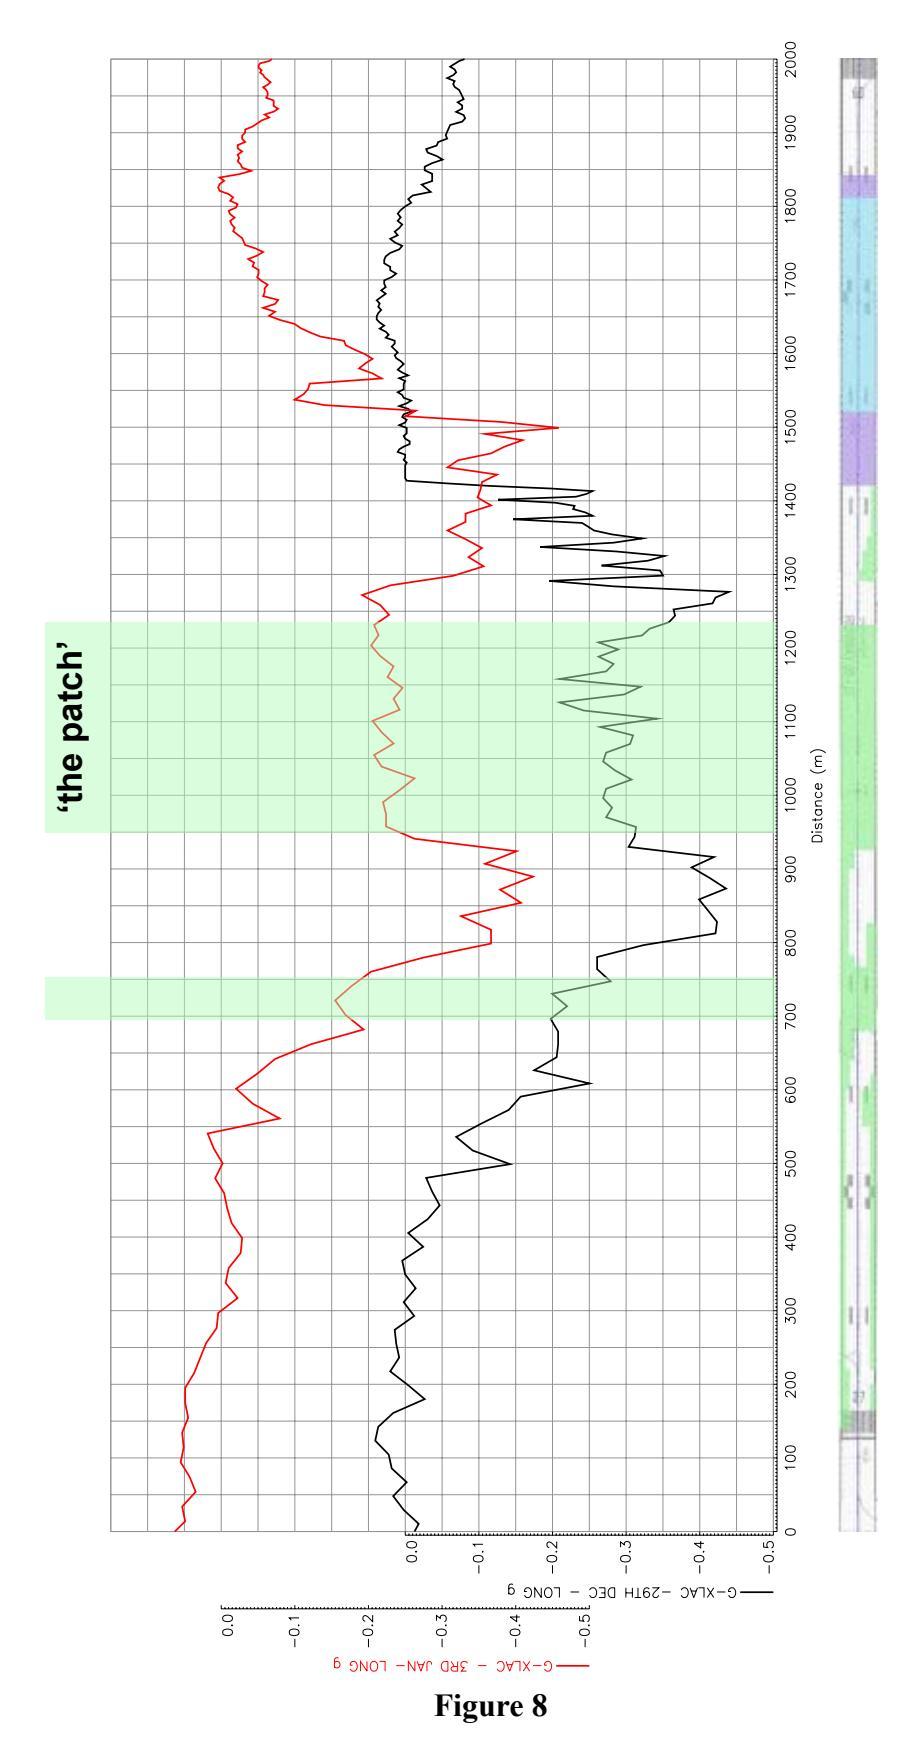
G-XLAC longitudinal acceleration vs. runway position for incidents on 29 December 2006 and 3 January 2007

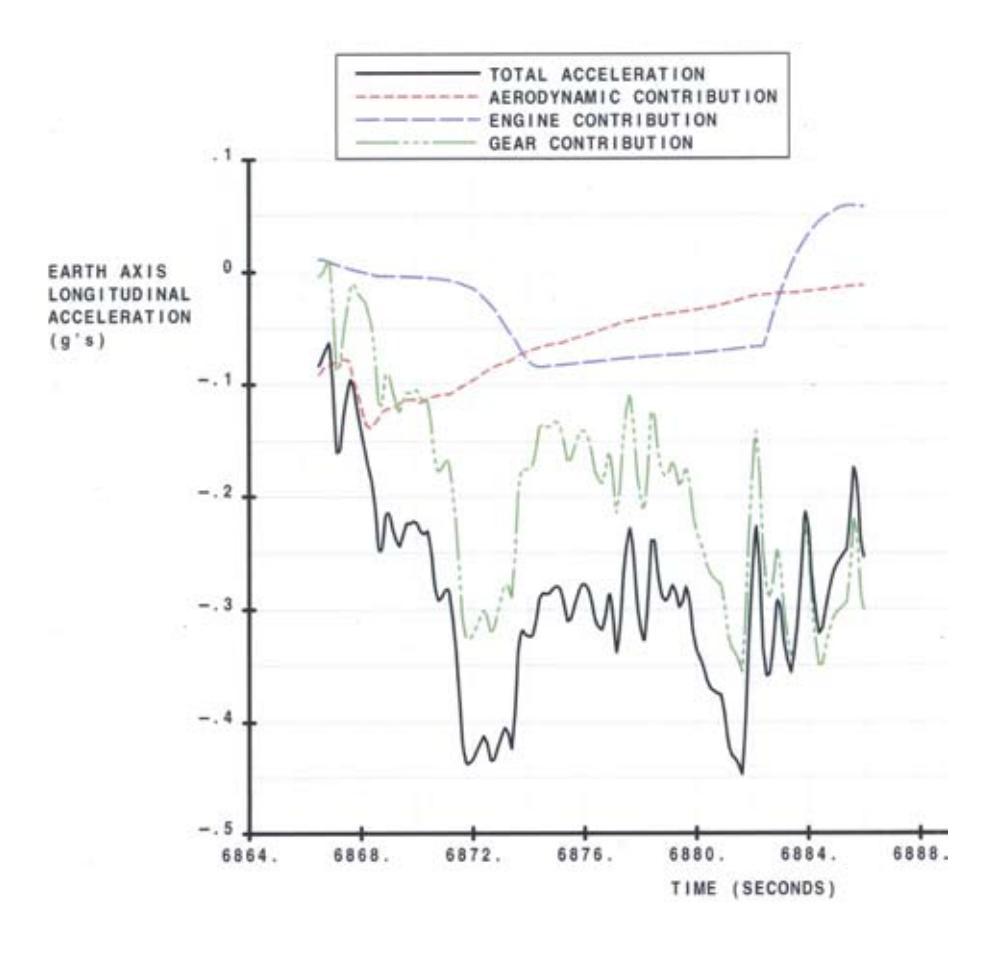
#### Figure 9

Figure 9 shows a combined plot of the decelerations for the G-XLAC landing on the 29 December 2006. The 'GEAR CONTRIBUTION' in this graph constitutes the net deceleration component from the landing gear which includes rolling resistances and braking forces. In this aircraft configuration, the main contributor to the 'GEAR CONTRIBUTION' was from the braking. The aerodynamic contribution in Figure 9 decreased as expected, as the airspeed decreased.

G-XLAC component deceleration contributions 29 December 2007 (Reproduced courtesy of Boeing)

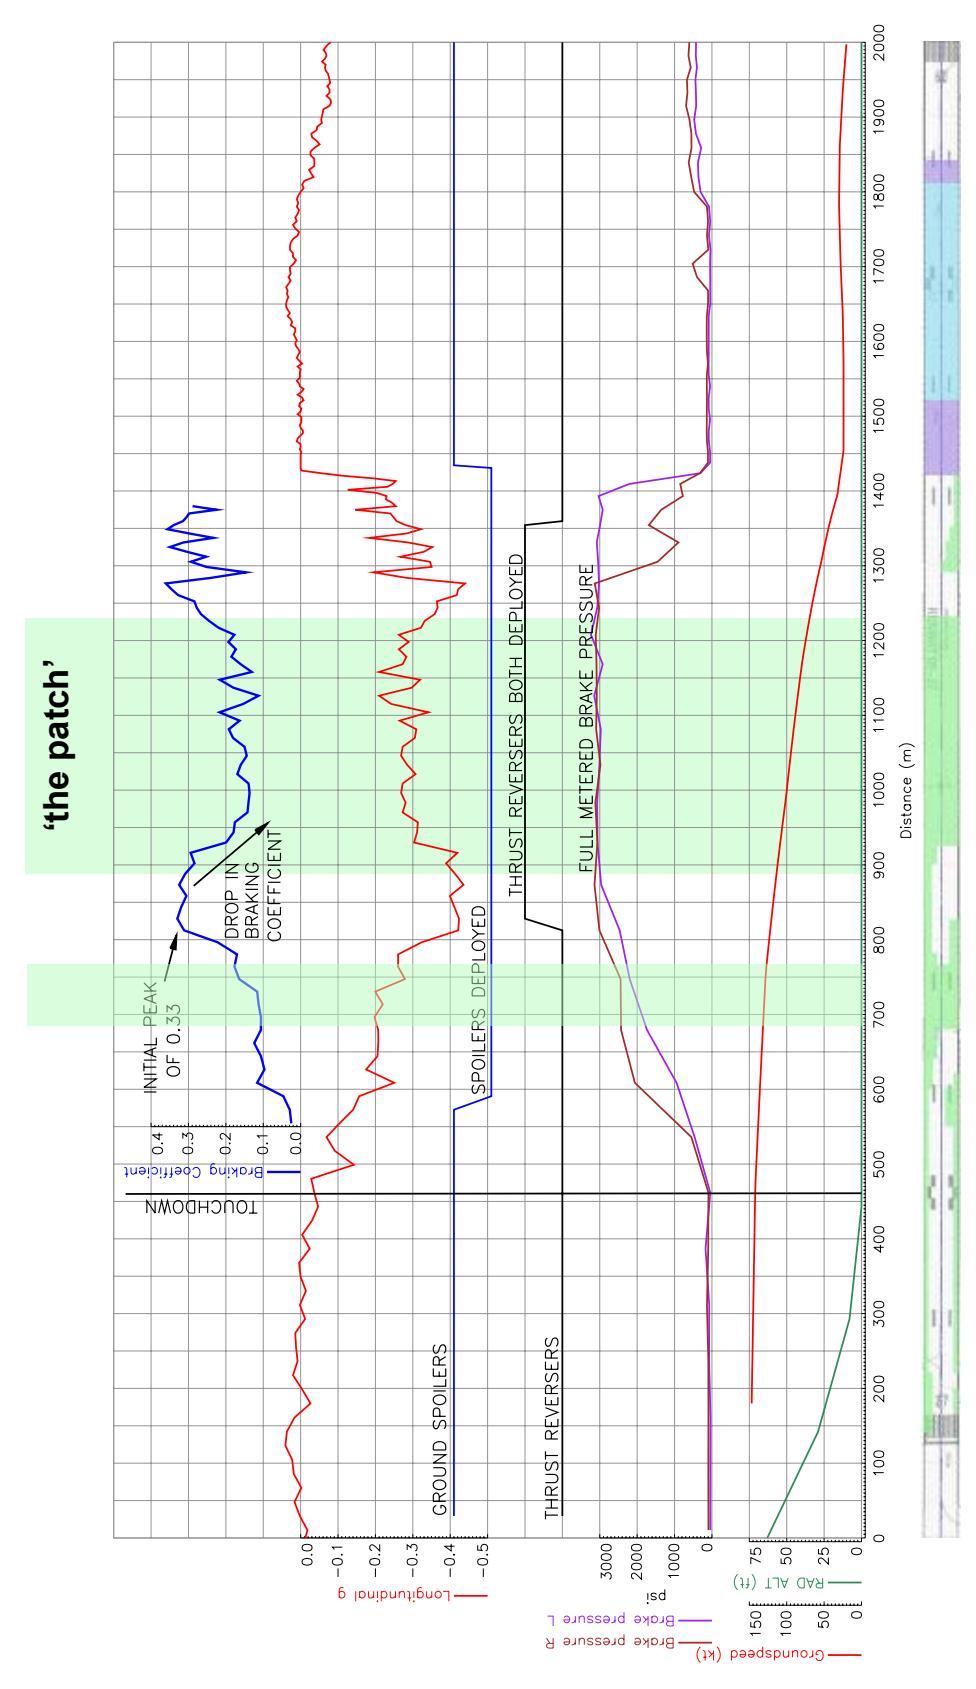
Figure 10 shows the braking coefficient increasing after touchdown, up to a peak of 0.33. After transitioning on to the ungrooved surface, the braking coefficient dropped to a minimum of 0.11. Transition back on to the grooved surface lead to an increase up to a maximum of 0.36.

G-XLAC Braking coefficient from 29 December 2006

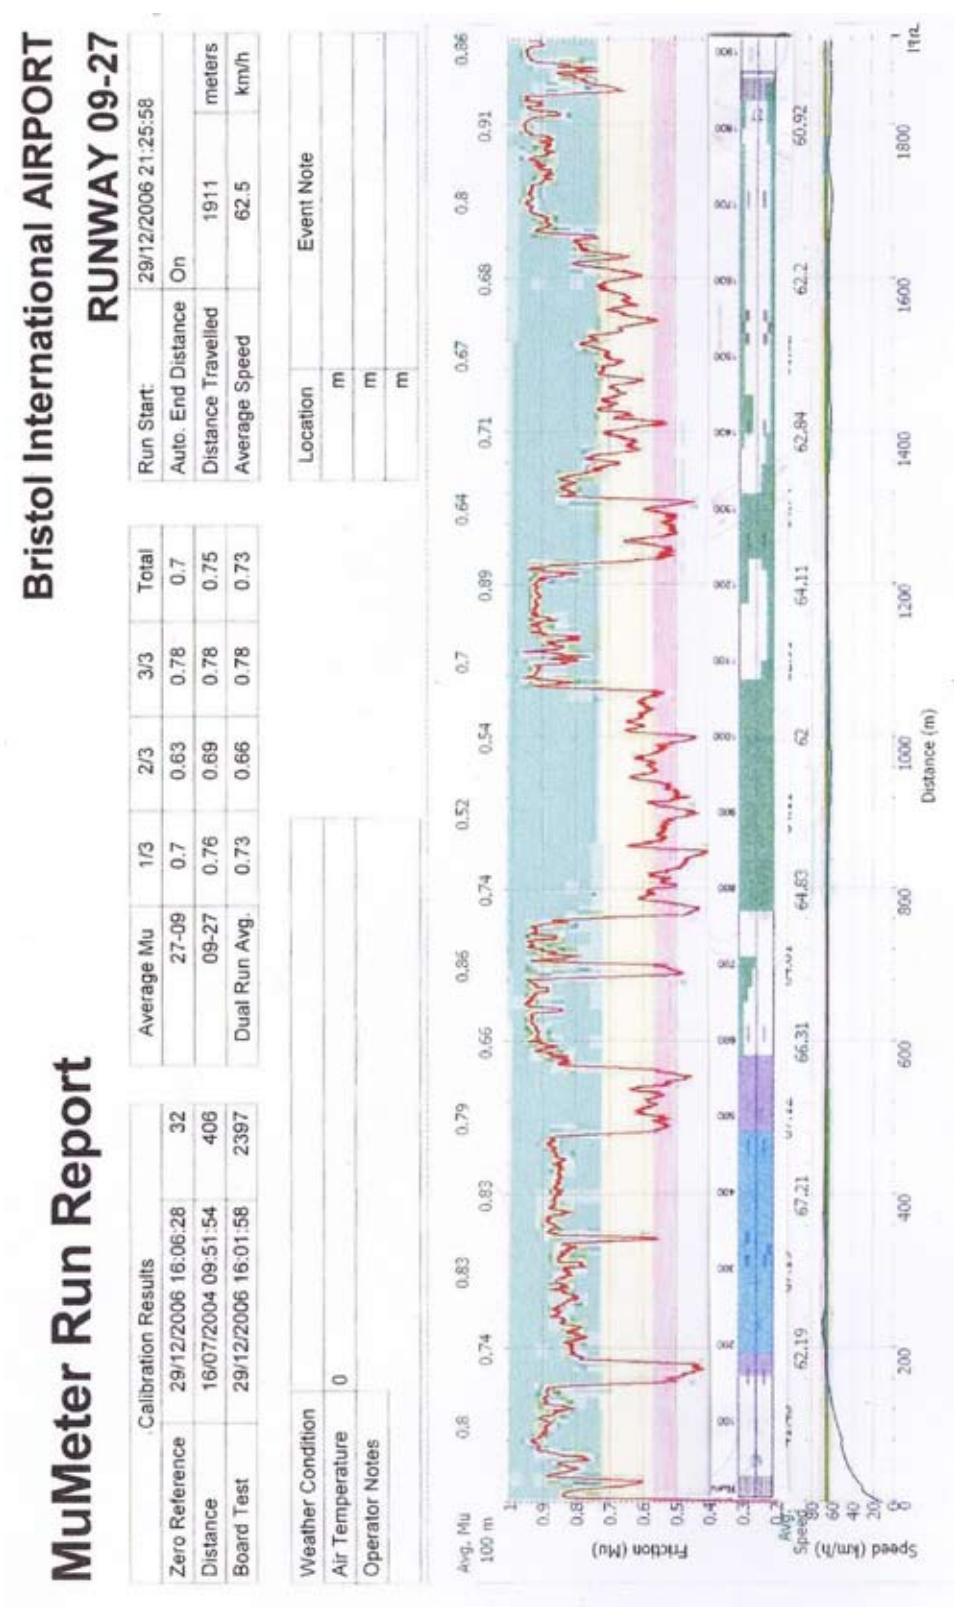
Friction measurement run of Runway 09-27 on 29 December 2006 when the runway state was 'wet, wet'. The runway surface condition at the time is depicted at the bottom

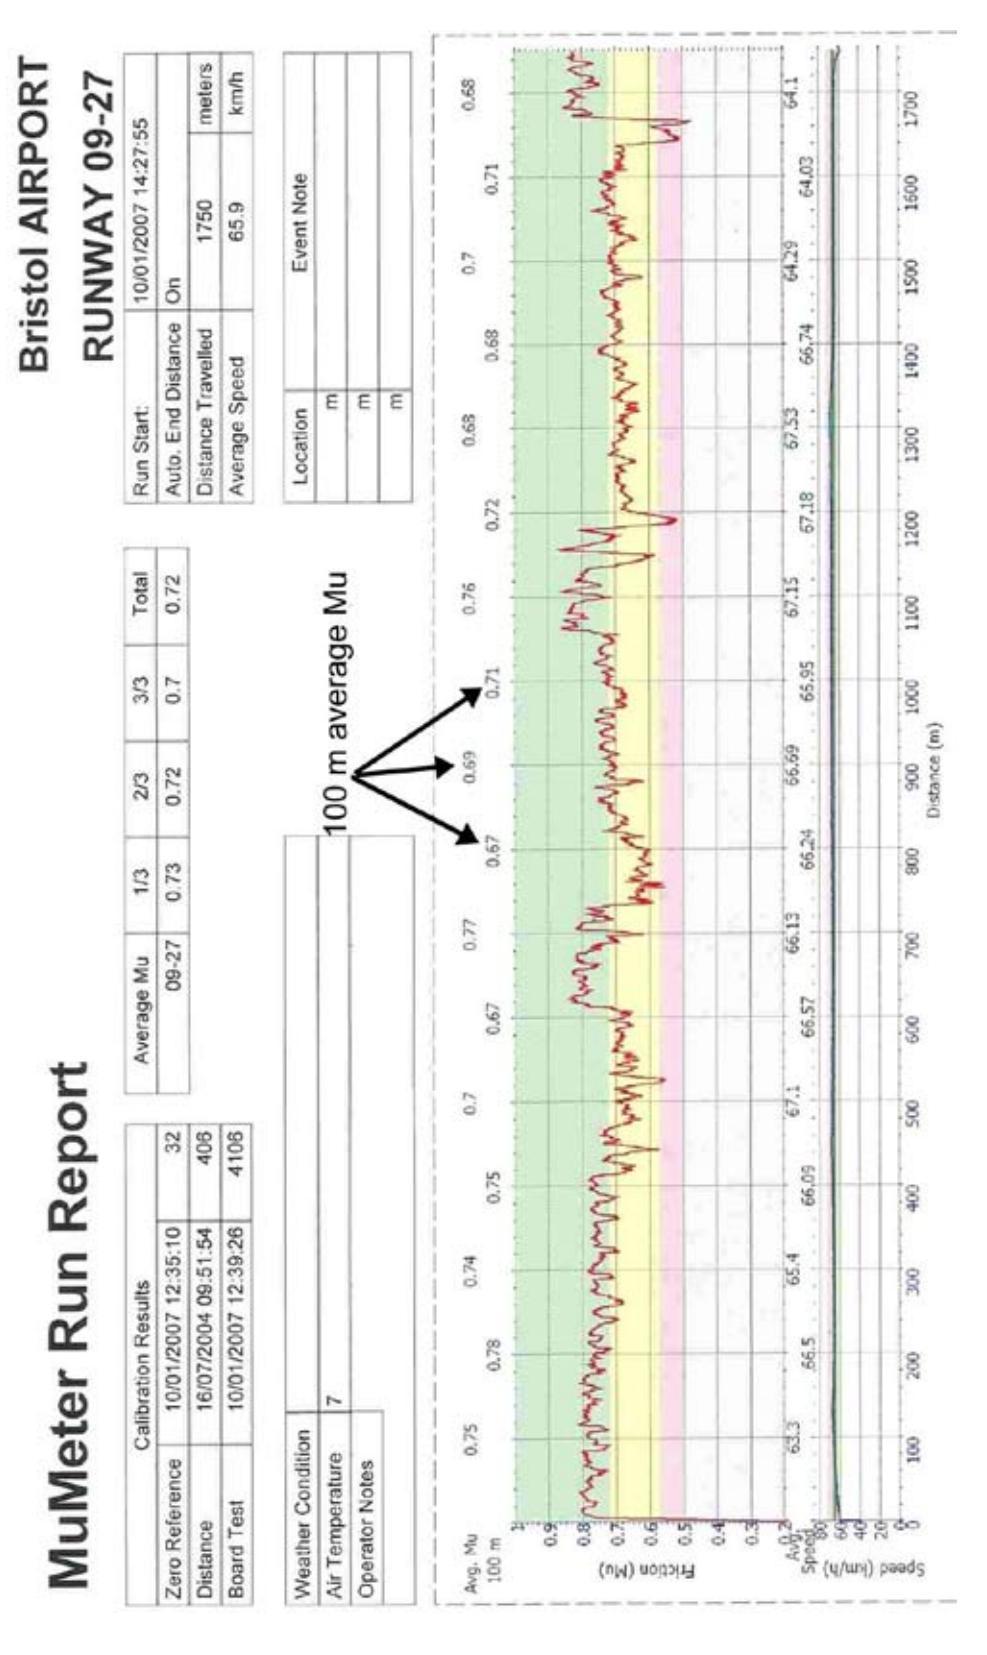
## Figure 13

measured in controlled self-wetting conditions. An example friction run plot from 10 January 2007 is shown in Figure 13. This run was carried out with the Mu-meter displaced 4 m left of the centreline. Runs in other lateral positions showed similar results. The lowest 100 m rolling average was not listed, but the small figures at the top of the graph are the averages for 100 m sections. The lowest 100 m average measured in this run was 0.67 which was above the MFL. Of significant note is that the large peaks and troughs from the run on 29 December 2006 (Figure 12) have disappeared.

Friction measurement run of Runway 09-27 on 10 January 2007 using self-wetting on a dry runway, displaced 4 m left of the centreline

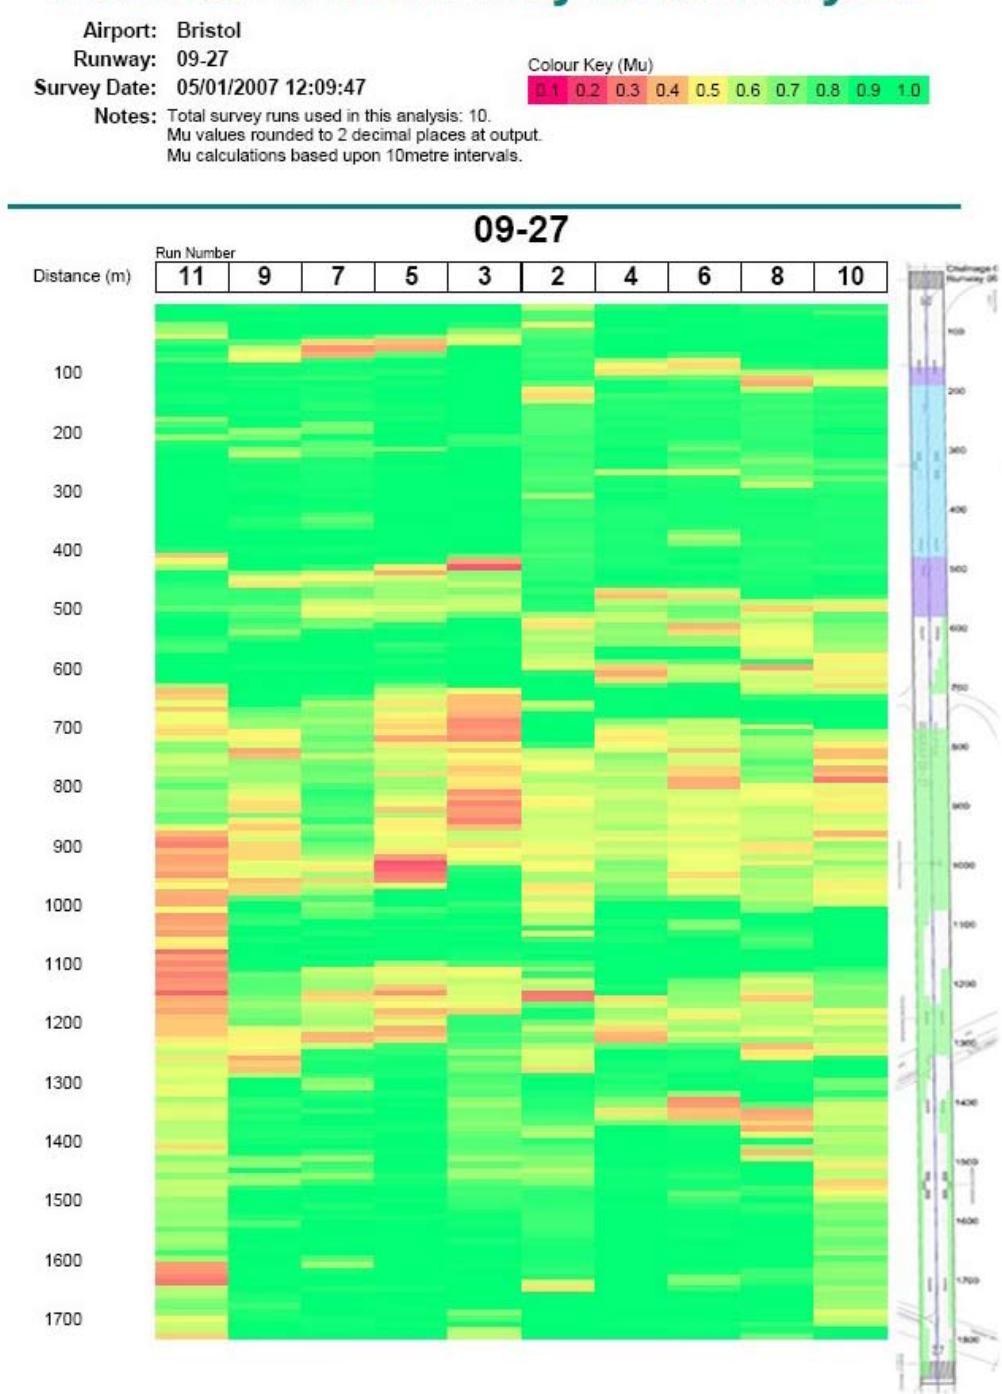
Figure B1

Friction measurement runs carried out on 5 January 2007 prior to temporary grooving, on a damp surface without self-wetting. Each 10 m portion of runway is depicted by a colour representing its friction value

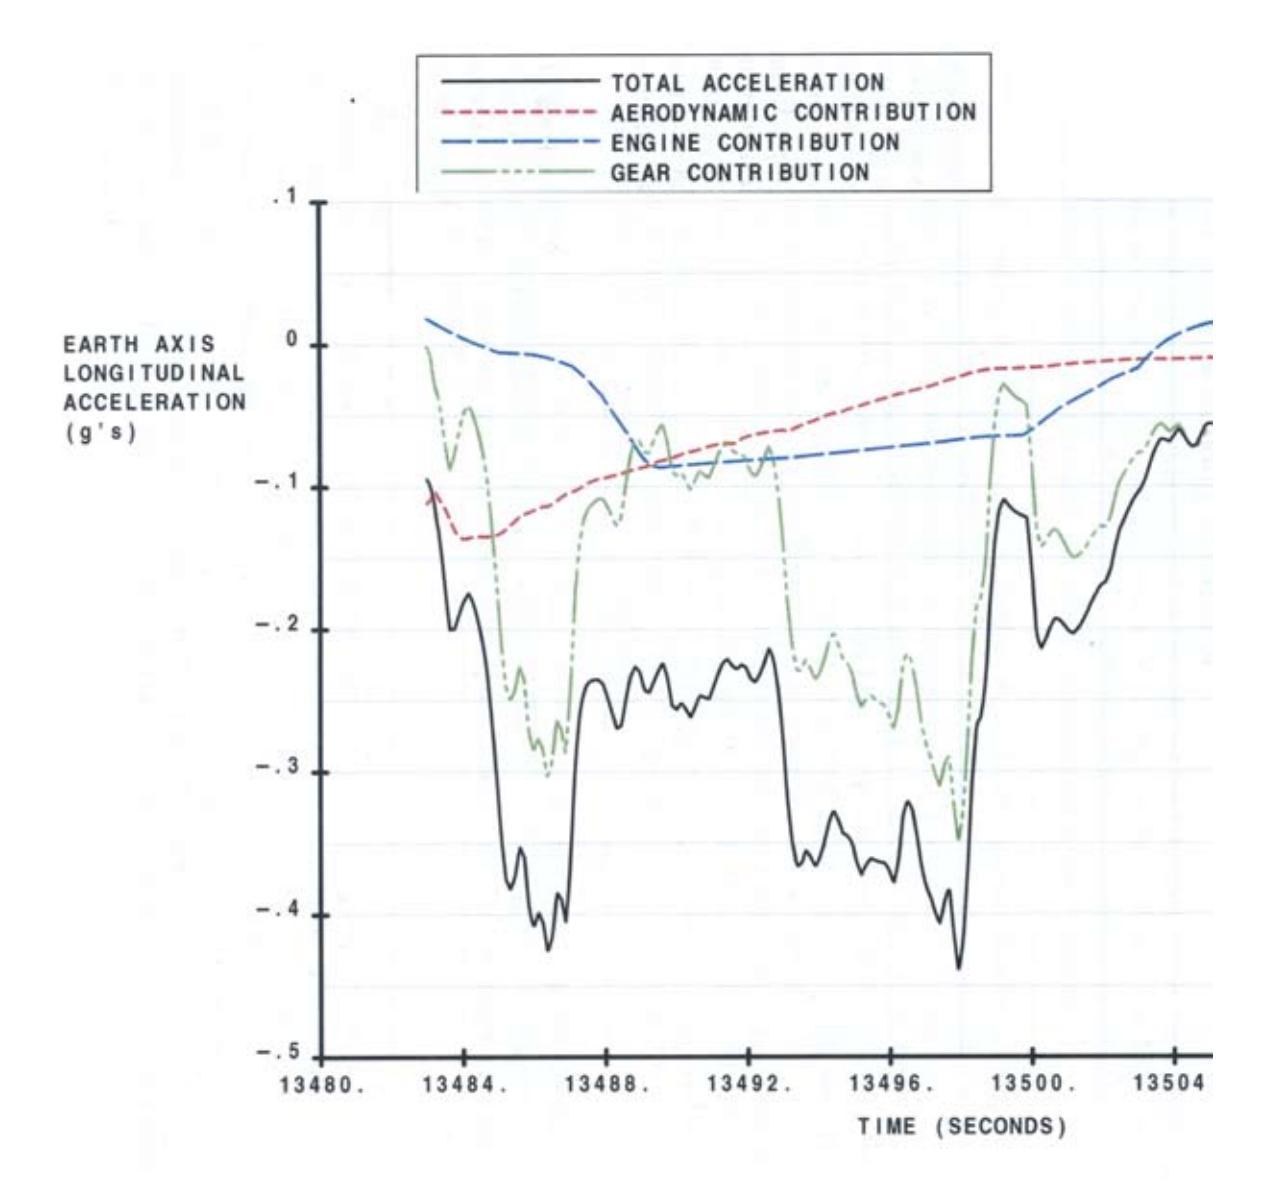
## Figure C1

G-XLAC component deceleration contributions 3 January 2007 (Reproduced courtesy of Boeing)

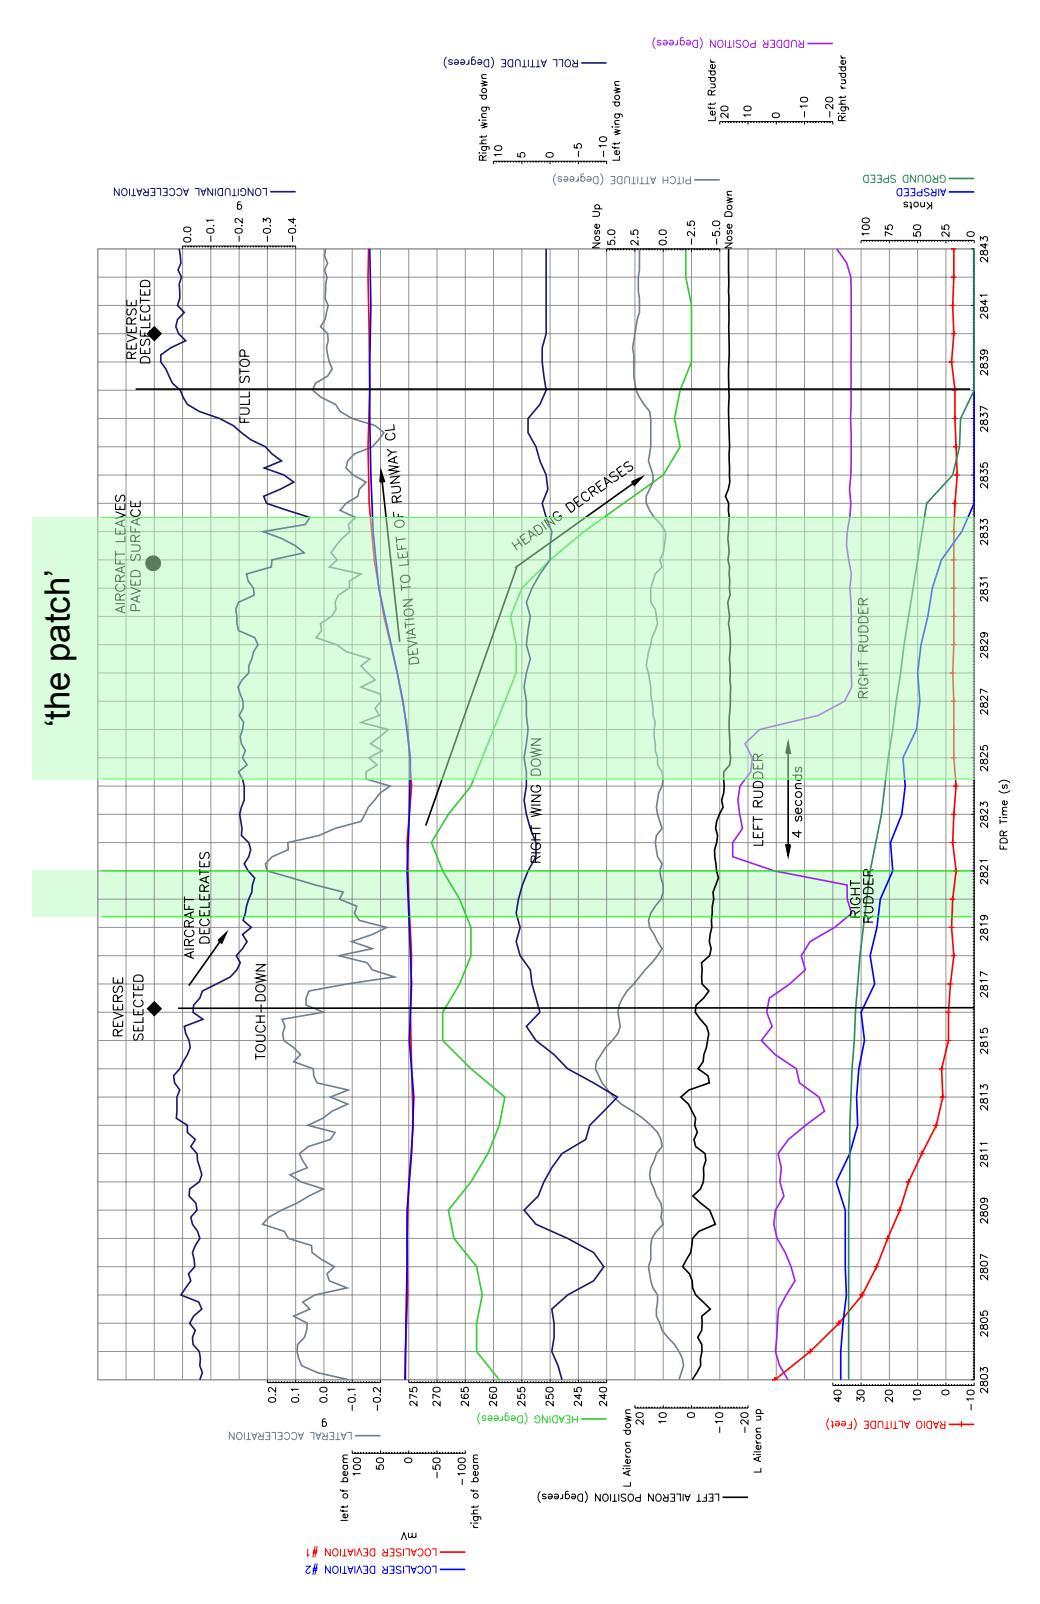
Figure C2

G-BWDA landing Runway 27, 29 December 2006

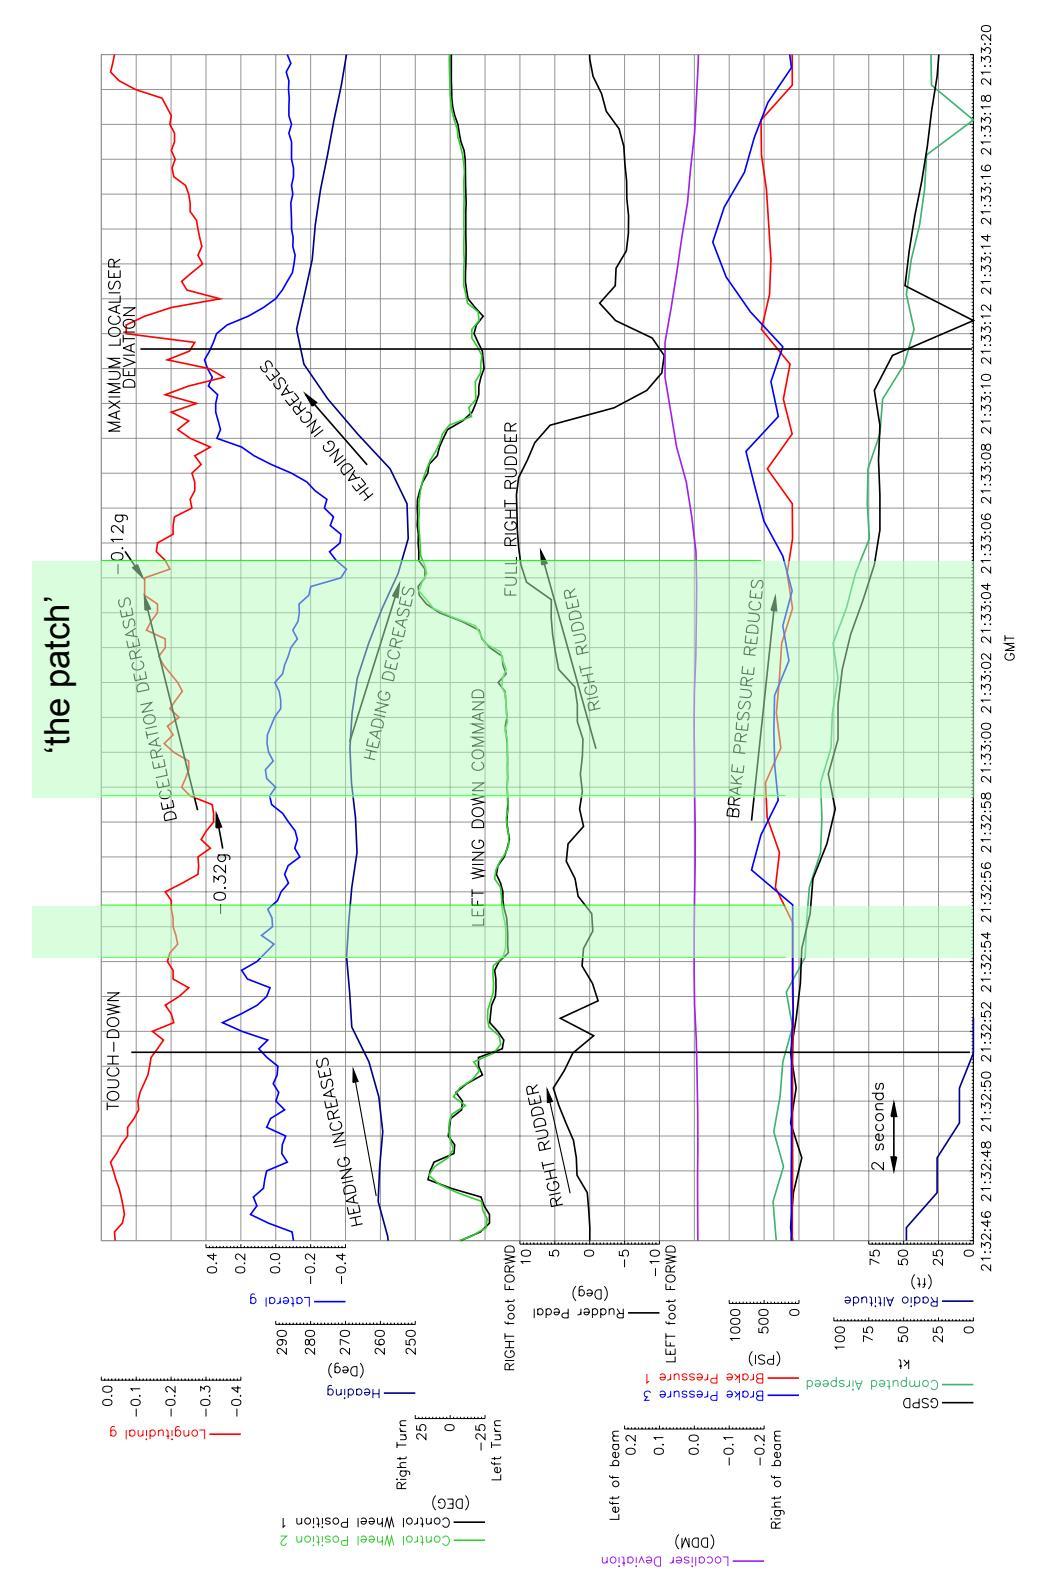
Figure C3

G-EMBO landing Runway 27, 29 December 2006

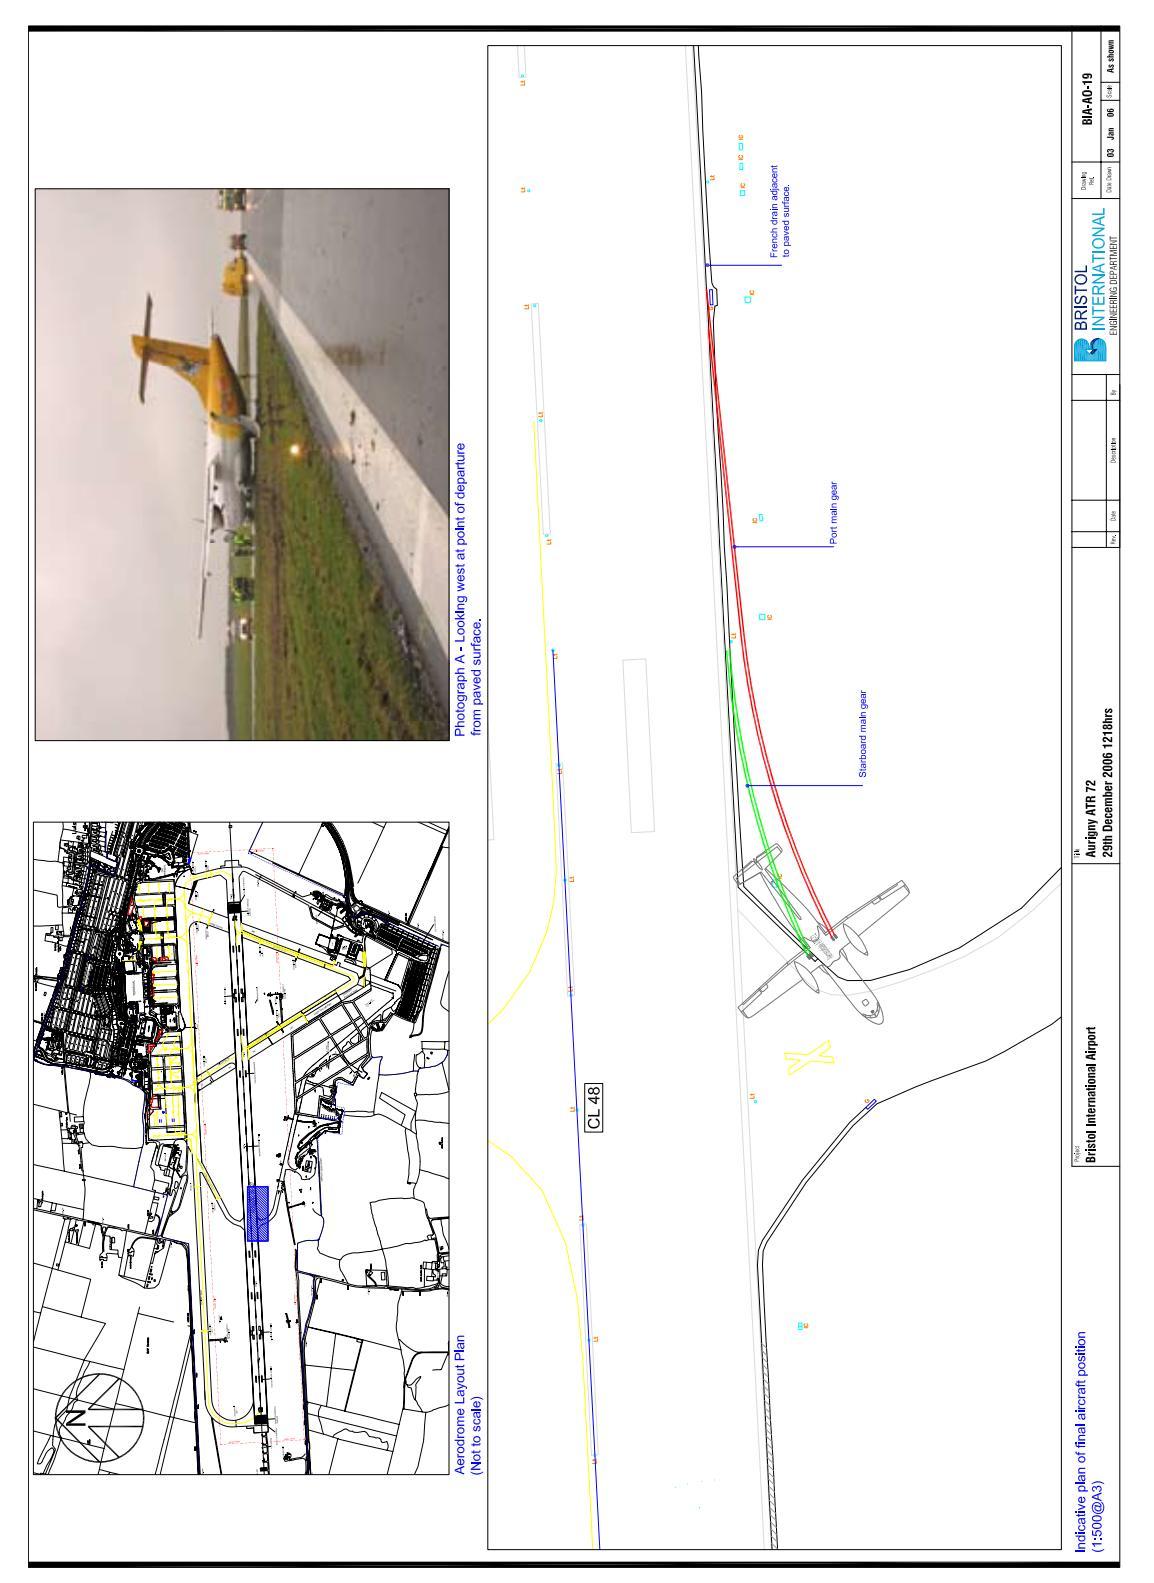
G-BWDA Position at BIA, 29 December 2006

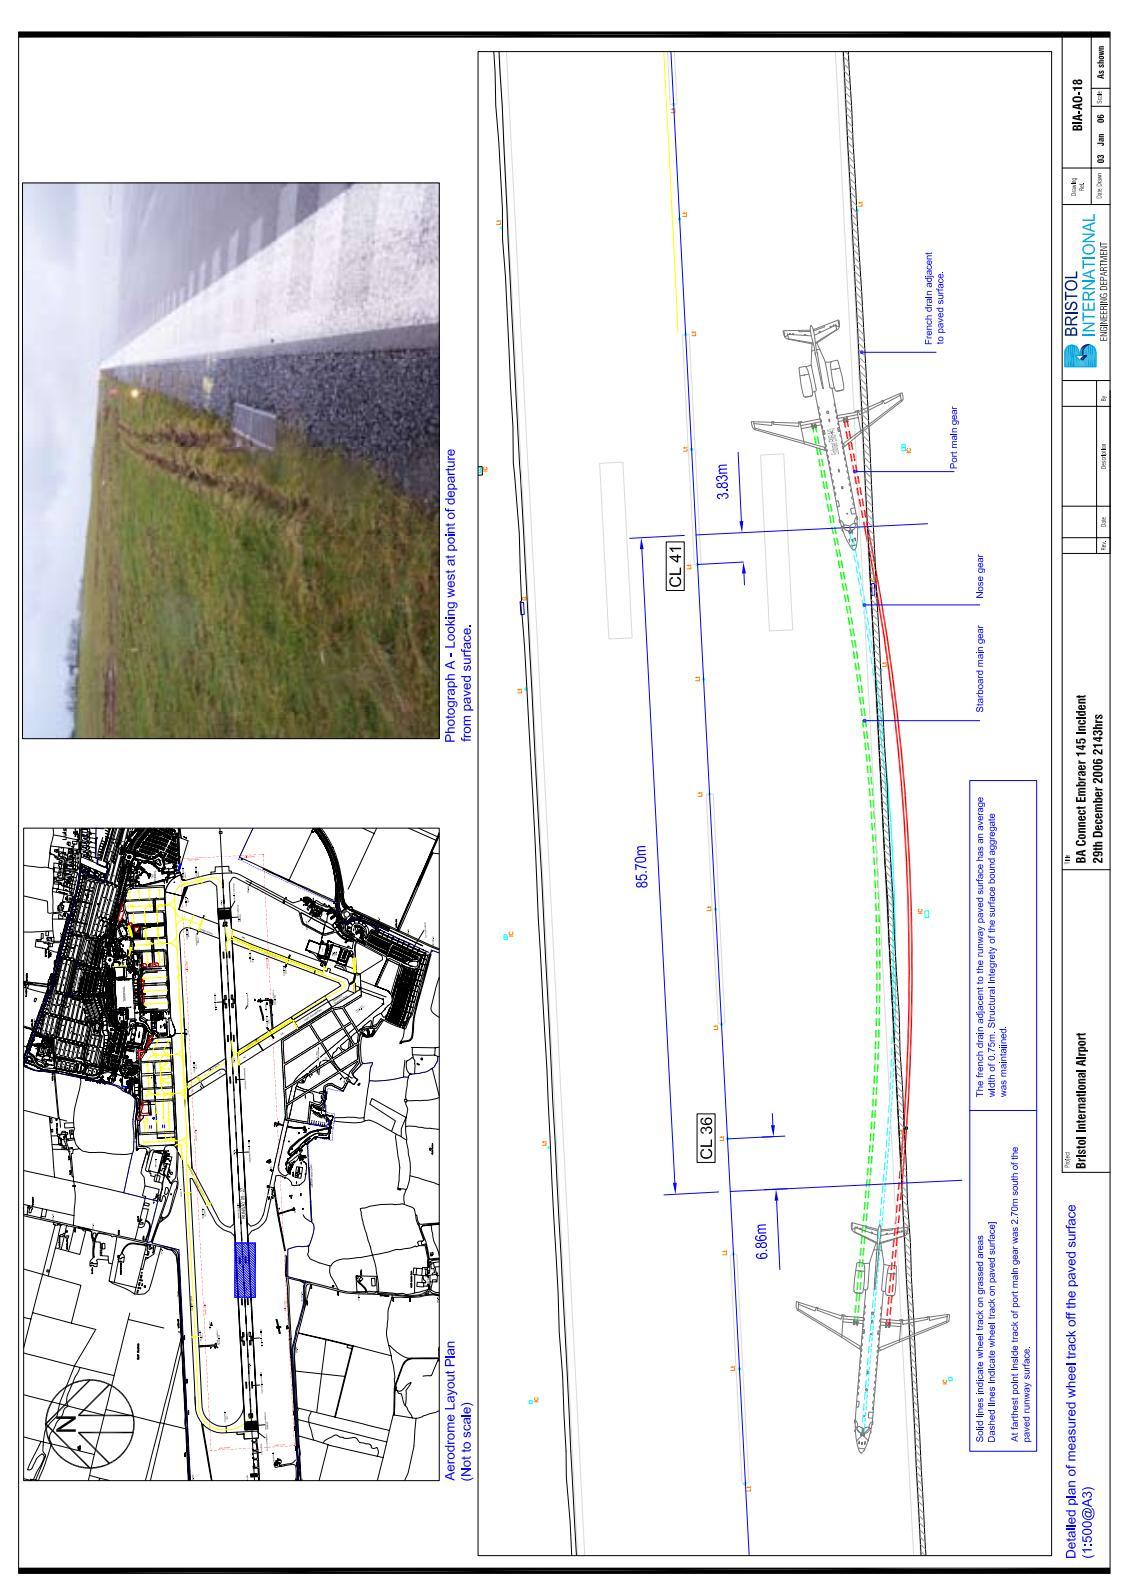
G-EMBO Position at BIA, 29 December 2006
