Report on the investigation into a release of phosphine gas during cargo discharge on board

Arklow Meadow

Warrenpoint, Northern Ireland

REPORT NO 21/2013

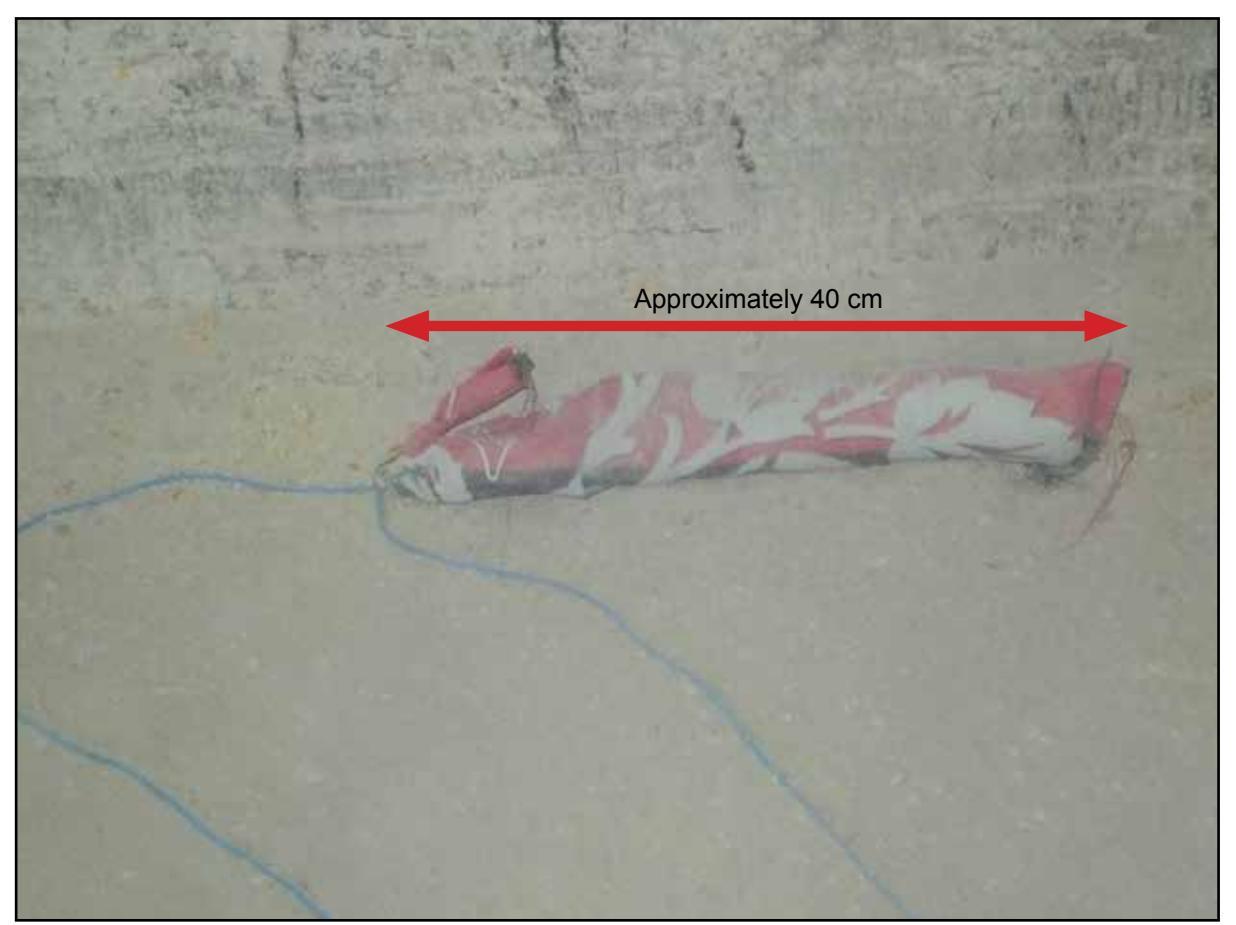
Figure 2: Fumigant 'sock' or retainer

- 1. Too much product contained in socks of low volume. This makes it difficult for water vapour present in the air to penetrate to the centre of the sock.
- 2. Unusually dry commodity causing low relative humidity.
- 3. Low temperature in maize slowing the production of phosphine.

Funigant pellets are designed to react with moist air to produce phosphine. However, the funigant pellets on board *Arklow Meadow* were tightly packed in the synthetic fabric socks (**Figure 2**) and it is likely that the pellets towards the centre of the socks had little or no exposure to the water vapour in the atmosphere until they were agitated when the socks were moved either by hand or by the crane grab. Furthermore, as the maize cargo had a middle moisture content of 11.5%, it was relatively dry (in the UK, grain cargoes are stored with a middle moisture content of around 14.5%) and the resulting relative humidity in the sealed cargo holds was possibly too low to trigger the generation of PH³.

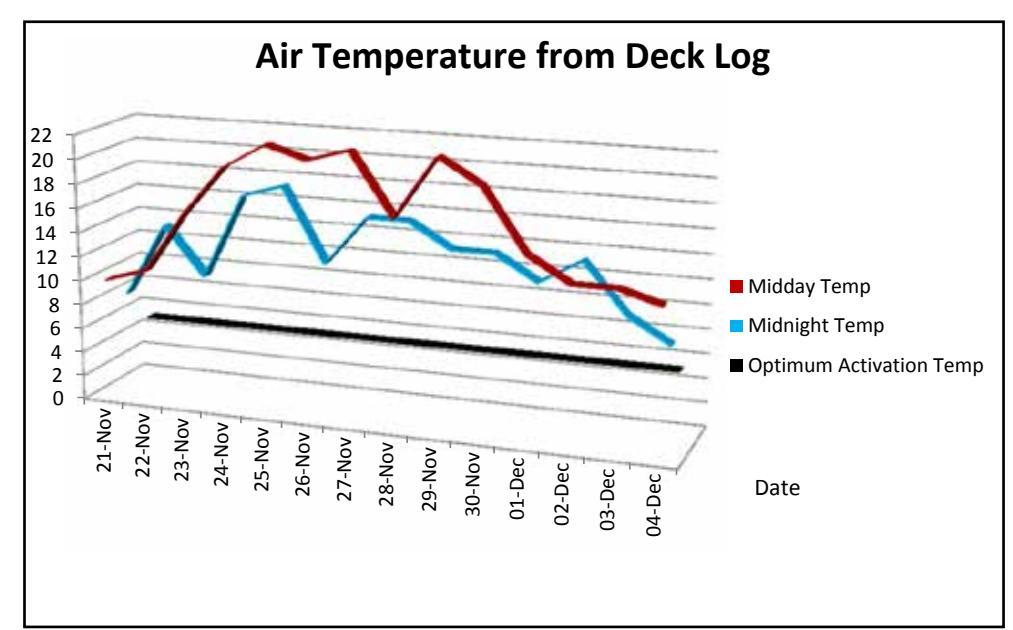
Figure 6: Midday and midnight air temperatures

It is evident from the exposure times recommended by the manufacturer of the aluminium phosphide used on board *Arklow Meadow* (**Paragraph 1.6**), that temperature is a key factor in the speed and effectiveness of the fumigant in generating PH³ in cargoes in transit. In this case, the temperature of the maize cargo was 10°C when loaded on board *Arklow Meadow*, and the air and sea temperatures generally remained above this temperature during the vessel's 14 day voyage (**Figures 6** and **7**). Therefore, although the FIC's estimate, that the exposure time required was 7 days, was possibly optimistic, the aluminium phosphide should nevertheless have been fully broken down and inactive by the time the vessel arrived off Warrenpoint if its decay was dependent on temperature alone.

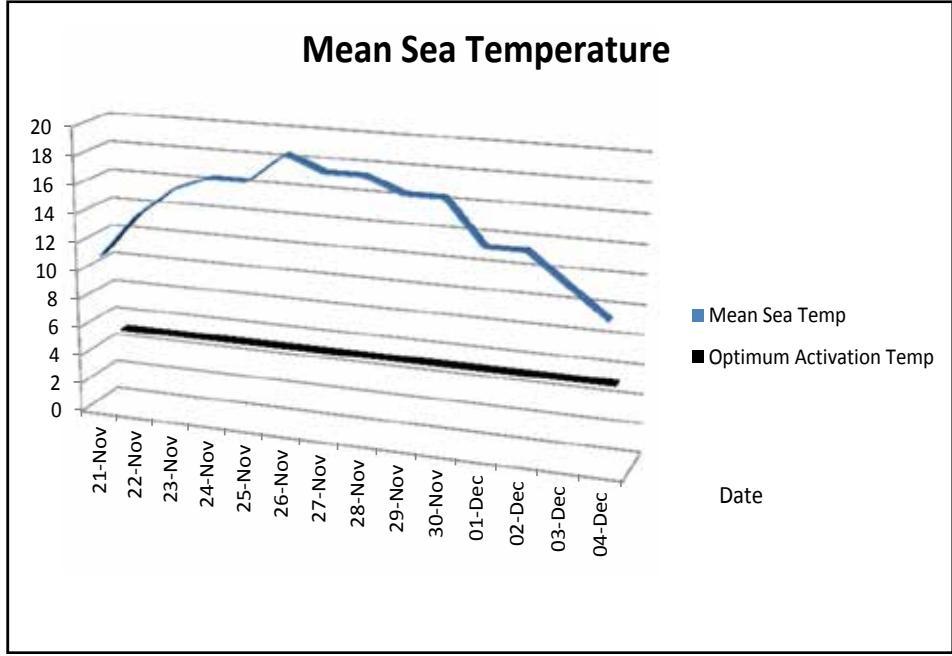
Figure 7: Daily mean sea surface temperature

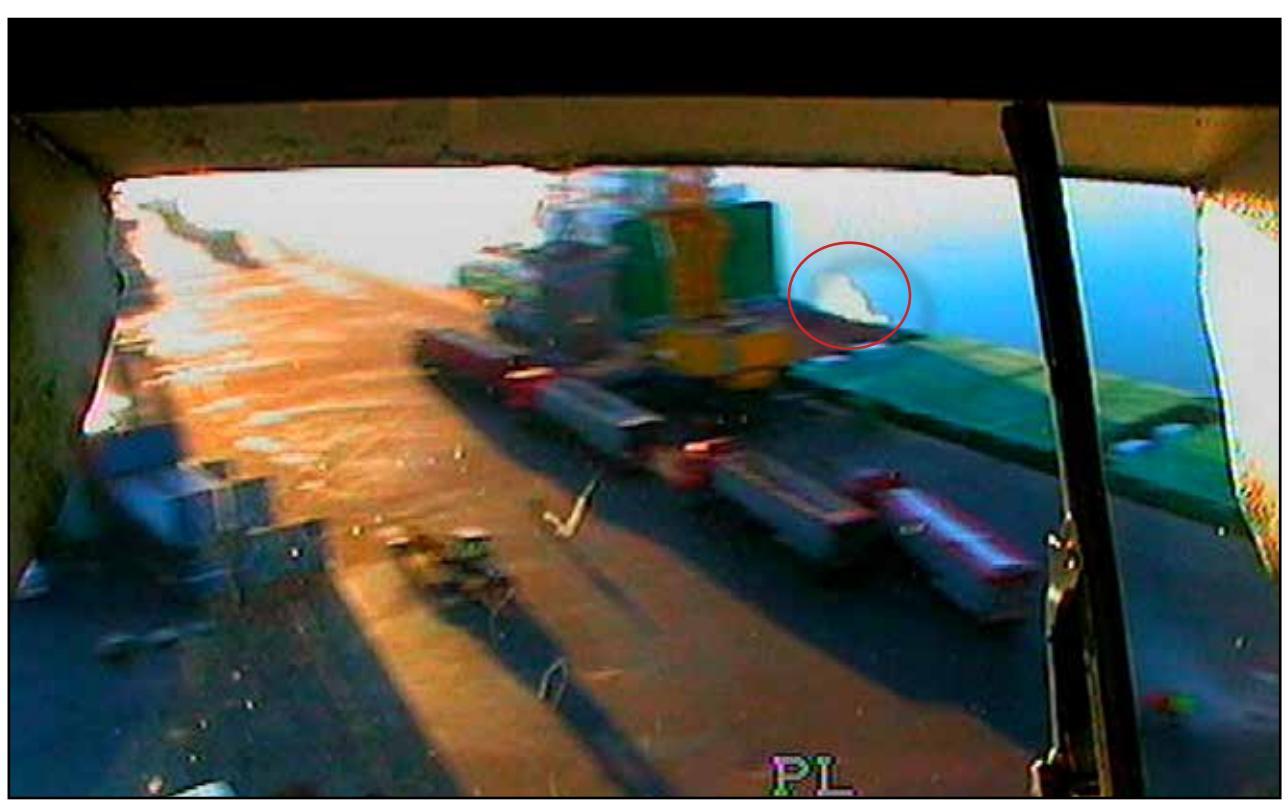
Figure 10: Smoke from fumigant socks inside a bag on Arklow Meadow's port side

The smoke generated by the socks on the deck and in the bag indicates the presence of large quantities of residual aluminium phosphide in the socks which produced sufficient phosphine to exceed 1.8% on the wet deck. This suggests that the formulation had not completely broken down.

With the fumigant still active, the failure to remove the fumigant residues from the cargo holds before cargo operations were started, and the subsequent incorrect handling of the fumigant residue that was eventually removed, resulted in the ship's crew and shore workers being exposed to high levels of PH³. The consequences of the crew's actions were that fumigant socks were inadvertently distributed into the shore hoppers and potentially into the food chain, and the fumigant socks that were placed onto the wet deck and then into the confines of a plastic bag soon reached their LFL and started to smoke.

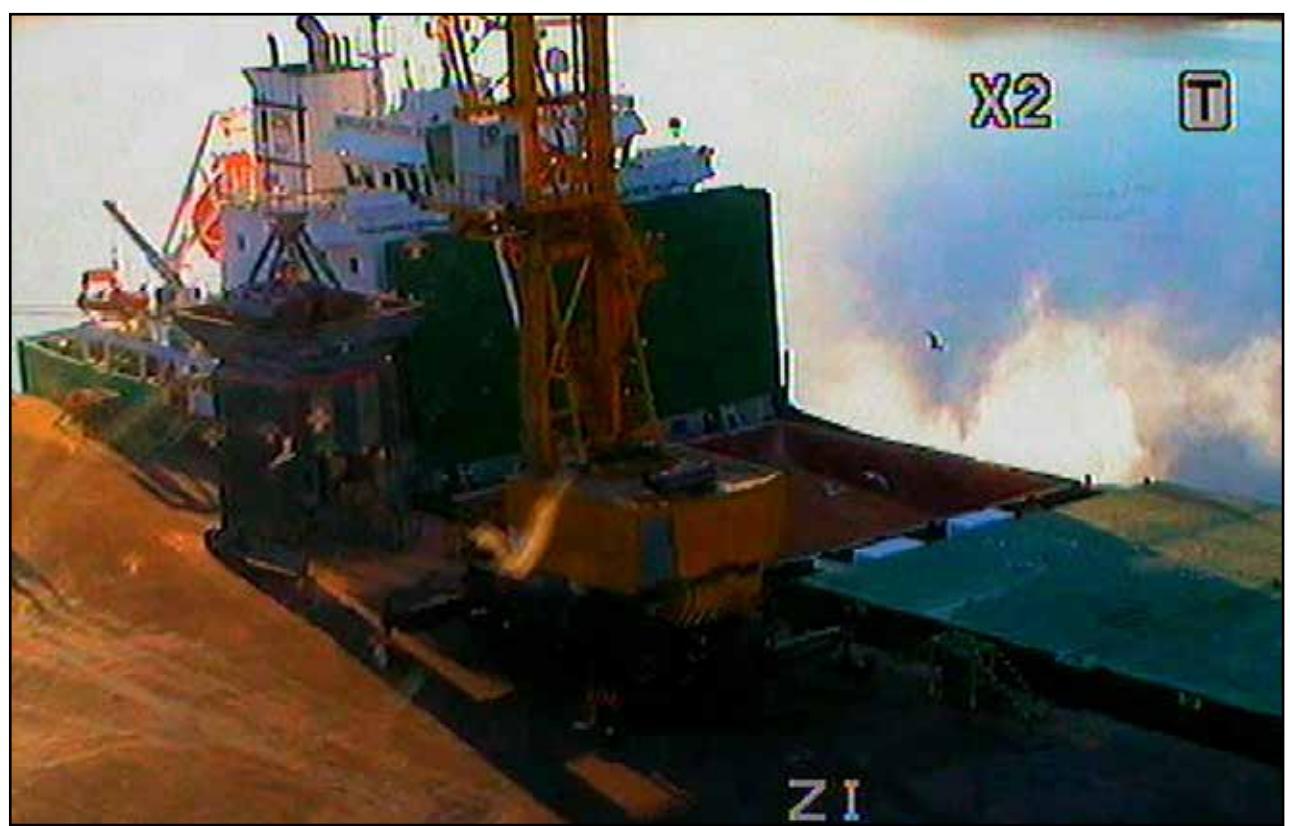
Figure 11: Denser smoke from bagged fumigant
