Report on the investigation of

the capsize and foundering of the fishing vessel

Heather Anne (FY 126)

REPORT NO 2/2013

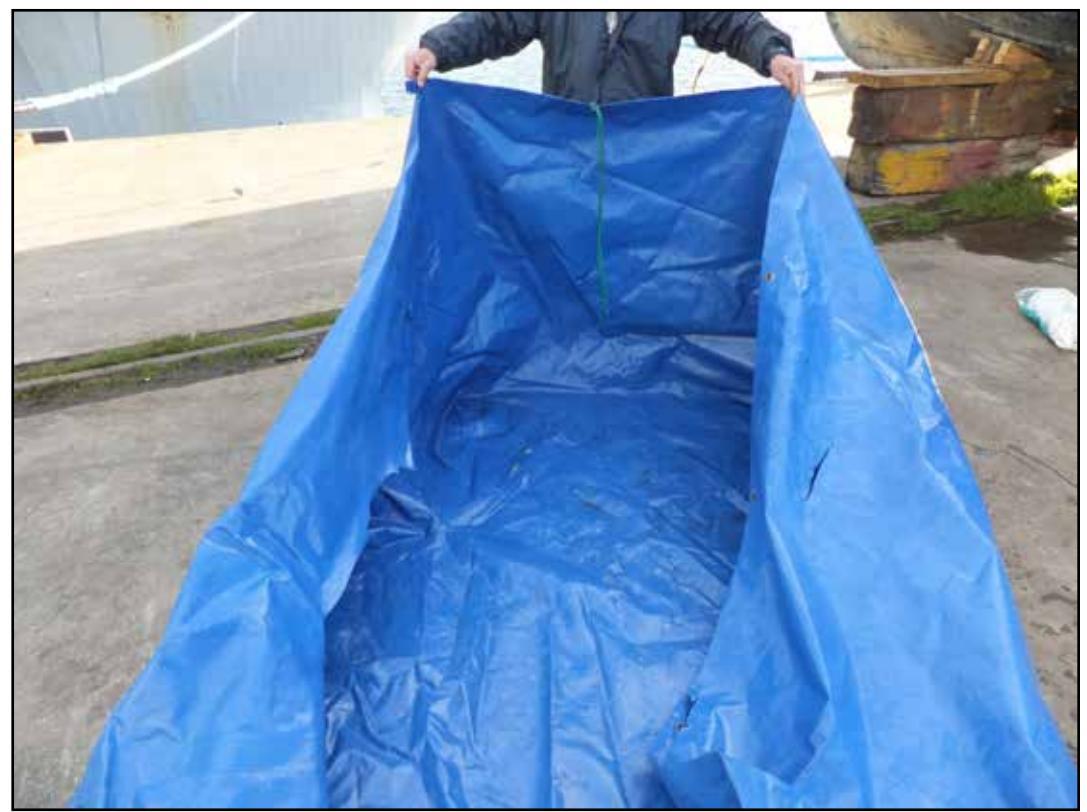
- In 2009 and 2010, *Heather Anne* was operated with a polyvinyl chloride (PVC) tarpaulin with welded seams (Figure 7) fitted inside the fishroom to form a central 'tank'. The tarpaulin was held in place by longitudinal pound boards on both sides. The 'tarpaulin tank', which had a capacity of about 3.4m³, was fitted to simplify the stowage and removal of catch within the fish hold when ring-netting. The 'tank' also helped to prevent the bilge pipework and pumps becoming blocked by tough but flexible fish scales that resulted from the brailing process.

Figure 7: PVC tarpaulin

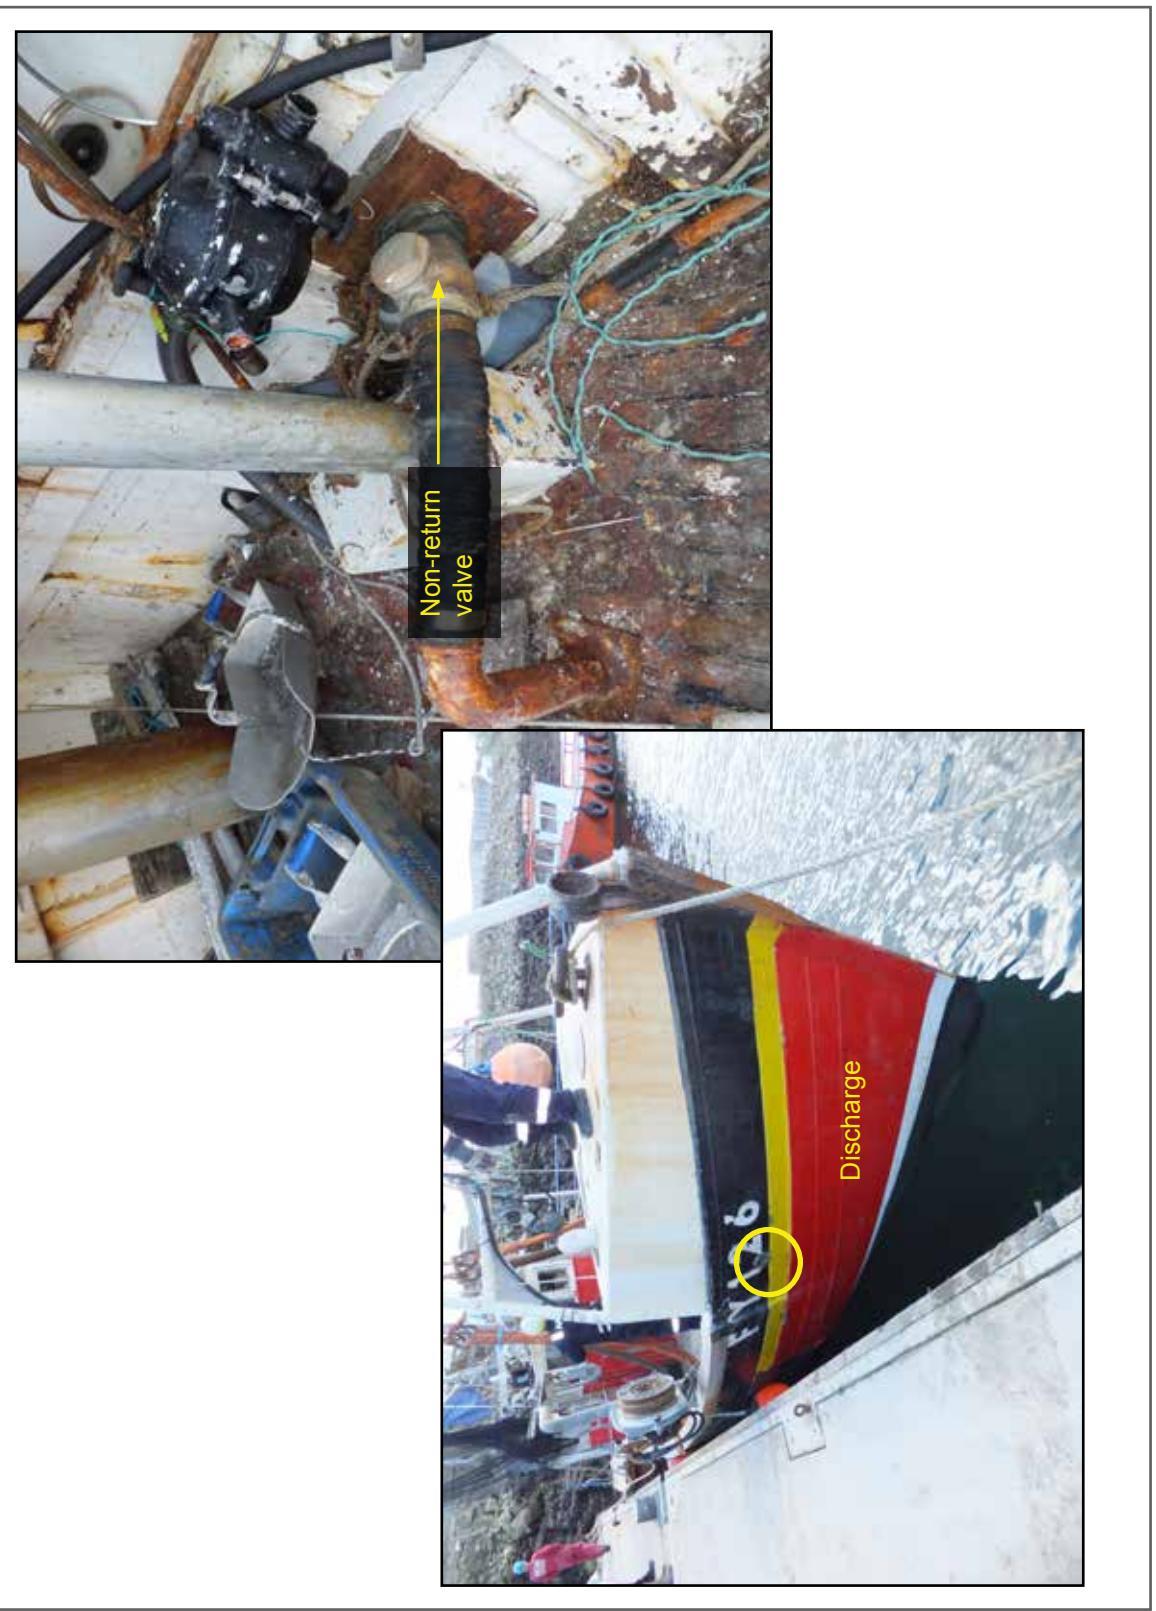
Three 4000 litre/hour electric pumps, two of which operated in tandem, were fitted below the deck in the fishroom. The pumps operating in tandem discharged through a 75mm diameter strengthened rubber hose, that passed through the deck via a steel deck fitting and overboard through the starboard bulwark (**Figure 8**) via a brass non-return valve.

The third pump discharged overboard on the port side below main deck level via a 30mm diameter rubber hose. The discharge hose on the port side was not fitted with a non-return valve.

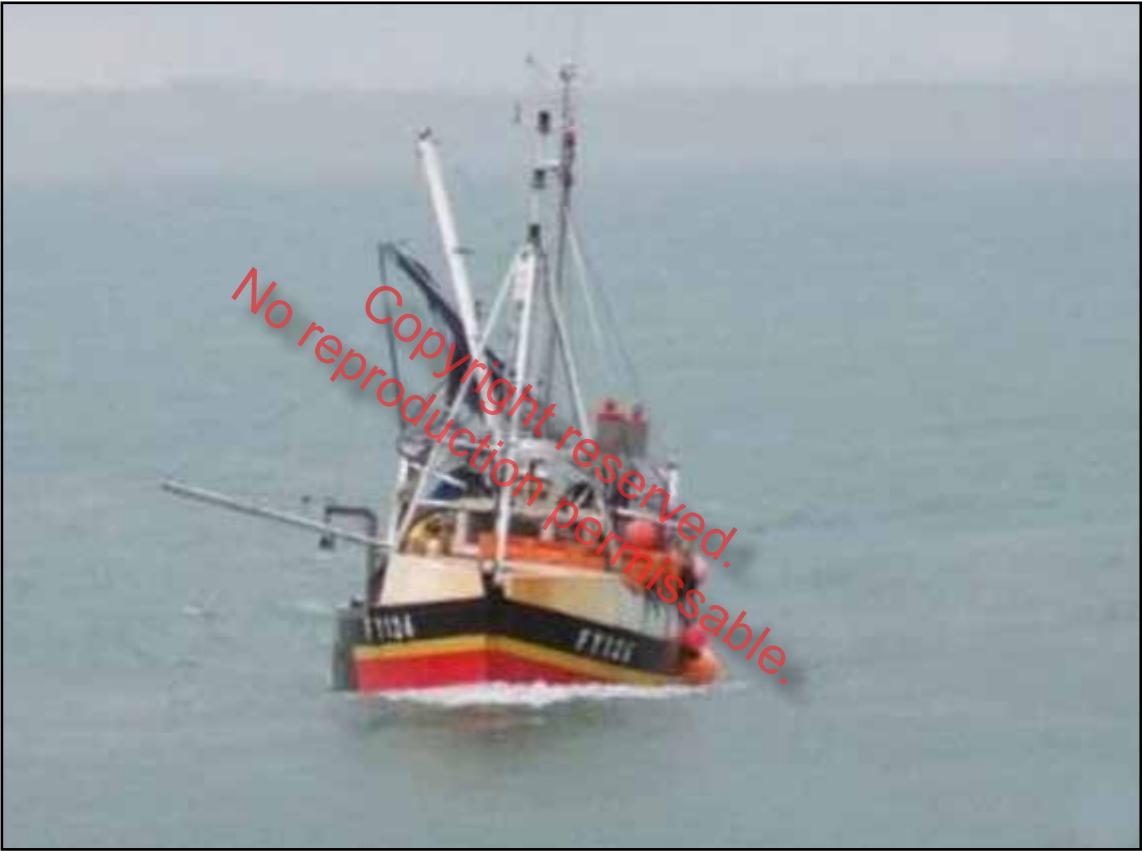
Figure 9: Heather Anne returning to Mevagissey on 19 January 2011, carrying 10.1 tonnes of Cornish sardines

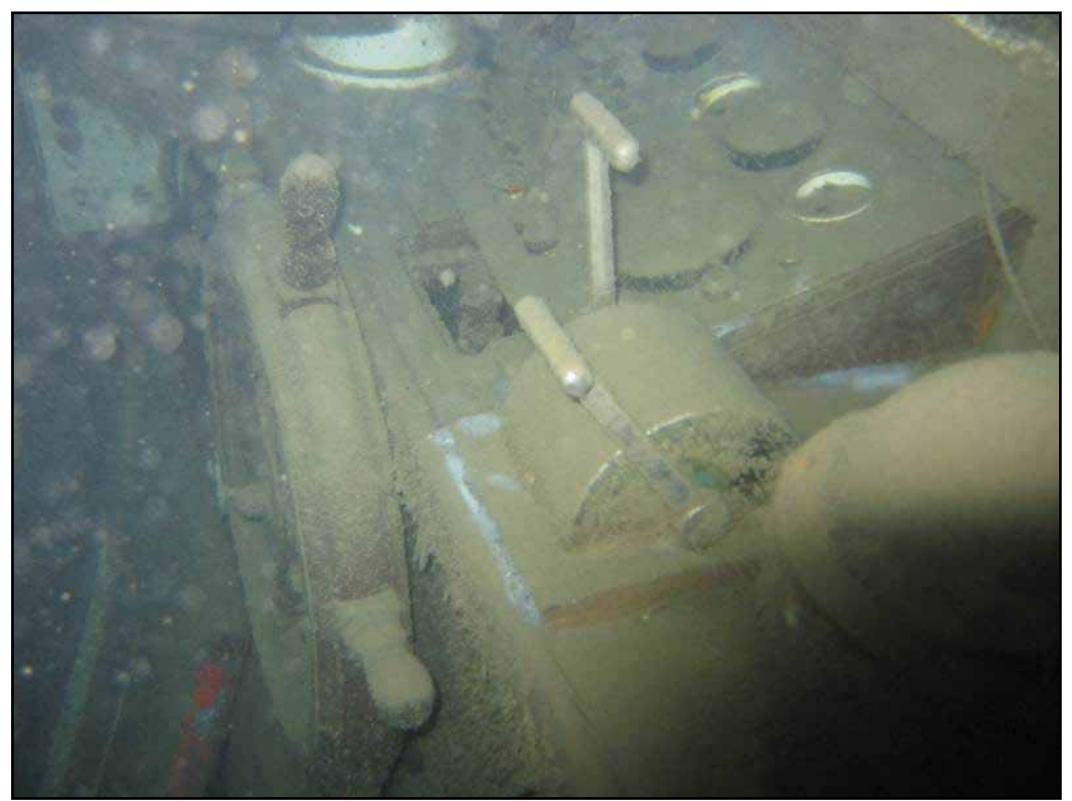
Figure 12: Position of engine throttle

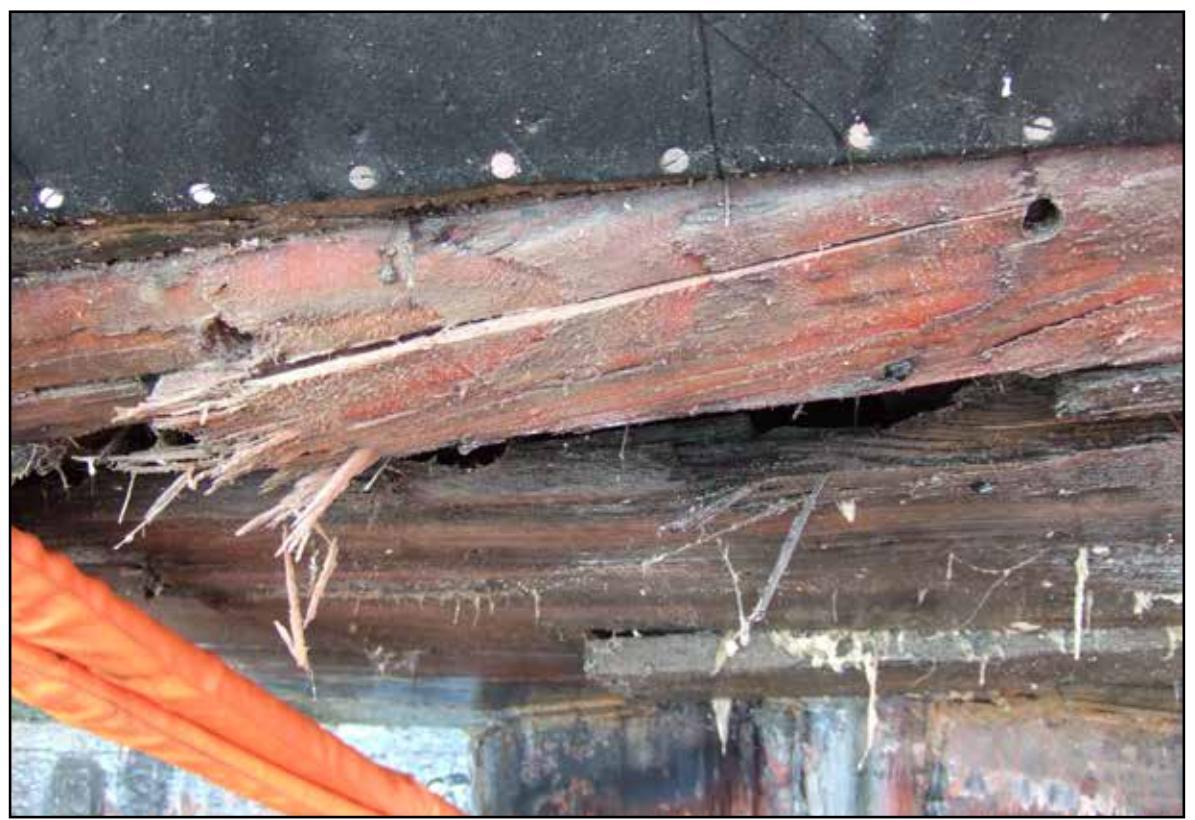
Close examination found that a localised area of planking on the starboard side turn of the bilge in the area of the fishroom was damaged (**Figure 16**). The damaged area was coincident with an area of the hull that had rested on the seabed and the position of a lifting strop used during the vessel's recovery.

Figure 16: Heather Anne - damage to planking

The hull damages found were all on the starboard side just forward of amidships where we understand the vessel had been sitting on the bottom. There were no hull damages on the port side in this area.

The timbers in way of the damages were all in reasonable condition with no sign of any rot. The 10th timber out from the keel appeared to have been renewed recently in a different wood from the original hull. There appeared to have been some refastening carried out fairly recently in way of the damaged area but this was not as extensive as it could have been with several planks having not been refastened over quite some considerable length. The two sprung planks, 5 & 7, were examples of this.

With the very poor state of the fastenings in the general area around the missing sections of planking the damage could have occurred when the vessel was lying on the bottom and may have been moving slightly.

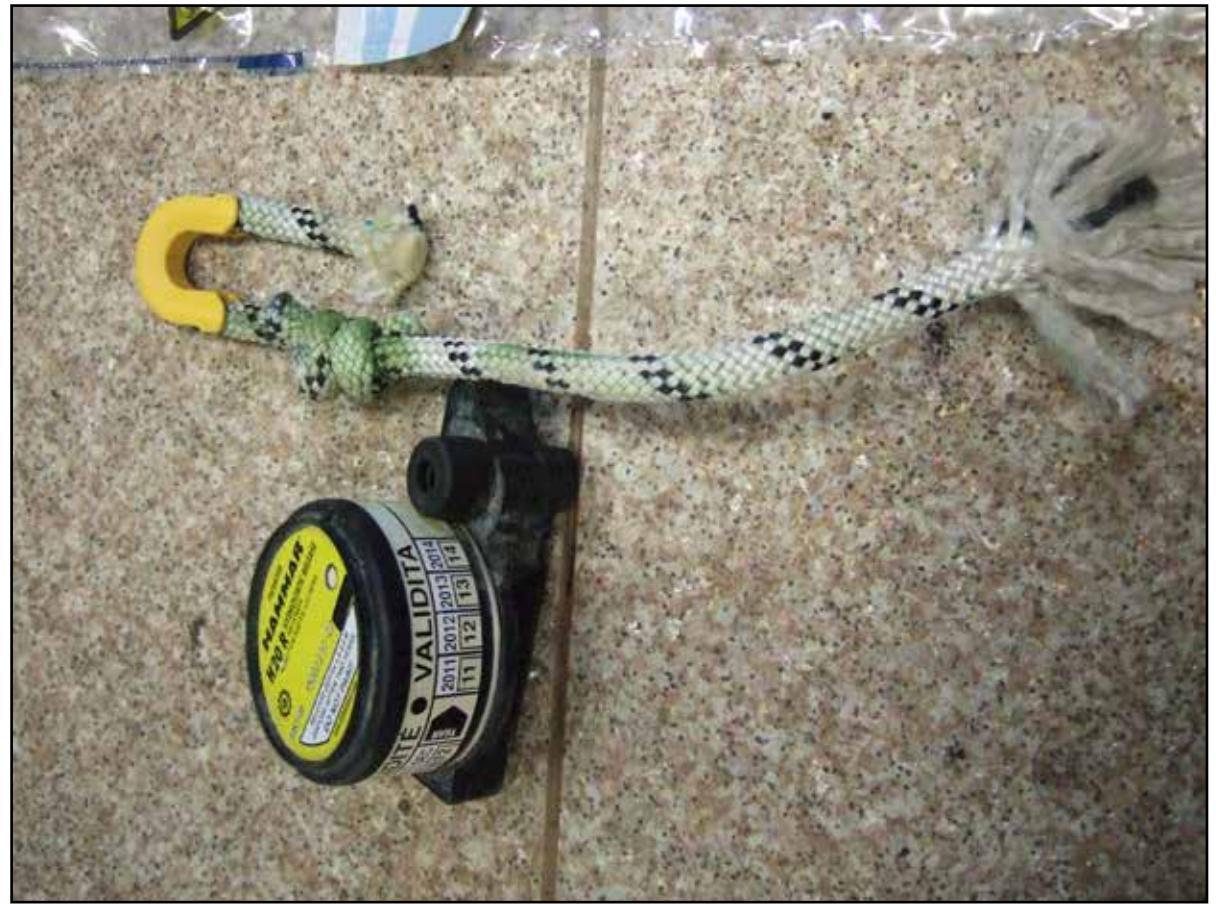
Examination of the liferaft HRU following its retrieval by the Devon and Cornwall Police (Figure 17) identified that the device had operated. A hologram on the HRU indicated that it had been fitted after 24 February 2009 but the date tabs showing its required replacement date had not been removed. The 'in service' life of the HRU was a maximum of 2 years.

Figure 17: Recovered HRU

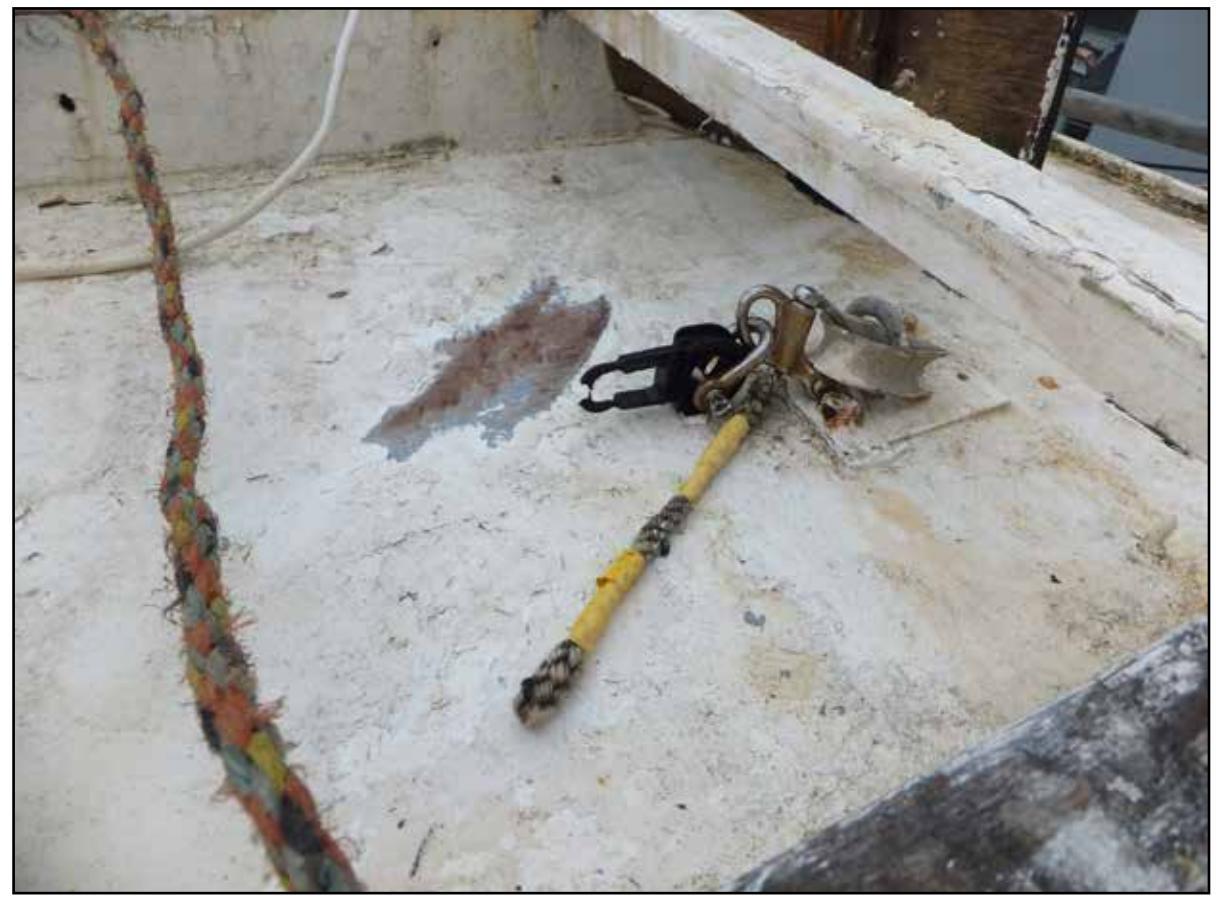
The remains of the HRU lower thimble which incorporated the 'weak link' was found on the starboard side of the wheelhouse roof. The 'weak link' appeared to have broken as intended (Figure 18).

Figure 18: Broken 'weak link'

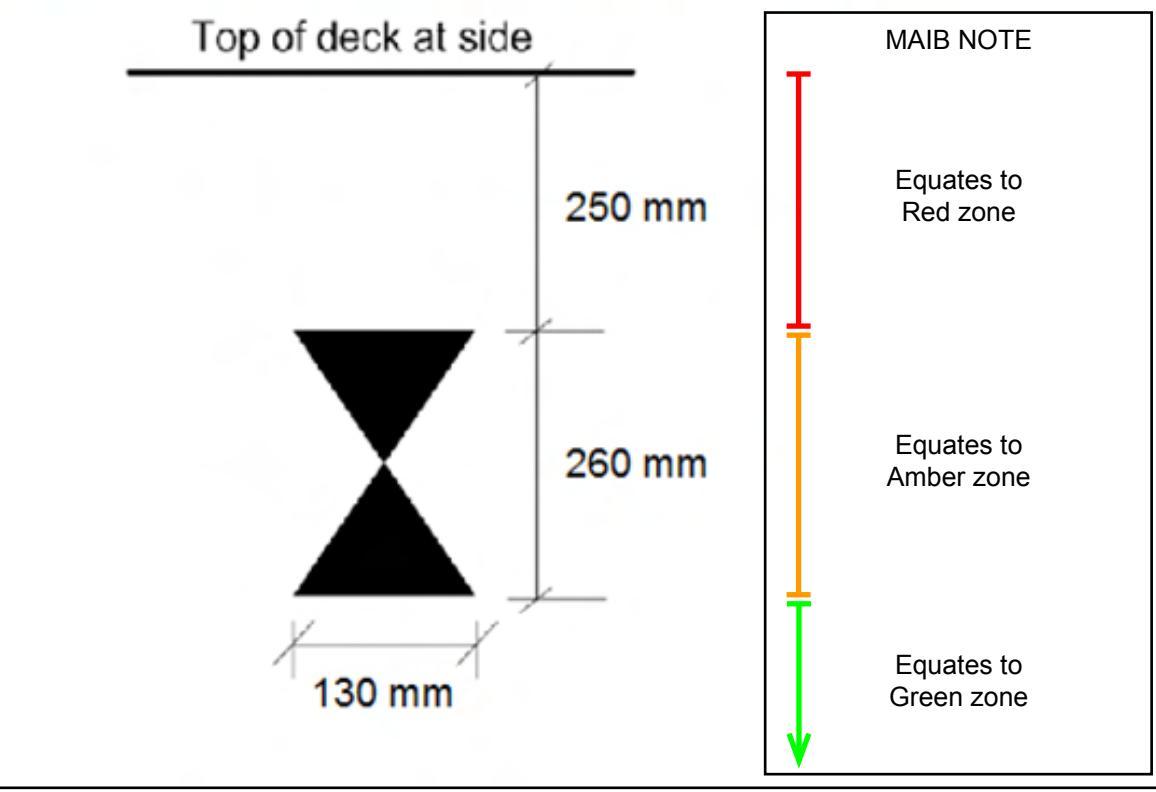
STABILITY NOTICE					
Name Heather Anne No. FY126 Owner 0 Length 11 metres Beam 4.2 metres	Loading & Lifting Guidance	Safety Zone	Minimum Freeboard	Maximum Recommended Seastate	
	Good margin of residual freeboard	Good margin of safety	At least 51 cm		
	Loading or lifting reducesminimum freeboard to less than 51 cm	Low level of safety	25 to 51 cm	1.3 m etres	
	Excessive loading or lifting reduces minimum freeboard to less than 25 cm	Danger of capsize	Less than 25 cm	0.7 metres

Figure 19: Stability notice and guidance mark

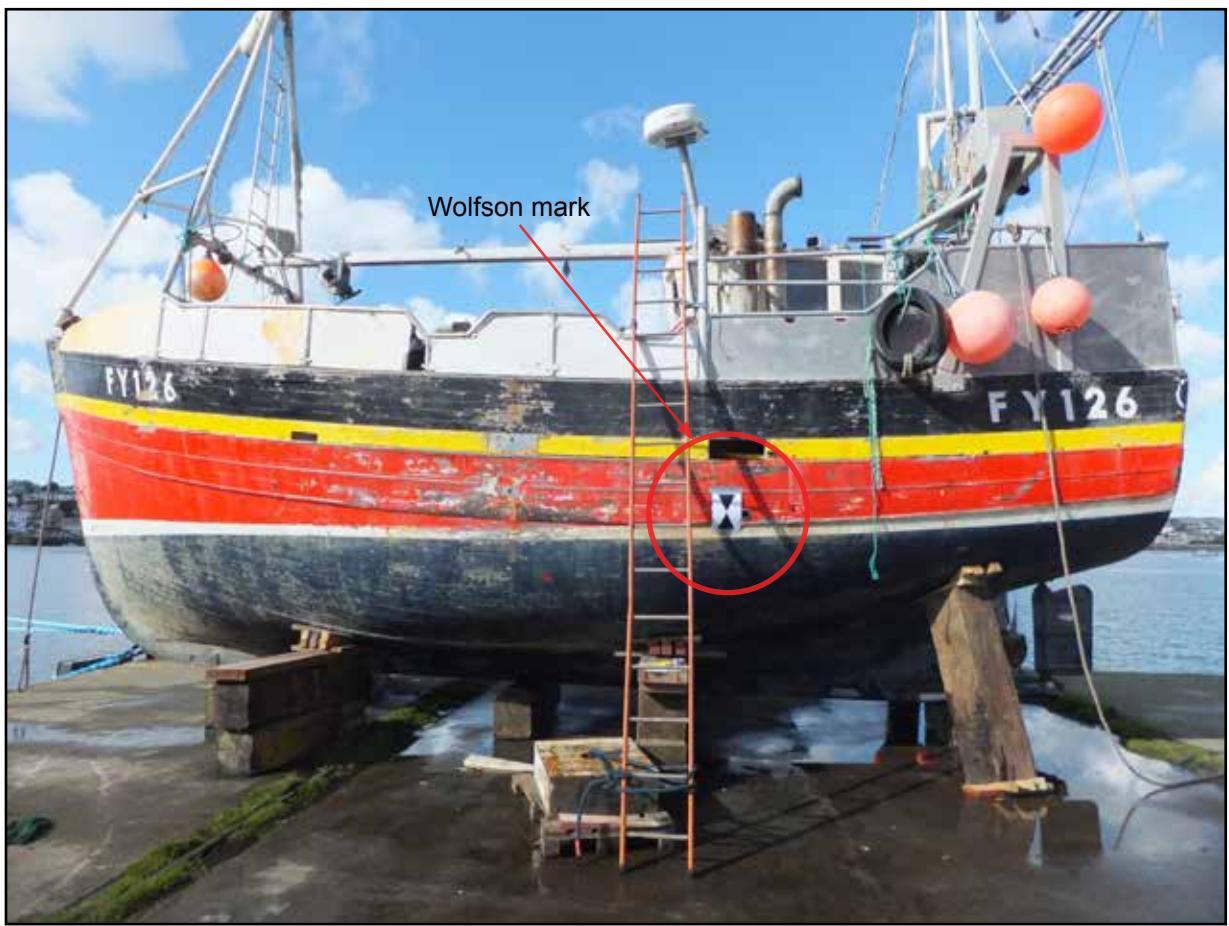
Figure 20: Heather Anne with freeboard guidance mark
