Report on the investigation into the

unintended movement of the ro-ro passenger vessel

Ben-My-Chree

Marine Accident Investigation Branch Mountbatten House Grosvenor Square Southampton United Kingdom SO15 2JU Report No 17/2010 December 2010

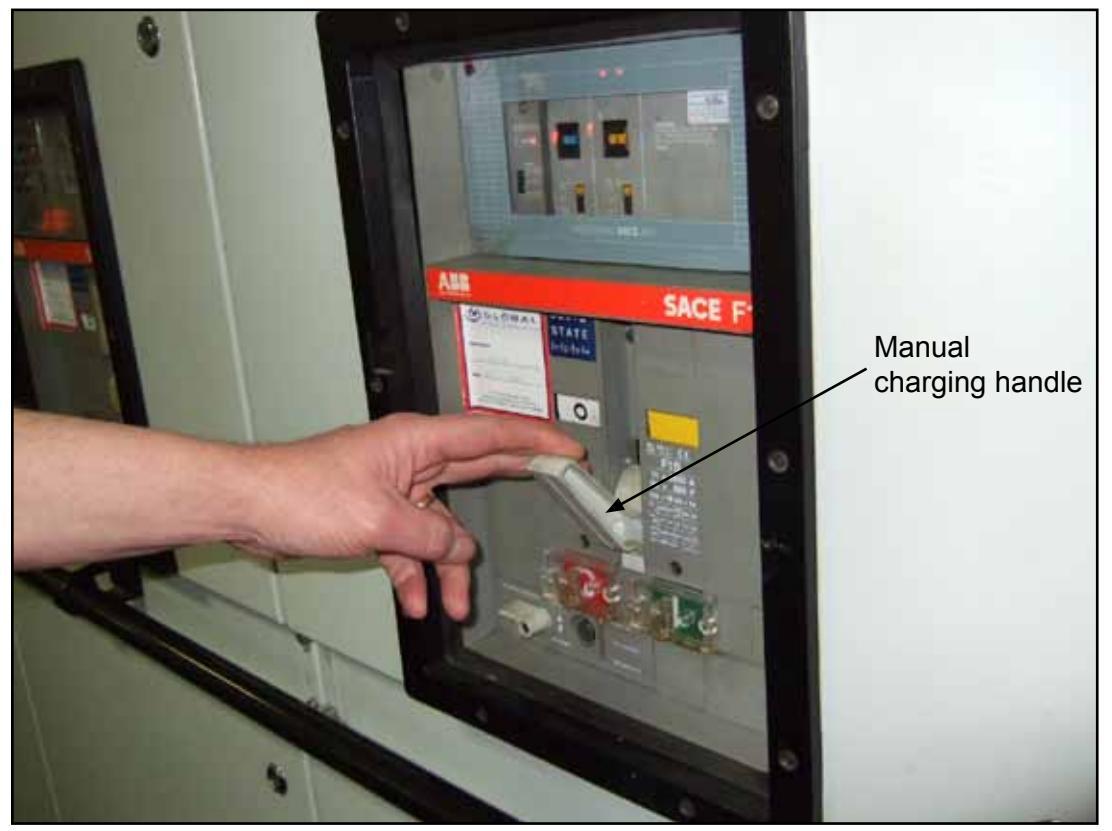
Figure 2

During the attempts to diagnose the MCB faults a fuse from an MCB charging spring motor fell out of its holder; but no one noticed it fall. The technicians then discovered that they could only engage the MCB manually by physically winding up the charging spring motor using its handle (**Figure 2**). They requested a third test and, at 1342, the 2/E asked the master to switch on the bow thruster again. This time the master observed the bow thruster motor start up as normal, and 2 minutes later he received a call from the 2/E who informed him that the tests were completed. At about 1350, the chief officer and master left the bridge and the 2/E left the ECR to prepare the port engine for departure. The starboard engine, still in engine room control, was left running.

Main circuit breaker

Shortly afterwards, one of the technicians found the missing fuse from the MCB charging spring motor circuit lying just under its holder, and he put it back in place. The spring motor was then observed to wind up under electric power. The technicians asked the chief engineer if operation of the forward bow thruster motor could be tried once again, but the chief engineer did not immediately relay this request to the master.

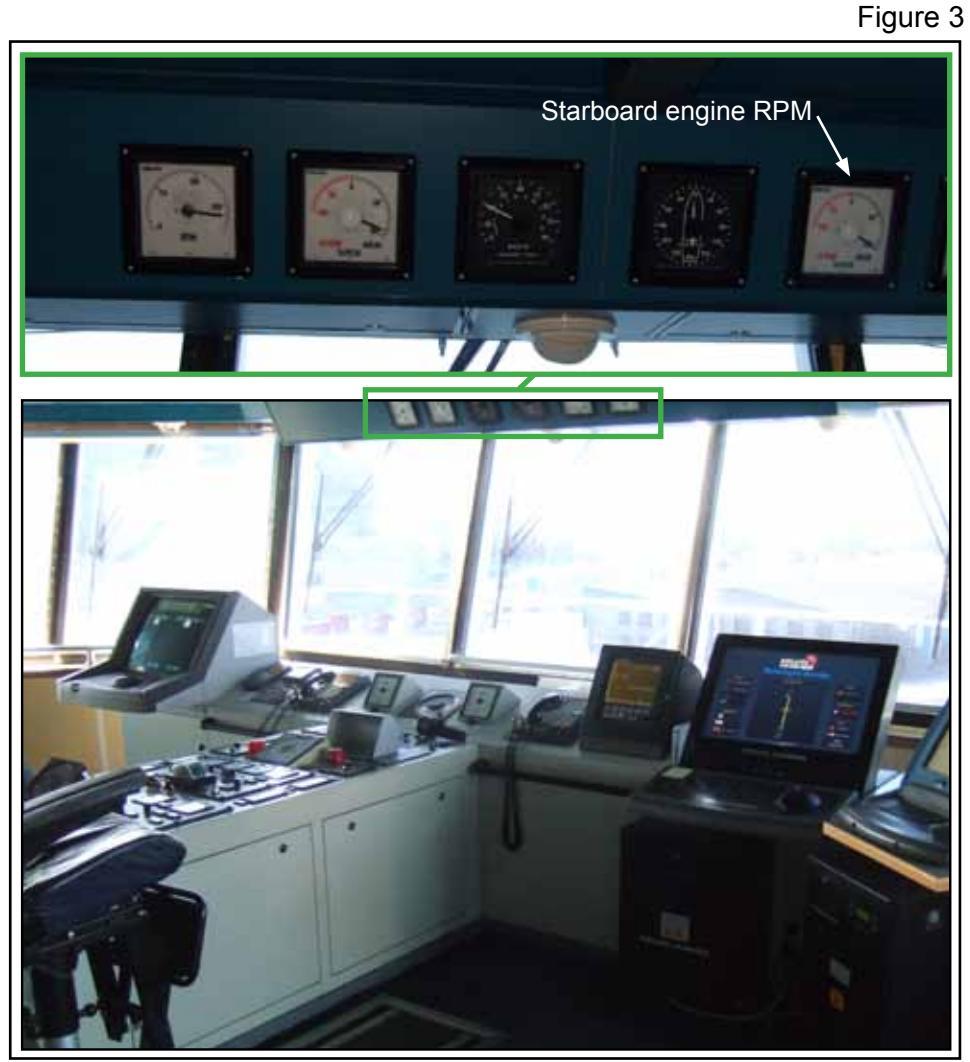
The chief officer approached the centre console from its side (**Figure 3**) and at 1357:22 moved the pitch control levers on both engines to the 100% ahead position. He also put both rudders hard to starboard. The rudder angle attained was 18.5 degrees on both rudders. He then asked the master if he could test

Central control station on bridge. Insert - deck head repeaters above bridge windows

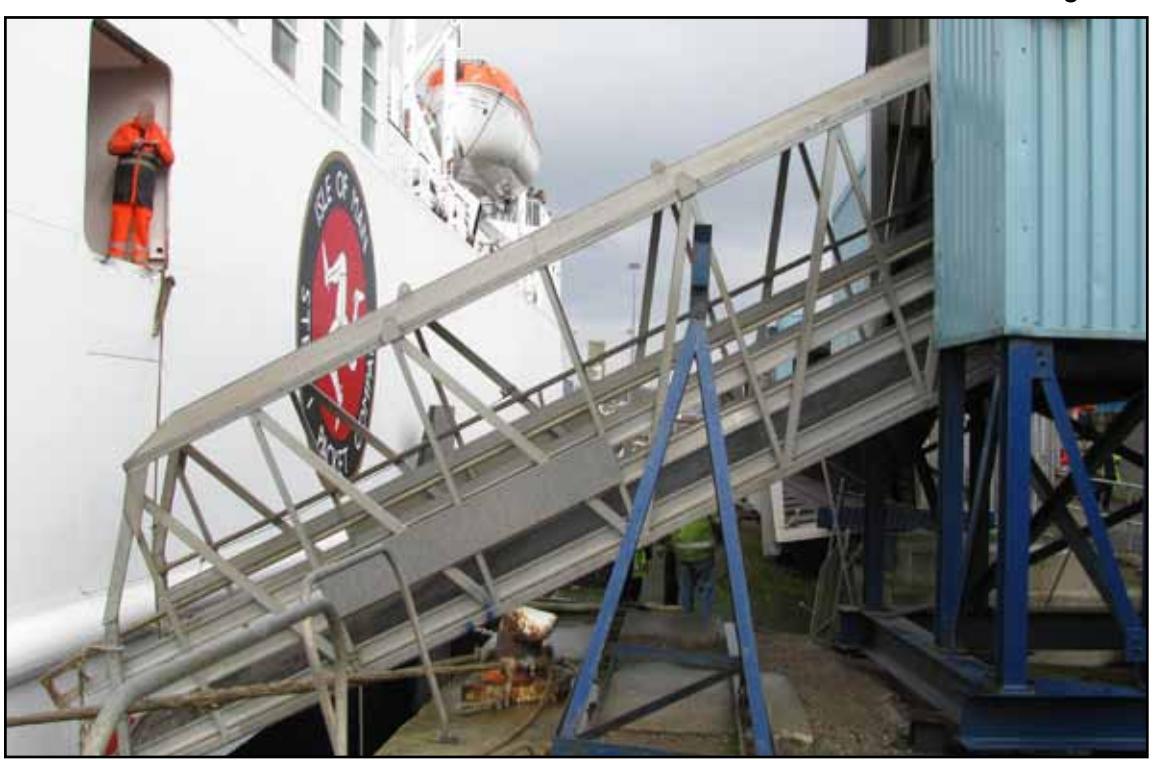
Figure 4

Two or three passengers, who were on the gangway and about to embark, ran inside the vessel. Some others, who were stepping on to the gangway from its shore compartment, were told by the gangway watchman to remain in the compartment of the shore structure, and they retreated quickly. The watchman then tried to disconnect the gangway from the vessel. He unlashed the forward securing line and, while he was trying to unlash the aft line the gangway pulled clear of the vessel and hung, suspended by its aft line (**Figure 4**).

Gangway collapse

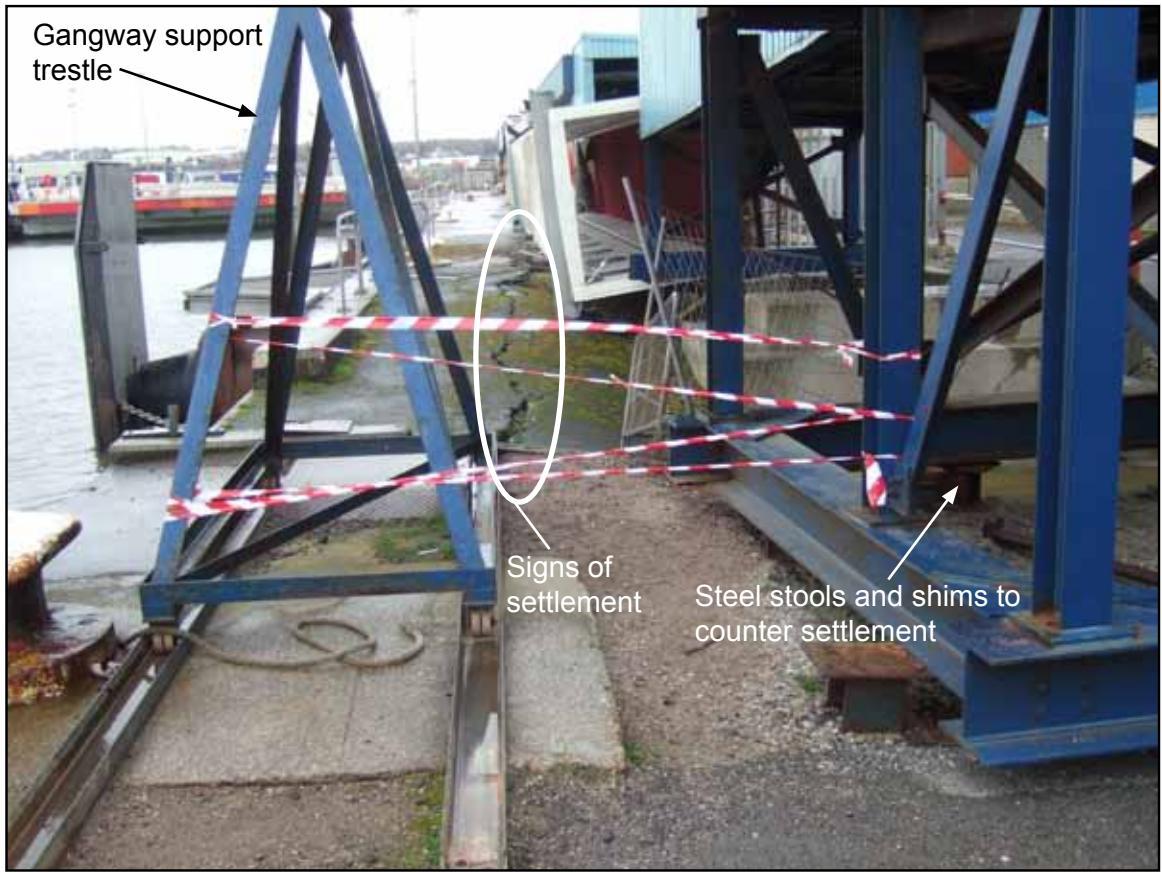
The gangway compartment was constructed over a disused underground tunnel originally used for cattle access. Although the original technical drawing showed that the supporting frames should have been secured to the foundation with 32mm diameter resin anchored bolts, the structure was free-standing and had not been bolted down. Settlement (**Figure 7**) of the ground in the area beneath the access structure and all along the quay had begun late in 1999 and had been a persistent problem.

Gangway compartment support and settlement

At the time of the accident, the ground had settled by approximately 800mm. The rate and extent of the settlement had been monitored since 2001 and, although efforts to strengthen the wall of the quay have been ongoing, there had been no investigation into the cause of the settlement. In 2000, additional concrete platforms were built and steel work added to the base of the gangway compartment to compensate for the settlement. Metal shims had also been added under the feet of the gangway compartment to maintain its height as the ground continued to settle. There was no routine maintenance or inspection of the passenger access structure, disused subway or cattle access tunnel.

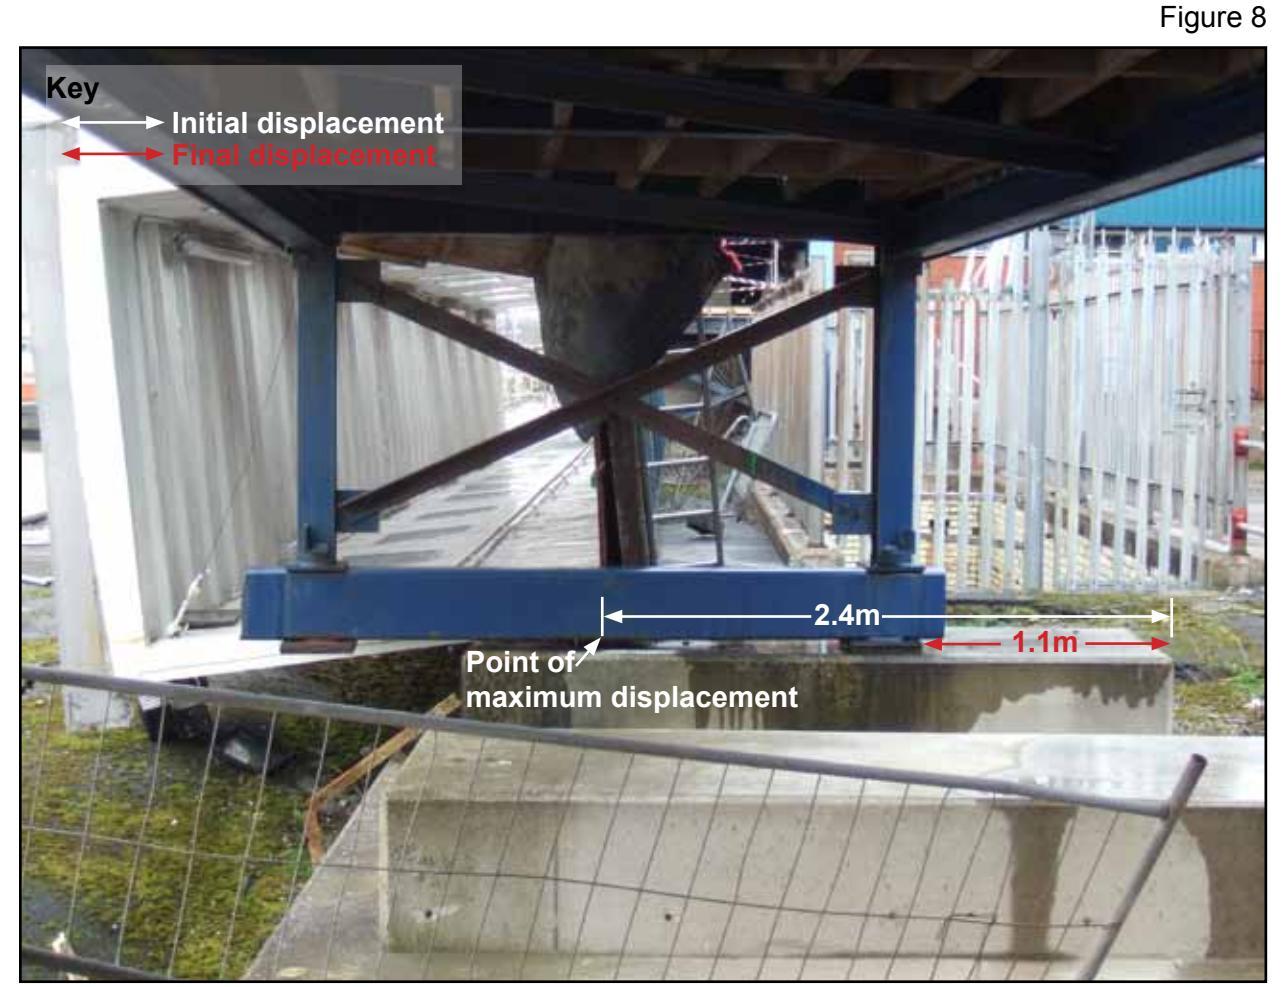
When *Ben-My-Chree* moved forward, the gangway compartment moved 2.4m to its side (towards the water), and it finally returned to a point 1.1m away from its original position (**Figure 8**) after the vessel had come astern. As the gangway pulled clear of the vessel, lugs at its outboard end damaged the vessel's shell door frame (**Figure 9**).

Movement of gangway compartment showing support frame in its final position after the accident

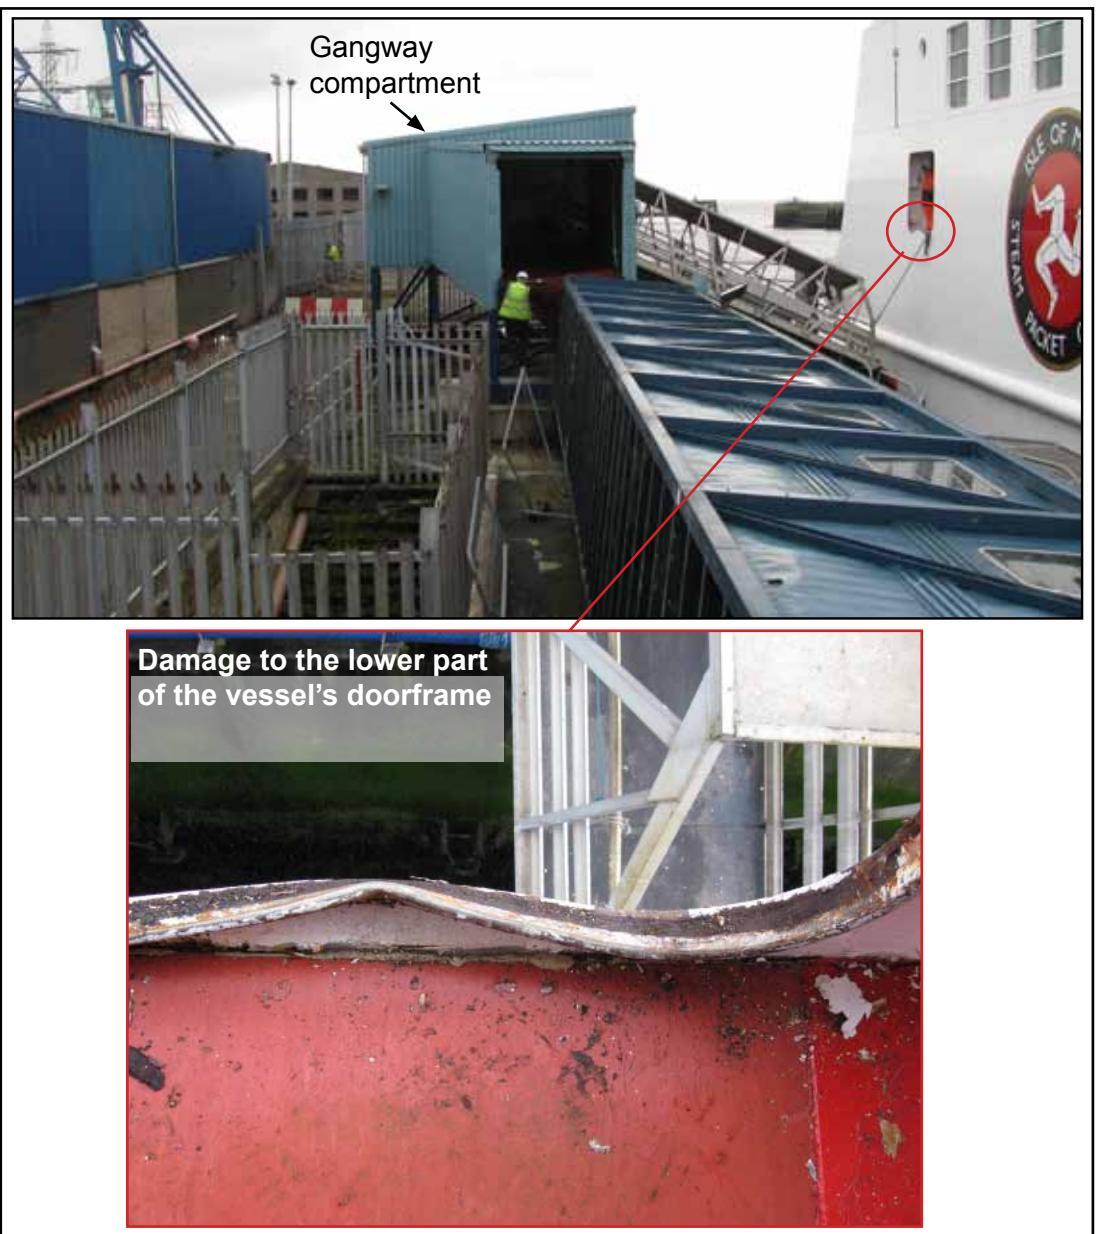
The scene immediately after the accident

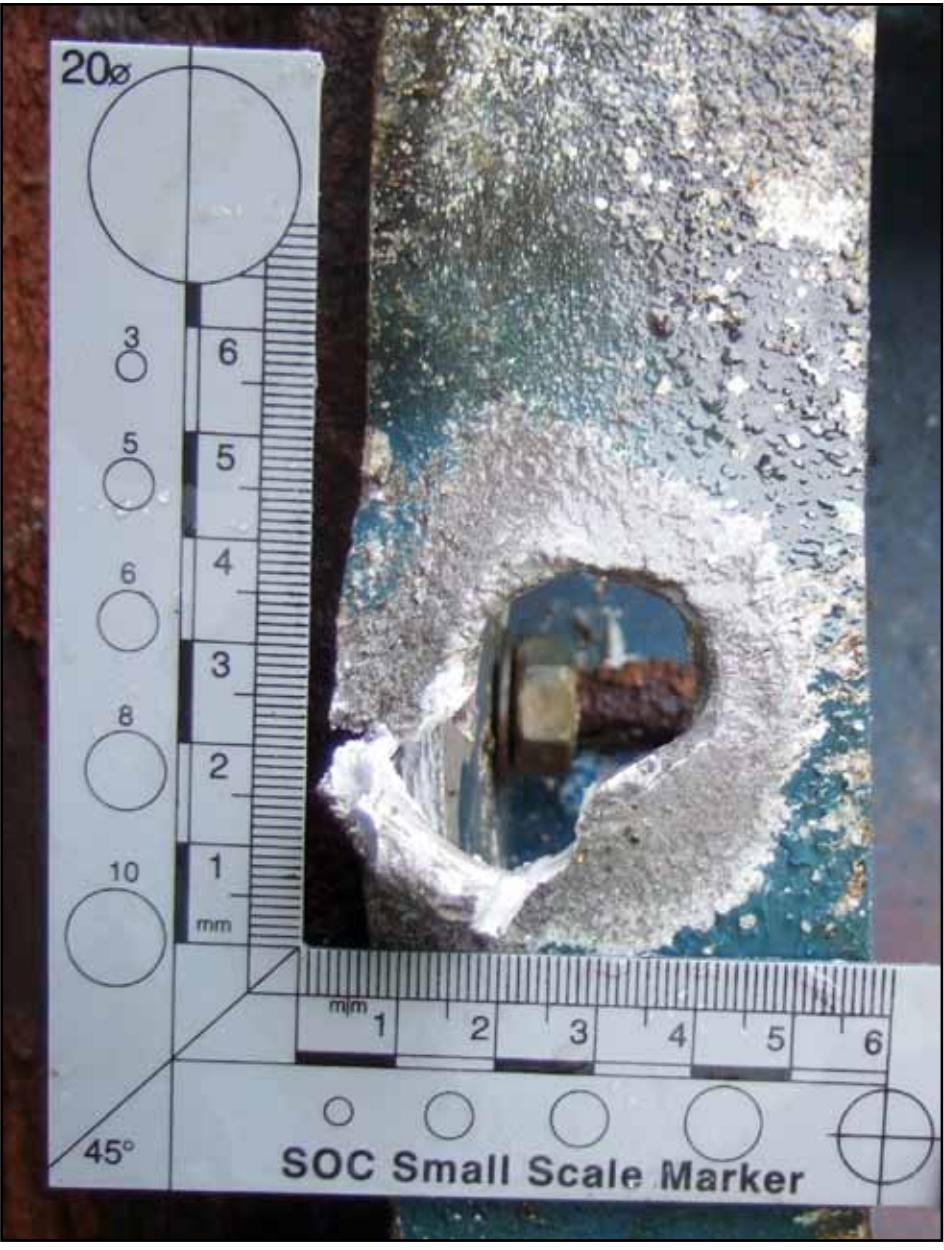
Figure 10

The steel fixing bolts at both ends of the suspended aluminium walkway were ripped out as it detached from the steel structures of the passenger terminal and the gangway compartment. All the electric lighting cables were sheared and the walkway fell to the quay. The ends of both the steel and aluminium in the structure showed evidence of heavy salt water corrosion (Figure 10).

Walkway securing boltholes showing signs of corrosion

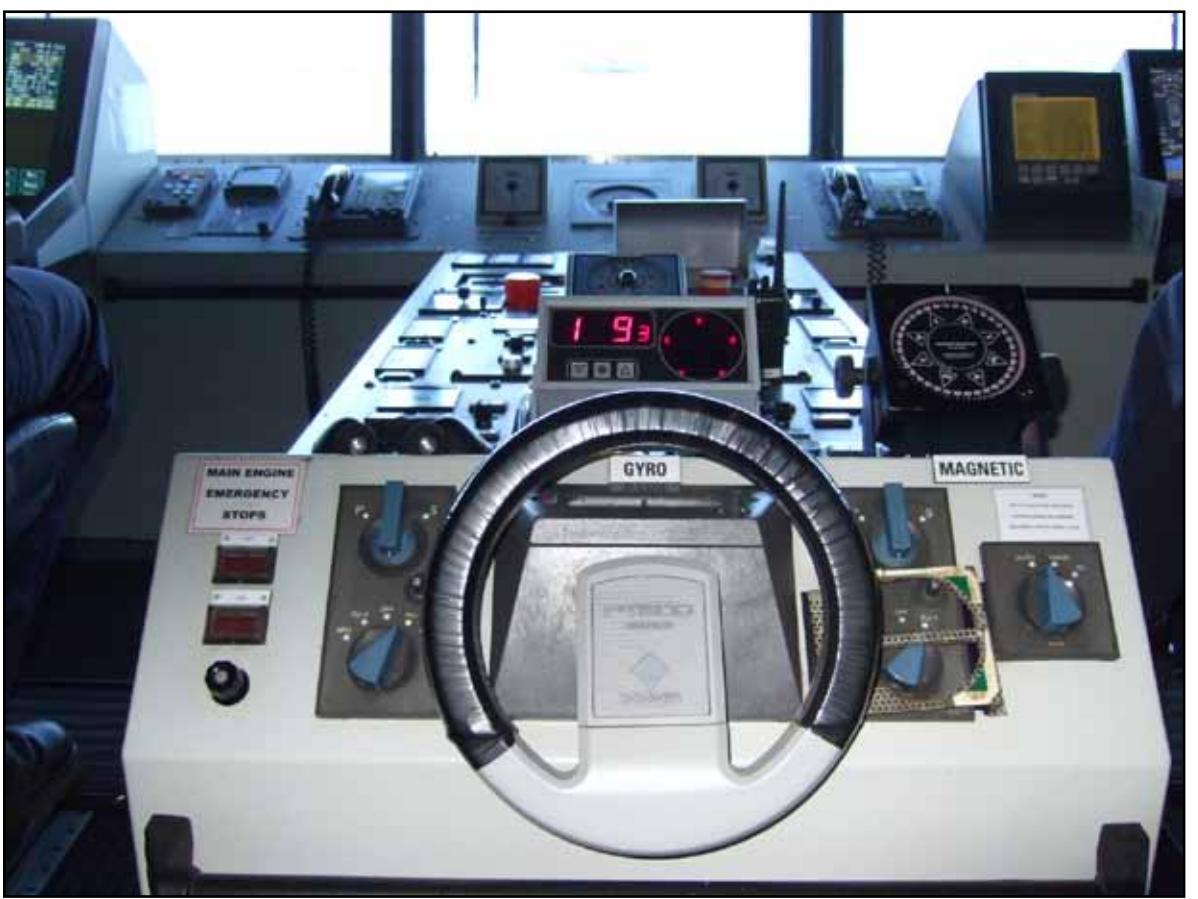
Figure 11

A talk-back system to the ECR was available at the main control panel and an internal telephone was located at the chart table. As the helm control panel was located at the end of the main control panel, the engine and bow thruster controls could only be reached from the side of the panel.

Centre control panel (bridge), looking forward
