Report on the investigation of

the grounding and subsequent foundering of

# fv Kerloch (J235)

> Report No 12/2010 October 2010

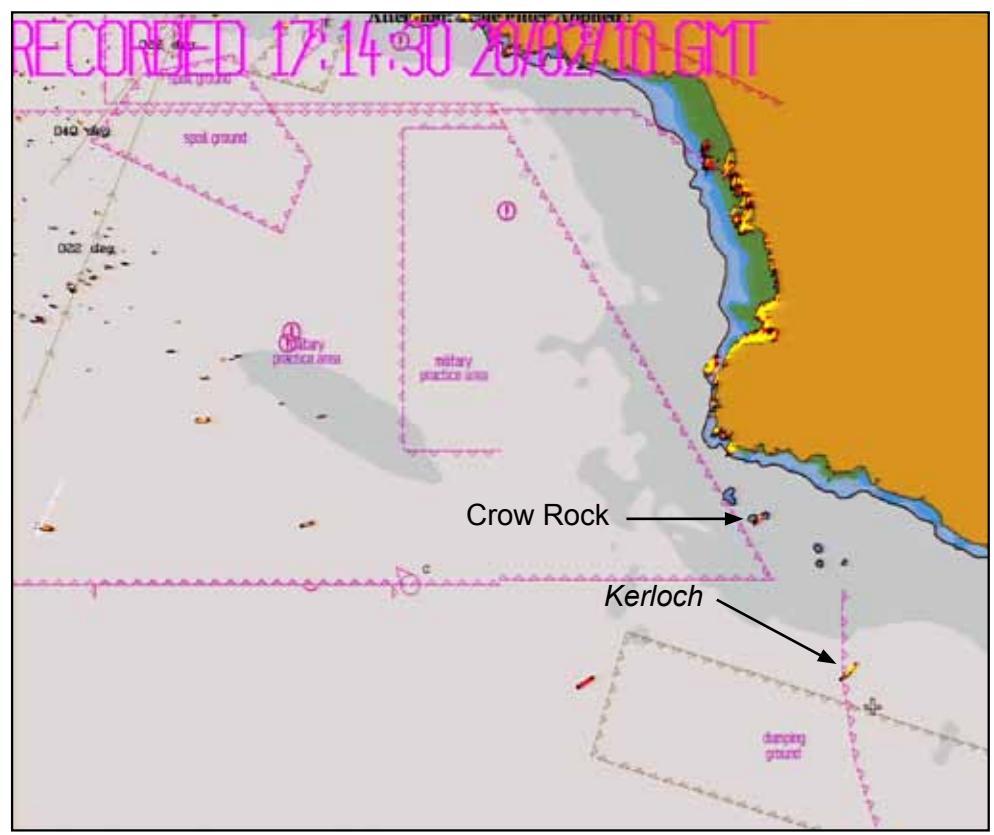
Figure 4b

The Milford Haven Port Authority (MHPA) Vessel Traffic Services (VTS) radar system recorded images of the vessel from 1708 onwards (**Figures 4a**, **4b**, **4c** & **4d**). The vessel remained outside the port limits at all times, and was therefore not being actively monitored by VTS.

Screen capture from Milford Haven Port Authority (MHPA) Vessel Traffic Services (VTS) radar showing area of accident at 1714

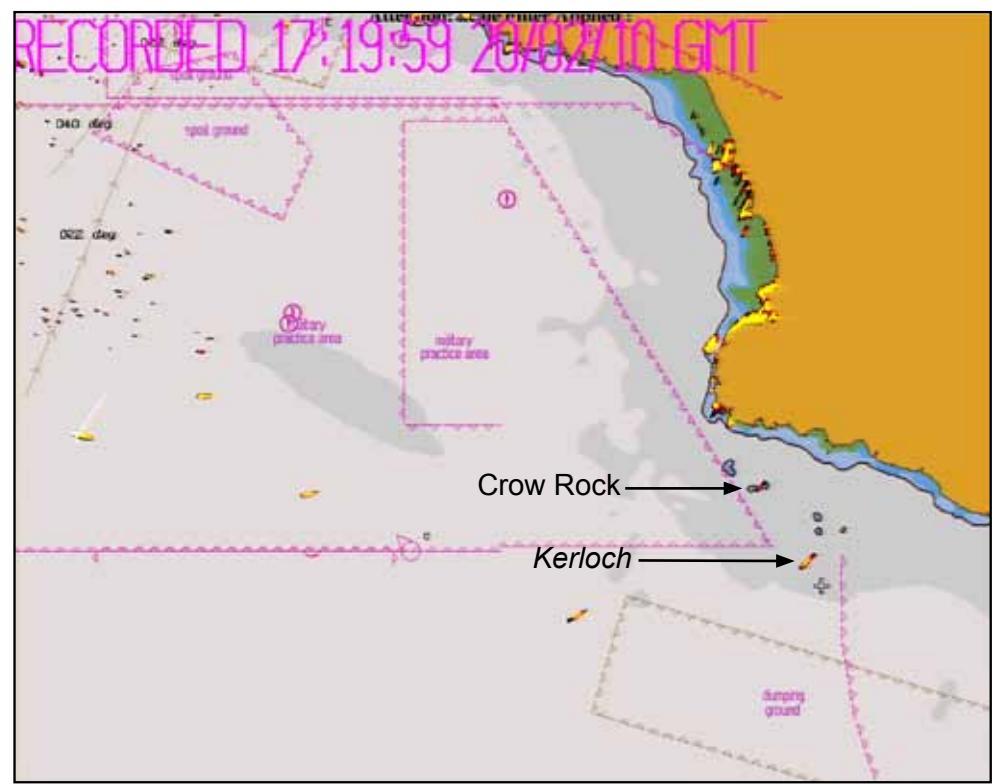
Figure 4c

Screen capture from Milford Haven Port Authority (MHPA) Vessel Traffic Services (VTS) radar showing area of accident at 1719

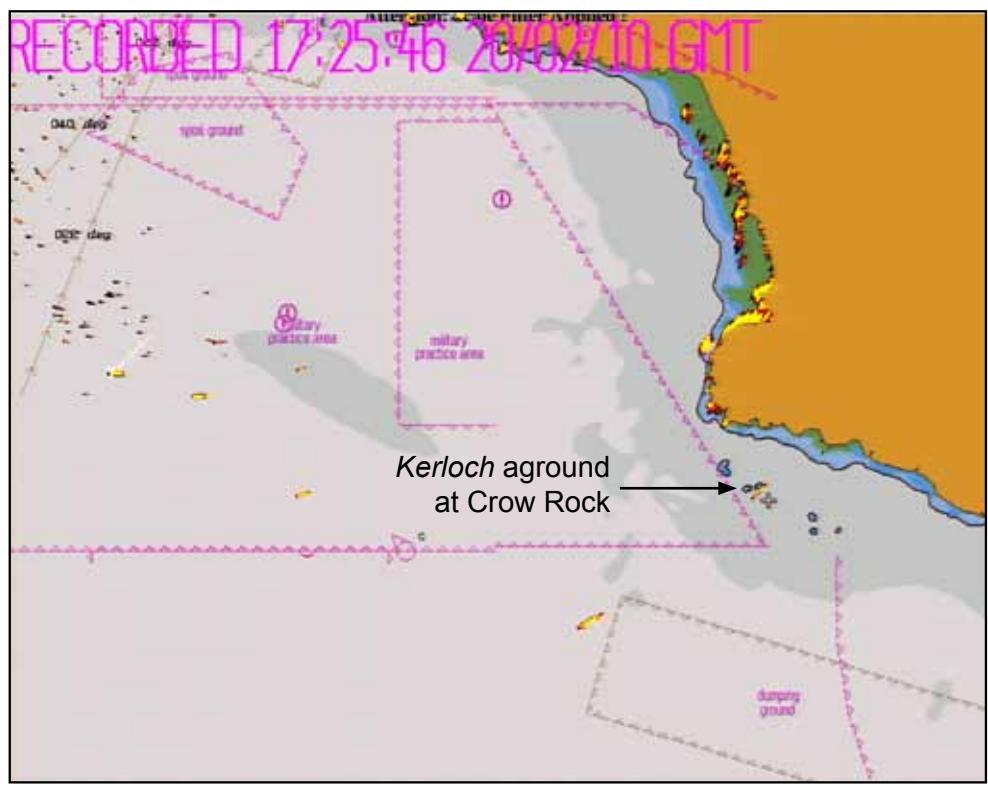
Figure 4d

The skipper recalled passing St. Gowan lightbuoy, about 5 miles south-east of Linney Head, but at some point later he fell asleep. He was next aware of being woken up at 1725 as he was thrown from his chair by the impact of the vessel grounding on Crow Rock.

Screen capture from Milford Haven Port Authority (MHPA) Vessel Traffic Services (VTS) radar showing area of accident at 1725

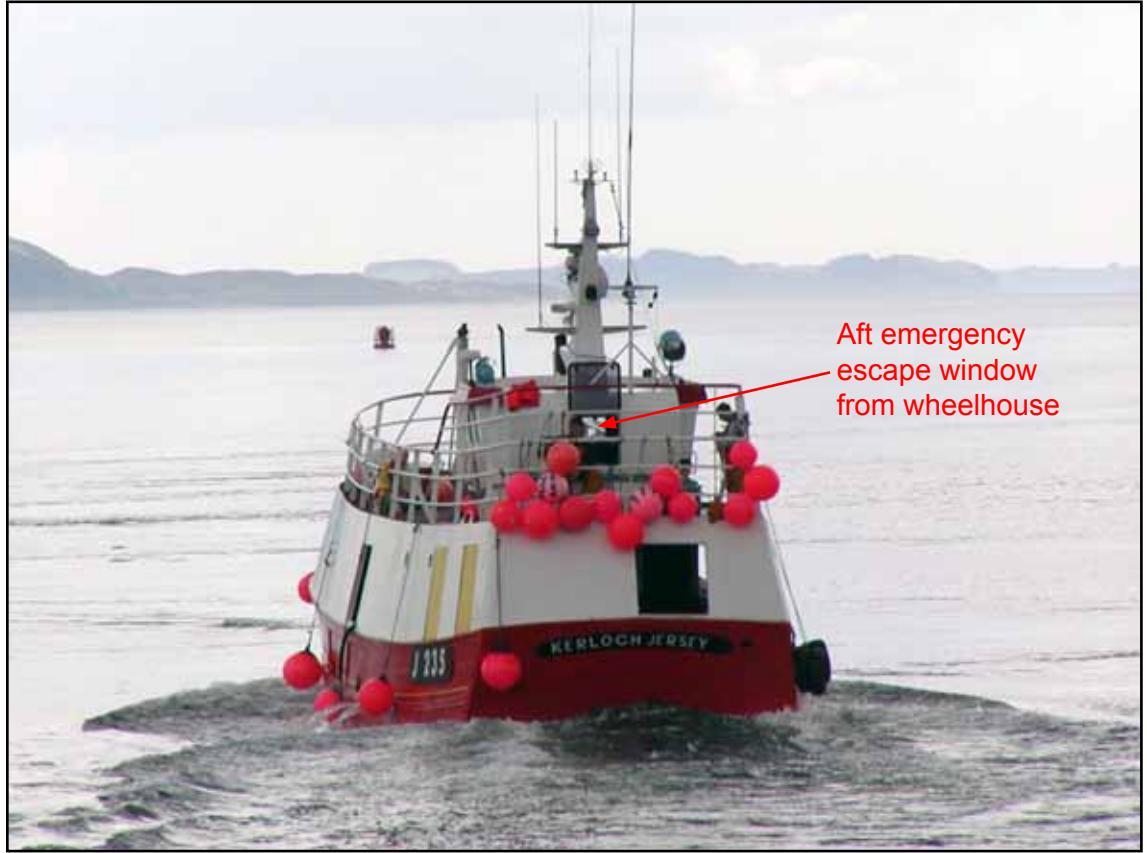
All three crew men arrived in the wheelhouse, just as the skipper was making his way out of the aft emergency escape window (**Figure 5**), he having decided that there was insufficient time to activate the vessel's DSC radio alert. The skipper also forgot to collect a hand-held VHF radio, located by the escape window. The deckhands immediately followed him out the window, and all four mustered on the port side of the shelterdeck top in the vicinity of the vessel's two liferafts and dedicated lifejacket stowage (**Figure 6**). No attempt was made to remove the EPIRB from its mount on the starboard side of the mast.

Photograph of Kerloch showing aft emergency escape window

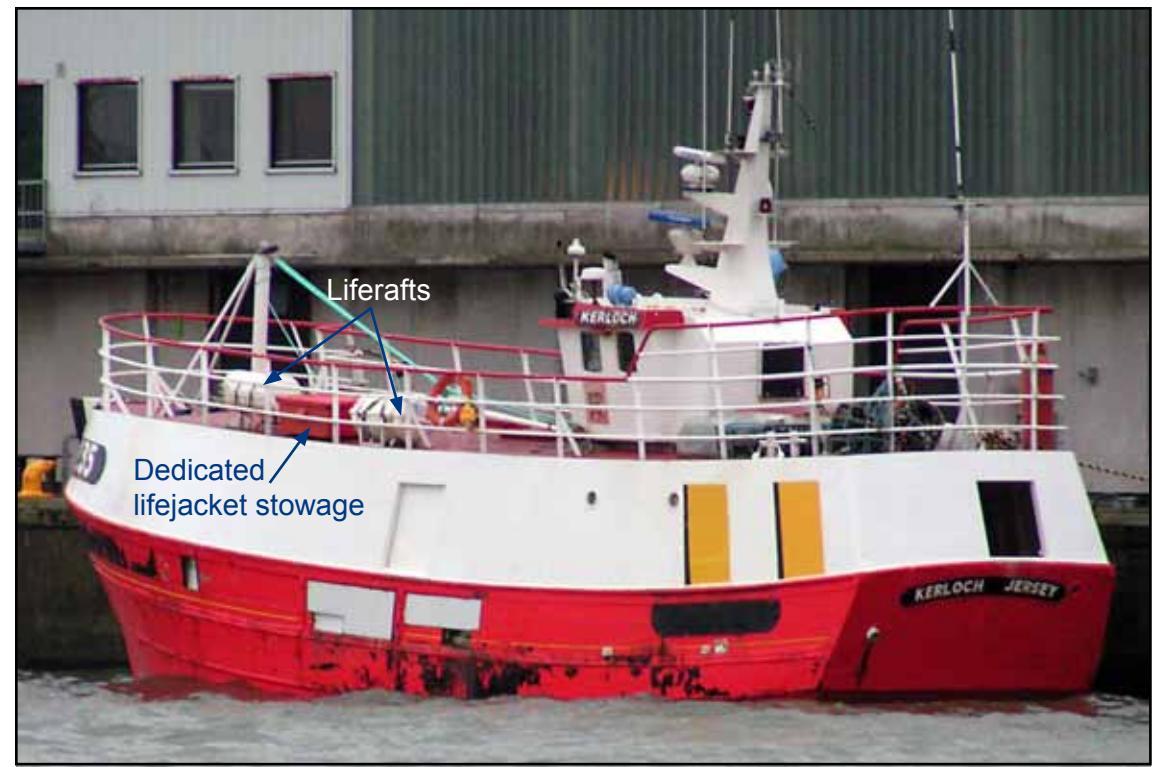
Figure 6

Photograph of Kerloch showing liferafts and dedicated lifejacket stowage

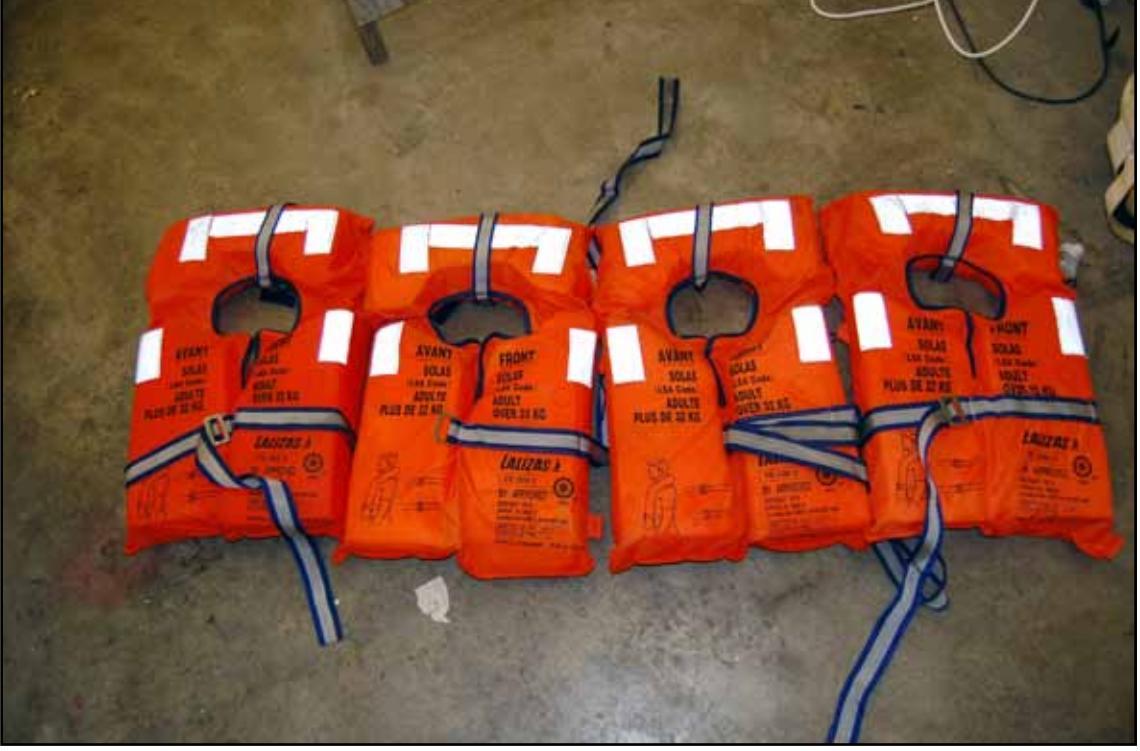
Figure 7

They each donned a lifejacket (**Figure 7**), then the skipper and one of the crew jettisoned the 8-man liferaft canister and started to deploy the painter. As the vessel continued to sink by the bow the crew became anxious about the time it was taking for the raft to activate, due to the length of painter that had to be pulled from the canister. However, the liferaft finally inflated upright (**Figure 8**), and the painter was then cut. One of the deckhands held onto the cut end, while the other two deckhands, then the skipper, jumped onto the liferaft, before boarding himself.

Photograph of lifejackets used during abandonment from Kerloch

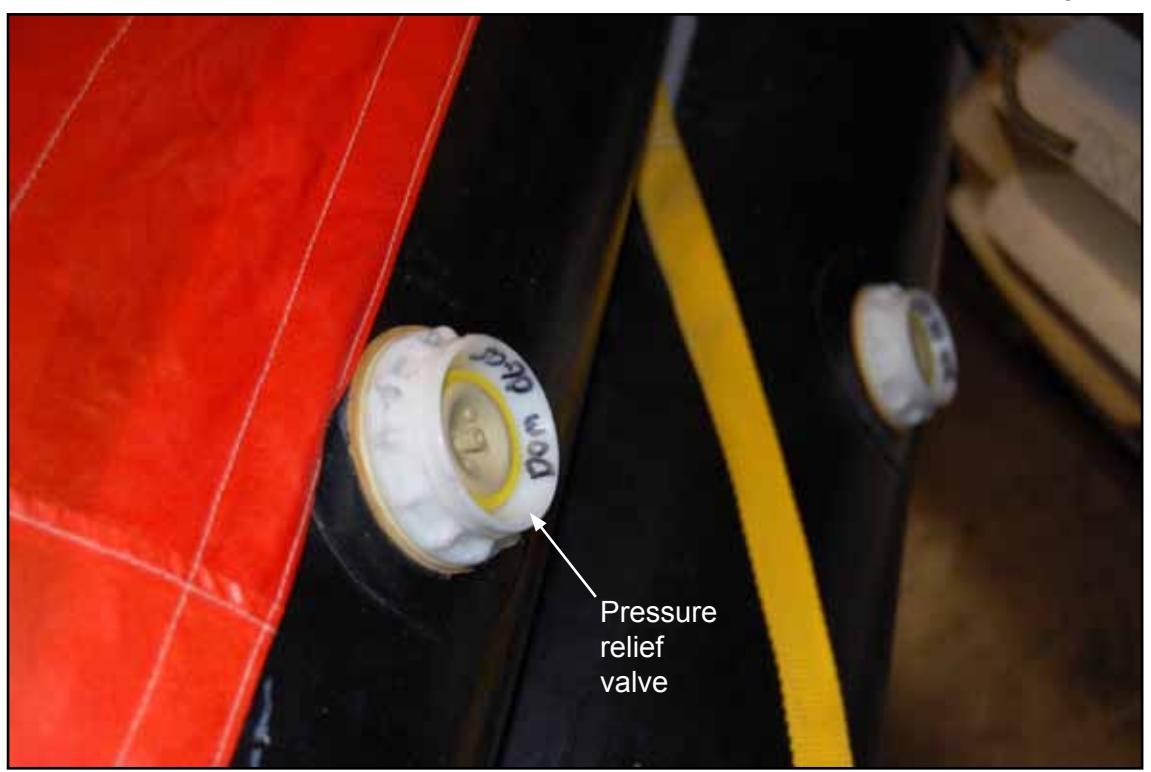
The liferaft remained safely afloat following the sinking, although the sound of escaping air caused some of the crew to again become anxious, thinking that a leak had developed. The noise was later attributed to a pressure relief valve **(Figure 9)**.

Photograph showing pressure relief valve on liferaft

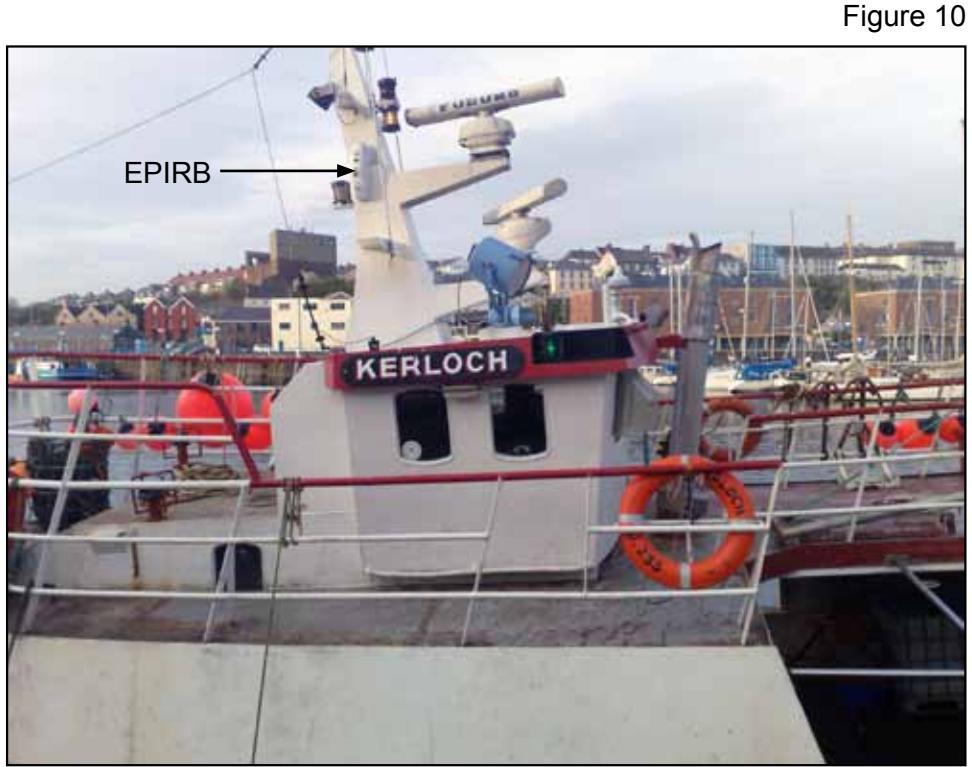
Photograph of Kerloch showing EPIRB mounted on mast

The EPIRB failed to activate immediately after the vessel foundered. The unit eventually deployed 3 days later, and it seems most likely that a period of worsened weather following the accident helped to eventually dislodge the unit from the wreck, perhaps when the wreck itself moved. Although the battery had expired, the EPIRB successfully transmitted.

The unit, however, stopped transmitting before it could be recovered, and any evidence regarding its initial failure to deploy was lost. Although fitted in a proprietary stowage, apparently free of obstructions, the EPIRB was located on the side of the mast. MGN 267 (F) notes that such a location will reduce the likelihood of a correct deployment; the installation position needs to be carefully considered.
