Report on the analysis of failed fuel oil regulating valve assembly

#### **Report on Analysis of Failed Fuel Oil Regulating Valve Assembly**

Annex E

## BACKGROUND

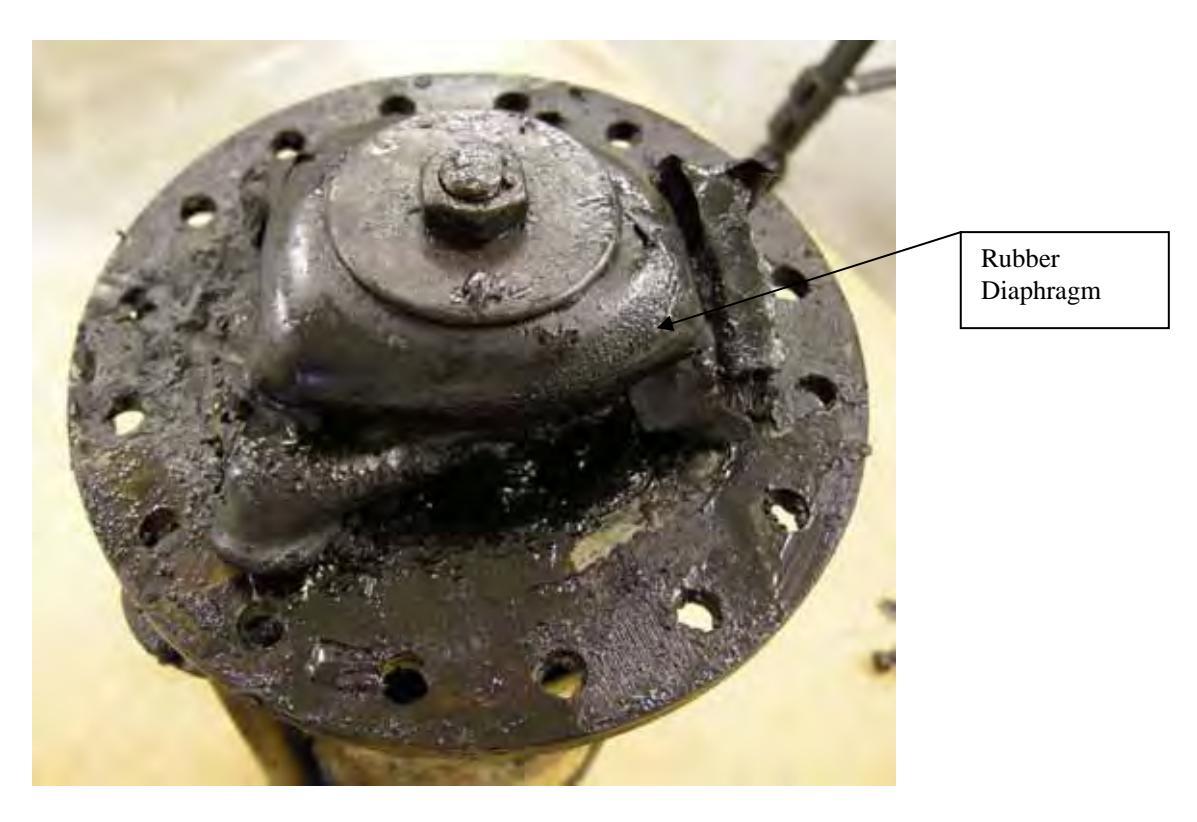
**Photo 1:** Showing diaphragm in situ with top casing removed. Note diaphragm is misshapen. Fuel oil residue is deep black in colour.

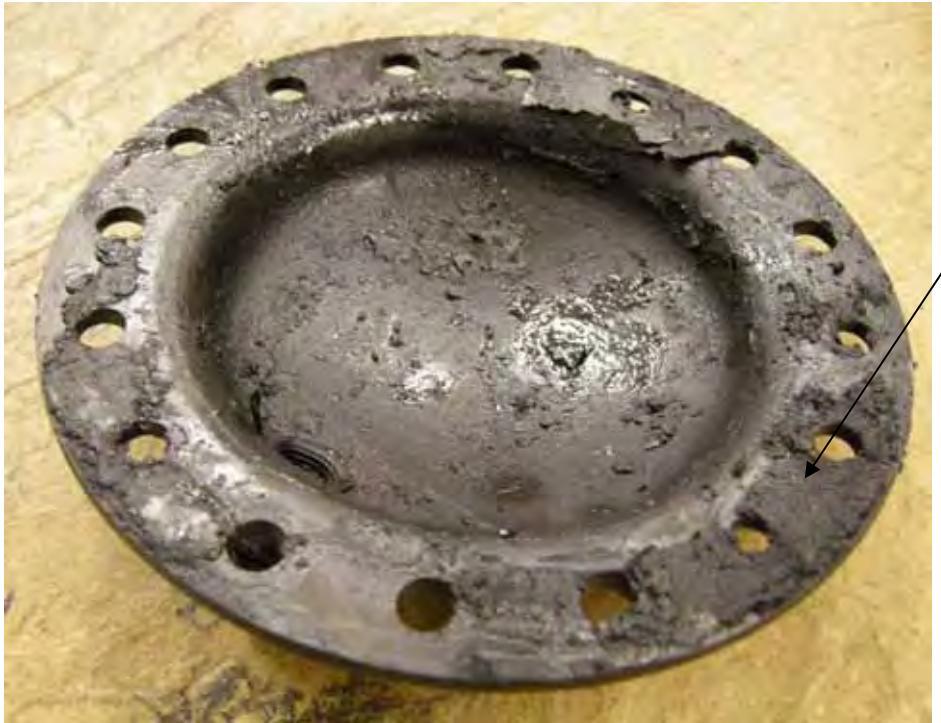
Gasket residue

**Photo 2:** Inside view of top casing. Note gasket residue is still present but insufficient to judge quality of seal.

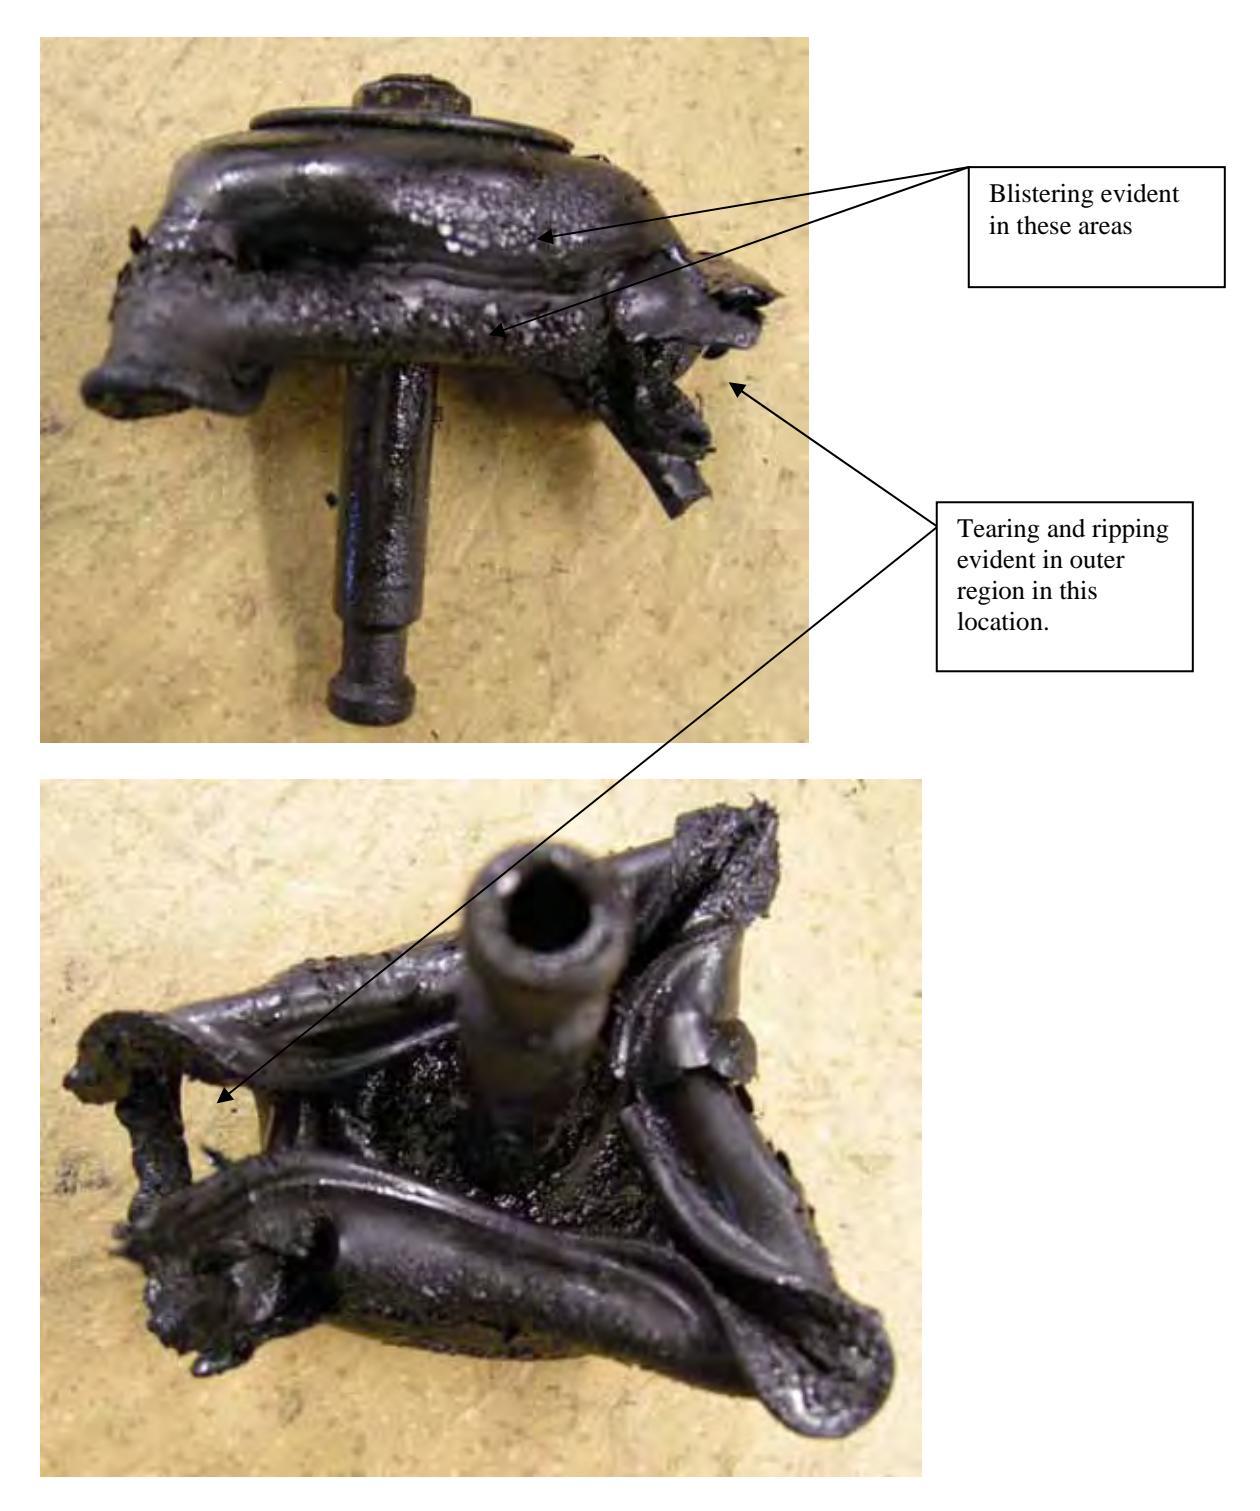
In general the diaphragm was heavily misshapen around the outer edges, this maybe due to normal use or due to the heat from the fire. The diaphragm showed signs of

deterioration around a portion of the outer edge with some tearing of the diaphragm evident.

Photos 3 & 4: Showing general views of diaphragm removed from valve assembly.

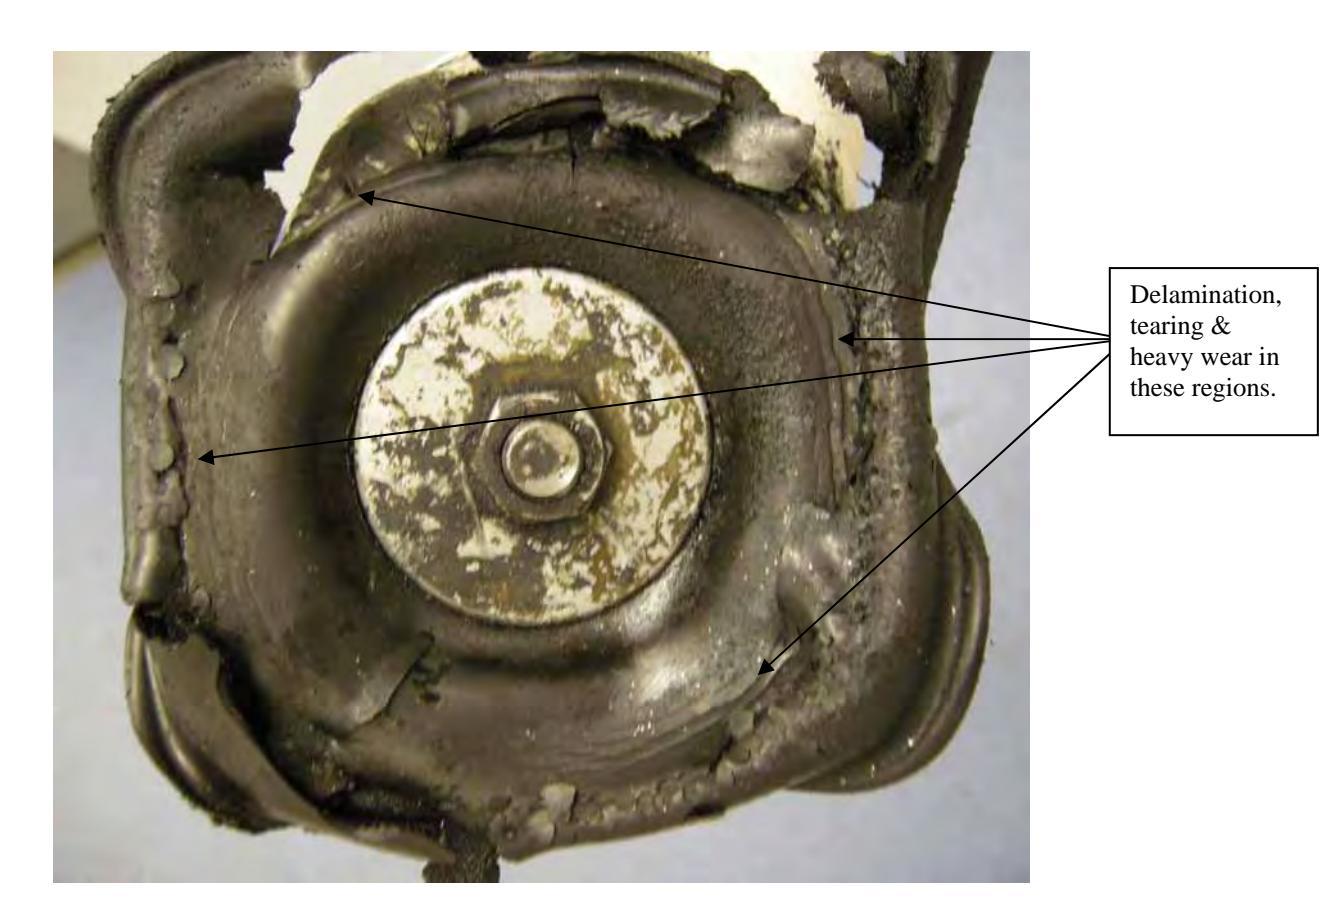
The main flexing region of the diaphragm also showed signs of heavy wear and creasing with some delamination of the rubber evident. There were also signs of tearing of the reinforcing fabric layer.

**Photo 5:** General view of diaphragm showing heavy wear & delamination in main flexing region.

The tearing and delamination of the diaphragm is thought to be relevant to the failure as most of this has occurred around the high flex region of the diaphragm i.e. indicative of high wear. Whilst the tear properties of rubber can significantly reduce on exposure to intense heat the majority of the tearing and delamination is concentrated on the circular region of high flex. It is also possible that the tearing damage in the outer edge portion of the diaphragm has originated from this same region but it has not been possible to confirm this.

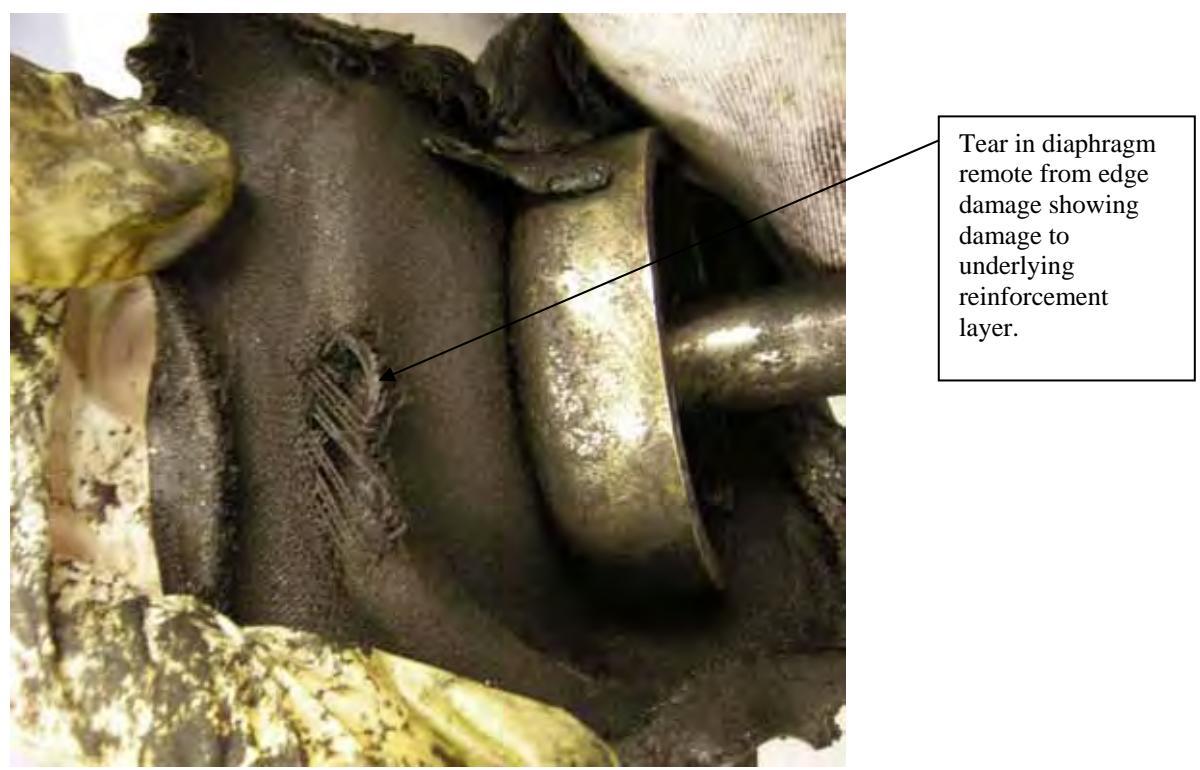
**Photo 6:** Tear in main flex region of diaphragm showing extensive damage to underlying fabric reinforcement layer.

The tearing of the rubber and the underlying reinforcement fabric is considered to be highly significant as this is remote from the edge damage and represents an obvious failure of the high flex region. Hence it is likely that the diaphragm has failed due to tearing of the rubber and underlying fabric resulting in a loss of fluid. The blistering observed on the upper surface of the diaphragm was originally thought to be charring / blistering damage due to heat exposure. However, closure inspection of the blistering shows the blisters to be regular circles with deep pits. This is typical of explosive decompression and can occur as a result of rapid pressure loss in a seal application involving gaseous products. A typical reference example of explosive decompression damage is shown in the photo below. This would not normally be expected with fuel oil as it would not be expected to volatilise easily. However, the resulting fire may have contributed to this damage by causing gaseous products. Hence, the blistering damage is more likely to have occurred as a result of the incident rather than the cause.

layer. These tears are thought to be the primary failure mechanism of diaphragm and probably occurred prior to any heating.

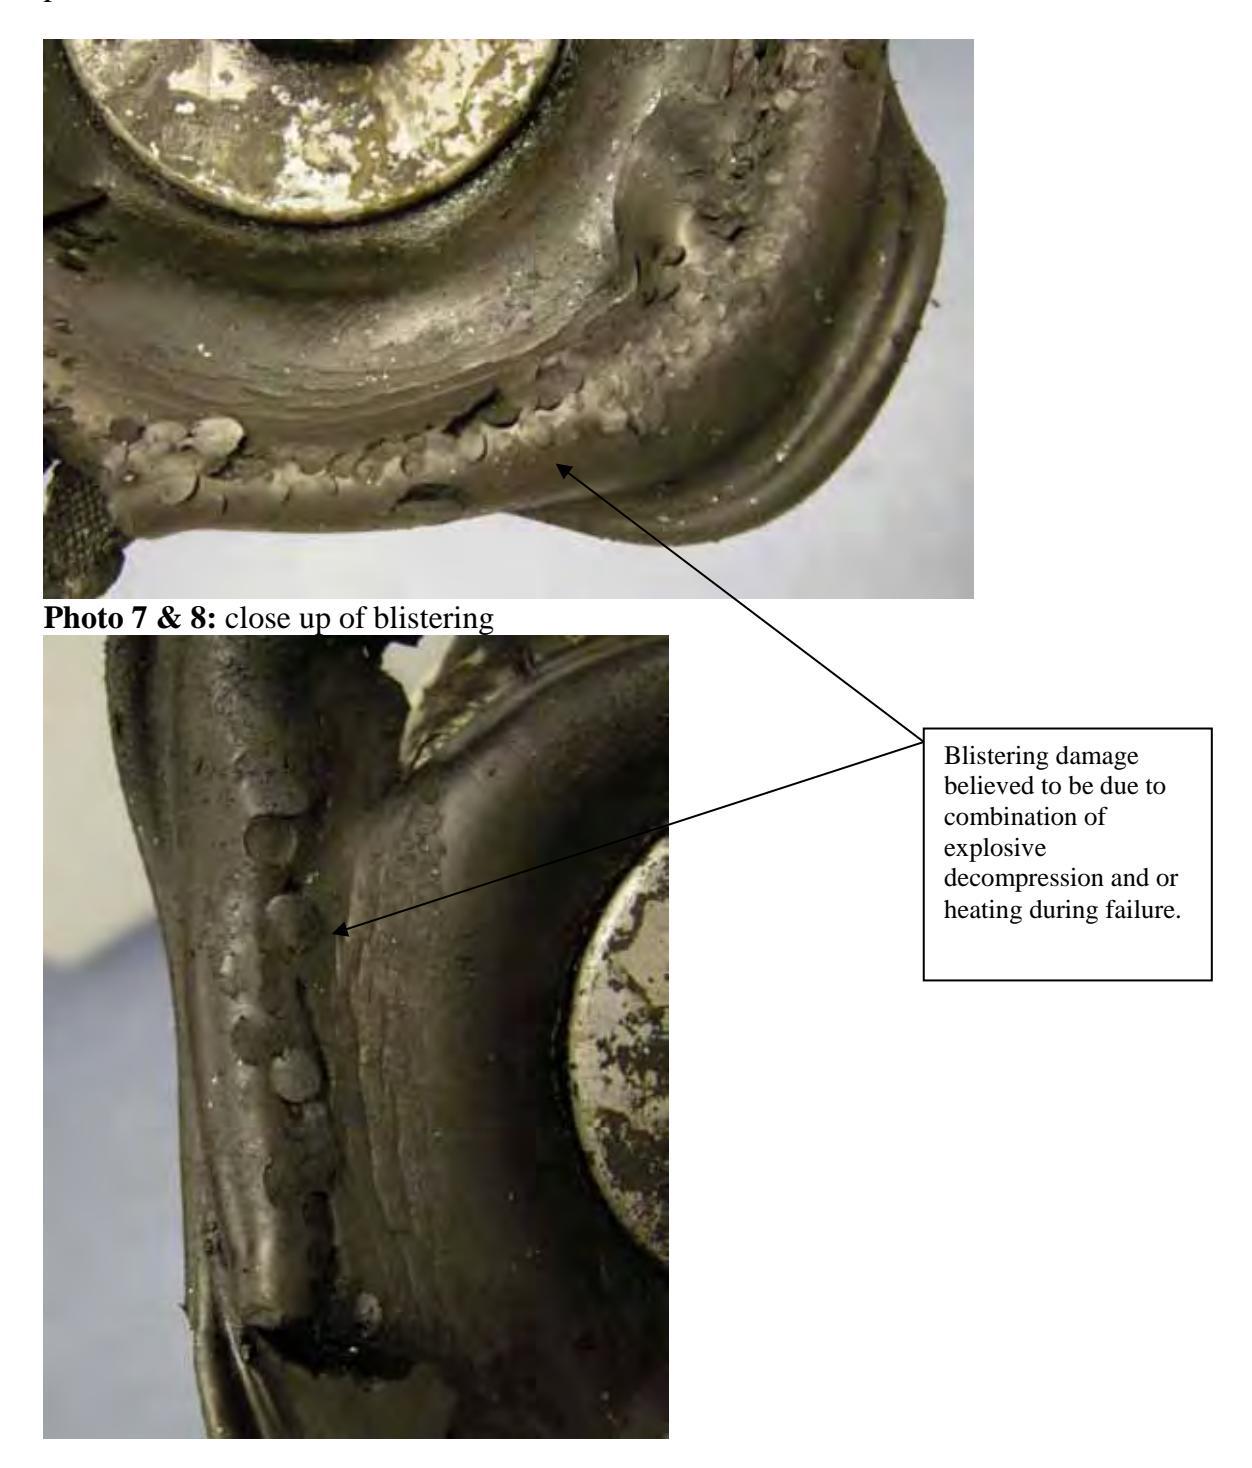
The upper surface of the diaphragm (fluid side) also showed significant evidence of blistering. Initially this was thought to be due to heat damage. However, closer inspection of the diaphragm showed no burnt residue, charring or heat deterioration. The diaphragm also remained flexible and pliable. The blisters produced significant craters in the diaphragm and hence are thought to be the result of explosive decompression as a result of the failure. This type of failure is normally associated with gaseous products and hence the resulting heat may have contributed to this phenomenon.

5. There is evidence of blistering on the upper side of the diaphragm (fluid side) which is typical of explosive decompression damage. However, this is normally associated with gaseous products and would not normally be expected to occur with a relatively non volatile material like fuel oil. However, the resulting fire damage / heating may have contributed to this phenomenon and hence this is probably an effect rather than a cause.

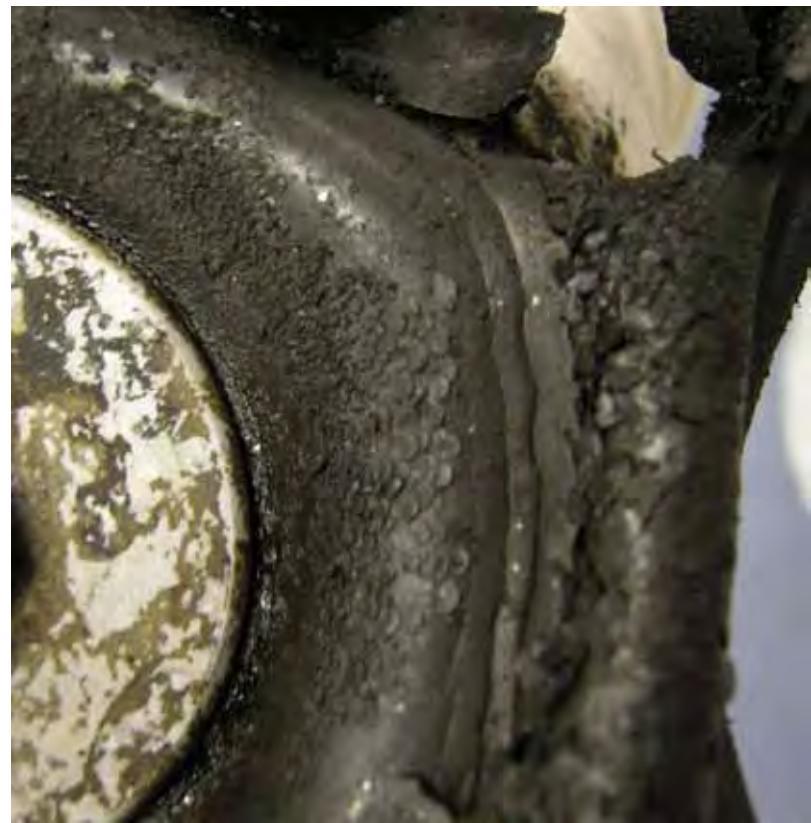
Photo 9: additional blistering damage

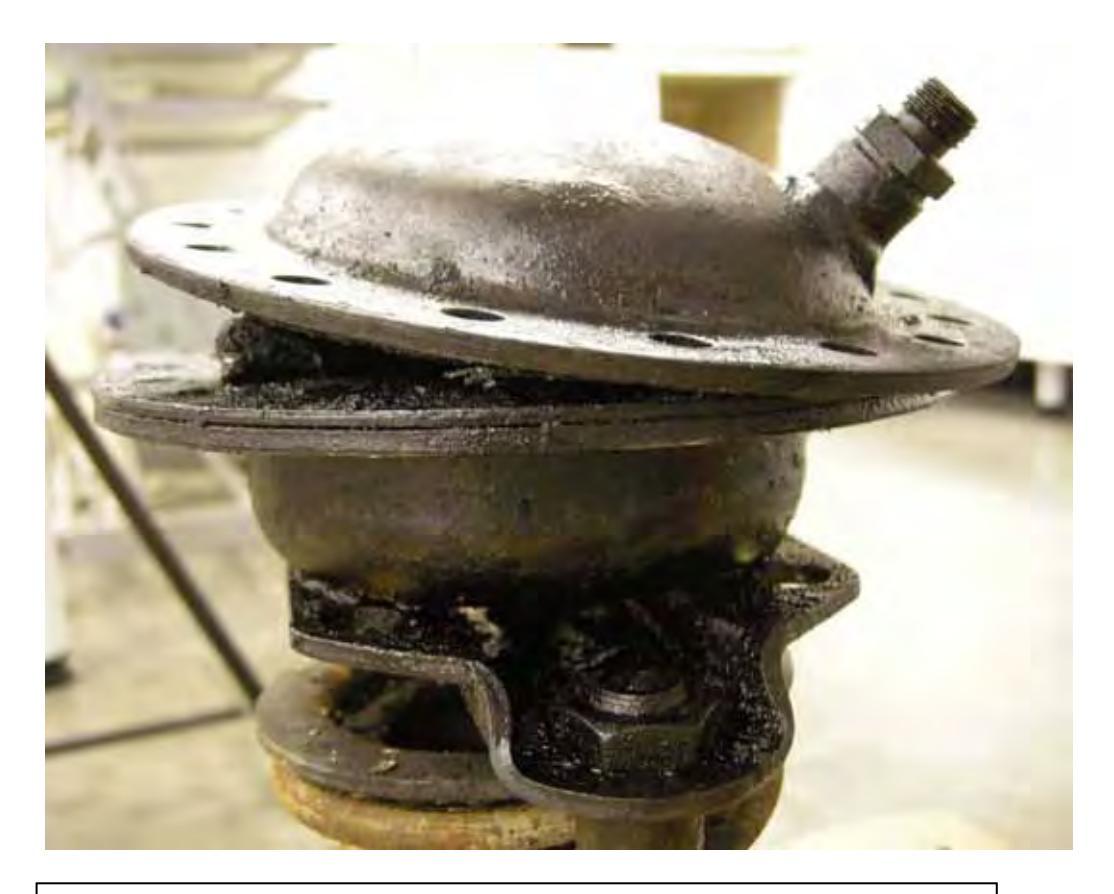
Diaphragm housing as received with retaining bolts removed.

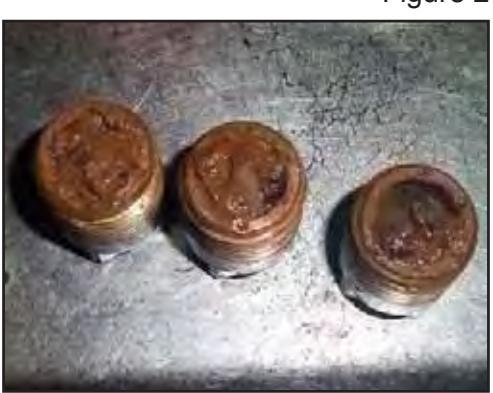
Figure 2
• The distribution pipework for the foam solution contained debris and was corroded (Figure 3).

80% of the foam generator nozzles within the auxiliary engine room were blocked by debris (Figure 2) and about 50% of the nozzles in the other protected spaces on board were also clogged.

The debris found in the nozzles and piping is most likely to have been rust and scale that had built up in sections of pipe in which water and/or foam solution had previously been trapped. This debris would then have been distributed along the pipes and into the nozzles during the annual blow through tests and when the system was operated. The resulting blockages were sufficient to prevent the aspiration of the foam solution.

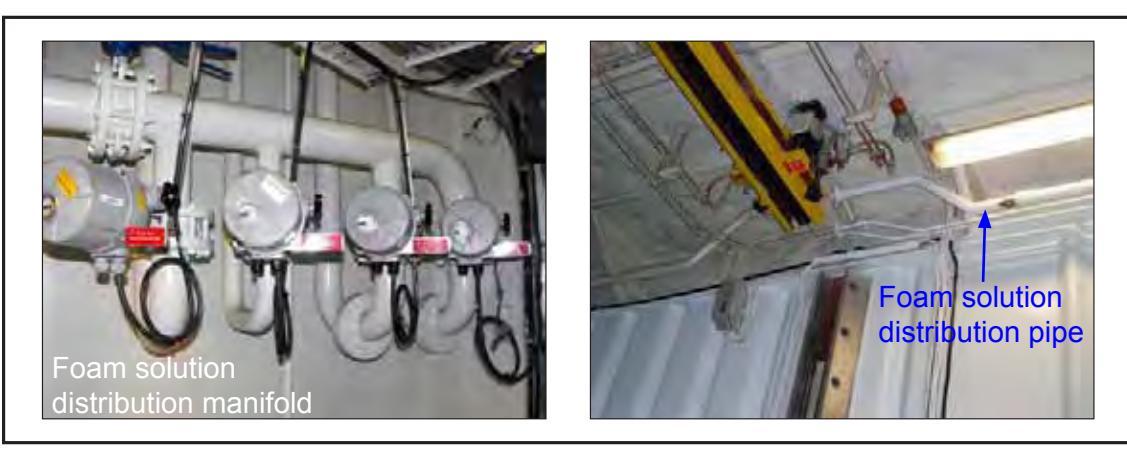
Figure 4

• There were several sections of the system's distribution pipes in which water and/or foam solution could have been trapped following the testing of the system (Figure 4).
