Bay Island Voyages' advertising leaflet

November 24, 2008

High speed craft; motion, ergonomics and injury: A summary report for the MAIB

HIGH SPEED CRAFT; MOTION, ERGONOMICS & INJURY: A summary report for the MAIB.

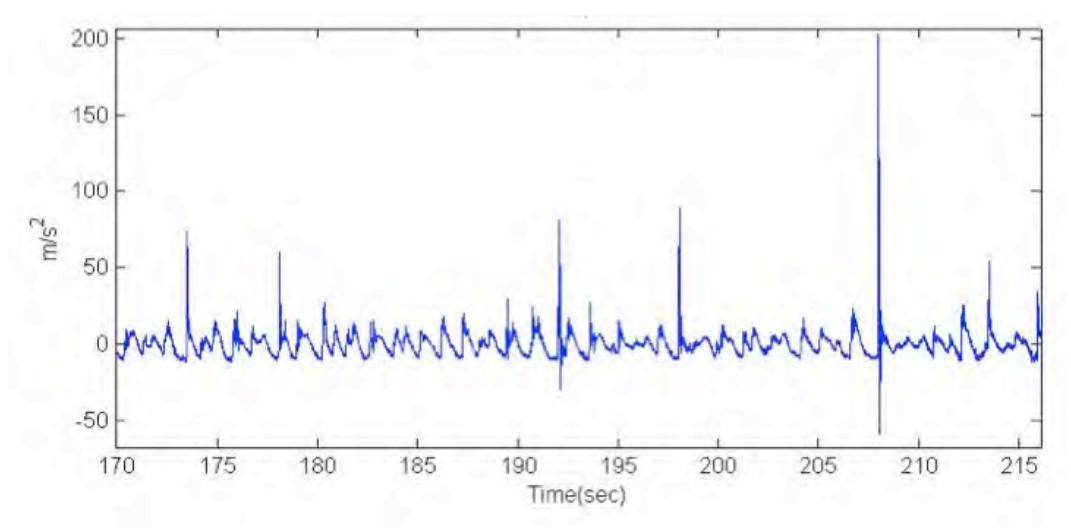
i) High Speed Craft (HSC) have been shown to experience impacts in excess of 20g perpendicular to the deck, and in excess of 10g parallel to the deck. An example of typical motion experience in a HSC is shown in Figure 1. This illustrates a section of a three hour transit in a 28' RIB, travelling at ~40 knots, in a sea state 1-2. Note the predominance of impacts of around two to three g, a number of impacts around seven g, and a twenty g impact.

Figure 1. An example of the deck motion (gZ) of a 28' RIB travelling at ~40 knots in a sea-state 1-2.

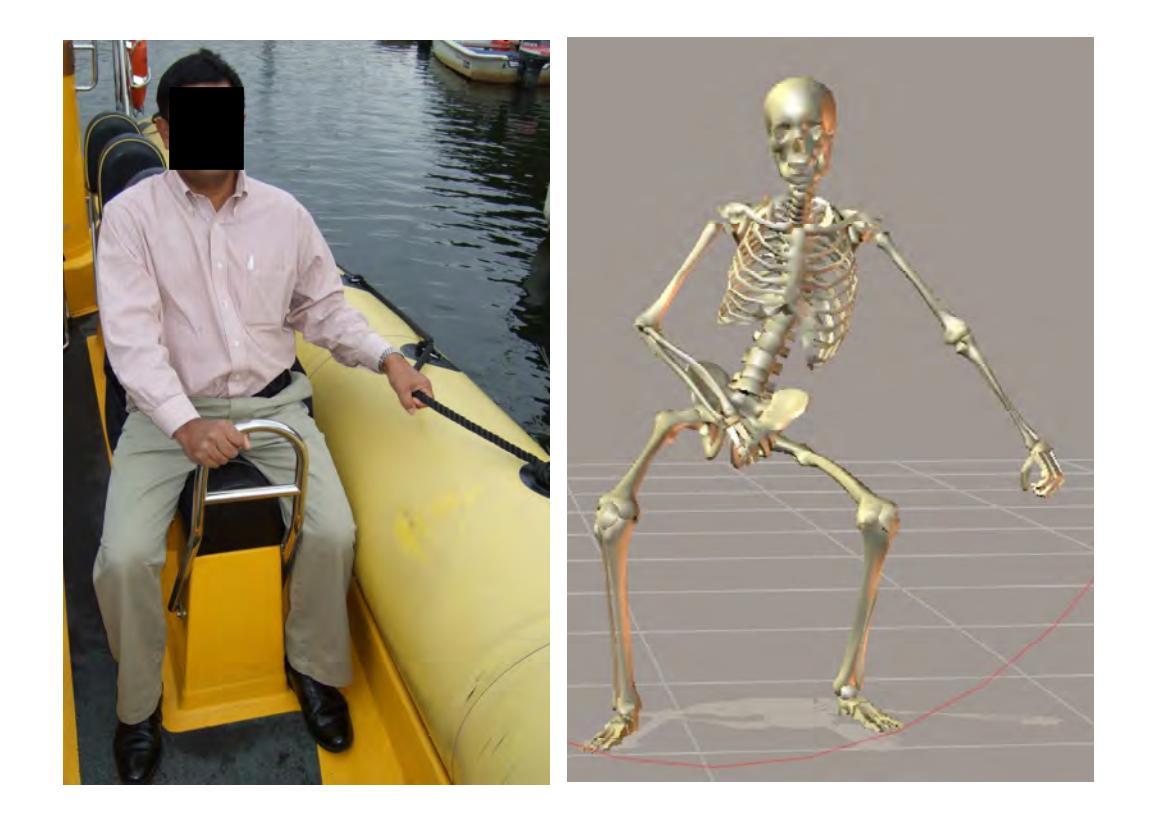
i. Posture; the principal issue is with the front seat and its handle. The position of the handle is considered to be too low and too narrow. By being too low it provides no support to stop the individual from being thrown forward as the boat impacts with the water. By being too narrow it provides little lateral support to the individual when the boat impacts with the water or during cornering. This poor support means that the individual will use other means of support and stability wherever possible. In this case the individual used the rope on the RIB sponson to provide additional lateral support. The problem with this is that it can result in the spine being misaligned and therefore being put at an increased risk of injury. Also the position of the seat means that the left foot of the occupant is not placed on the flat deck with a non-slip surface, and is therefore on an angled surface that will be slippery when wet. This may also reduce the stability of the seat occupant. This situation can be avoided by repositioning the seats so that they have the appropriate non-slip deck space around them. This would most likely require the number of passenger seats on the boat to be reduced. The issues with seat design and the occupants posture are graphically described in Figures 2, 3 and 4 where an illustration using a skeleton has been used to describe the resultant posture of the spine.

Figure 2. An illustration of the casualty's anticipated posture during the transit indicating the curvature of the spine.

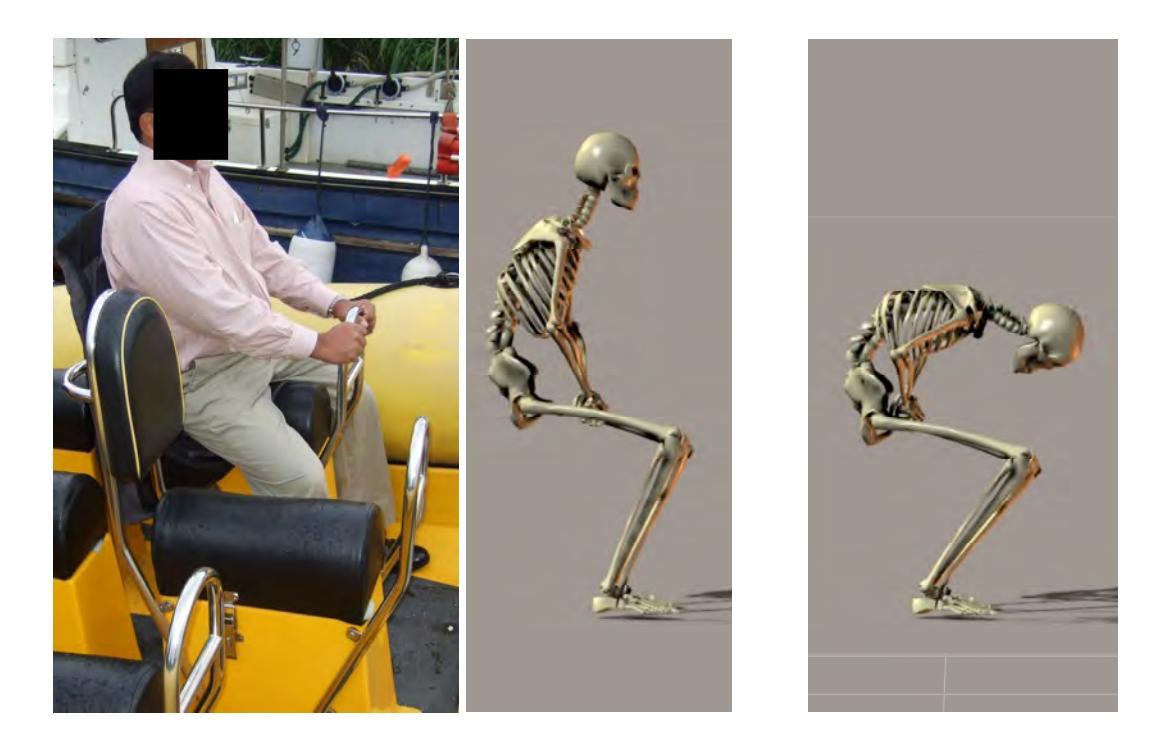
Figure 3. A graphical representation of the effect of using a 'low, narrow' handle on the seat occupants posture pre and post wave impact indicating the inability to maintain a good posture with spinal alignment.

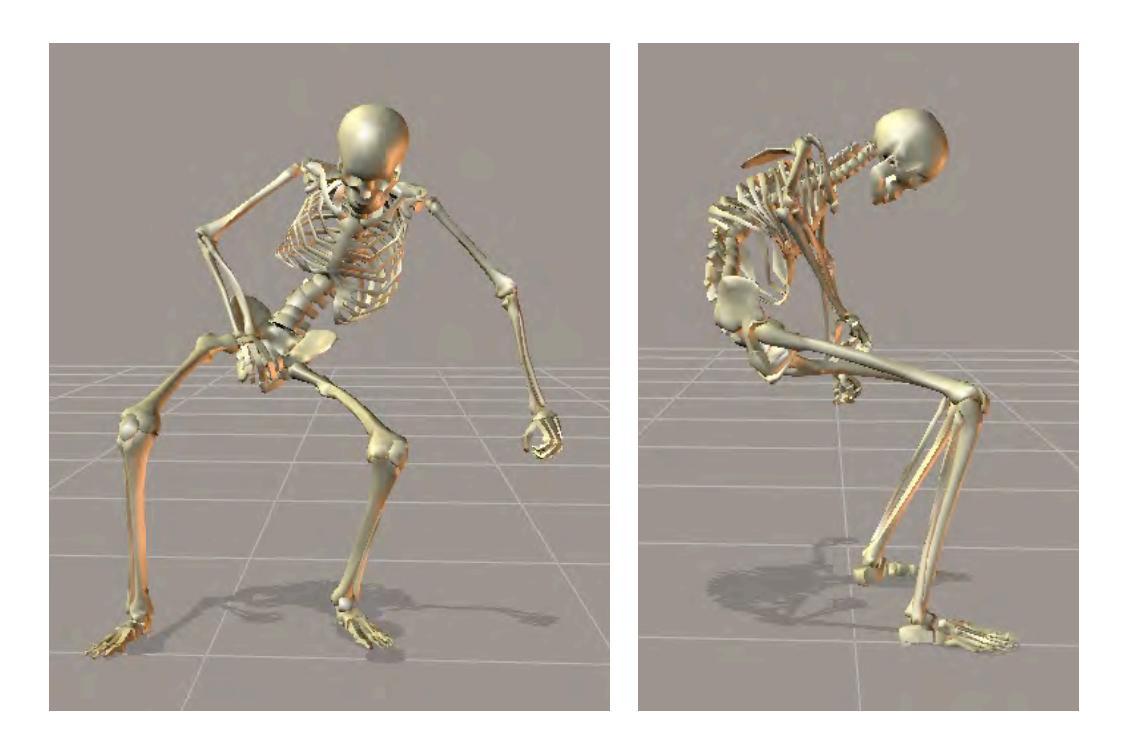
Figure 4 An illustration of the casualty's anticipated posture during the wave impact.

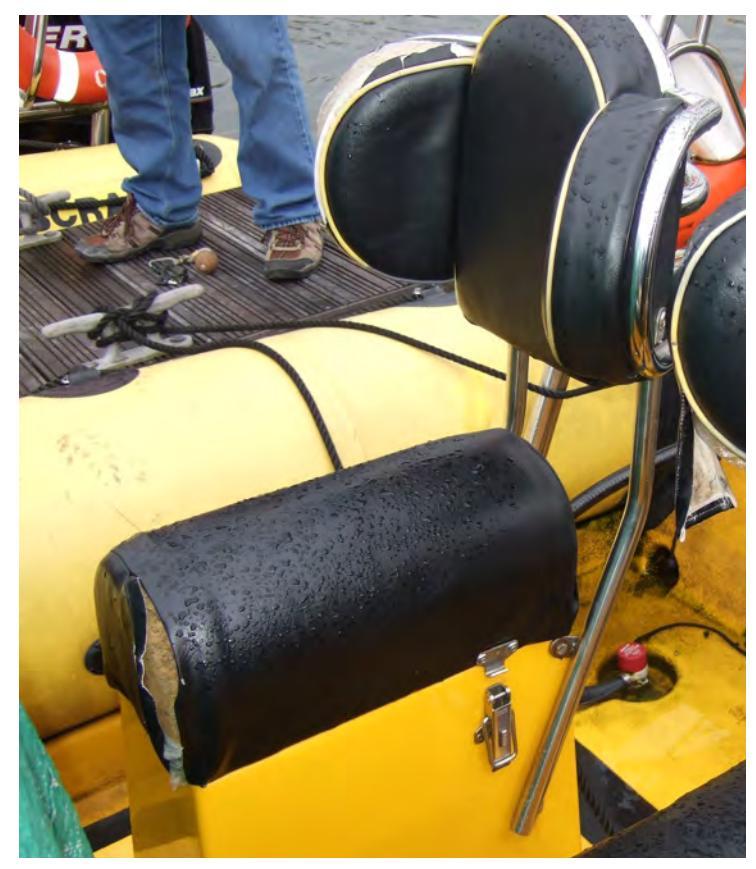
iii. Unfortunately the HSC industry does not recognise the seat as being one of the most important features of the boat. An example of this is shown in Figure 5 where the seat cushion covers have been allowed to degrade and no maintenance has been undertaken. This lack of maintenance will allow water ingress to the cushion, as well as the foam material to protrude through the holes, both of which will accelerate the degradation process.

Figure 5. An example of wear-and-tear on a RIB seat, demonstrating a lack of maintenance, which accelerates the degradation of the seat cushion.

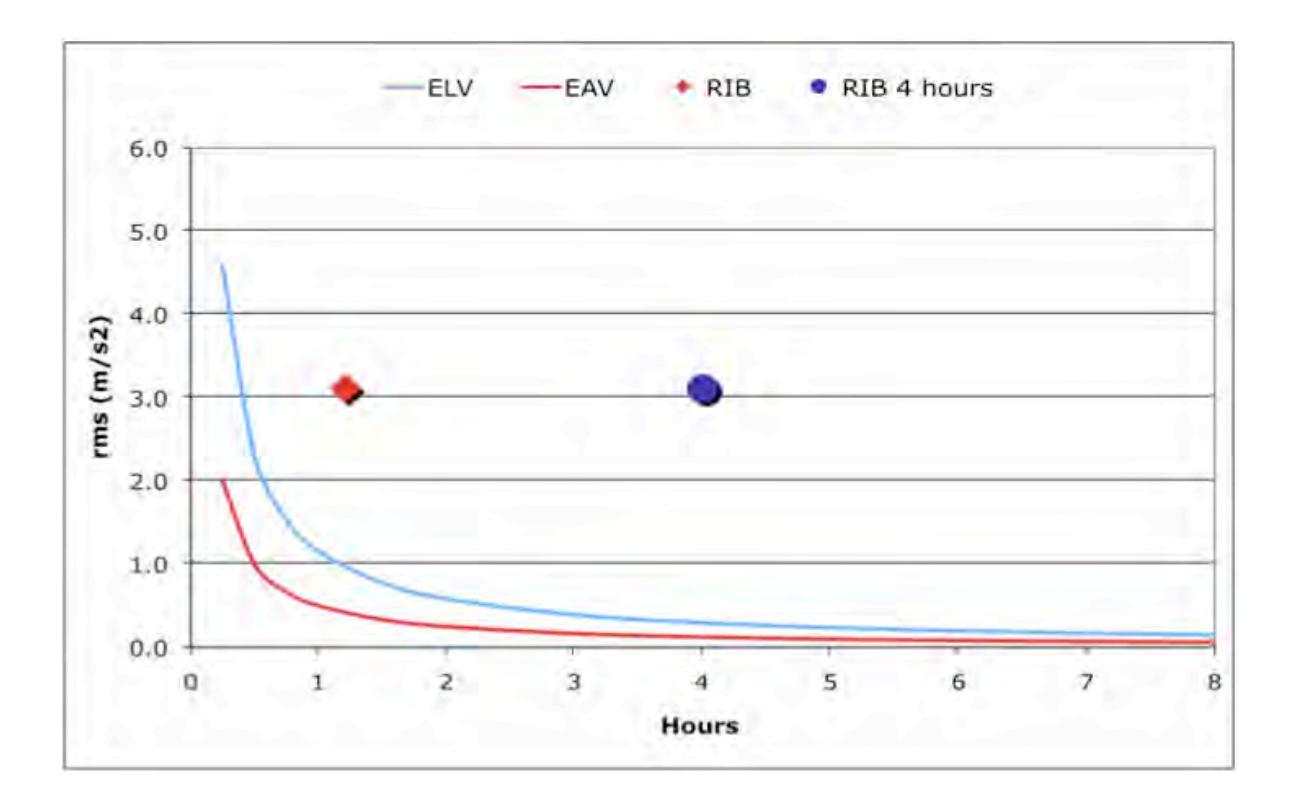
iii) An example of how extreme HSC motion is compared to terrestrial transport is that the 8 hour WBV exposure action value can be exceeded within 15 minutes in an 8.5m RIB travelling at ~40kts in a seat state 2. The graph shown in Figure 6 indicates how far in excess of the recognised Exposure Action Value (EAV) and Exposure Limit Value (ELV) a 28' RIB travelling at ~40kts in a sea-state 2 will be. At one hour the exposure is 7.5 times the EAV, while at four hours the exposure is 10 times the ELV and 24 times the EAV.

Figure 6. An example of how a 28' RIB travelling at ~40kts in a sea state 2 will exceed the EU WBV Exposure Action and Limit Values.

iv) Compliance with this legislation by the HSC industry sector will assist in reducing both the risk of the acute injuries described above and chronic injuries that are common in professional HSC operators.
