Report on the investigation of
the collapse of cargo containers on

Baltic Sea

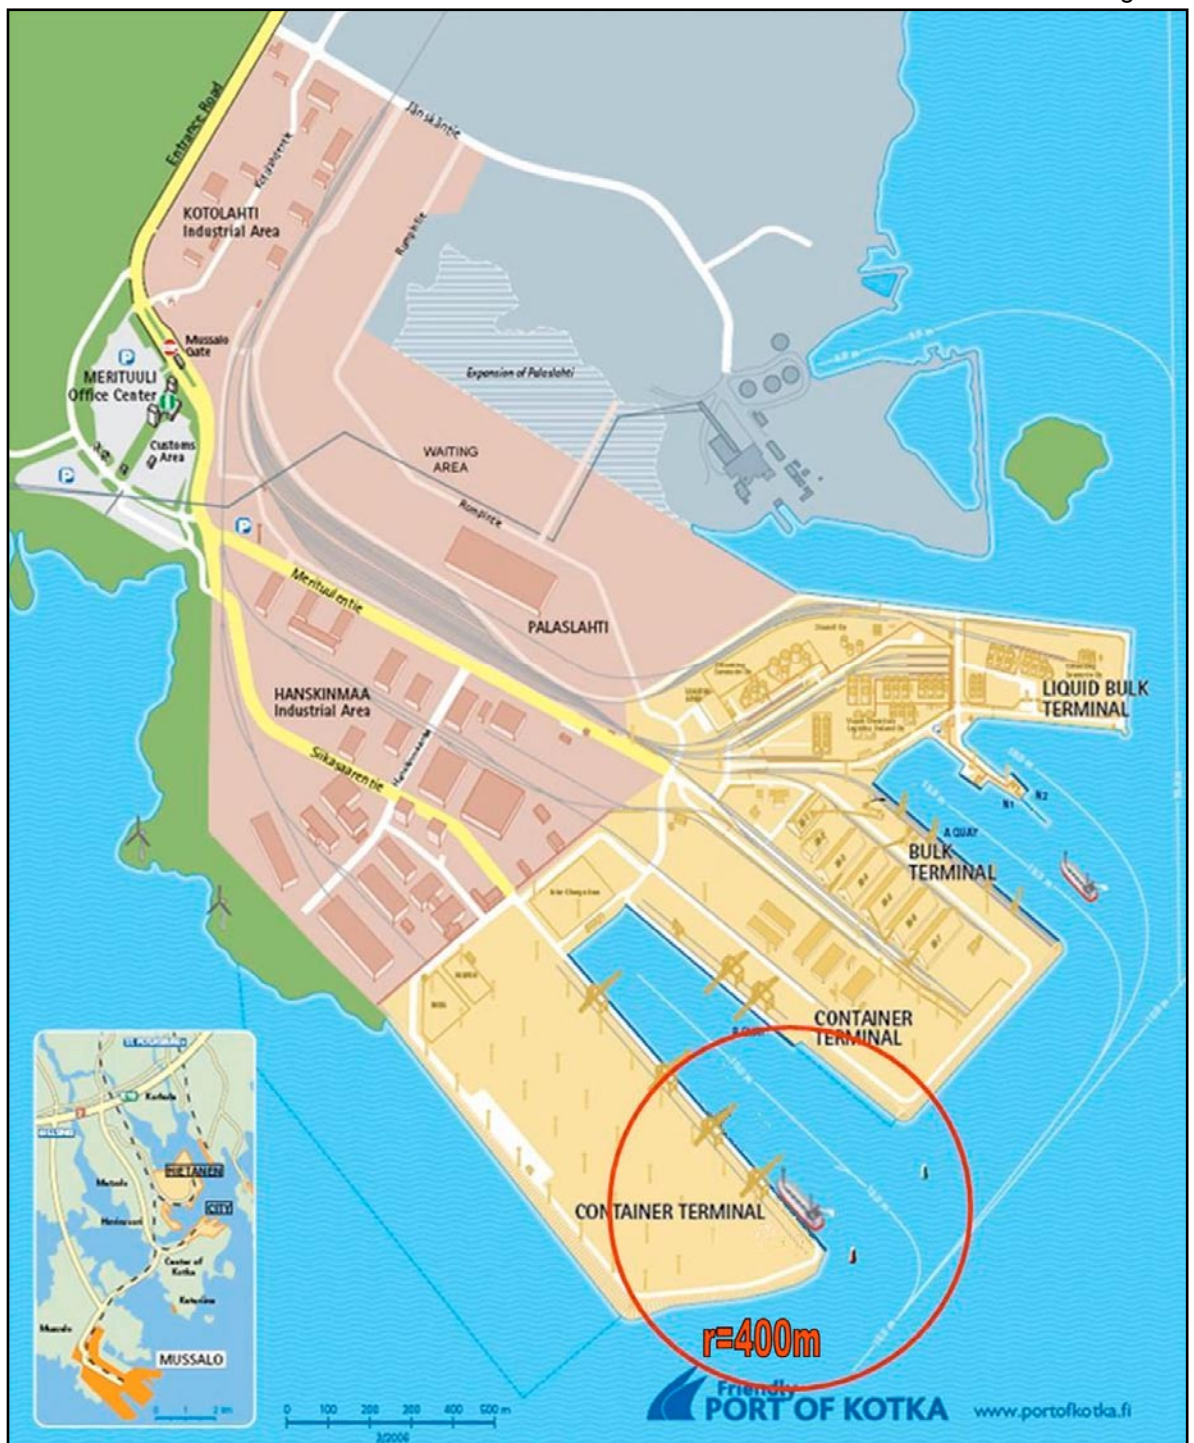
400 metre restricted area placed around vessel at Kotka - Finnish emergency plan

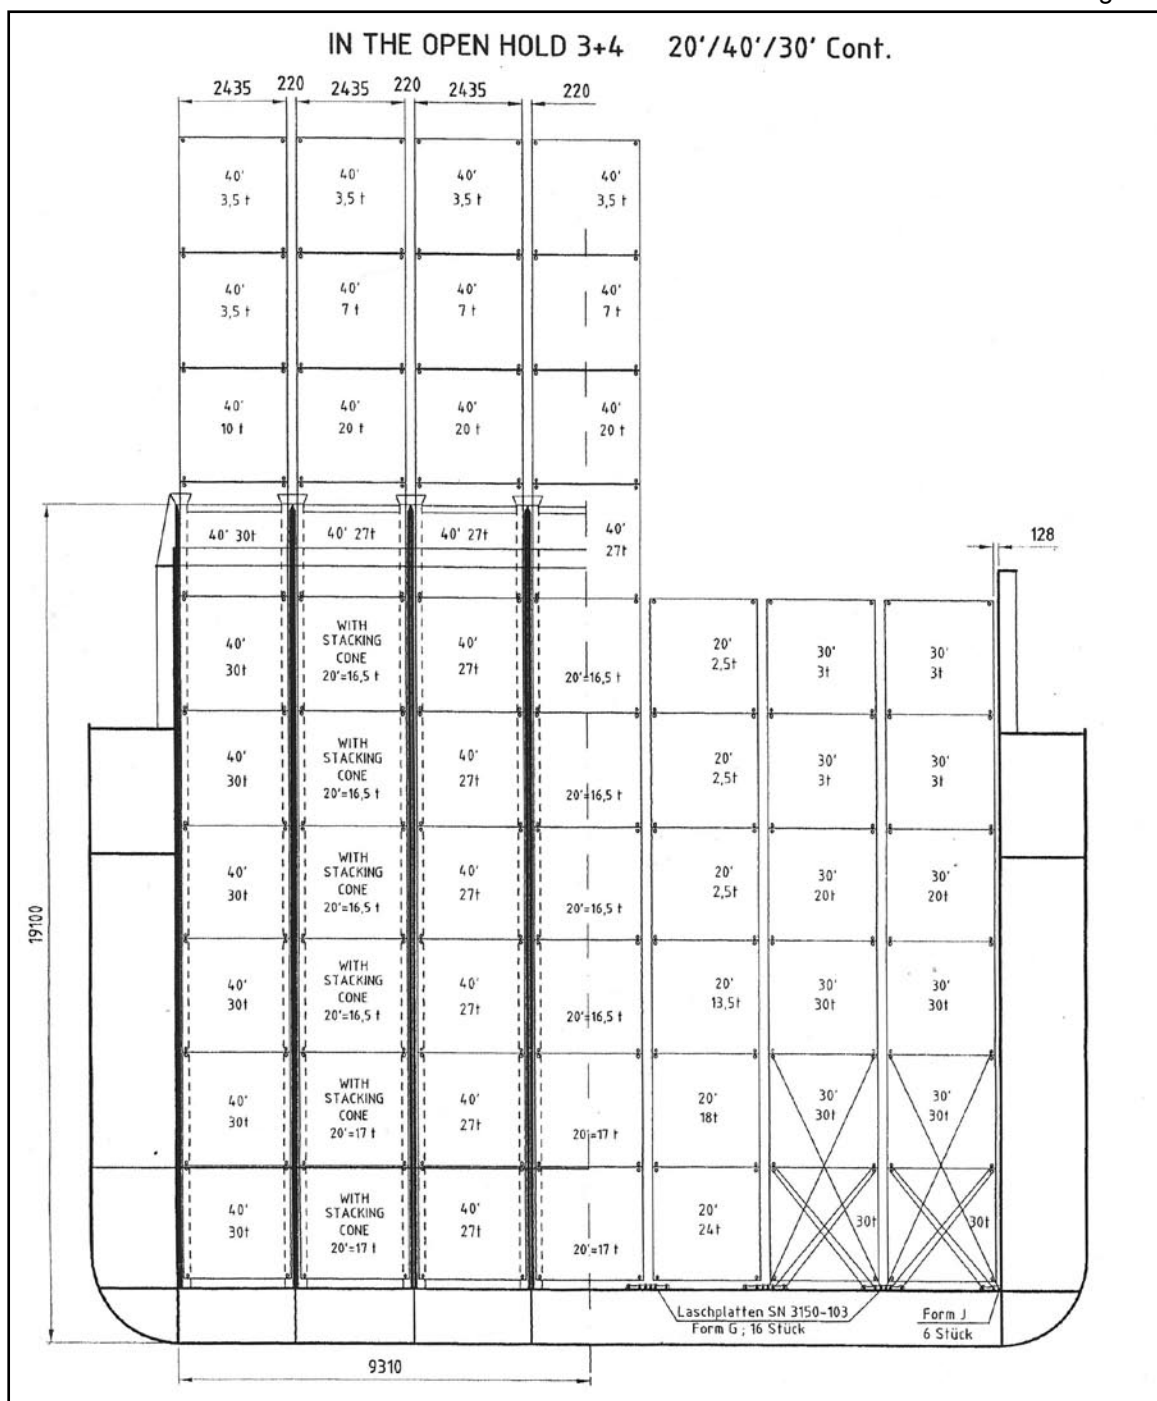
The lowest four 30 foot containers in the collapsed stack were designed to carry non pressurised bulk materials. They were all fully laden and three had an allowable stacking weight of 100,500kg (100.5 tonnes) at $1.8g^2$, with the remaining container being able to support 108,000kg (108 tonnes). This information was stamped onto the CSC safety approval plate, which was fixed at the end of each container (**Figure 9**).
