Report on the investigation

of a major LPG leak from the gas carrier

Ennerdale

> Report No 10/2007 May 2007

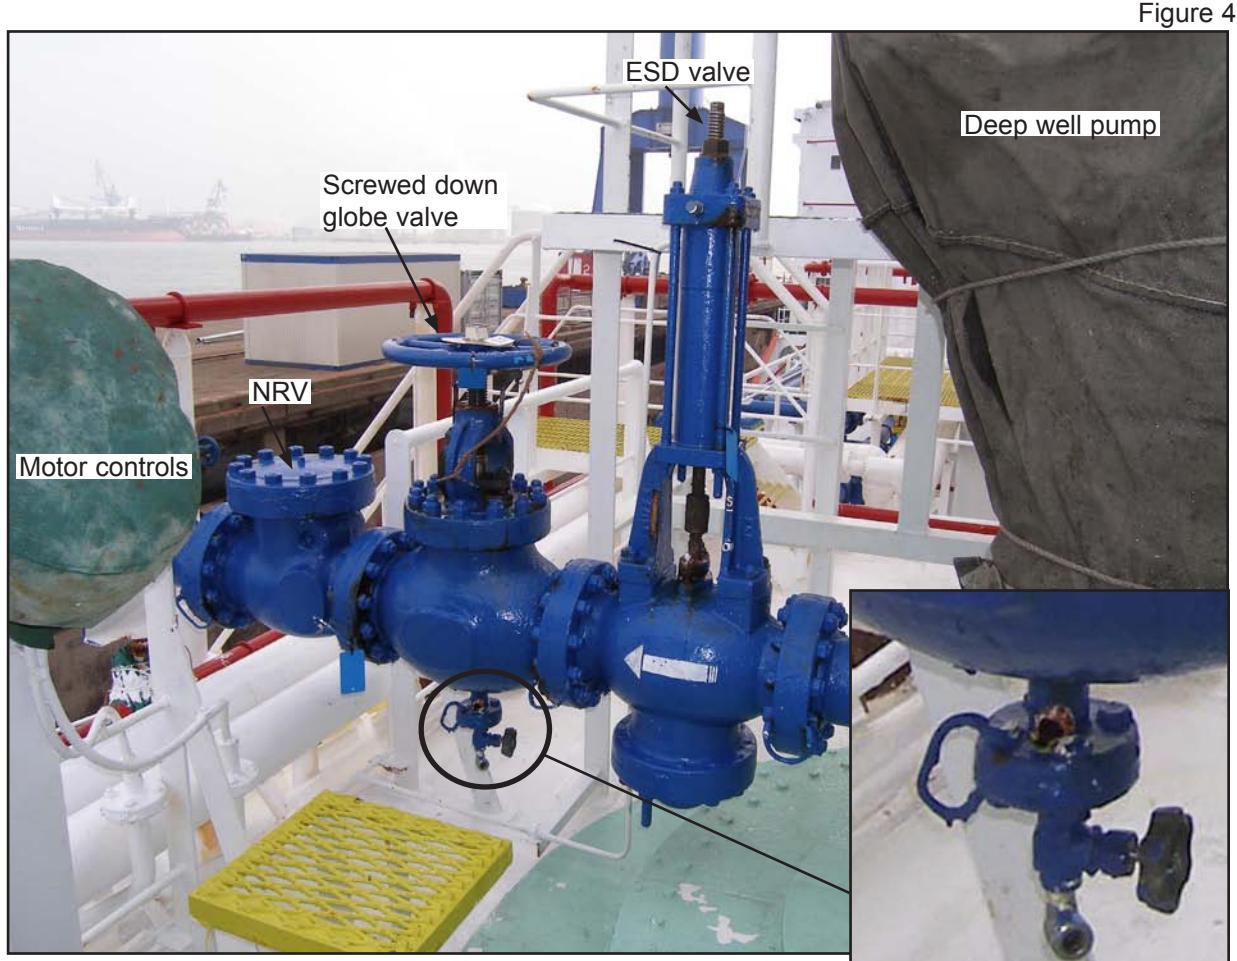
No 1 cargo discharge line

The sampling points used in this accident were situated beneath the manual globe valves on the discharge lines of the tanks (**Figure 4**). To obtain a representative sample, the cargo was circulated from the tank using the deep well pump, via the discharge line, and back into the tank, via the loading line.

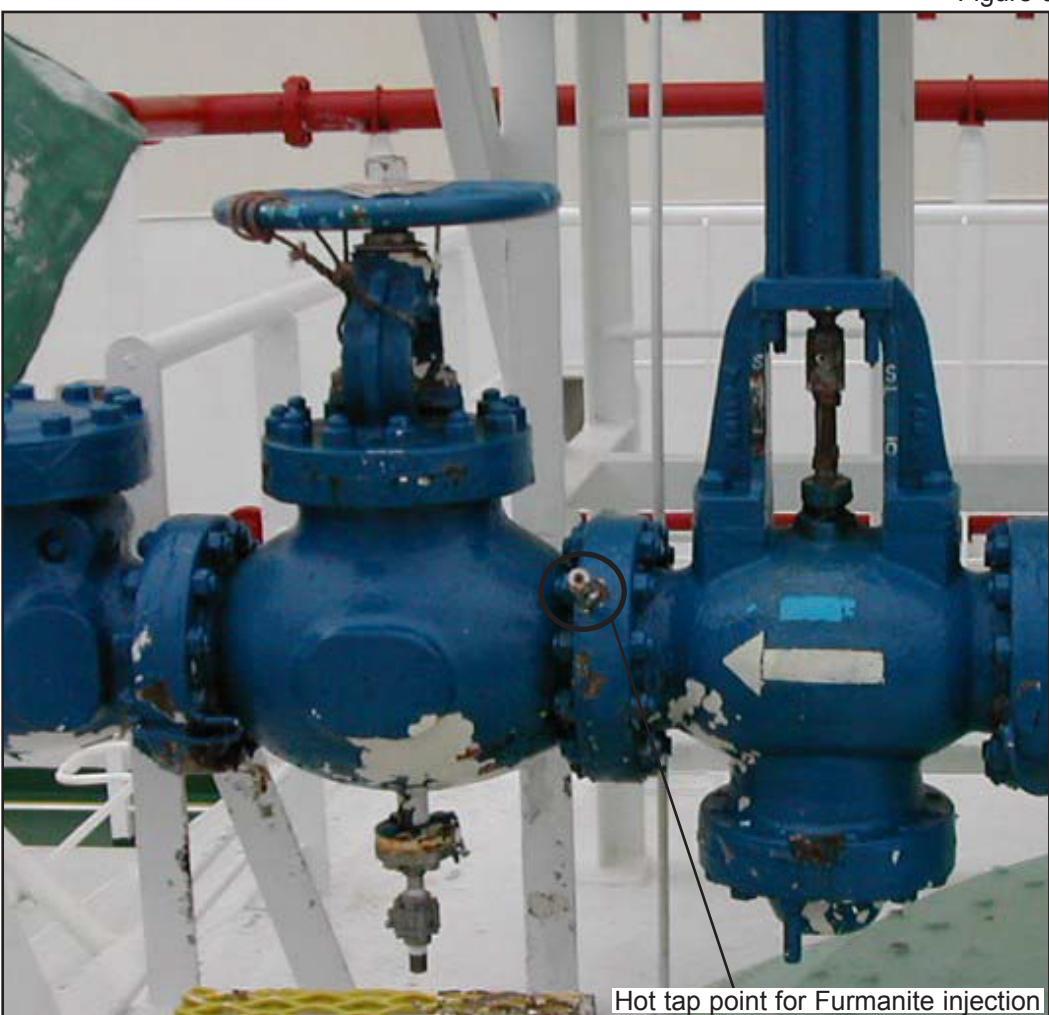
Figure 9

At approximately 1000 on 18 October, the decision was made that the hot-tap injection method represented the best chance of sealing the leak. At 1340, preparations were complete and the contractors started to drill a hole into the flange of the globe valve. By 1425, the hot-tap was in place and they started injecting the sealing compound, which was delivered in 16 cc packets. It was initially estimated that 40-60 packets would be required. However, it was not until 93 packets had been inserted, at 0240 on 19 October, that the flow of cargo was sufficiently reduced to enable the ice ball to be removed and the leak capped. A new $\frac{1}{2}$ ball valve, fitted with a thread adapter to screw on to the $\frac{3}{8}$ stud piece, was fitted to close off the pipework (**Figure 9**).

No 2 sampling point repair

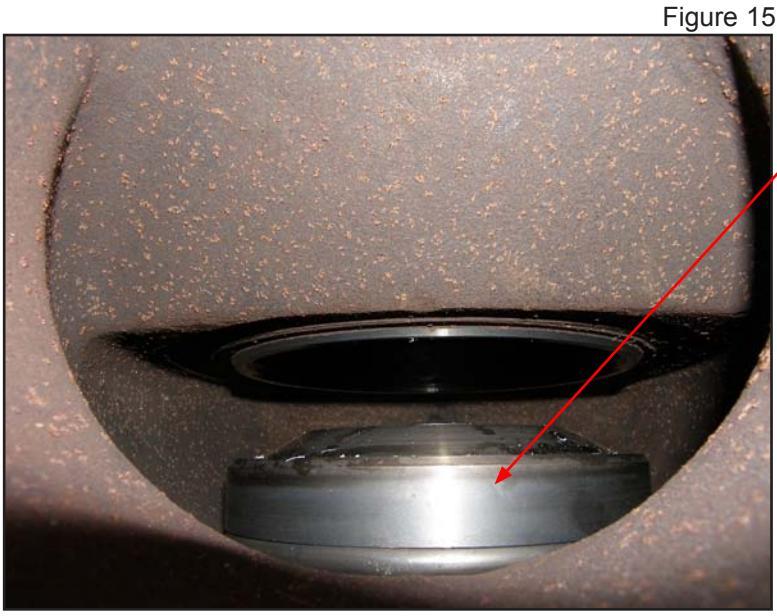
Once in dry dock, all the ESD valves onboard *Ennerdale* were removed and examined. No problems were found except with the ESD valve on the No. 2 discharge line. It was found to be jammed open, and obviously accounted for why the ESD valve had not contained the leak **(Figures 14 & 15)**. The bottom of the valve, which contained the valve disc and spring assembly, was removed **(Figure 16)**. It was discovered that a small burr in the valve guide was preventing the valve disc from rising, under the force of the spring, on to the valve seat **(Figures 17 & 18)**. The burr was adjacent to one of two tack welds that held the guide in position in the bottom of the valve body.

No 2 ESD valve viewed from pressure side

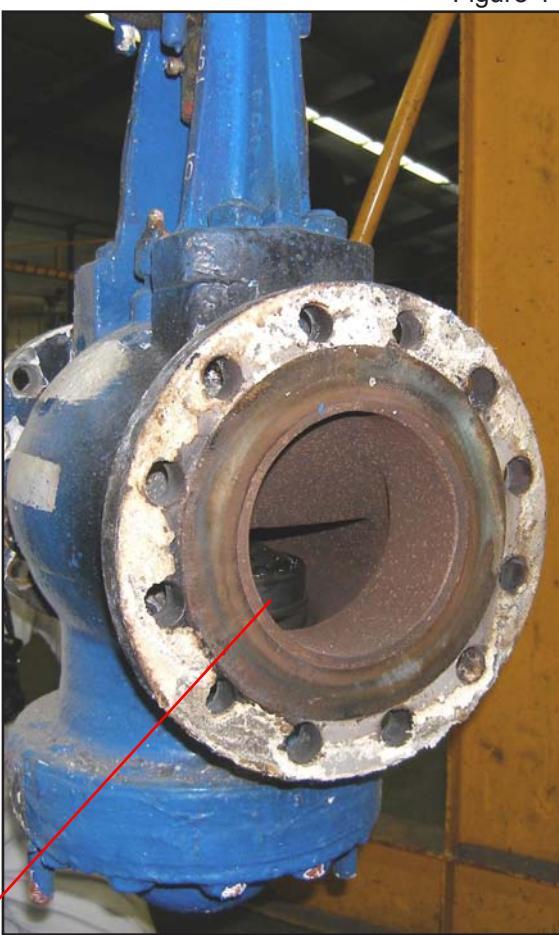
Inside No 2 ESD valve- seat at top and valve disc at bottom

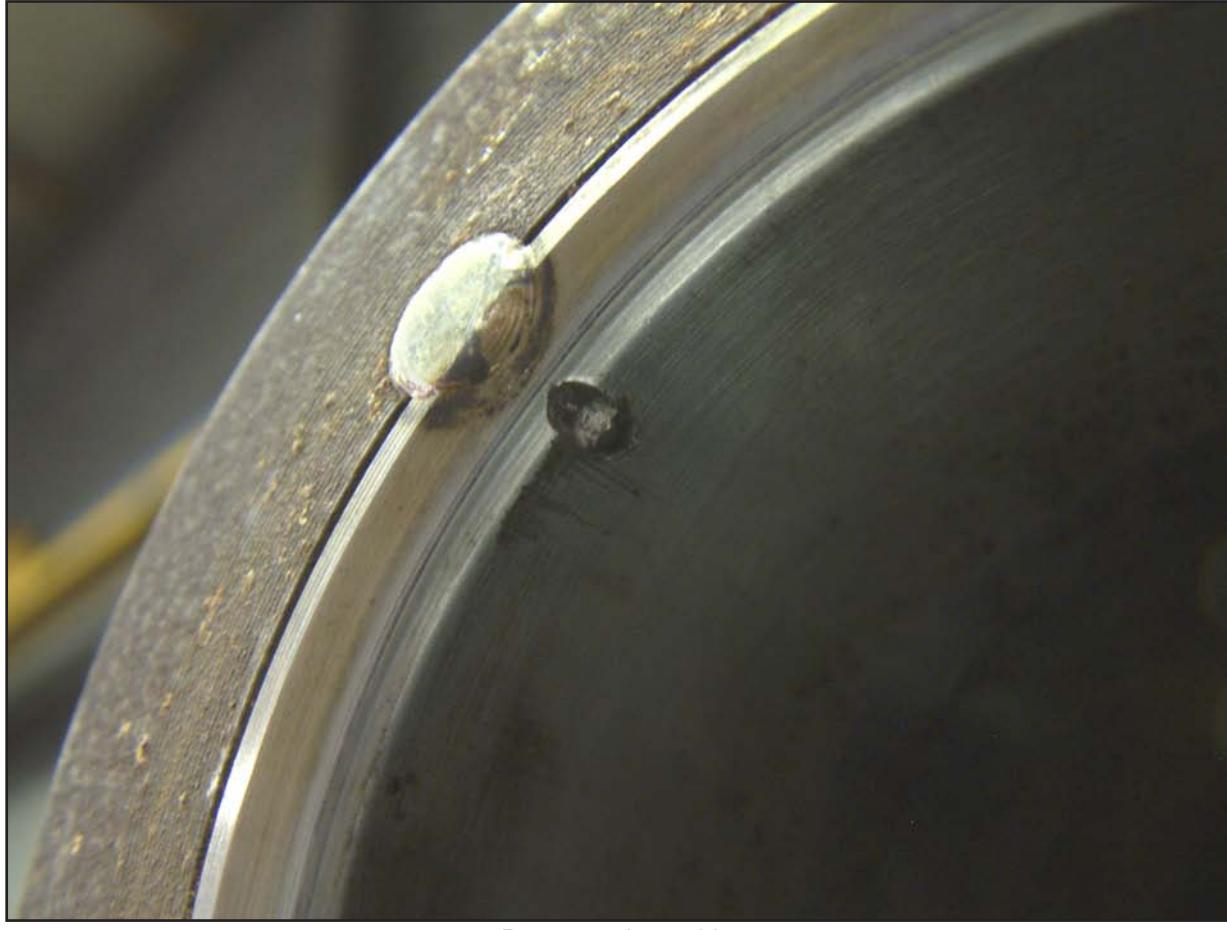
Burr on valve guide

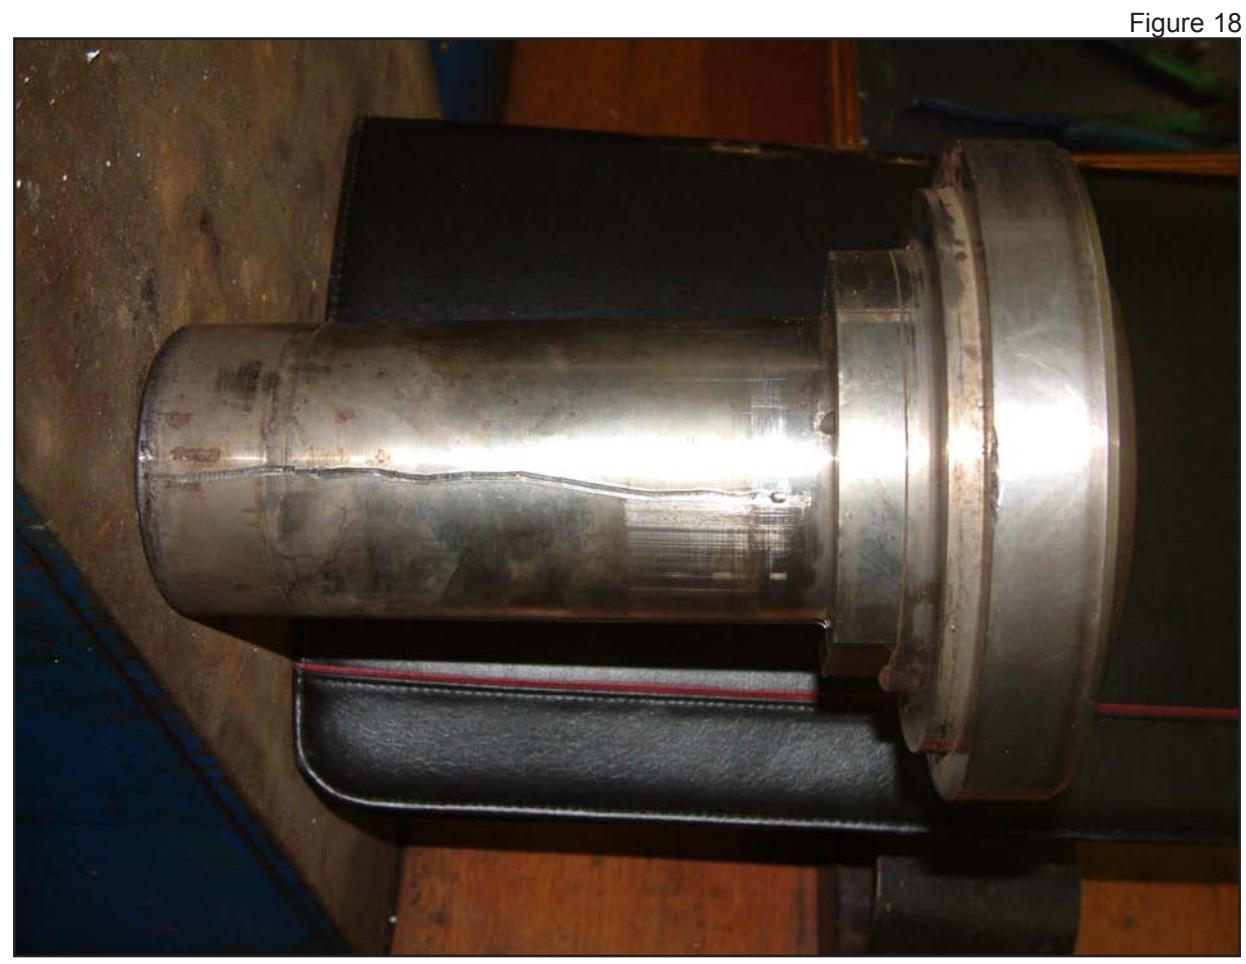
Scoring damage on valve disc body

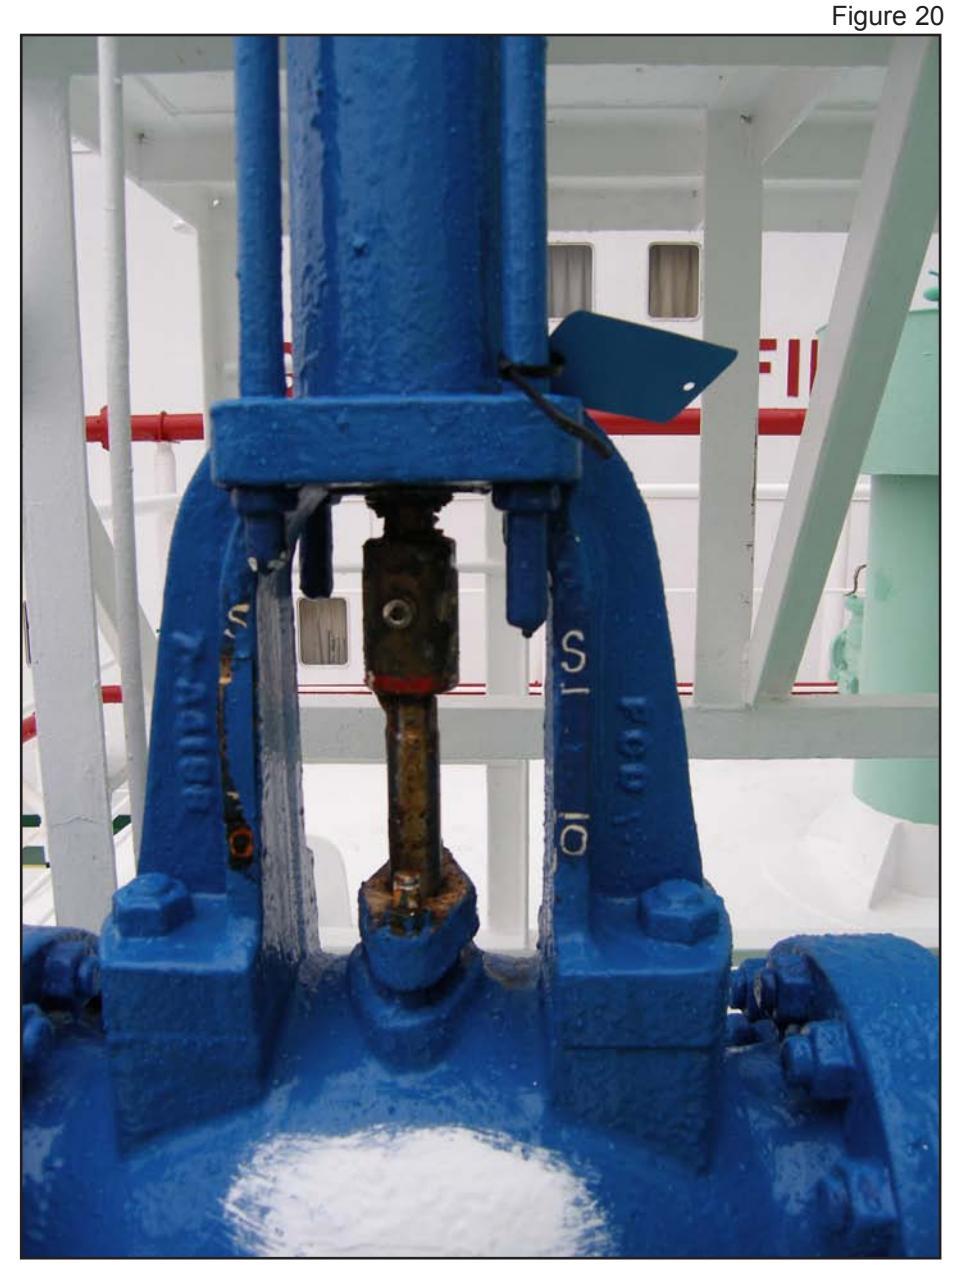
However, what became clear during MAIB's investigation was that the operators, and many assessors, did not realise that the JIS 20 K ESD valve design does not provide a positive indication of the valve's position. The joint between the actuator spindle and the valve stem was used as an indicator of whether the valve was open or shut (Figure 20). The fact that this indication method could only positively show when the valve was open, not shut, was overlooked. This fundamental omission in the design of the JIS 20 K compromised the ability of this valve to act as an ESD valve, since no confidence could ever be placed in the valve being shut under the current testing regime.

The IGC Code does not require ESD valves to have positive indication of the valve position. It does, however, require the valve to be capable of local manual closure. The JIS 20 K ESD valve was approved by class at build as meeting ESD requirements **(Annex A)**. It is assumed local manual closure of the valve was interpreted on the basis that the hydraulic pressure could be removed locally by disconnecting the hydraulic pipe to the actuator. The stem on top of the valve can be screwed down using a wrench, but this could only be used to push the valve open, not closed. A consistent interpretation of the IGC Code requirements for ESD valves is required to ensure there is no ambiguity about the need for the valve position to be indicated, or the ability to manually close the valve.

ESD valve position indicator

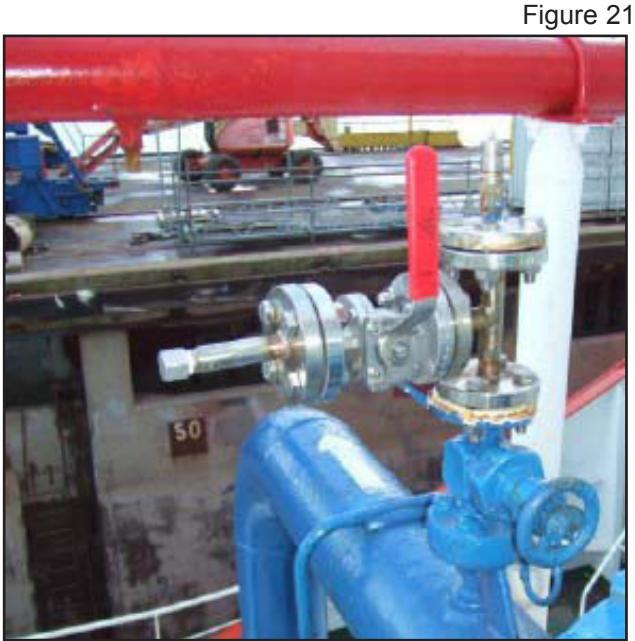
Modified No. 2 sampling point

- The manual globe valve drain cocks on *Ennerdale* have been replaced with flanged ball valves to prevent them from being unscrewed, and the drain cocks will no longer be used for cargo sampling.
- A dedicated closed loop sampling system has been fitted, in position, after the NRV on the discharge line, with two valves between the cargo line and the sampling point (Figure 21).
