Extract from Subsea 7 Shell EPE Pipeline Inspection report

Boreas Consultants Ltd report entitled: Goldeneye Pipelines Assessment of Trawl Gear Incident at KP75.230

# Goldeneye Pipelines Assessment of Trawl Gear Incident at KP75.230

Boreas Report Number BR06022/SUK-56-A/Rev A Issued 15th February 2006

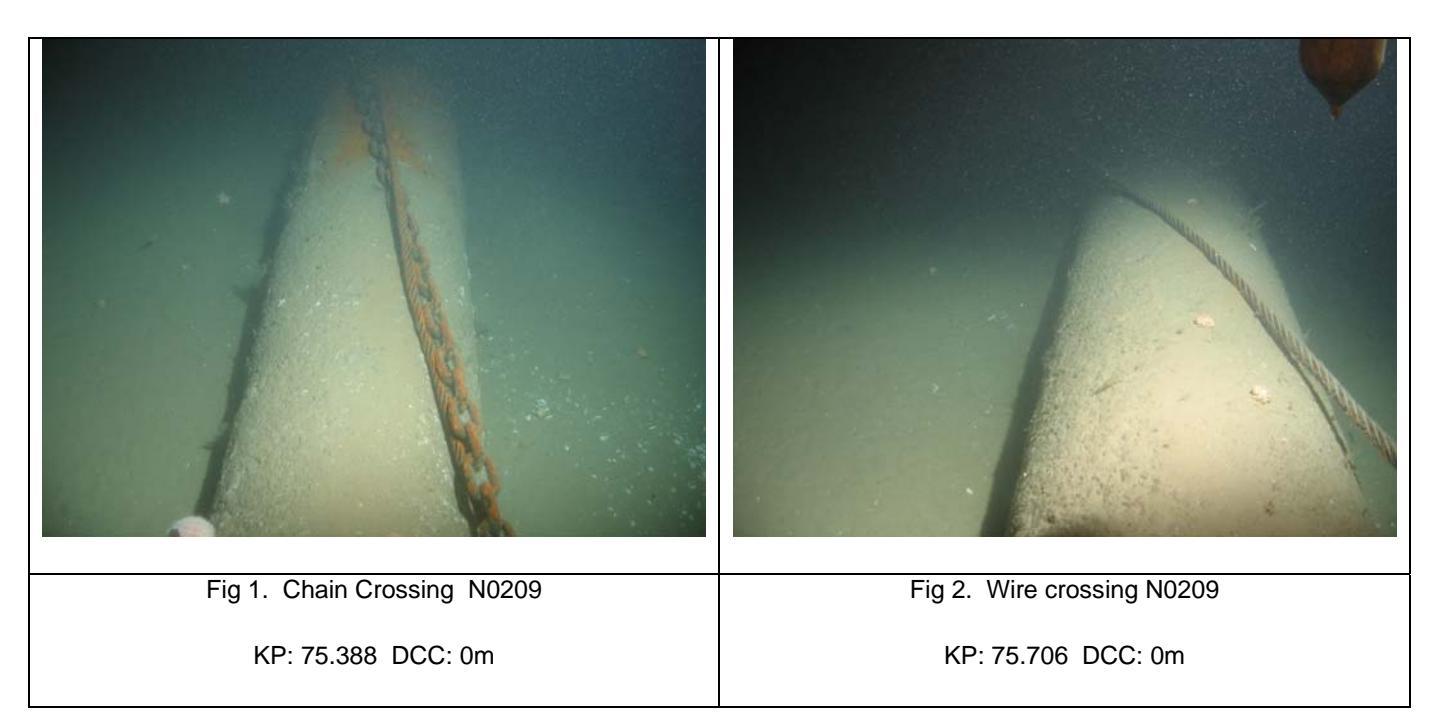
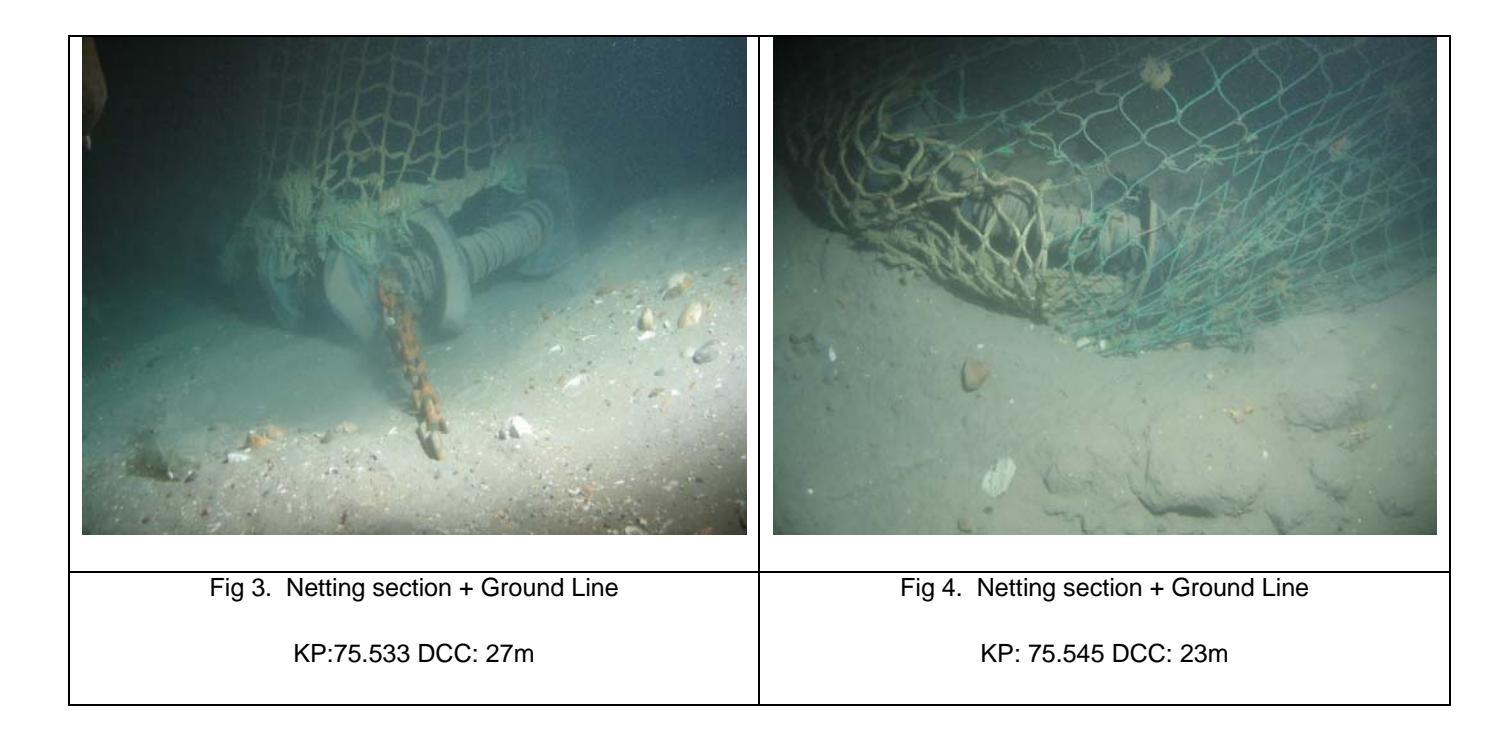
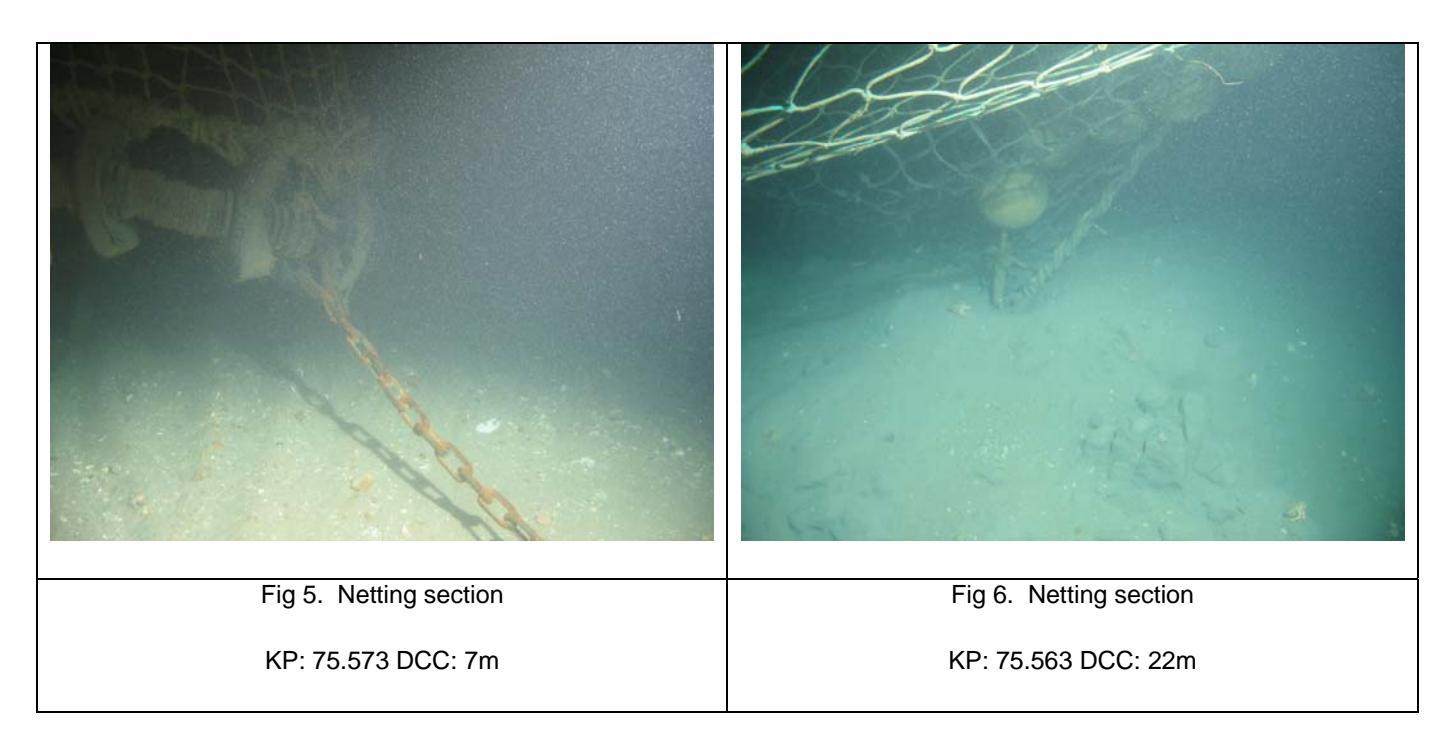
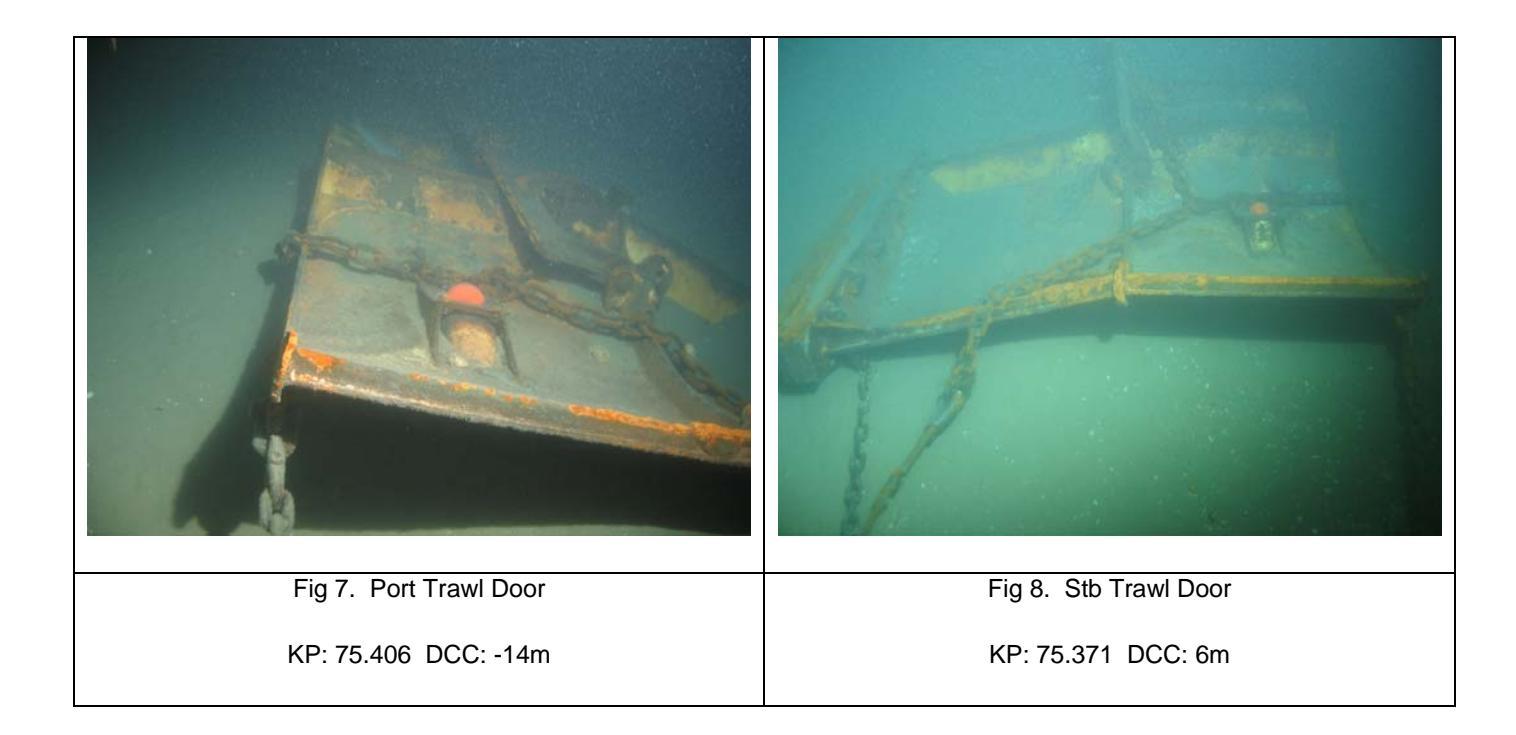
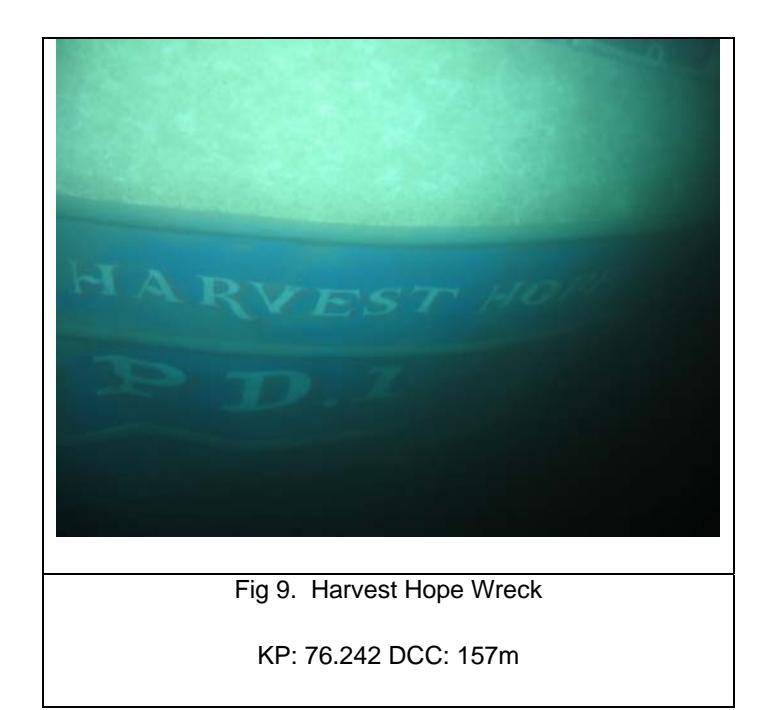
#### 2. Photos of debris items

The survey identified the debris of the trawl gear and the location of the wreck in the vicinity of the N0209 and N2805 pipelines (See drawing no. ET0261/KSS/05/1254). The trawl gear section was found to be located on and between the N0209 and N2805 pipelines. The trawl gear was not connected to the wreck of the Harvest Hope. The debris includes the net, and associated gear, two tow chains and the port and starboard trawl boards. A summary of the all debris is contained within the events listing below.

No evidence of the net having been caught on any pipeline or seabed feature in the vicinity of the trawl gear debris was observed during the survey. No damage to the pipelines was observed during the survey.

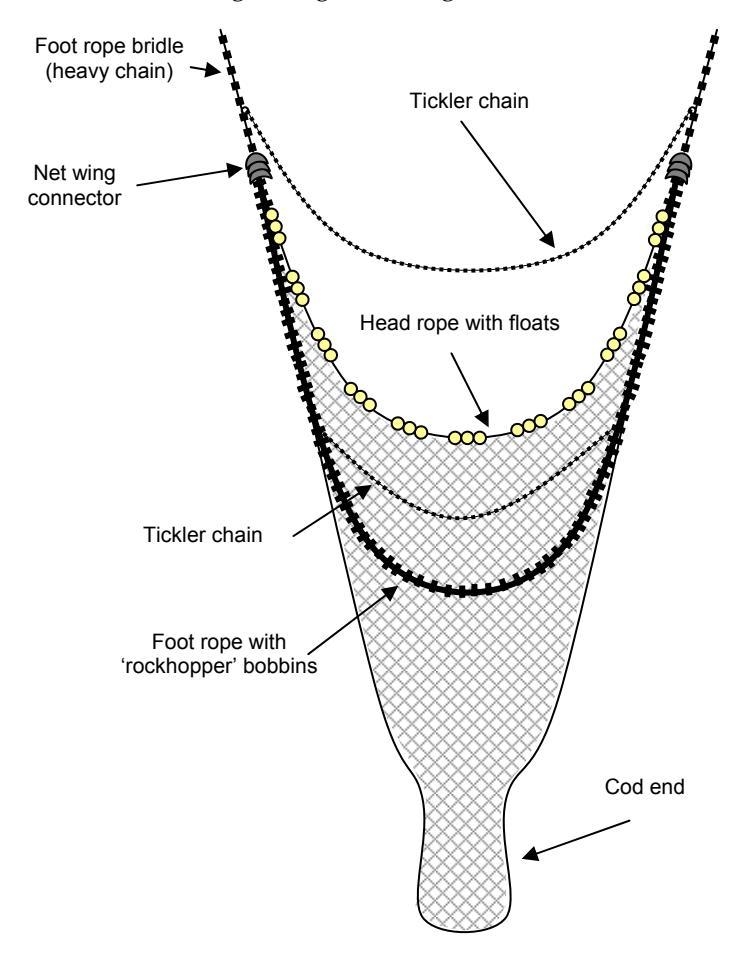
Figure 4.1 Plan view sketch of the trawl gear

Based upon observation of the ROV inspection footage, the gear was single rig, with simple rectangular V-doors. Wire and chain combination bridles link the foot rope of the net to the doors, while wire bridles connected to the chain bridles connect to the upper wings of the net. A plan view sketch of the gear is given in Figure 4.1.

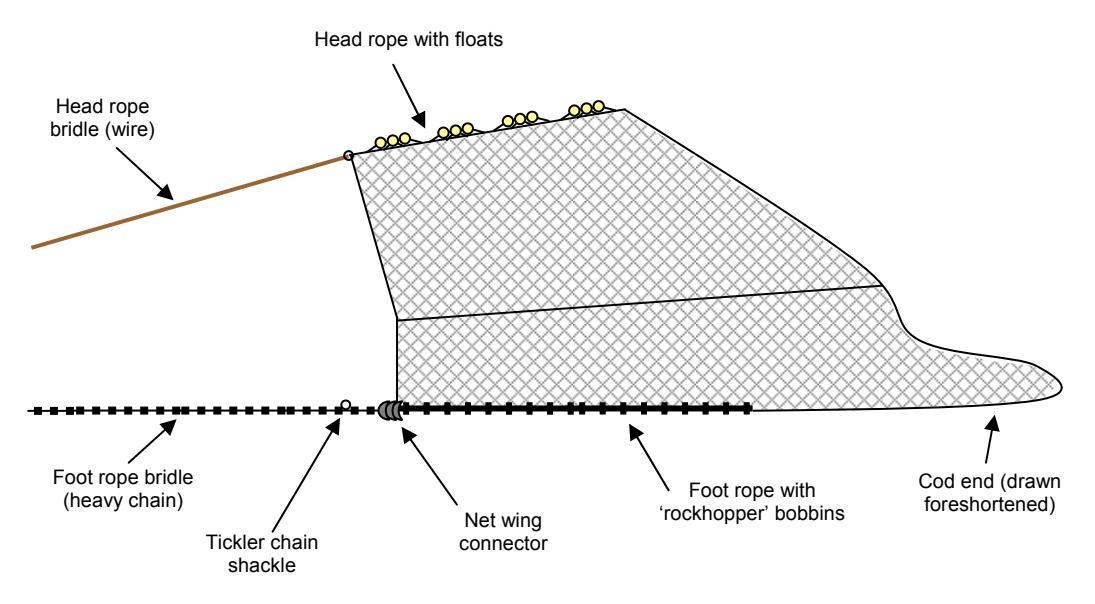
Figure 4.2 Sketch of the trawl gear in elevation

An approximate sketch of the gear, in elevation, is given in Figure 4.2. Although this may not be very accurate with regard to the wing arrangement and, especially, the cod end, it does illustrate the salient points. The skipper of the *Harvest Hope* stated that the net actually has twin cod ends; this arrangement is unlikely to have influenced the way the gear came fast, or the recommendations for its removal.

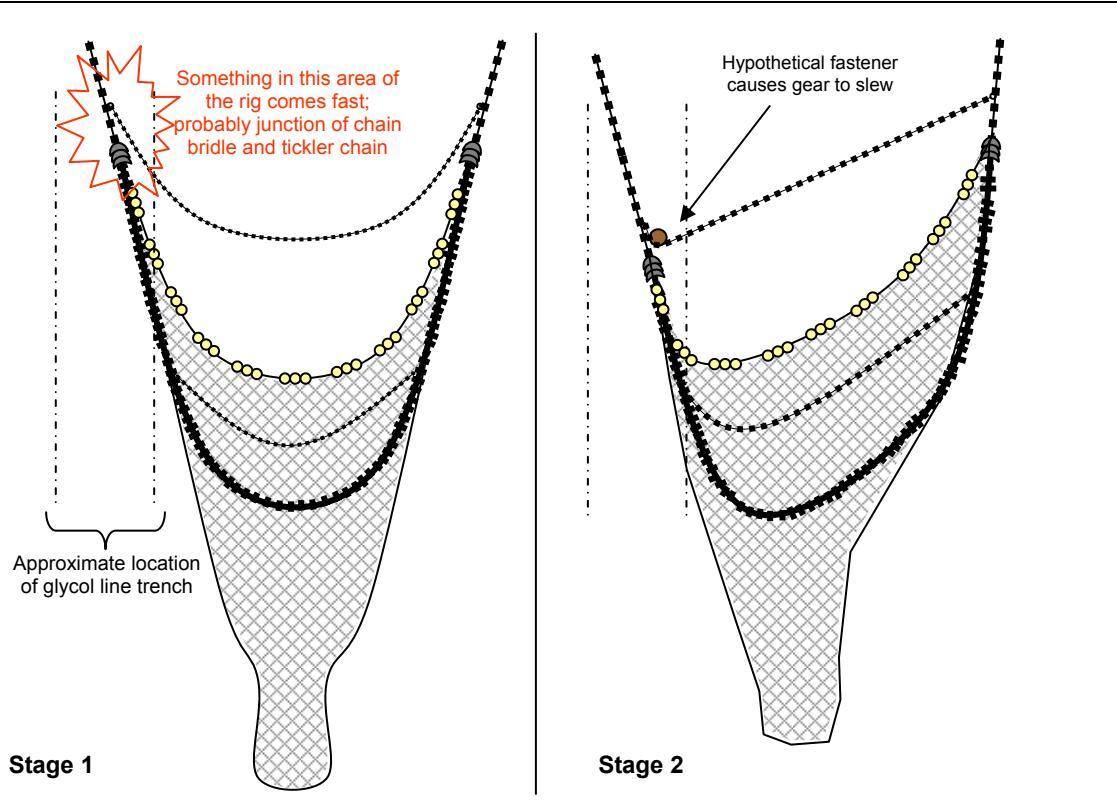
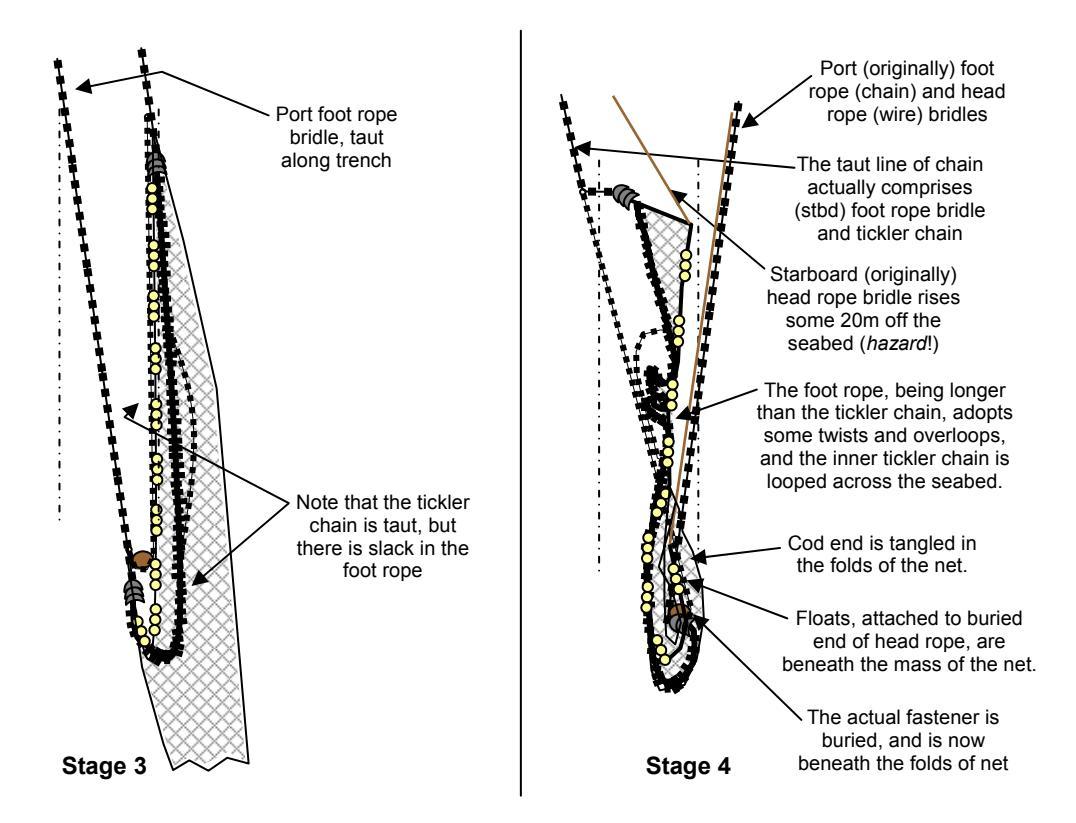
In the process of coming fast, the foot rope was flipped across the starboard warp/tickler chain. Because the tickler chain is shorter than the foot rope, a number of twists and turns appeared in the foot rope. Meanwhile, the back of the net, to the cod end, became entangled with the port wing (close to, and covering, the fastener).

This sequence is illustrated in the sketches - Figure 4.4 and Figure 4.5.

Figure 4.4 Schematic of trawl gear coming fast - stages 1 and 2

Figure 4.5 Schematic of trawl gear coming fast - stages 3 and 4

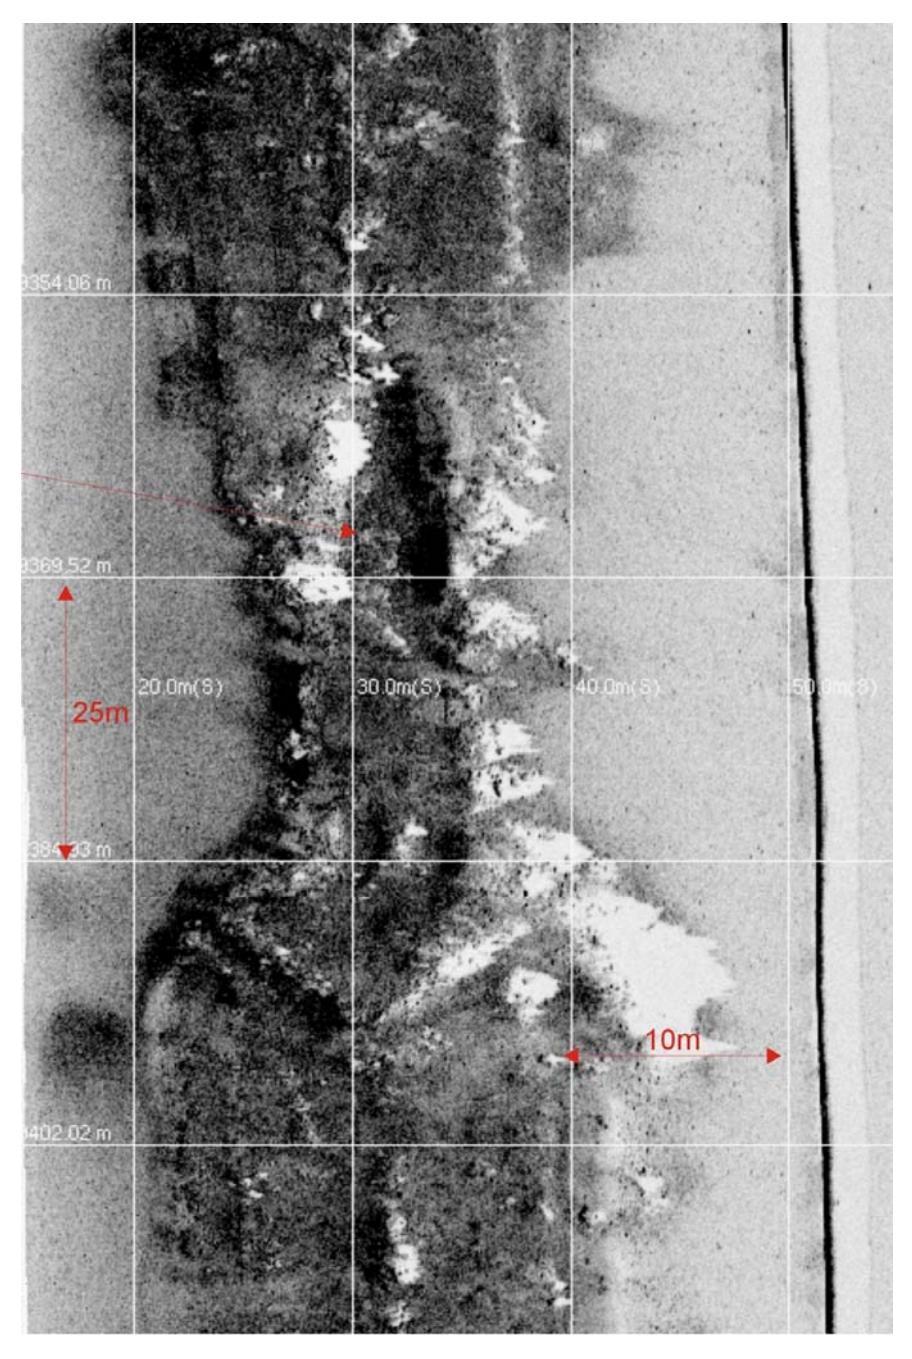
Figure 5.1 Segment of side-scan trace for KP75.152 ~ KP75.275

Side-scan sonar traces, taken prior to the gear coming fast, have been inspected (following the review meeting). A segment for the location where the gear is fast is presented in Figure 5.1<sup>[3]</sup>.

The sonar was towed along the left of the picture (i.e. Figure 5.1), heading from the bottom upwards. To the right of the picture the hard black return with the white band of shadow behind it represents the 20" gas line. The trench of the glycol line is nearer to the track of the sonar. To the bottom of the picture (beneath the lowest white fix marker), the trench is 'typical': in the middle is a small heap (dark return to the left, white shadow to the right) which should lie approximately above the Glycol line. There is little in the way of residual spoil to either side. Then, about a quarter of the way up the picture, there is a V-shaped heap across the trench. Above that, until almost the top of the picture, the trench is narrower and significant spoil heaps, including large lumps, are visible. At the top of the picture, above the top fix marker, the trench starts to look more like the 'typical' trench, although the result is rougher, and some residual spoil remains, especially on the right.

This corroborates the earlier analysis. In light of all the evidence, and the analysis, it is recommended that the optimum approach to removal would be to pull the net in the reverse direction to that in which it came fast. Consideration may be given to high pressure water jetting of the soil mound, although this will have to be performed with the net in place – i.e. jetting through the net.

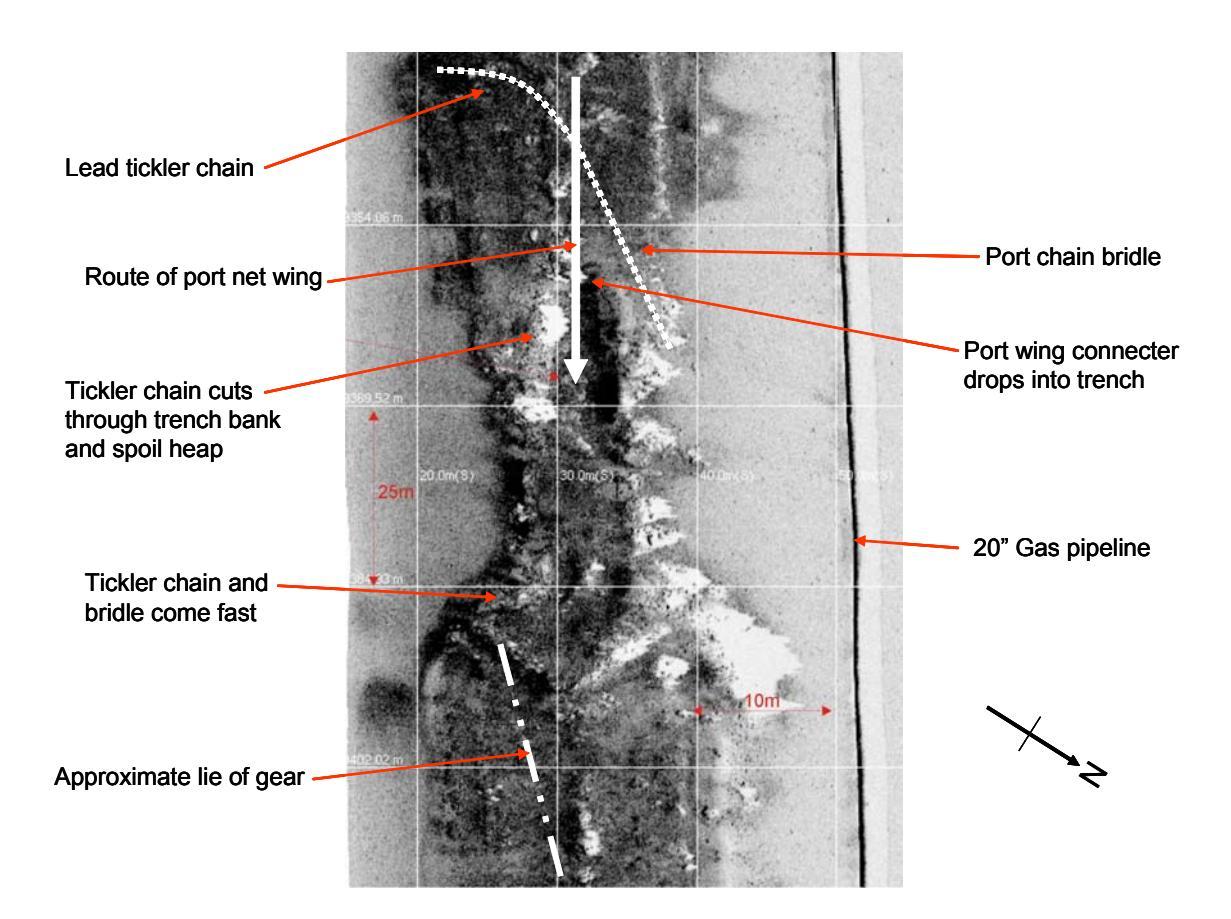
Figure 5.2 Proposed sequence of events superimposed on the side-scan trace.

It may be noted that an inspection of the ploughing logs, and of the side-scan data, has revealed one other location where there is a similar, if less marked, V-shaped heap. This is in the vicinity of KP48.500. This should be investigated to see whether it poses a similar threat to demersal trawl gear.

It is recommended that the trench depression in this area, especially close to the V-shaped bank, be levelled with rock dump once the gear has been recovered, to ensure that this cannot occur again. The volumes of rock required will not be large as it is only required to smooth the profile to ambient seabed level.
