Report on the investigation of the Brenscombe Outdoor Centre canoe swamping accident in Poole Harbour, Dorset on

6 April 2005

Marine Accident Investigation Branch Carlton House Carlton Place Southampton United Kingdom SO15 2DZ

> Report No 22/2005 December 2005

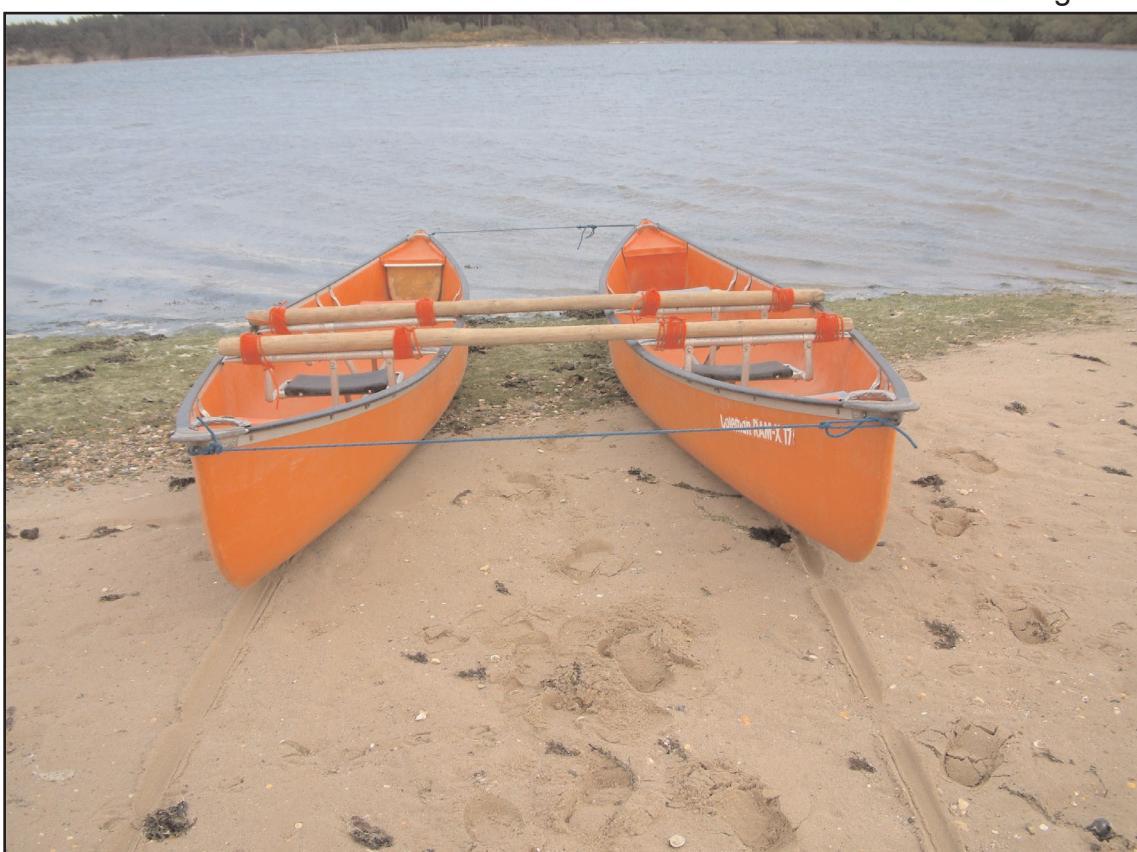
The instructors helped to connect the canoes across the midships sections, using two large wooden spars which were secured by ropes to the seat supporting structures. The canoes' stems and sterns were tightly lashed together using short ropes (**Figure 5**).

Rafted canoe arrangement

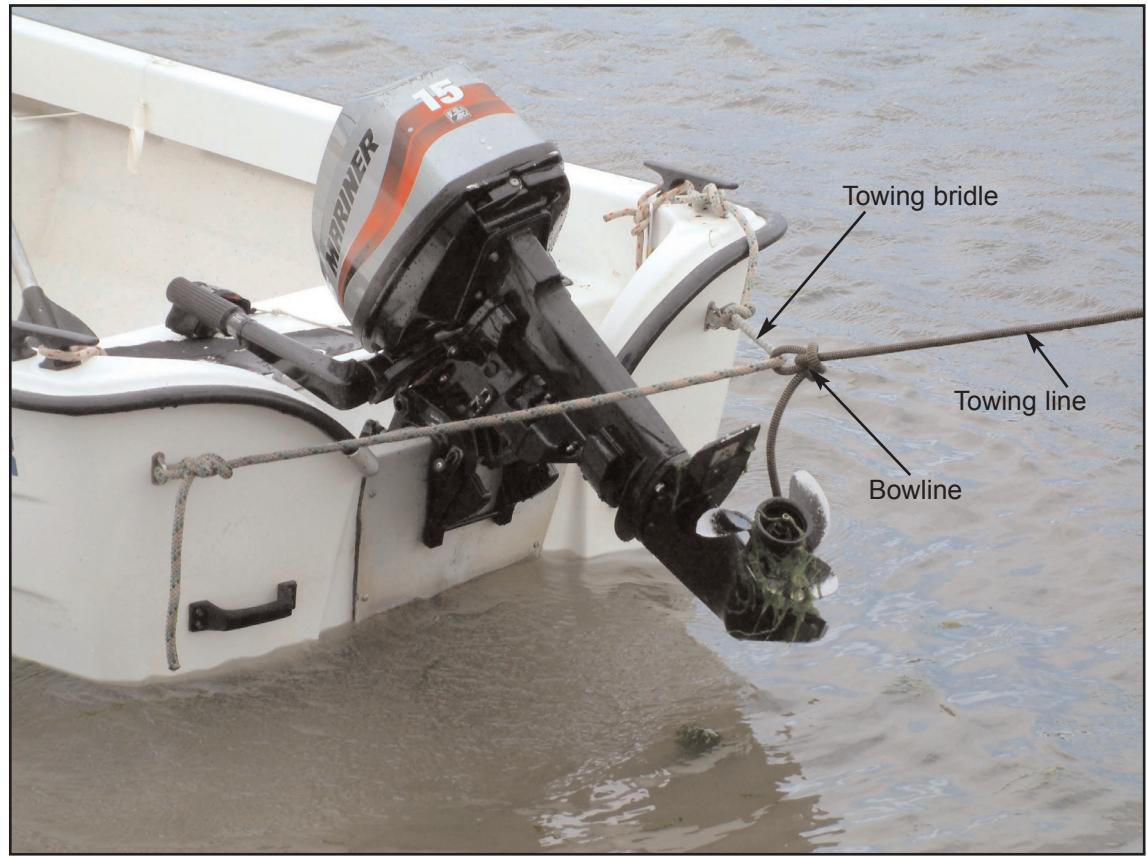
A short towing bridle was fitted to the stern of the safety boat, and a towing line was connected between the bridle and the canoes' stem rope by bowline knots. This enabled the towline to move freely along both the bridle and stem rope. The towing arrangement is shown in **Figures 6 and 7**. In an effort to make up for lost time, the canoes were towed across open water towards Goathorn Point. The option to return to Bramble Bush Bay was not considered, despite the obviously deteriorating weather conditions.

Safety boat bridle and towing line arrangement

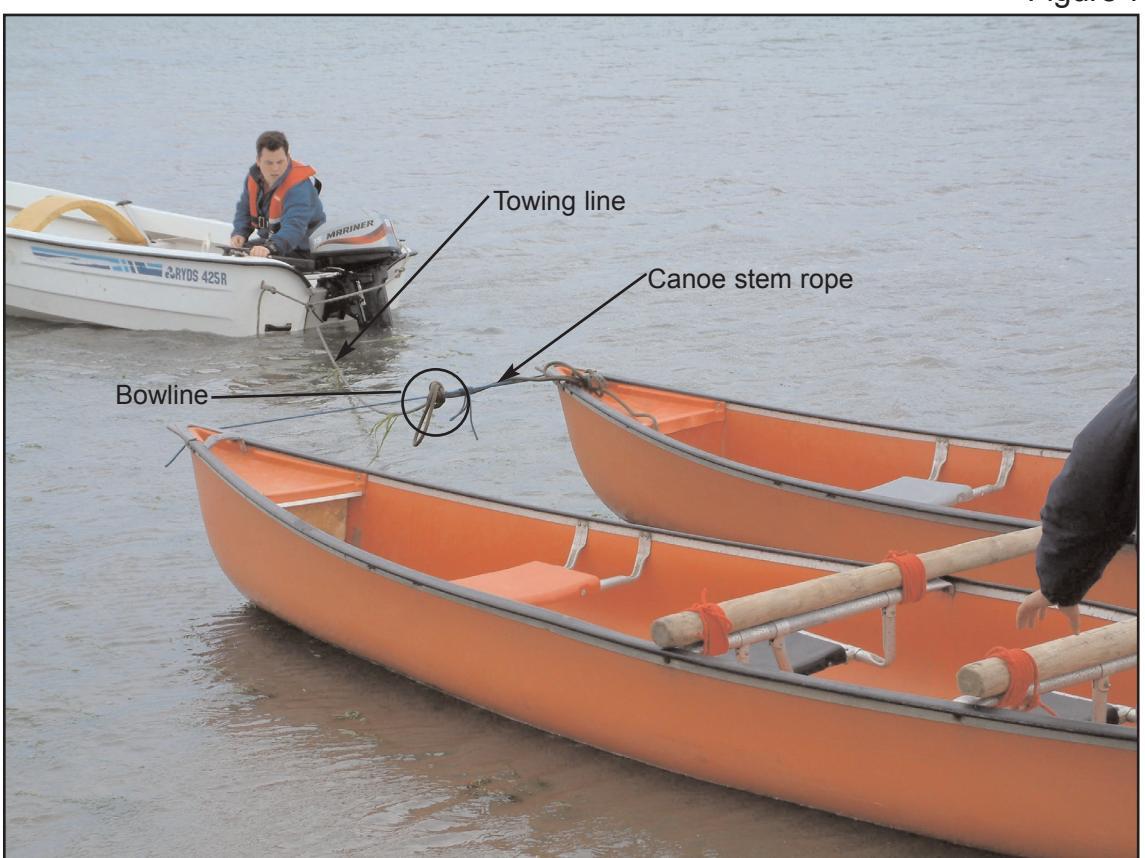
Canoe stem rope and towing line arrangement

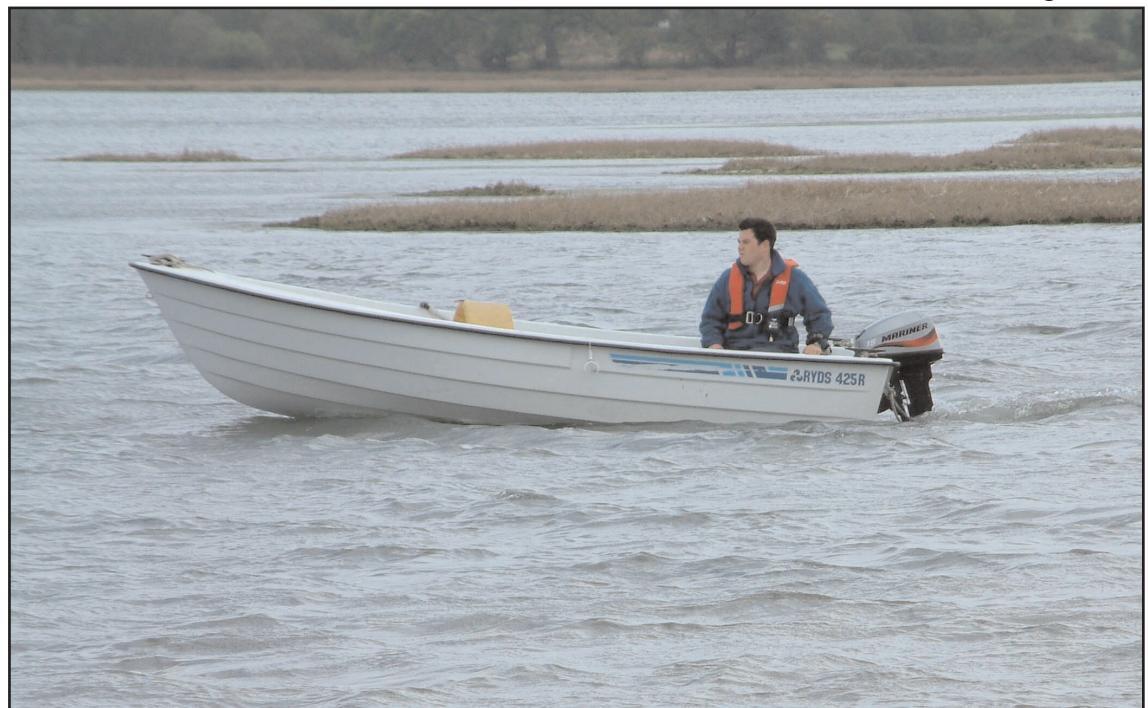
Figure 10

Safety boat - RYDS 425R

- 14. The safety boat was inadequate for its role and was not equipped with distress flares or a VHF radio. [2.8.2, 2.8.3]
- 15. The safety boat engine power output of 11.2kW exceeded the boat's designed output of 7.4kW. [2.8.4]
- 16. The safety instructors were not familiar with towing techniques involving rafted canoes. [2.9.1, 2.9.2]
- 17. It was not normal BOC practice to inform the Poole Harbour Authorities when entering or leaving the water. [2.10]

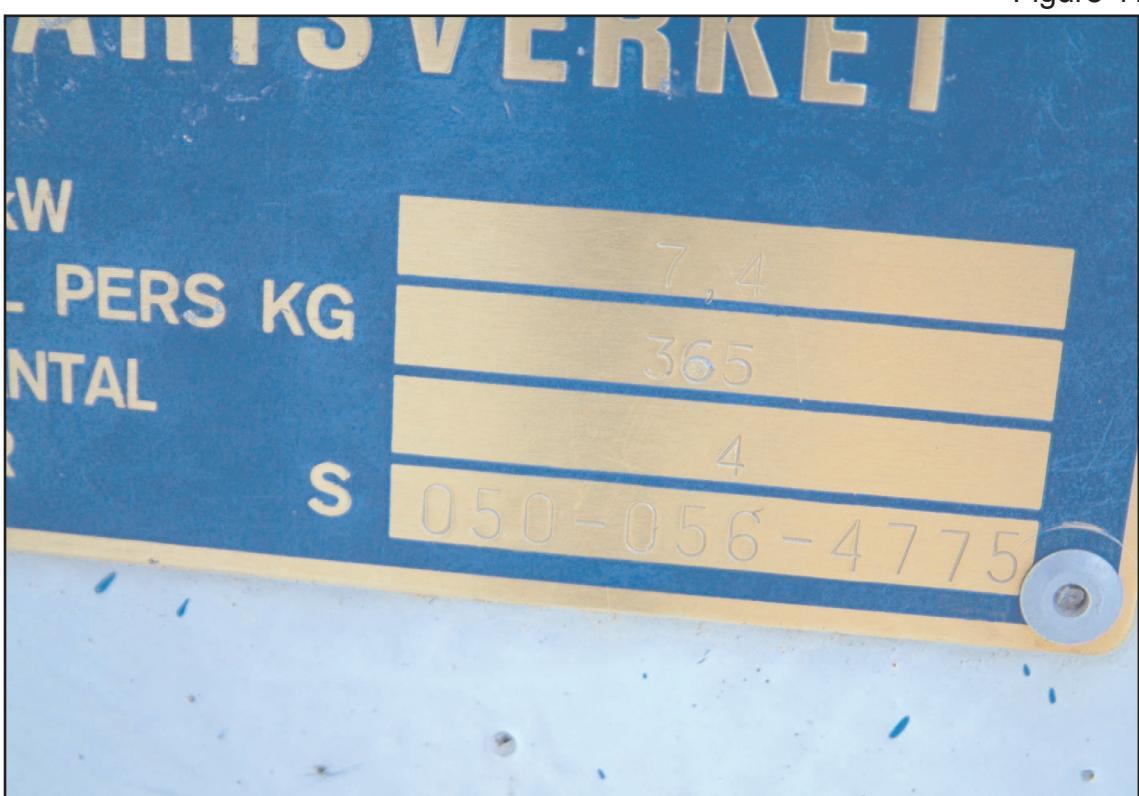
Figure 11

Safety boat identification plate

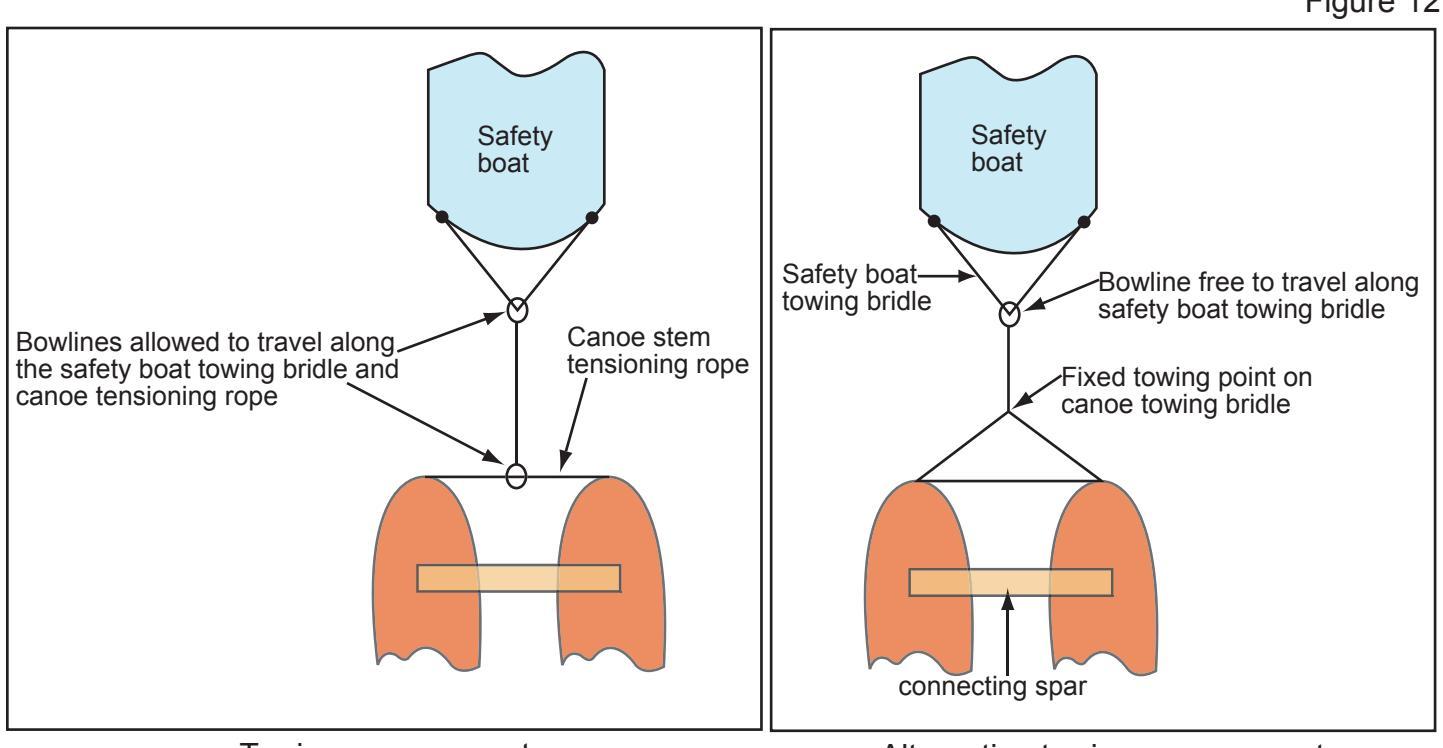
Figure 12

Alternative towing arrangement

Both the RYA powerboat, and the BCU syllabi, cover various towing techniques, but the rafted canoe configuration is not covered, despite it being in widespread use. Appropriate towing techniques to suit the particular circumstances can be learnt through "on the job" training. Inclusion of rafted canoe towing techniques in the RYA and BCU syllabi would provide a very helpful baseline.
