Report on the examination of the RIB's steering system by Hypro Marine

Report on the Condition of the Hydraflex Outboard Steering System ex-RIB Installation involved in the Loch Lomond incident

Prepared at the request of Marine Accident Investigation Branch

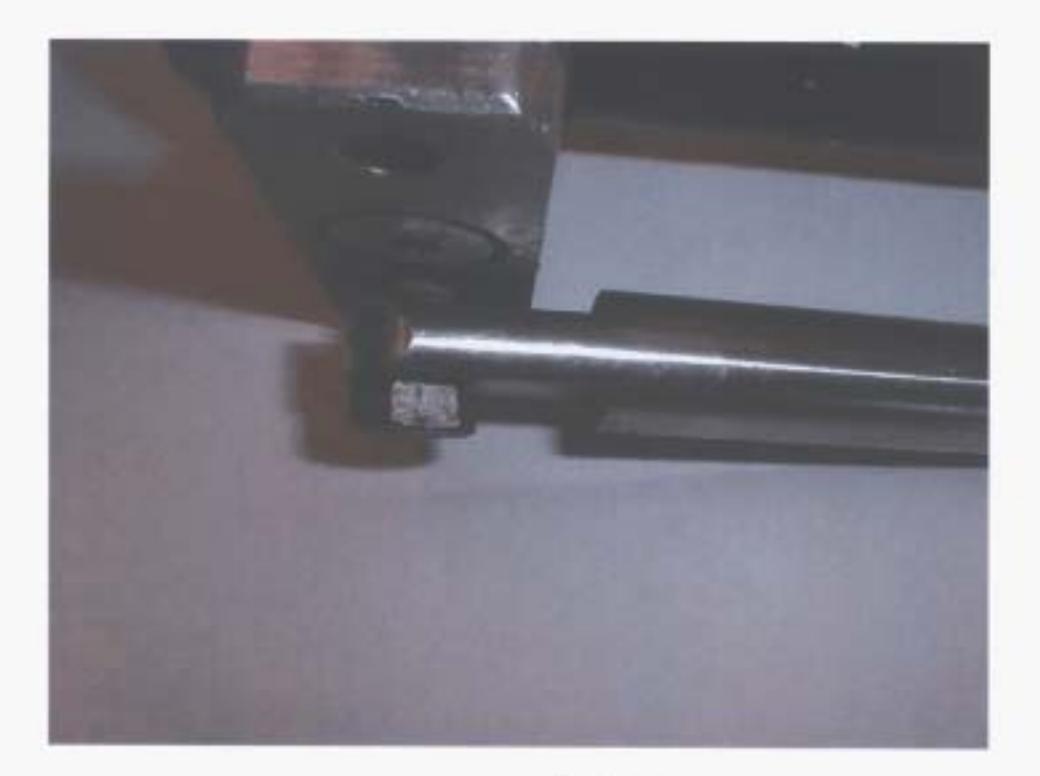
Photo A

The overall condition of the steering system is poor, with significant loose movement in the mechanical link between the steering system and the outboard. There appears to be a mixture of questionable fittings used on the installation and a poor selection of hose specification and type of end fitting. There is evidence of the use of an incorrect thread on a critical connection of the steering actuator to the outboard engine. (Photo A)

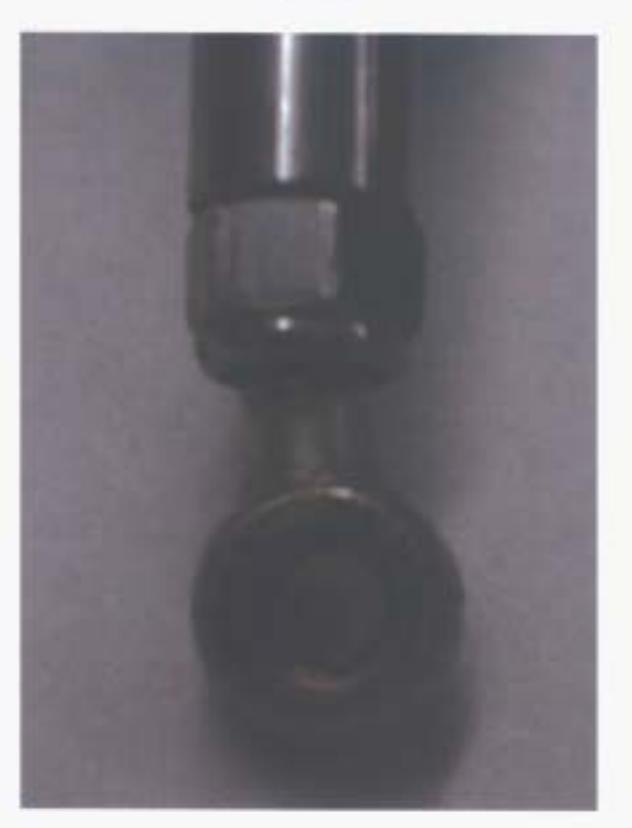
Photo B

- The drag link making the connection between the steering actuator and the "tiller arm" on the outboard is bent at the uniball end. (Photo B) The bolt making this connection is incorrect at M10 (should be 3/8" UNF) and should have been retained with a Nyloc locknut. The other end of the drag link is loose to the actuator, either as a result of the bolt being too long or a missing spacer.

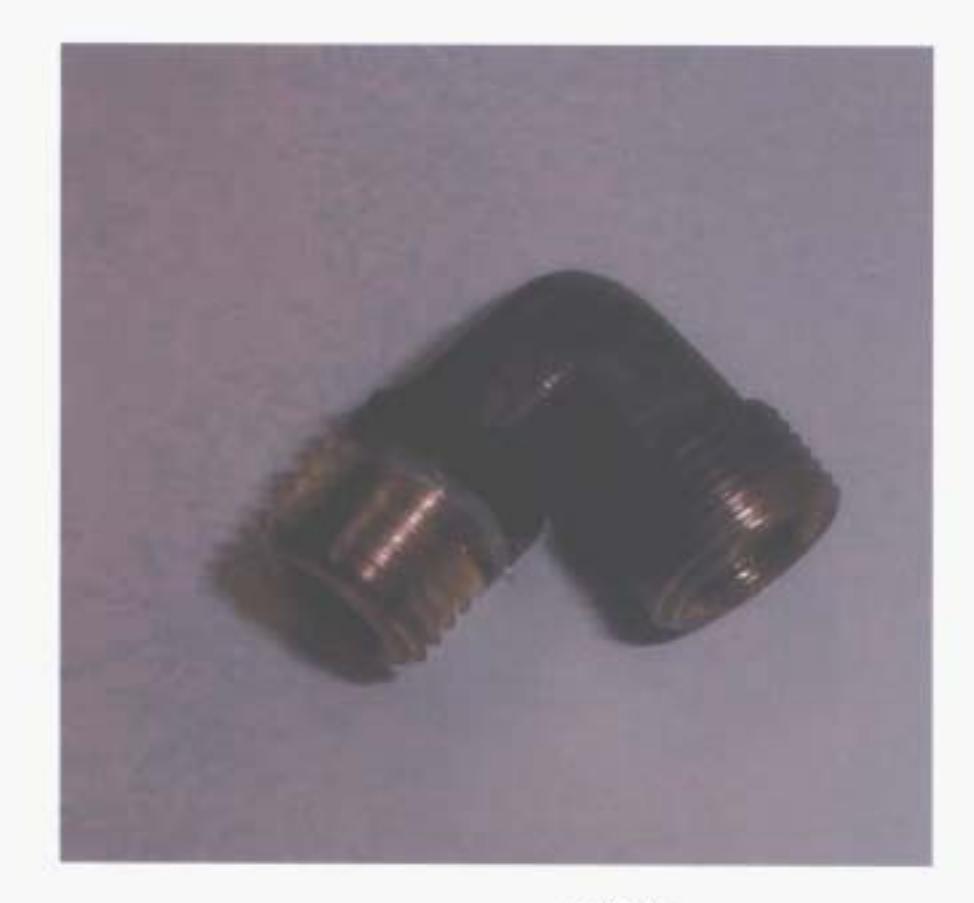
Photo C

- 4. The hose at the helm has steel standpipe ends, made with brass nut/olive compression fittings (not recommended by manufacturers). One fitting is of Parker manufacture, and is bent (photo C). The other is of Wade type and has been made with an Enot universal olive.

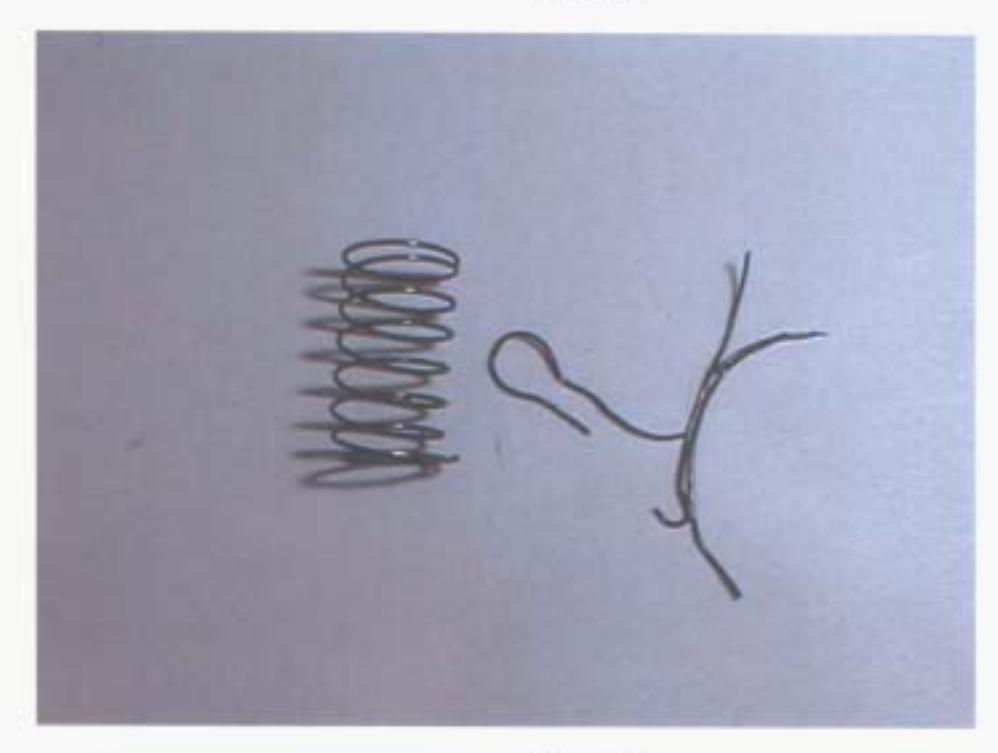
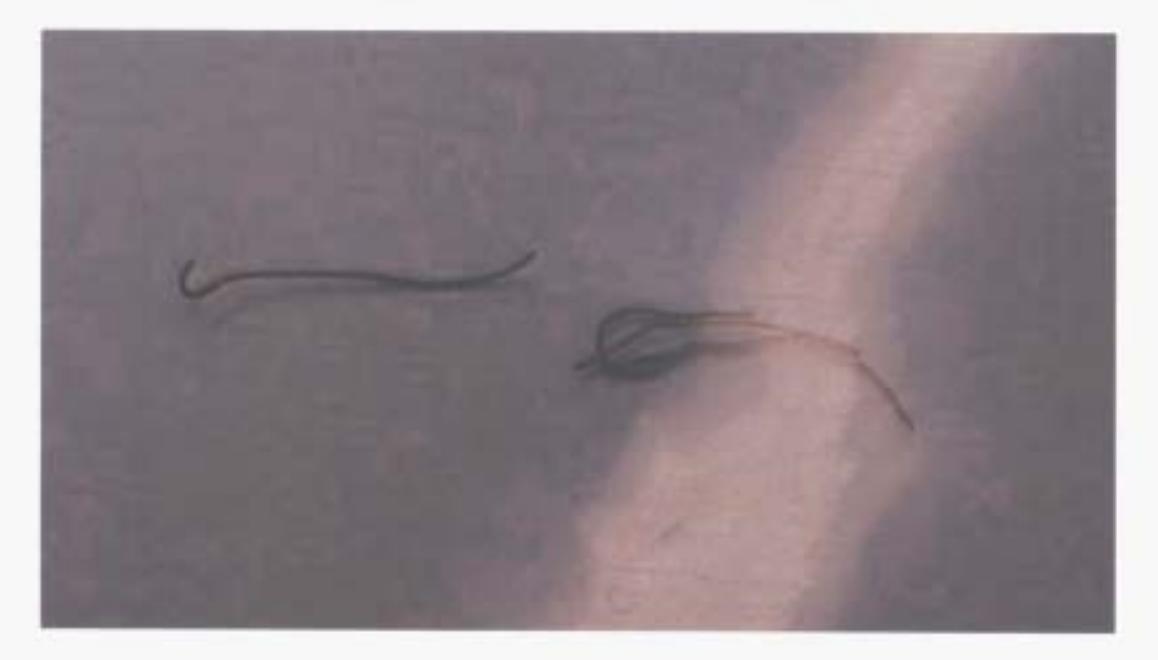
- 1) Sludge and water evident in casing
- 2) Remnants of what appears to be a pre-fill check valve spring trapped in pilot piston grooves (photo D & E).
- 3) Heavy scoring on piston barrel and mating shaft (photo F).
- 4) Evidence of second pre-fill check valve spring located loose in pilot check cavity.
- 5) Heavy corrosion in helm casing around shaft seal causing seal distortion (photo G).
- 6) Large scores evident in pilot check cavity presumed to have been caused by loose spring fragments.
