Report on the investigation of

a fatal accident on board

mv Nordstrand

> Report No 8/2005 April 2005

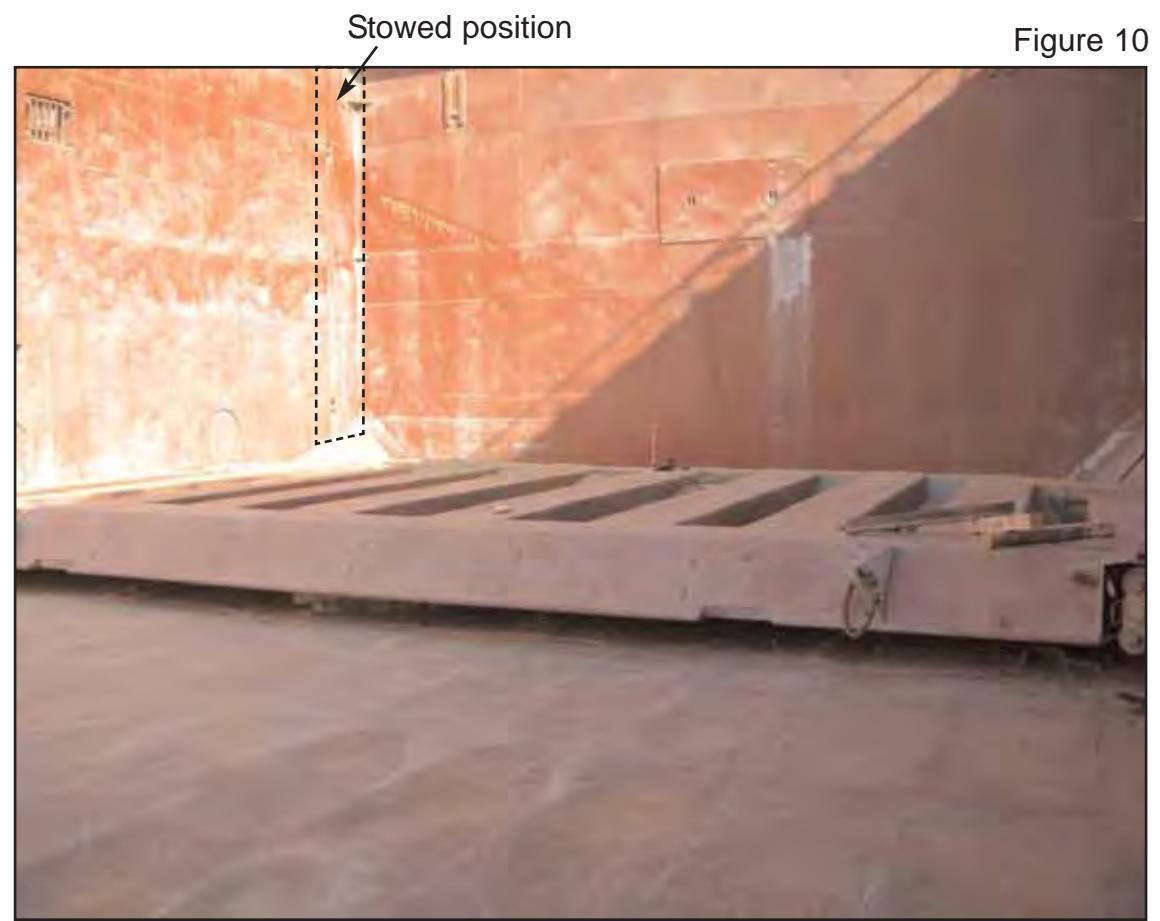
The portable bulkhead was found to have fallen forward onto its slab sided front, with its base coming to rest slightly forward from its stowed position (Figure 10). It was also discovered that the top 1/3 section of the port and starboard side sealing backing plates was supporting the bulkhead. This created a 23cm gap between the forward face of the bulkhead and the hold deck, just providing sufficient clearance between the hold deck and bulkhead to prevent the chief officer from sustaining fatal injuries. There was also a thin layer of wheat cargo remaining under the bulkhead (Figure 11).

Position of fallen bulkhead in relation to stowed position

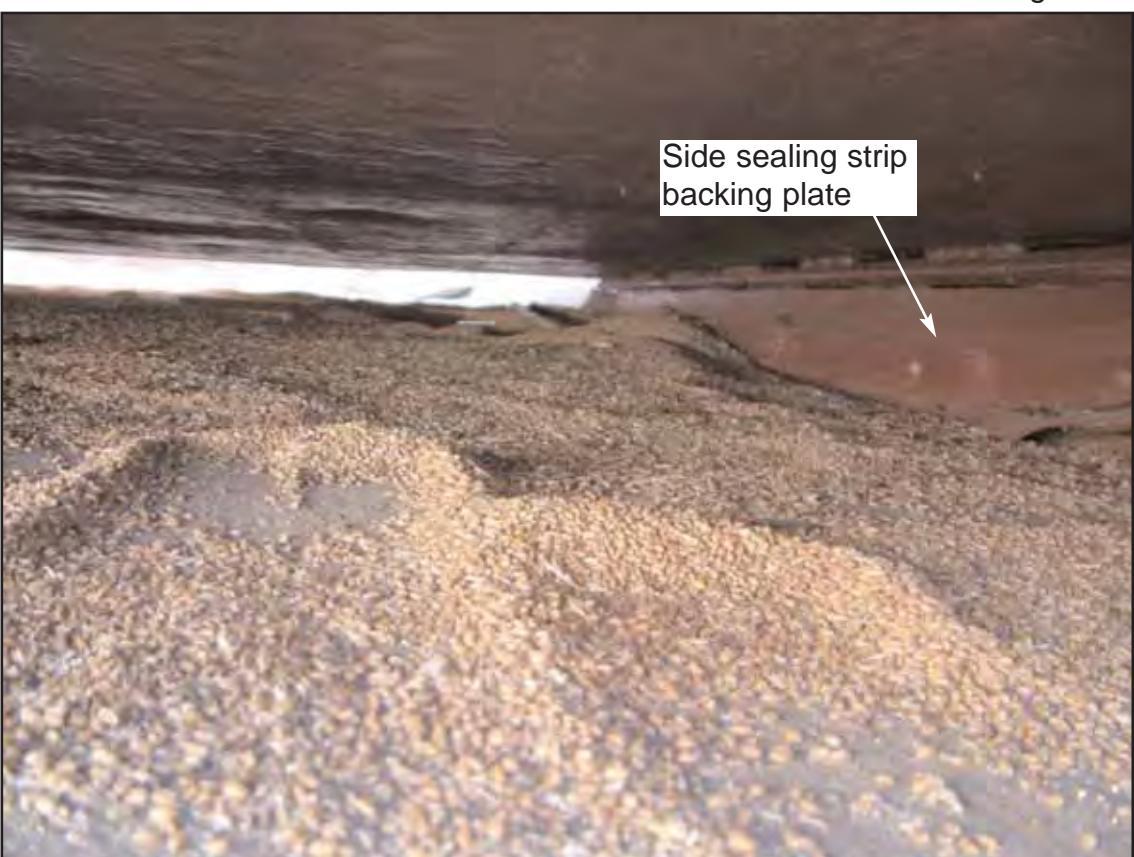
Figure 11

View under fallen bulkhead showing supporting side sealing strip backing plate and remnants of the wheat cargo

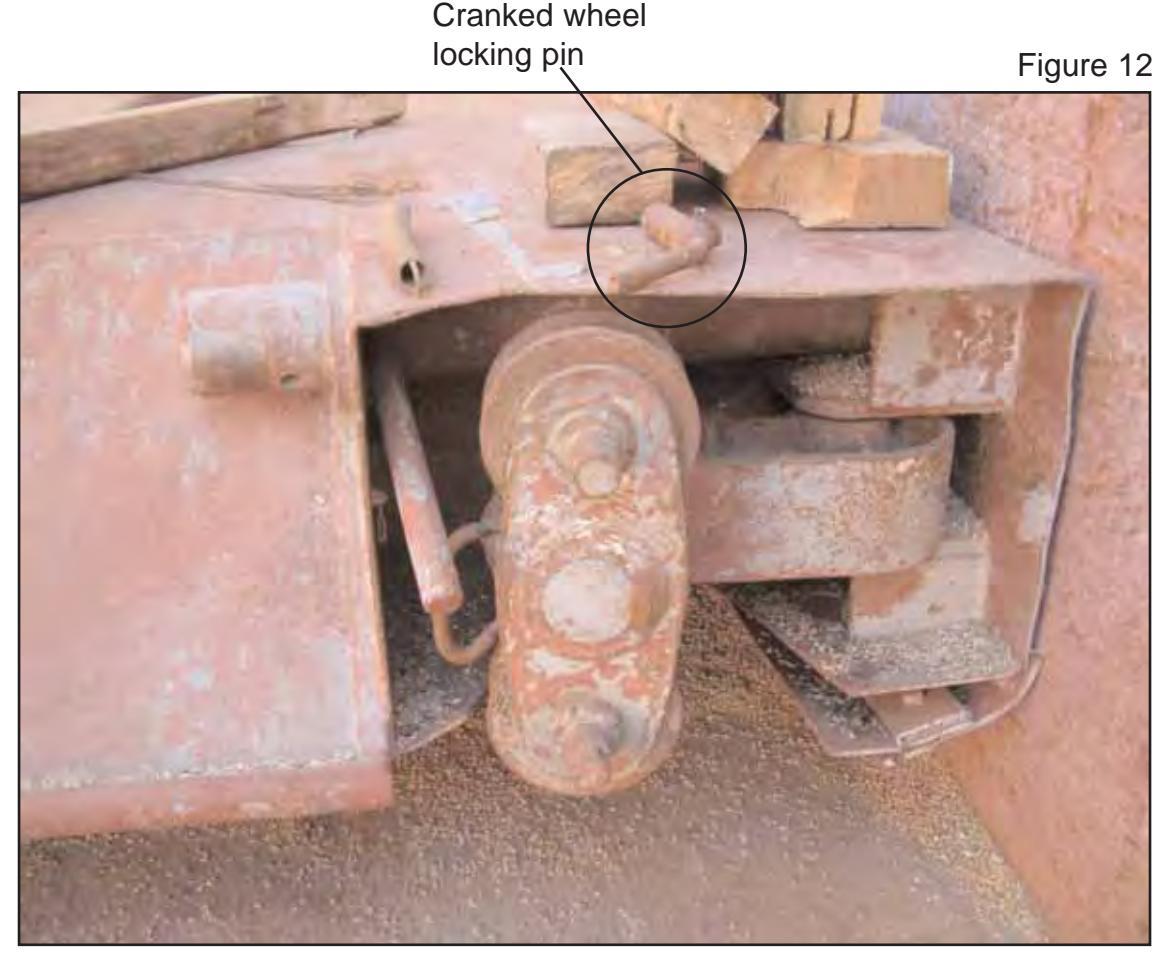
The port and starboard wheel arrangements were still in their respective stowage recesses (Figure 12) and the associated cranked wheel locking pins were found in the hold, close to the fallen bulkhead. The port and starboard top main securing bolts were discovered to be in their withdrawn positions (Figures 13 and 14). The starboard main securing bolt easing handle had been broken off, but the appearance of the bolt's structure and surface corrosion suggested this had failed before the accident (Figure 15). The cranked locking pins for the port and starboard top main securing bolts could not be located, despite a thorough search of the bulkhead wheel recess areas and the hold deck. None of the crew were able to produce the locking pins or identify when they had been last seen.

Port wheel arrangement still in its recess on the fallen bulkhead

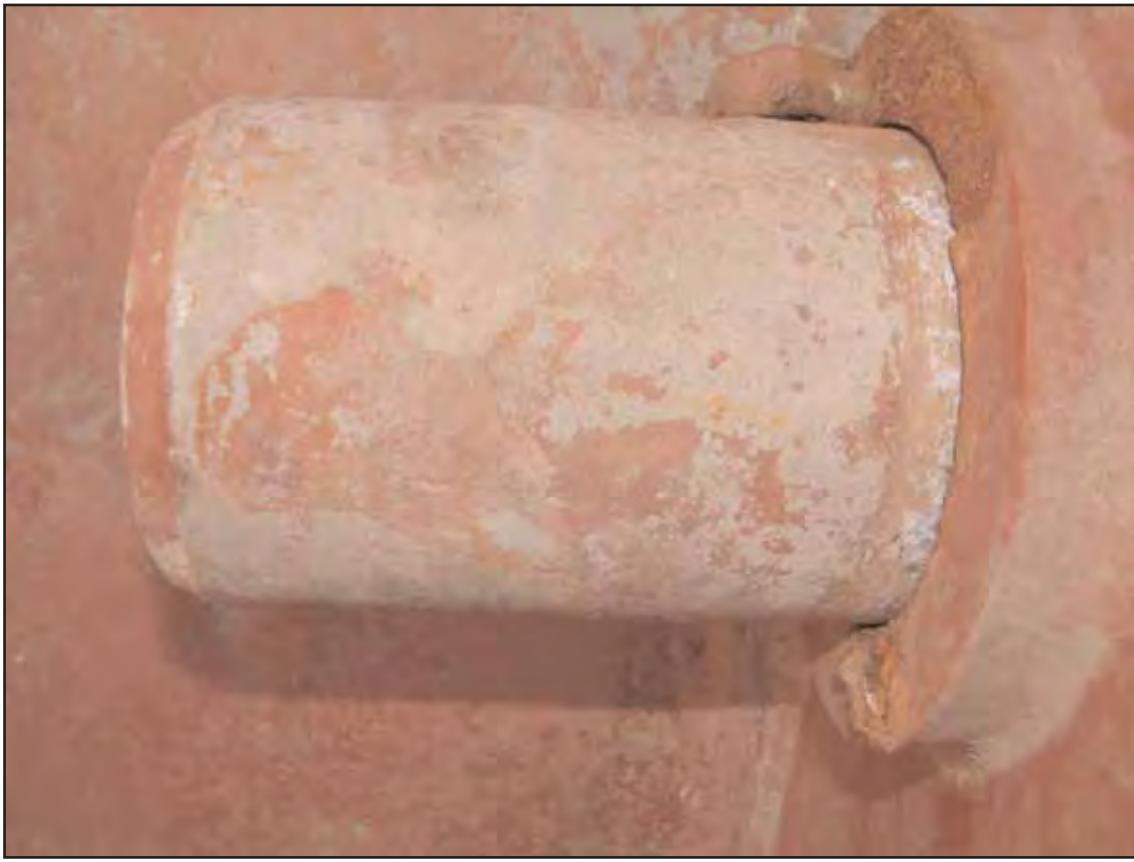
Port top main securing bolt in the disengaged position

Post-accident examination revealed that the starboard upper main securing bolt was found to be in the disengaged position. Dimensional checks of the exposed section of the port top main securing bolt and comparison against the manufacturers drawings, suggests that there was, at most, 10-15mm of the securing bolt within its mating slot. Even with 15mm of engagement, effective security of the bulkhead would have been most unlikely because of the shift in its position while it was jacked up.

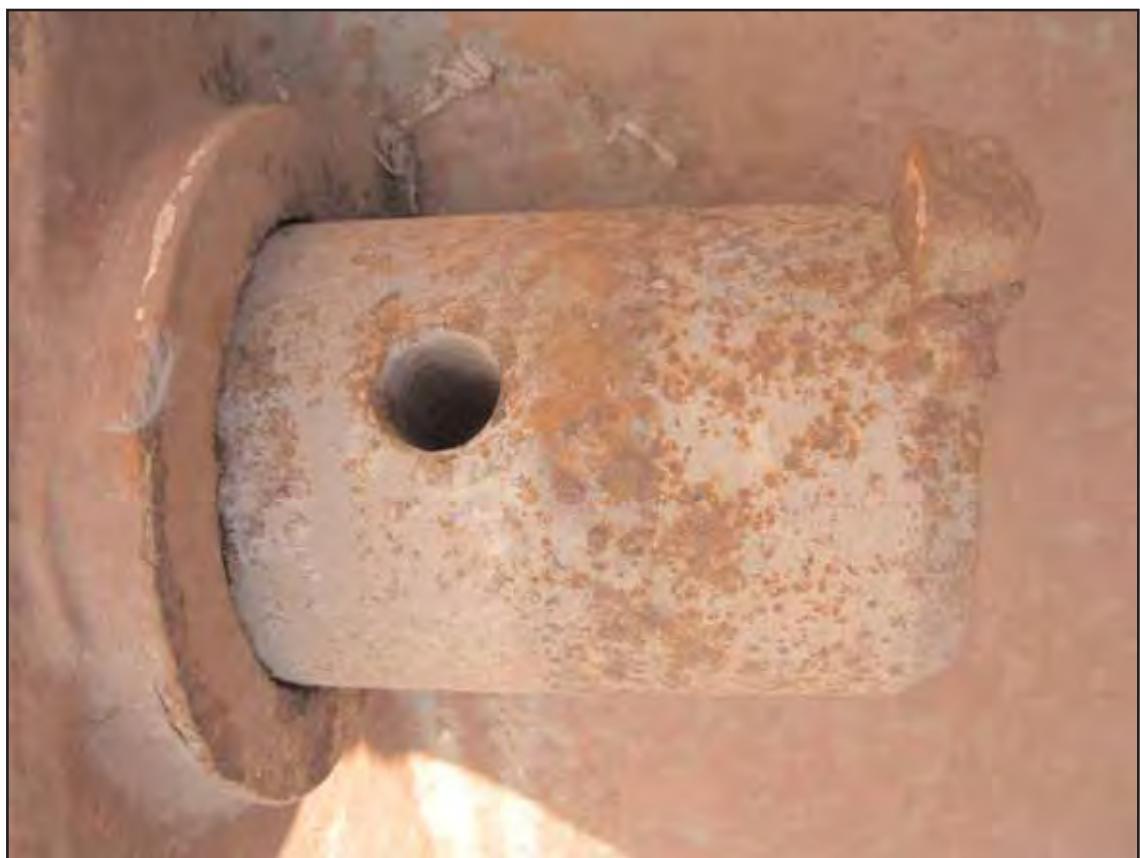
Starboard top main securing bolt in the disengaged position

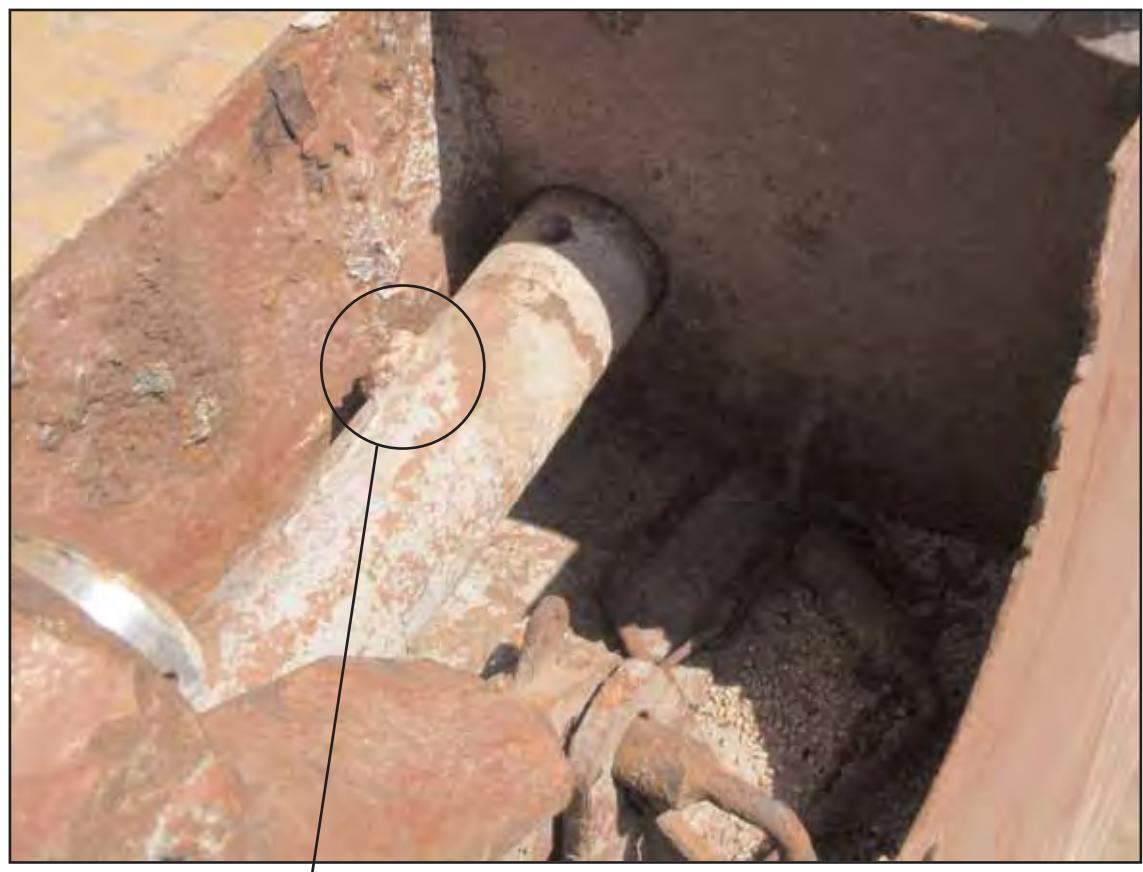
Fractured starboard top main securing bolt easing handle

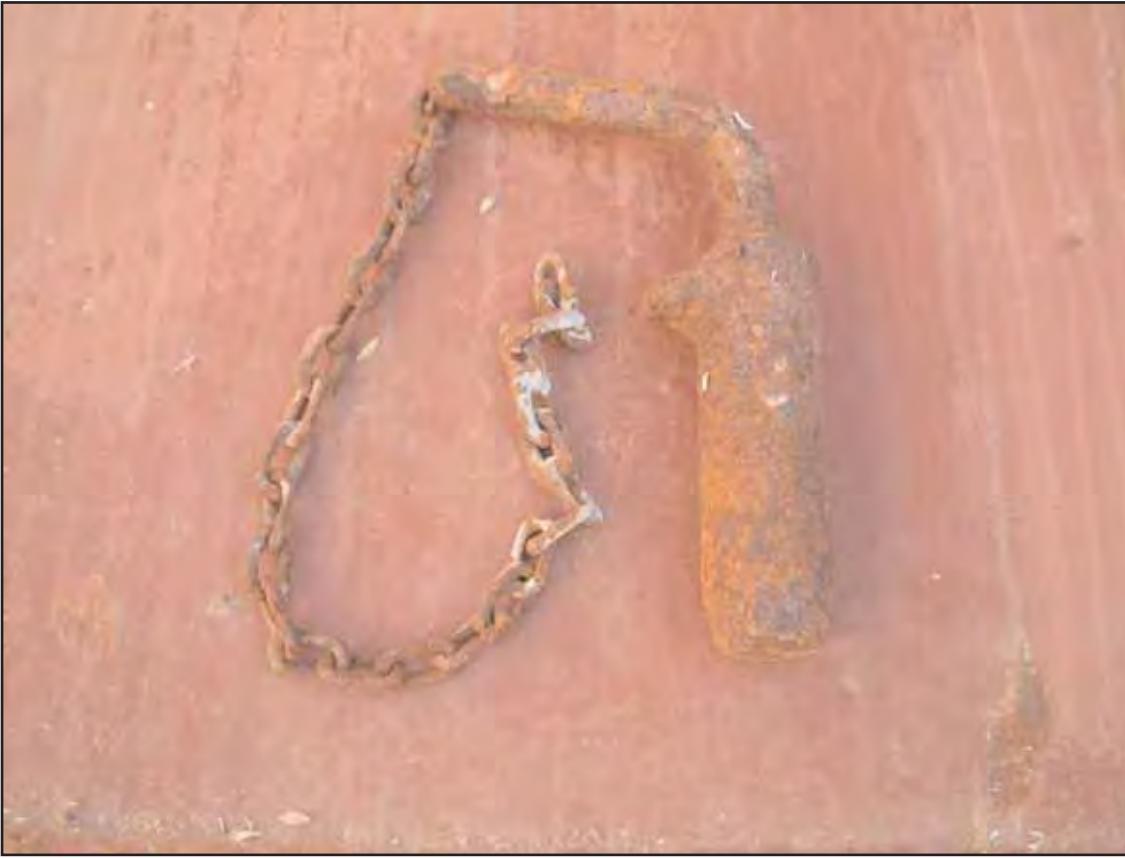
Figure 17

All the original wheel locking pins were in a poor, corroded condition and the attached securing chains were either broken or missing (Figure 17).

Corroded wheel locking pin with broken securing chain

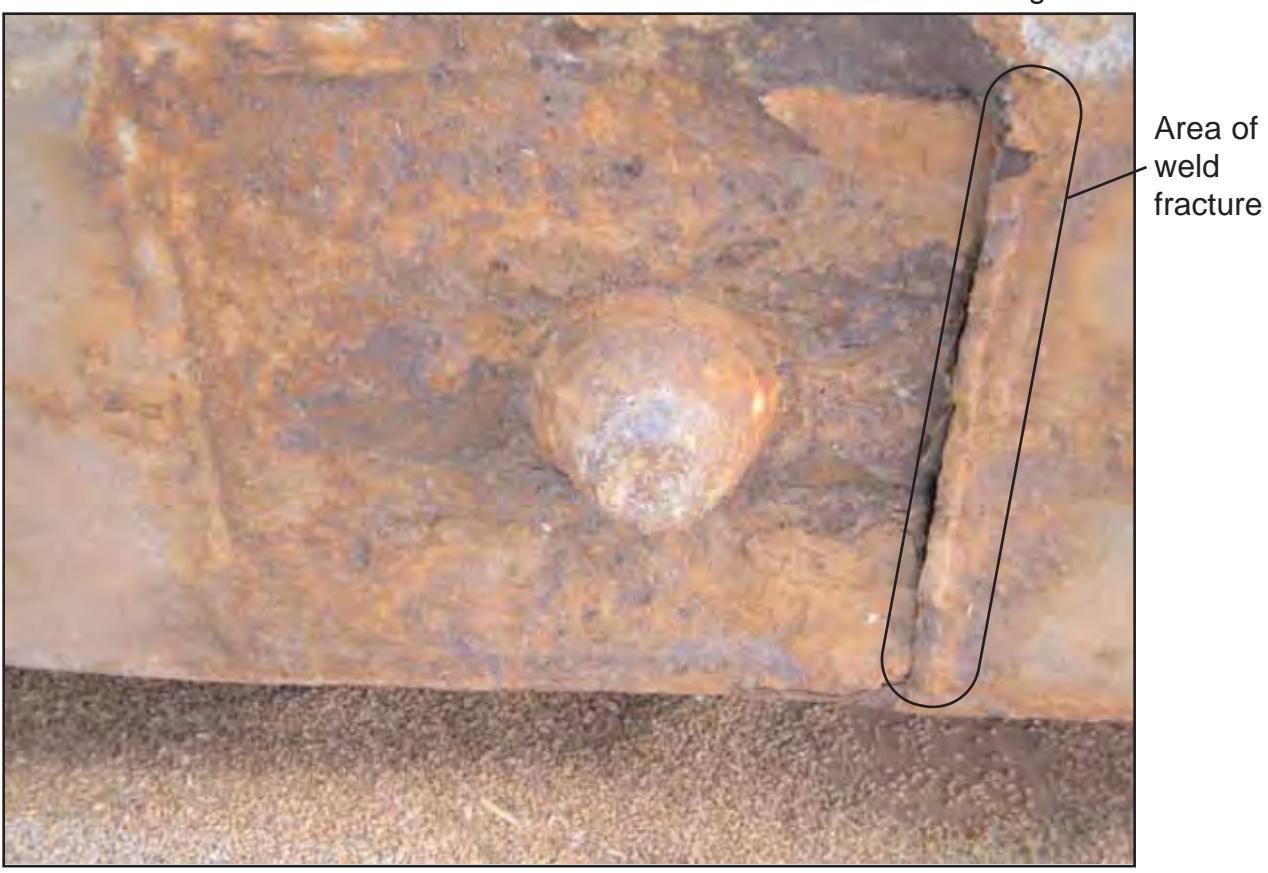
Figure 18

The steel plate at the base of the bulkhead that supports the centre line tapered locating pin had areas of deep corrosion. One side of the plate weld had fractured. The condition of the fractured surfaces suggests that this failure predated the accident (Figure 18).

Tapered pin supporting plate showing corrosion and weld fracture

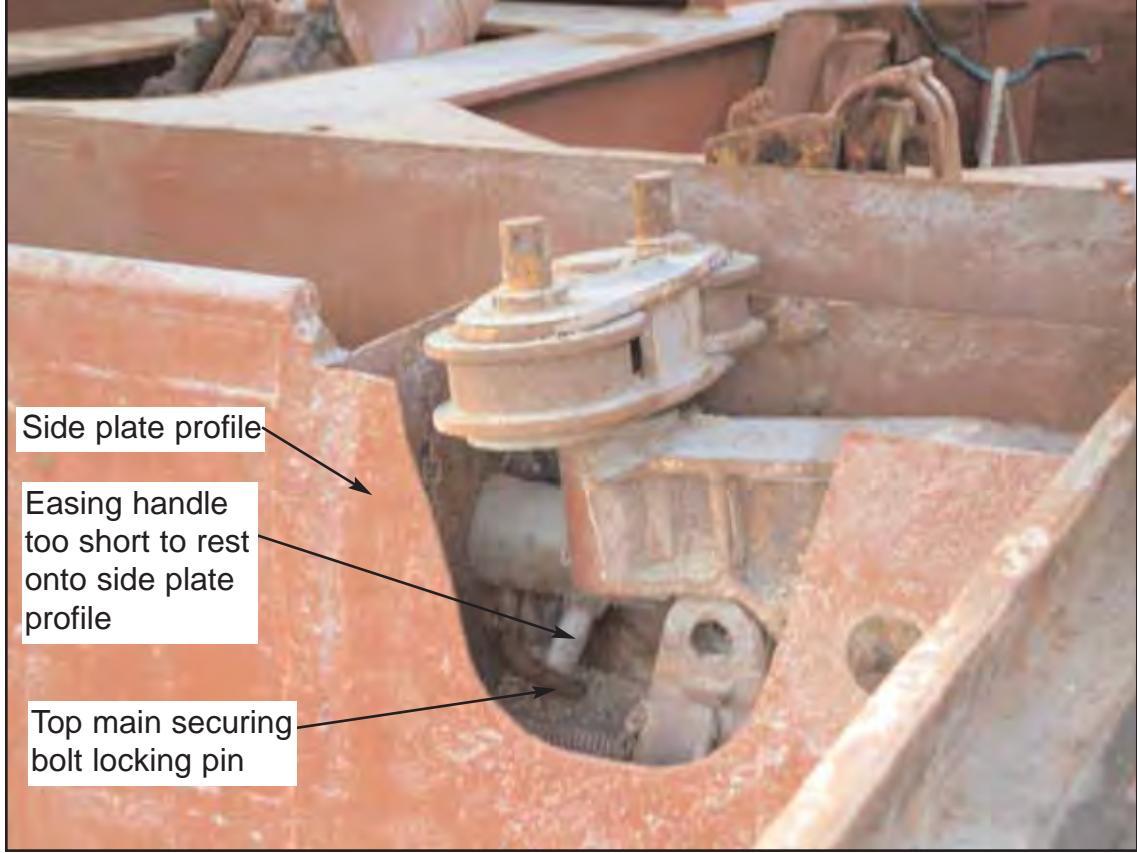
View of forward portable dividing bulkhead starboard top main securing bolt locking pin

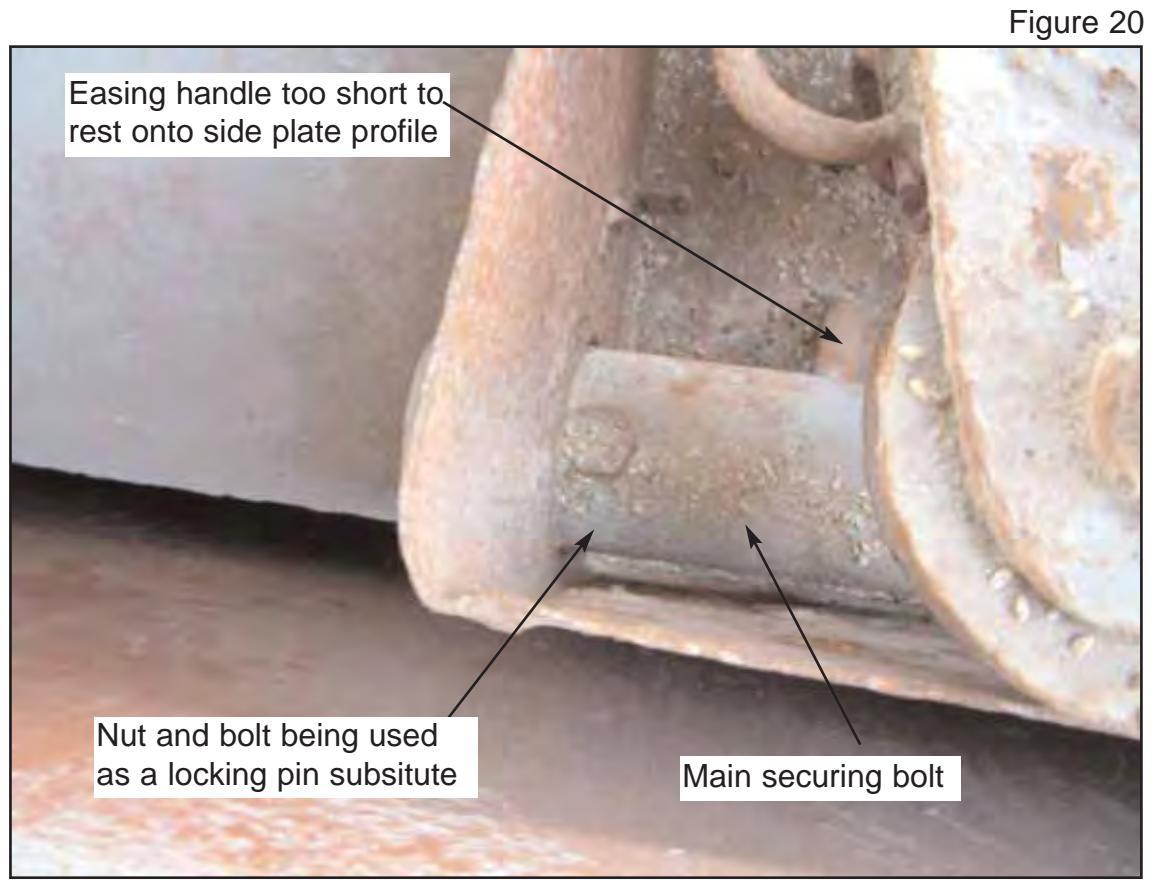
The forward portable bulkhead port upper main securing bolt had an original cranked locking pin fitted. However, this pin was found to be located underneath the main securing bolt and could not be easily seen from above, rendering routine security checks difficult. It appears that the main bolt might have been turned using the easing handle after the locking pin had been fitted, or the main securing bolt might have vibrated around to end up in that position. The port and starboard main bolt easing handles were also too short to have rested onto the recess side plate profiles, which helps to secure the bolt when the wheels are in the stowed position (Figure 19). In the case of the port upper main securing bolt, the original cranked locking pin was missing and had been replaced with a conventional nut and bolt arrangement (Figure 20).

View of forward portable dividing bulkhead port top main securing bolt, nut and bolt substitute for locking pin
