Report on the investigation of

the grounding of

HC Katia

while undergoing sea trials in the Solent

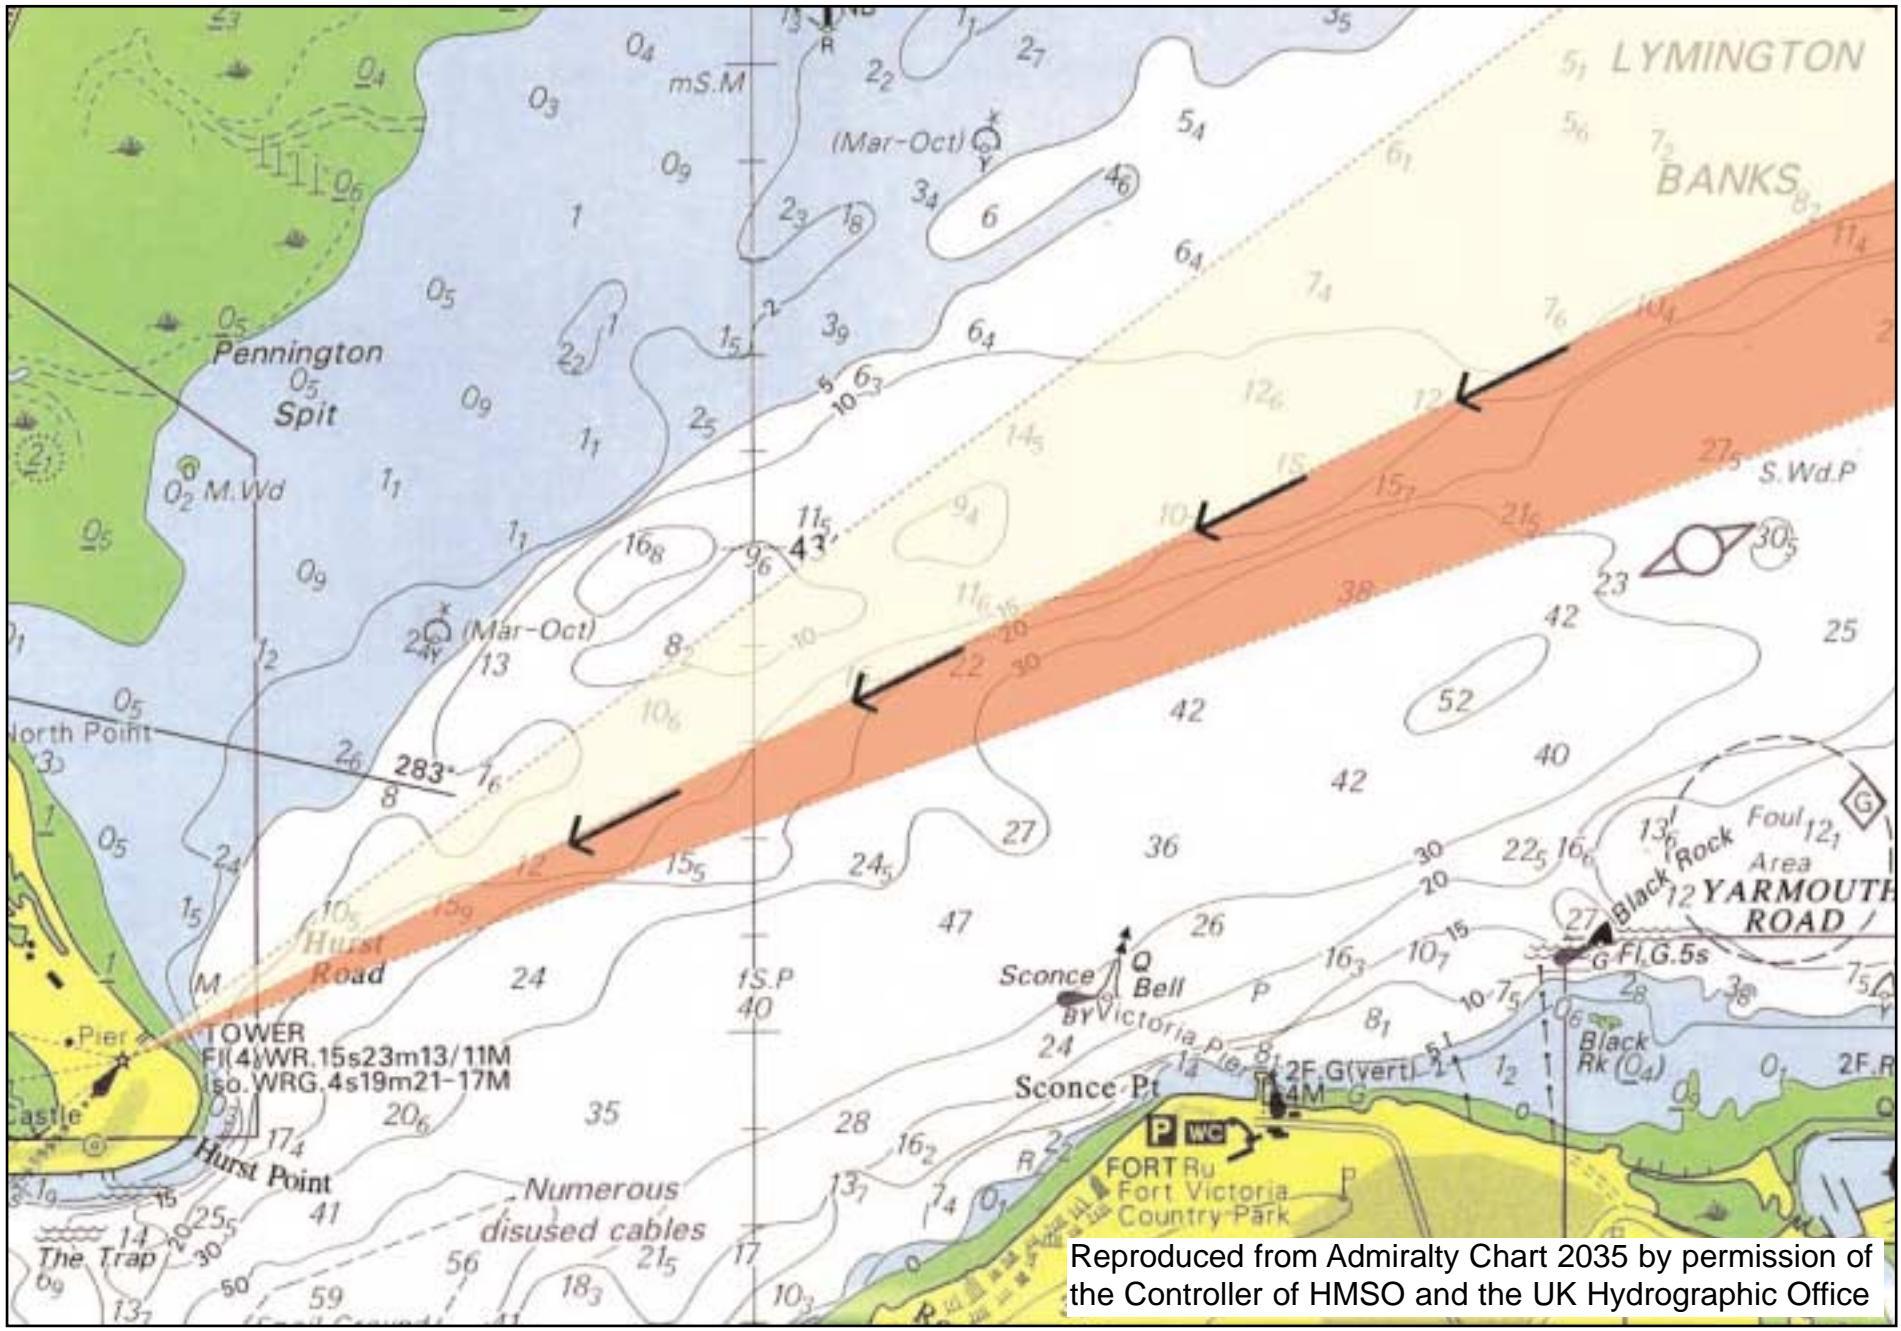
Hurst Point chartlet

A little time later, *Katia* approached the turn at Hurst Spit, for the first time at night. The chief officer was steering towards the spit, using the boundary between Hurst Point light's red and white sectors to maintain his track.

The charterer's representative was still on the bridge and was talking to the chief officer. The chief officer suddenly realised that the vessel was too close to Hurst Spit, and put the control lever hard to port. At the same time, the master told him that he was too far over to starboard. The vessel turned rapidly to port, but, when about 90 degrees from her original course, her starboard side rose abruptly and dropped down again as she momentarily grounded on Hurst Spit. The chief officer stopped the engines, and many alarms sounded in the wheelhouse.

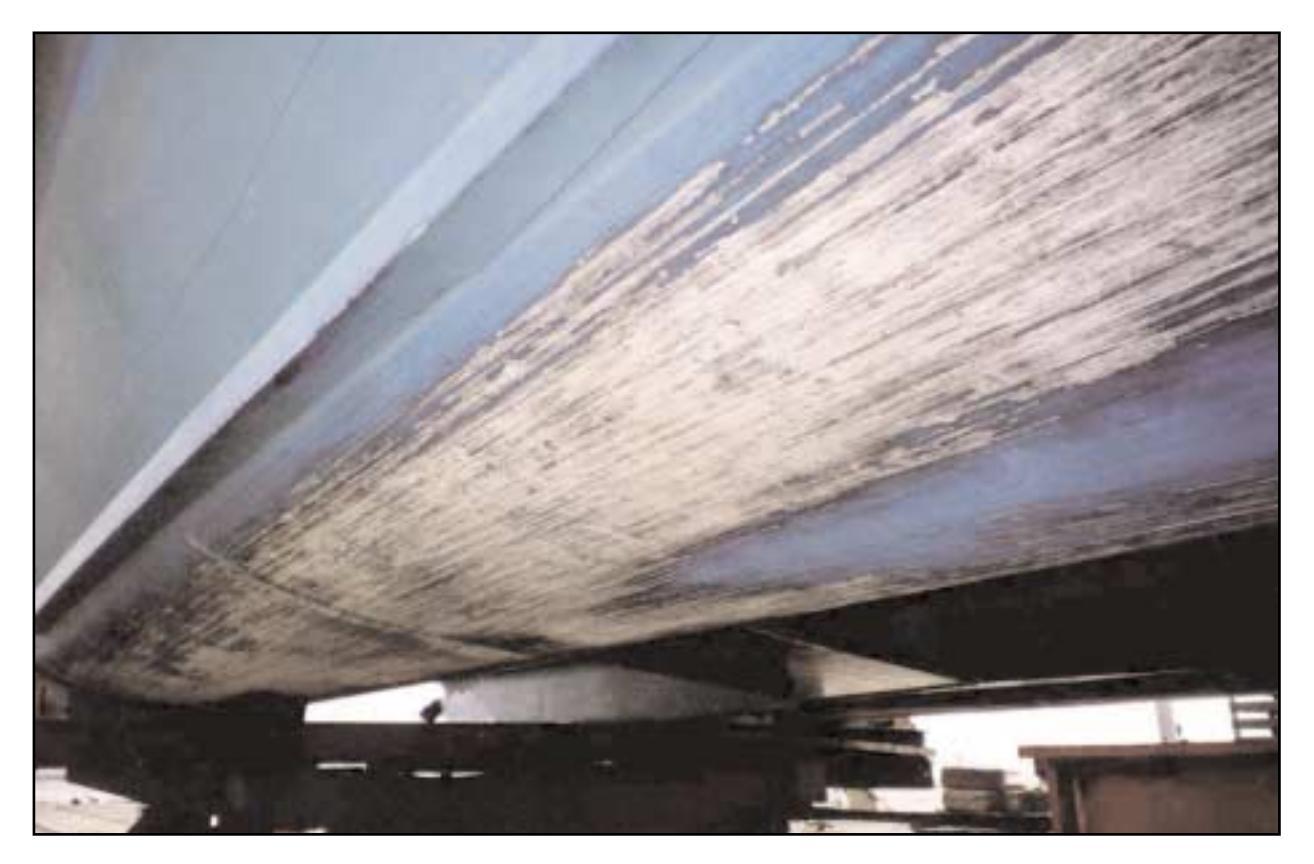
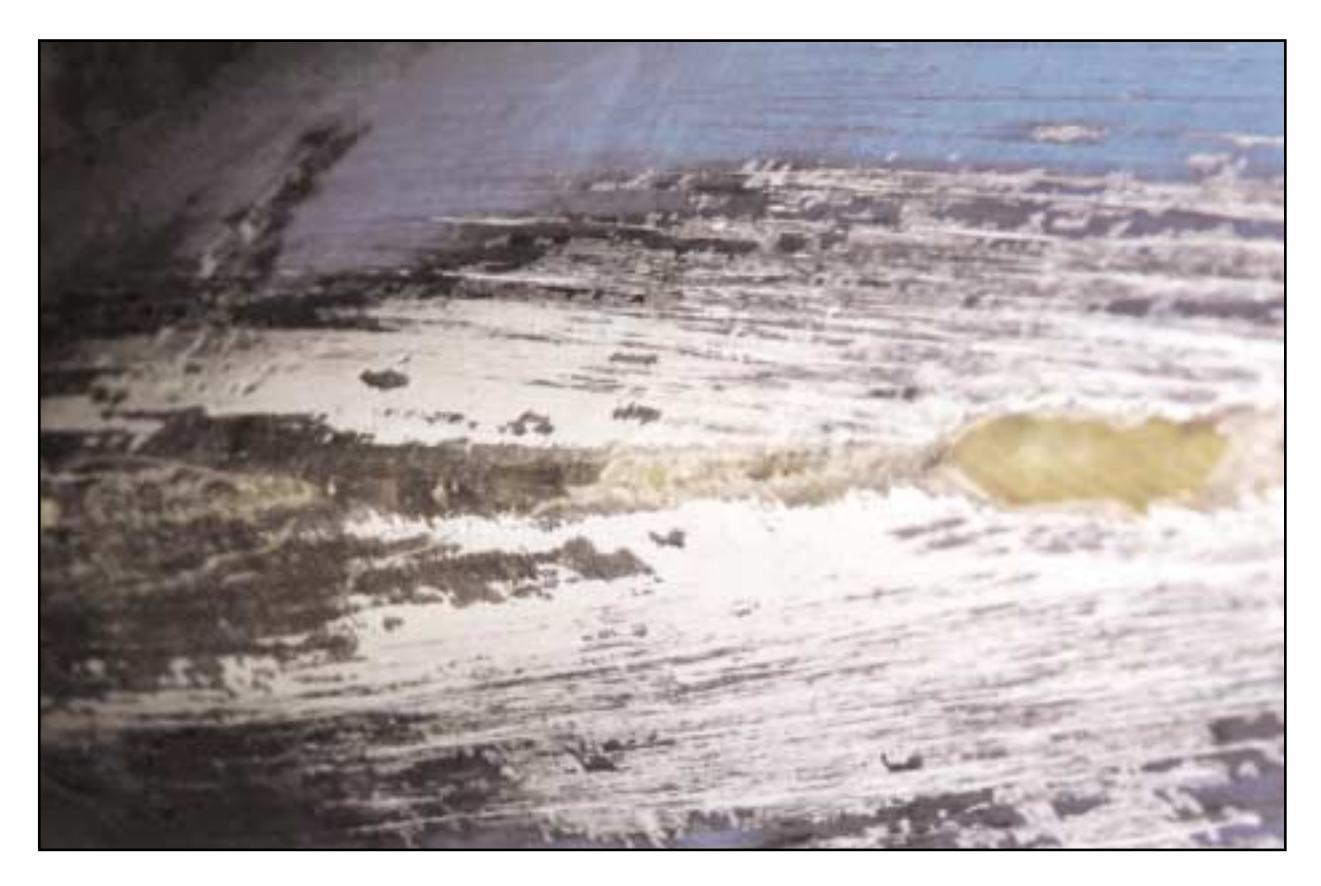
Figures 8 and 9 - Hull damage

Subsequently, the vessel was inspected out of the water. Both hulls were found to have suffered minor damage (Figures 8 and 9), and the water jet impellers were damaged by shingle and sand to the extent that two required replacing.

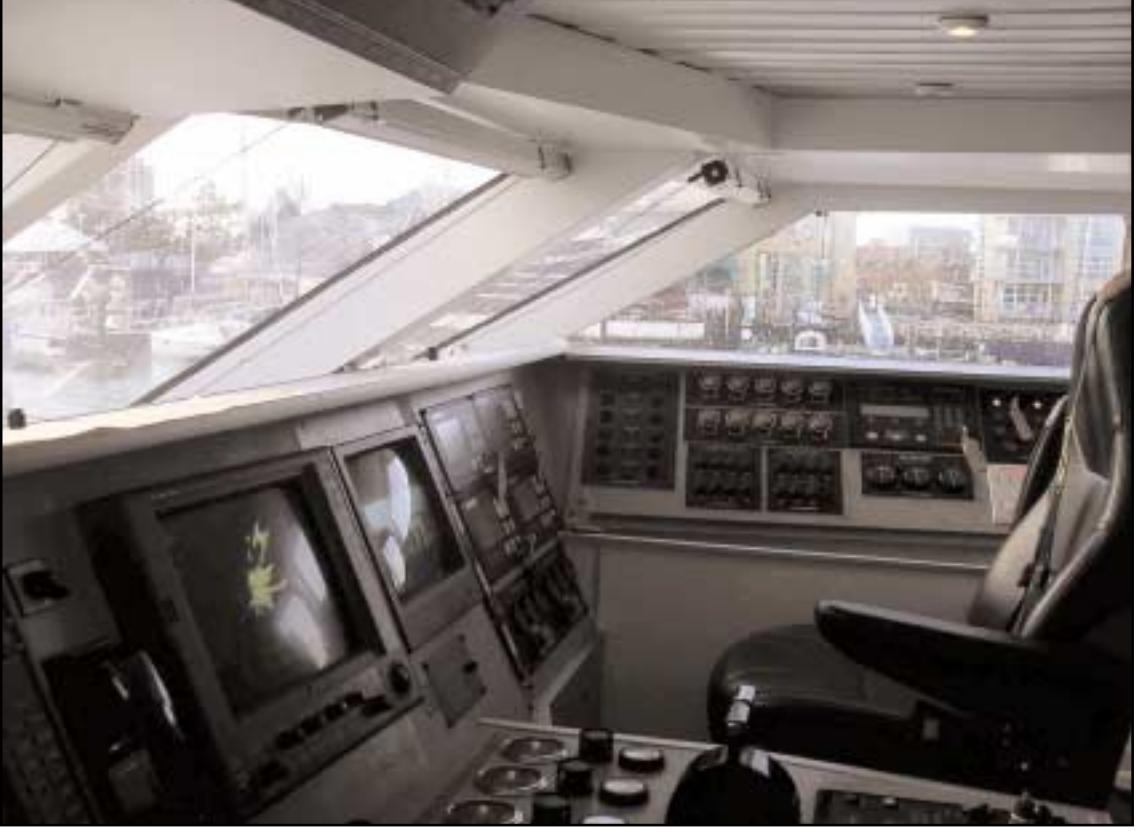
Operating compartment window frames

The builder fitted decorative mouldings around the large scantling stiffeners between the bridge front windows, to conceal wiring and pipework, which restricted the visibility from the pilot's control position.

Blind sectors shall be as few and as small as possible, and not adversely affect the keeping of a safe look-out from the operating station. If stiffeners between windows are to be covered, this shall not cause further obstruction inside the wheelhouse.

The total arc of blind sectors from right ahead to 22.5° abaft the beam on either side shall not exceed 20°. Each individual blind sector shall not exceed 5°. The clear sector between two blind sectors shall not be less than 10°. Figure 10
