Report on the investigation of

a fatal accident

during a vertical chute evacuation drill

P&OSL Aquitaine

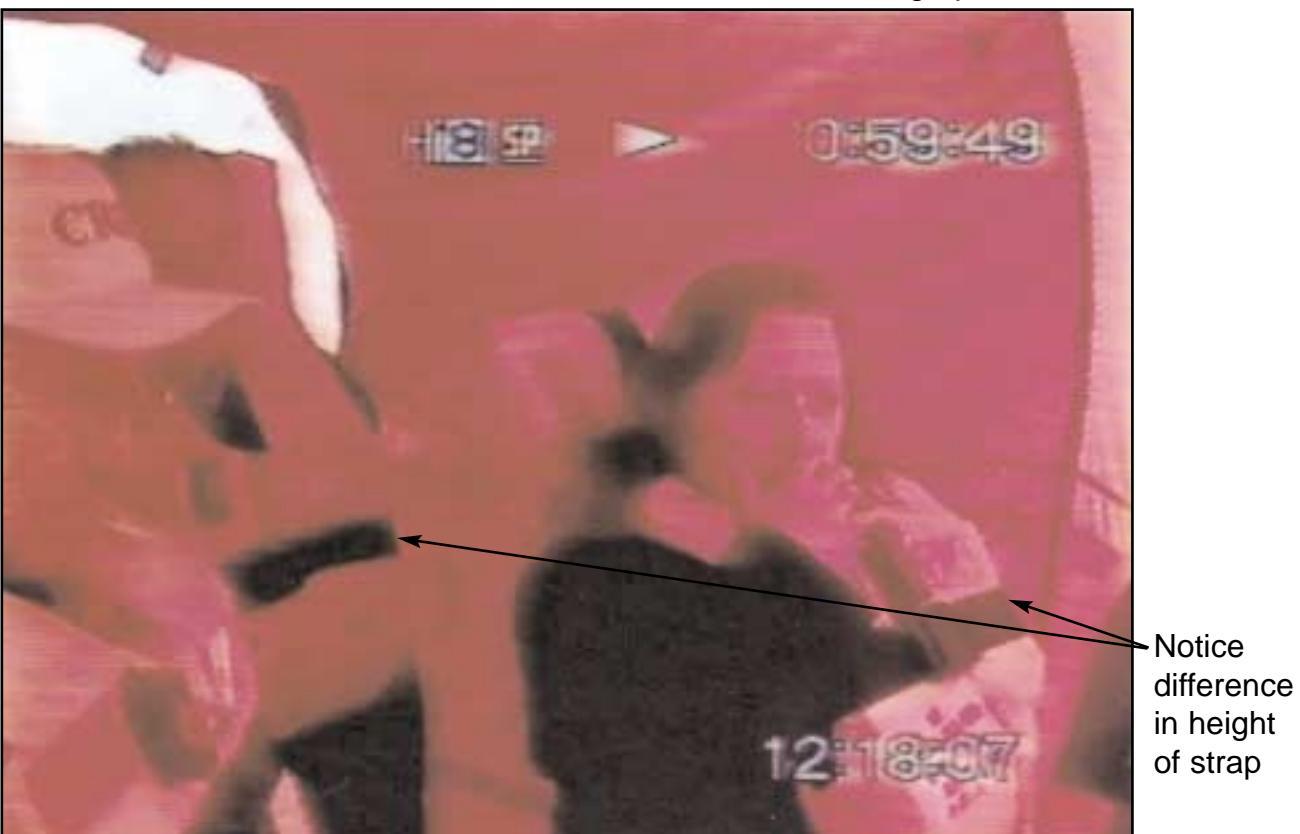
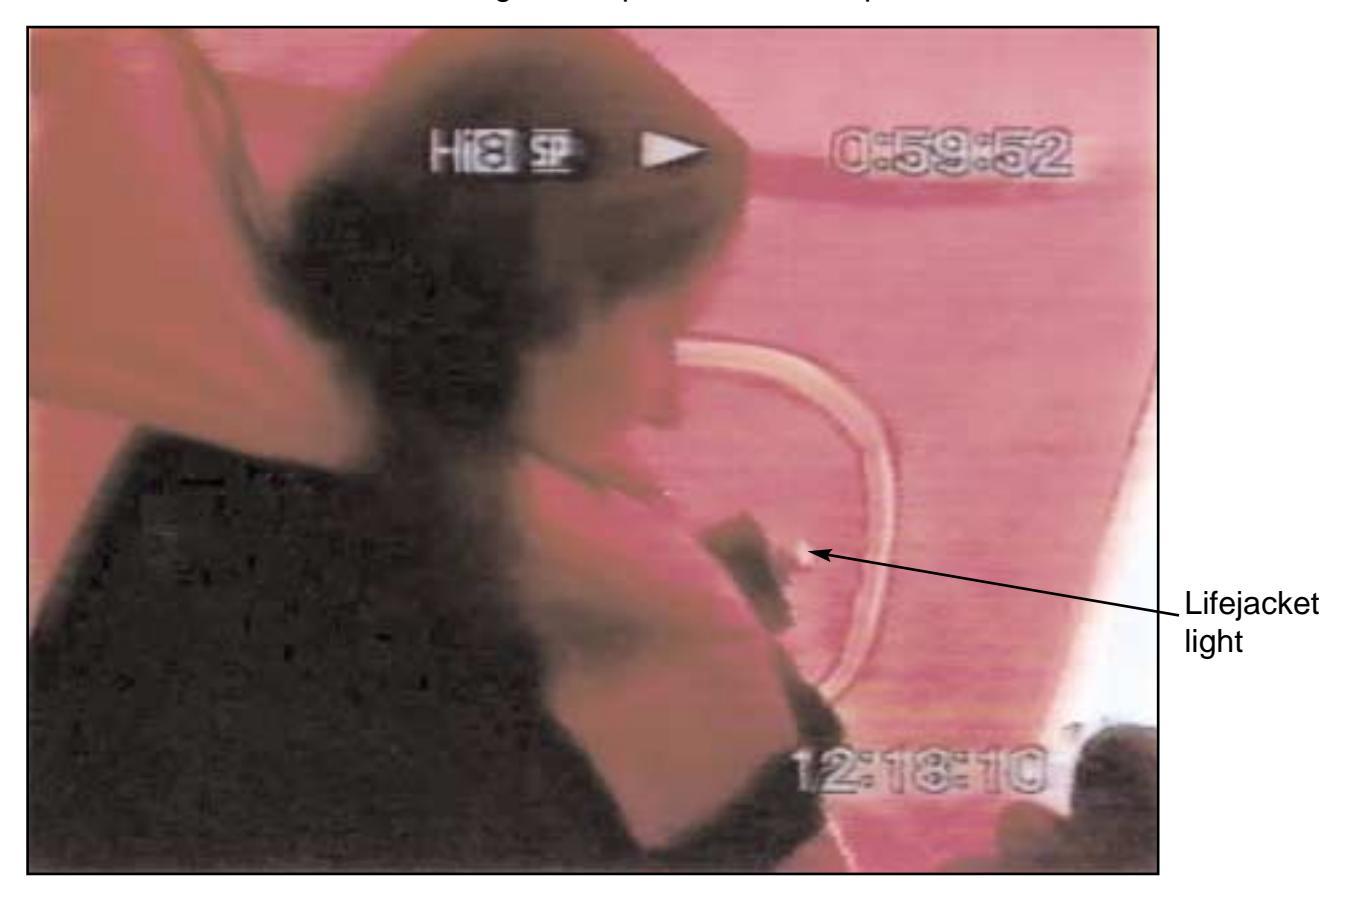
Photographs 3a and b

Mrs McCabe-Jones waiting in the queue near the top of the chute

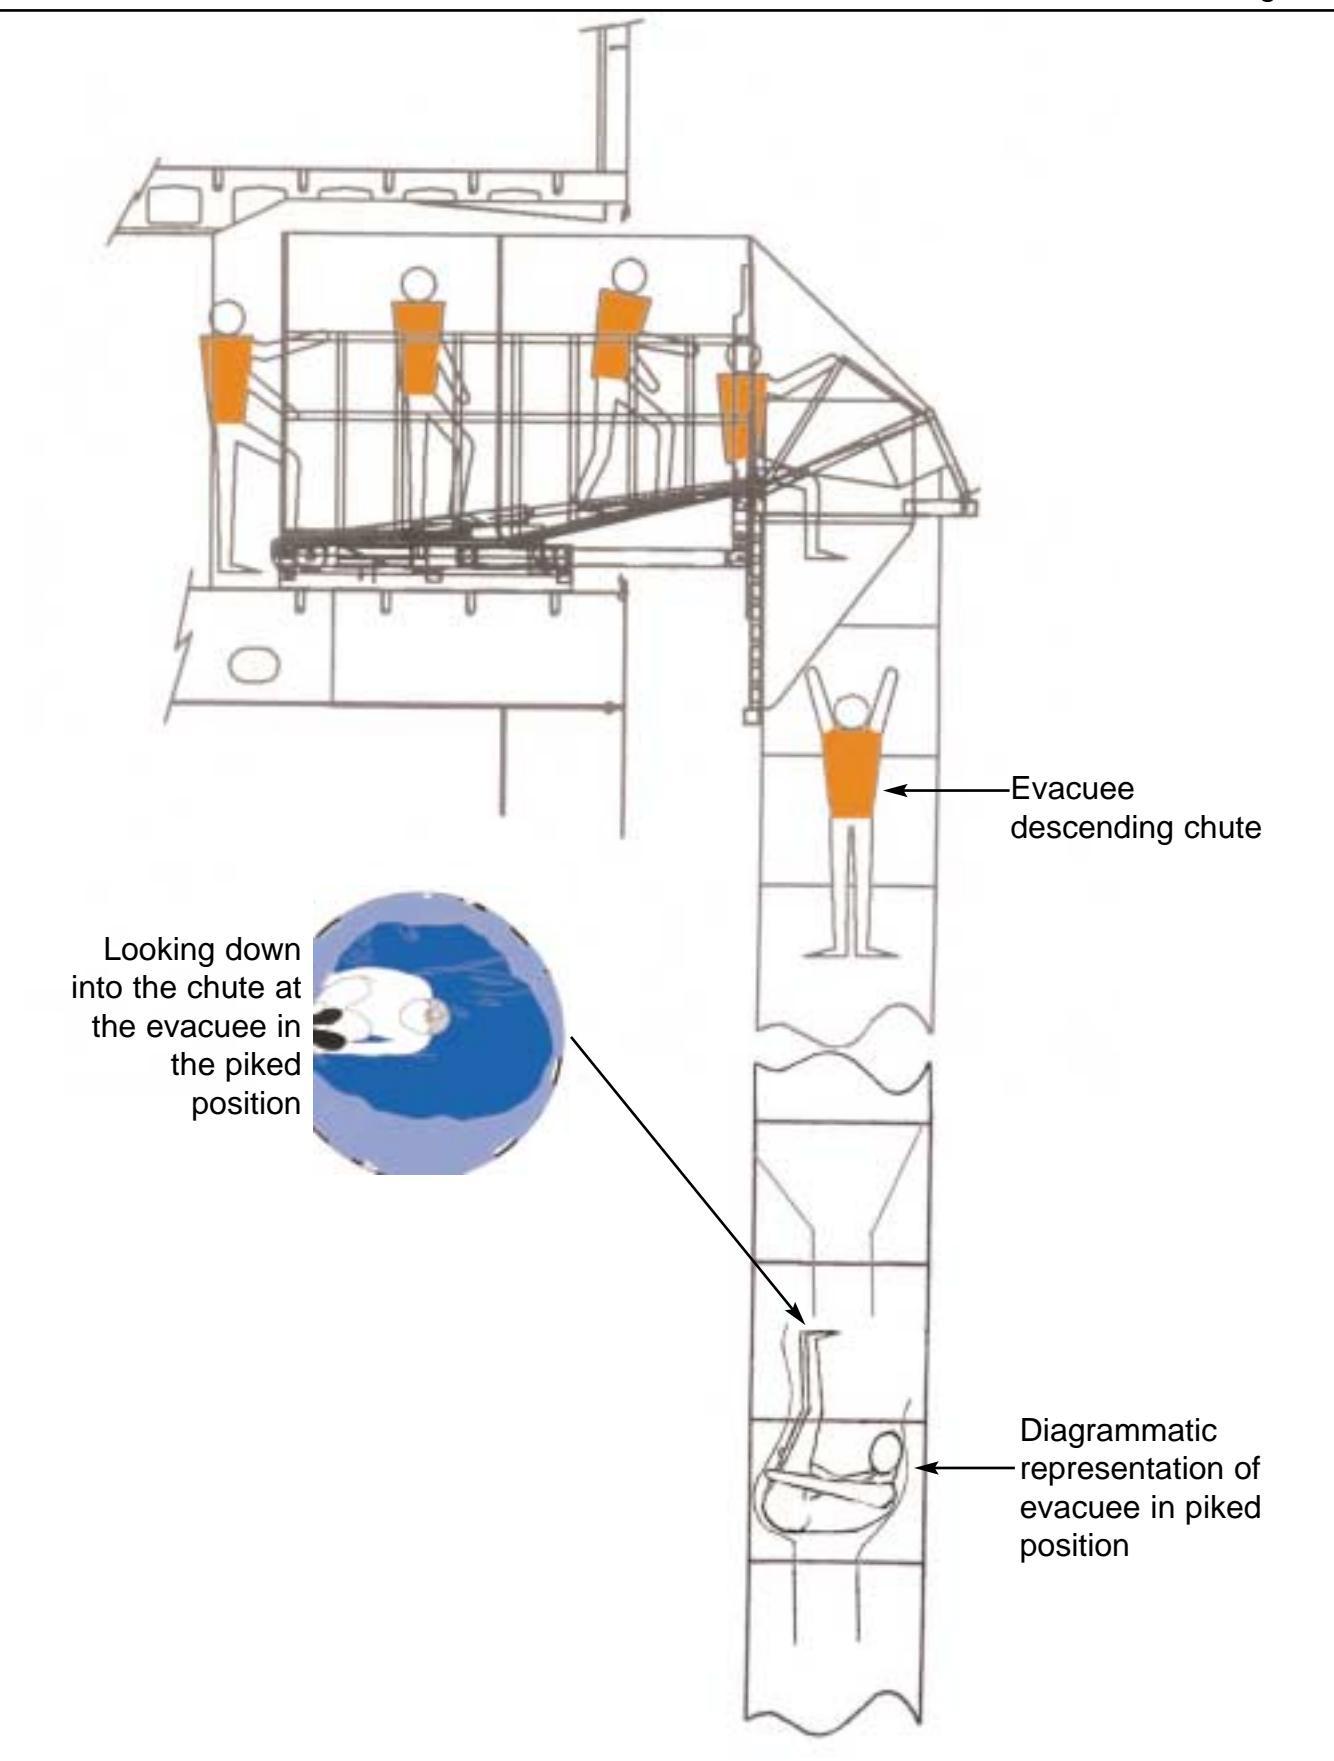
He found her stuck in one of the socks, with her arms and legs above her body in a back down, piked position (see diagram 3). Her lifejacket had come off and she handed it to him. He also found her day jacket, unbuttoned and off, in the cell. The sweeper noted that she was rational, able to follow instructions and was able to give him her hand. Her breathing did not seem laboured, although she did complain of having difficulty in doing so. Having moved the lifejacket and jacket out of the way, he took hold of her hand and tried to pull her up, but she could not move. He told her to bend her legs, and he pulled on her hands in an attempt to get her feet to go down first. Mrs McCabe-Jones then slid through the sock. The sweeper followed her down to the next cell but, again, found her still stuck in the same position. He tried to pull on her hand again, but was unable to move her.

Showing evacuees descending the chute and in the piked position

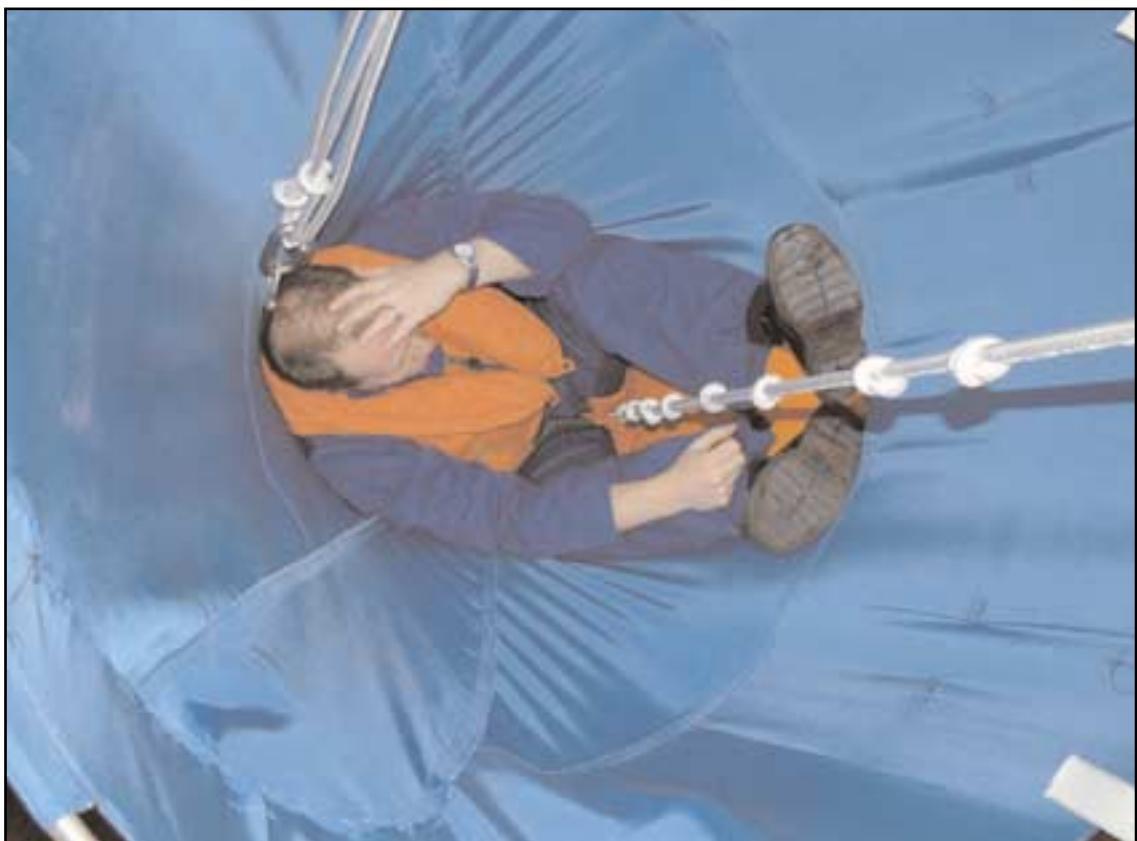
Photograph 10

During the first day, each of the participants recreated (with the aid of a harness and a knotted line) the position in which Mrs McCabe-Jones was found. With growing confidence, the participants were able to assume quickly the same position, without great discomfort. Then the participants were able to explore different possible reasons as to how she assumed the piked position. The second day carried on with the latter work until a possible scenario was derived (see photograph 10).

A participant of the reconstruction sitting in a sock in the piked position

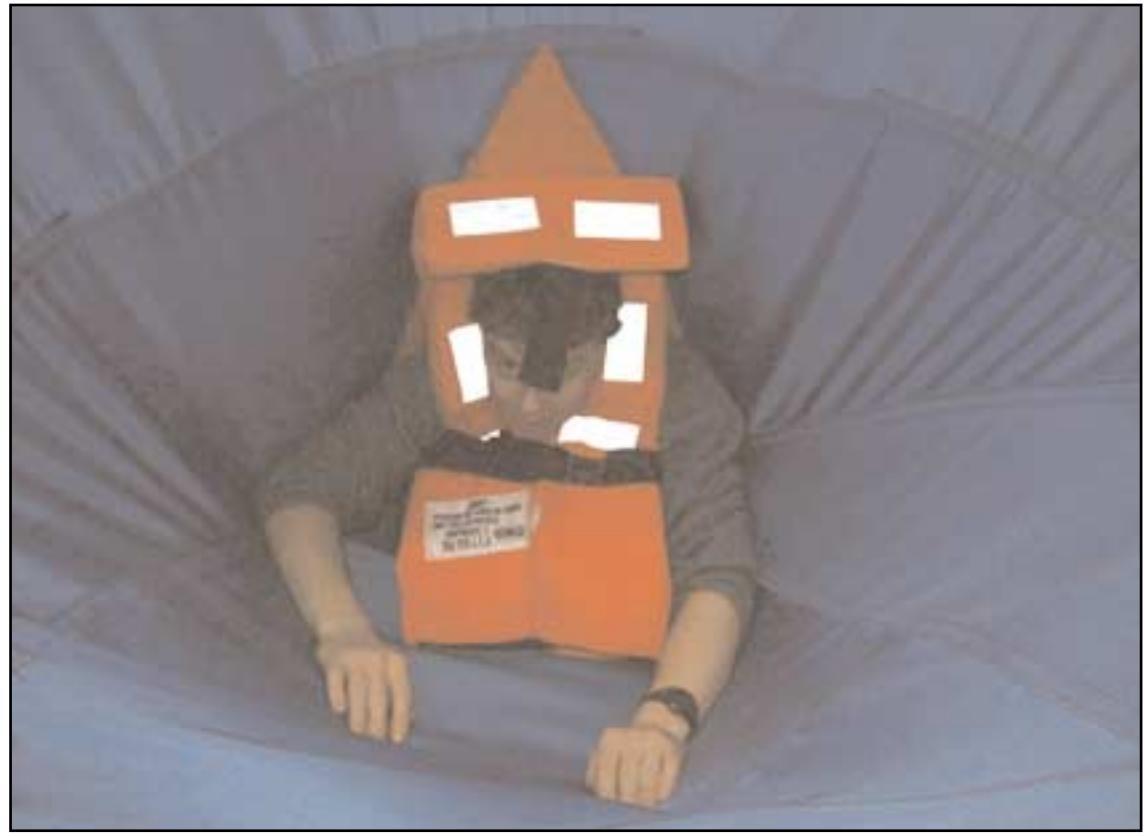
Photograph 12

Stage 1 - Lifejacket rode up

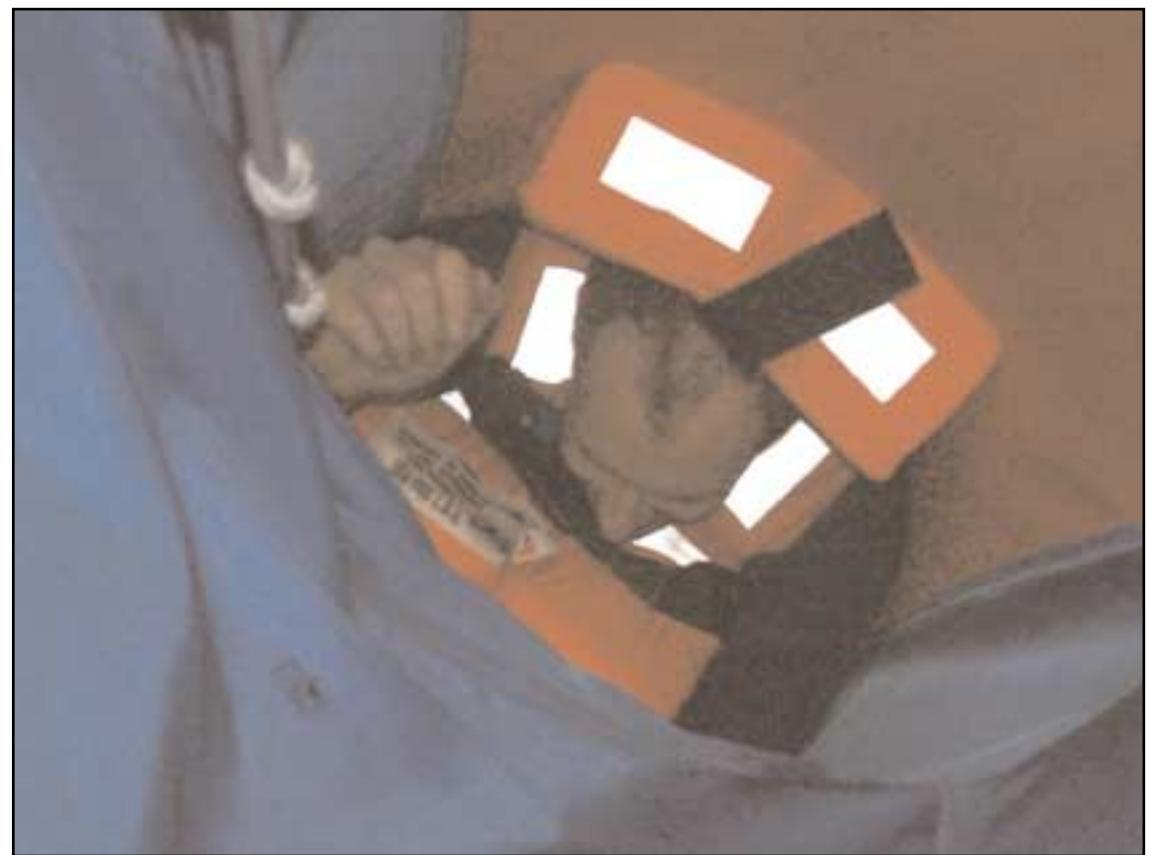
Photograph 13

Stage 2 - Lifejacket rode up

The sweeper was unable to lift her up physically so that she could push her legs down into the sock, allowing her to continue her descent in the correct attitude. She slipped from one cell to another, but retained the same piked position. The sweeper needed some sort of apparatus to help him lift her out of the piked position. The QinetiQ report also concluded that sweepers should be provided with some means of mechanical purchase in assisting evacuees if they became stuck in the chute.

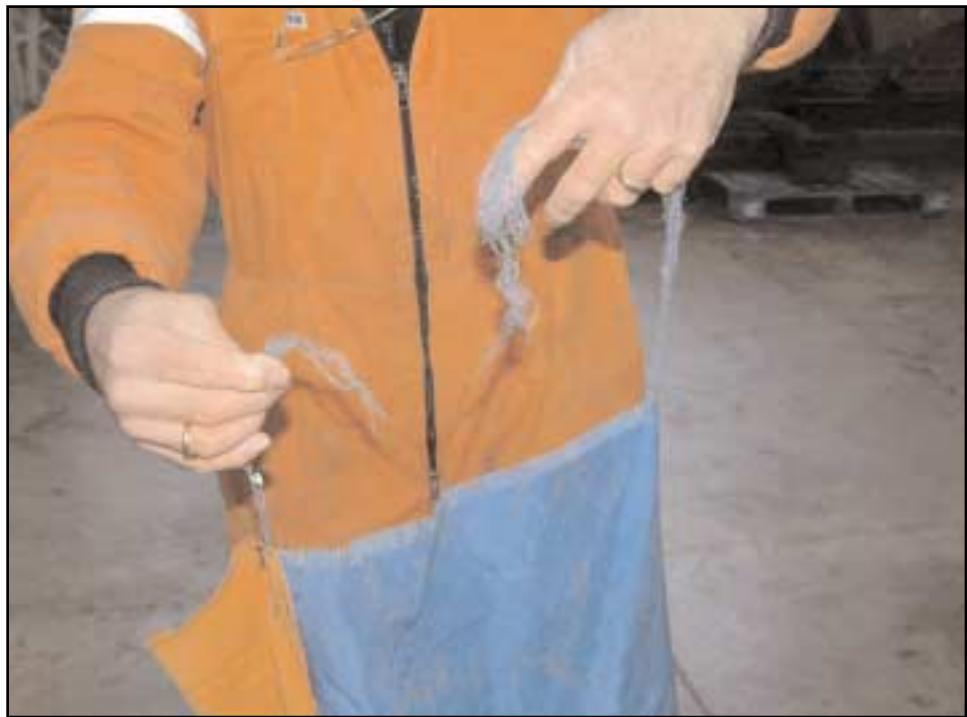
Photograph A1/7

Cell No.1 The lower end of the external section connects around the opening in the liferaft. There is a 94cm vertical slit between bungee positions 3 and 4.

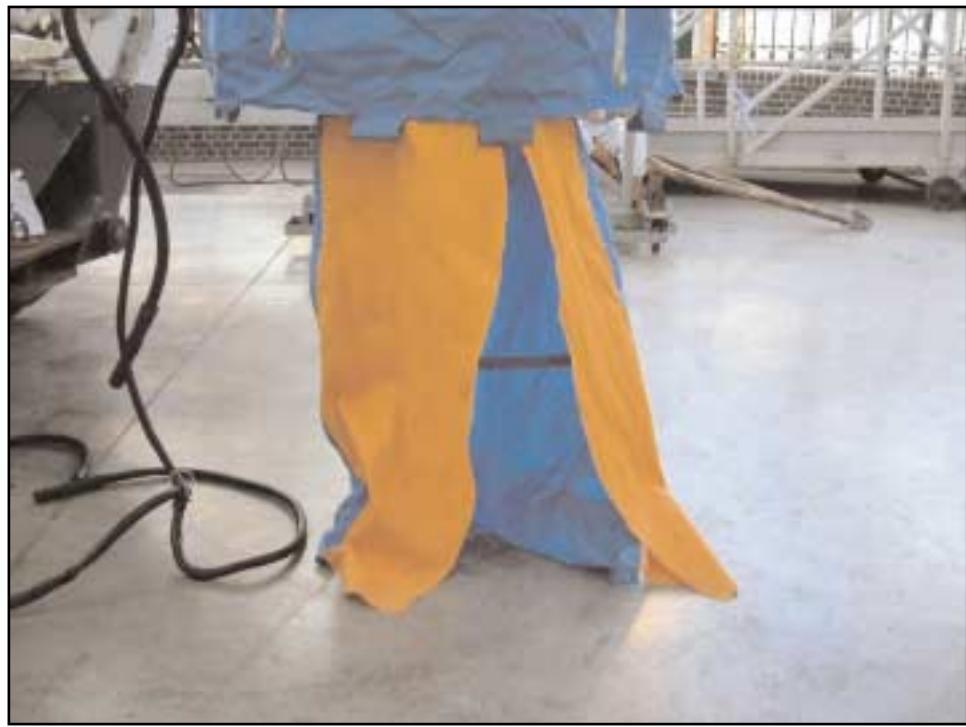
Photograph A1/9

The mid-height hoop attachment, between bungee positions 3 and 4, is completely detached. Between bungee positions 2 and 3 it is 90% detached, and between bungee positions 1 and 6 it is 30% detached (**see photograph A1/9**).

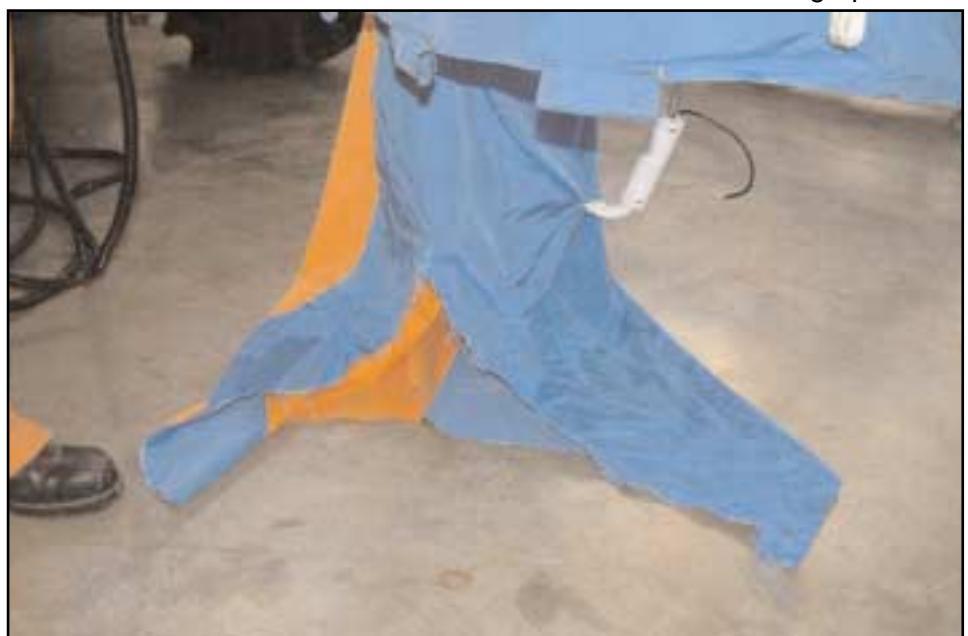
Photograph A1/10

Cell No.4 There is a vertical slit in the lower 60% of the sock between bungee positions 3 and 4 (see photograph A1/10).

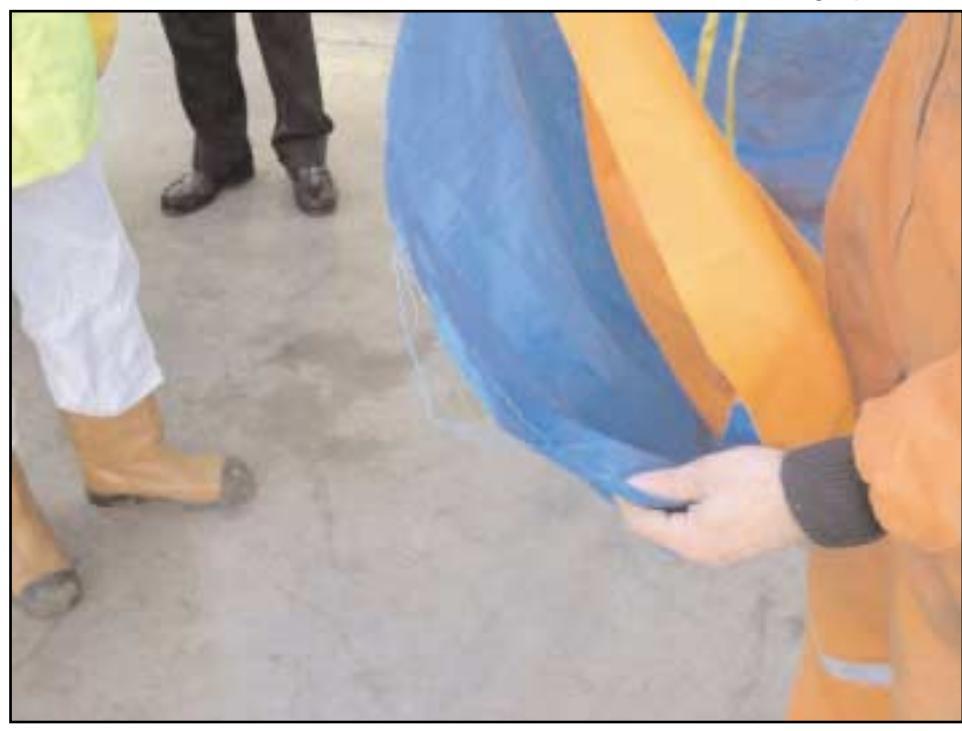
Photograph A1/15

There is the start of fraying to the blue fabric at the bottom of the sock that forms a stirrup (see photograph A1/15).

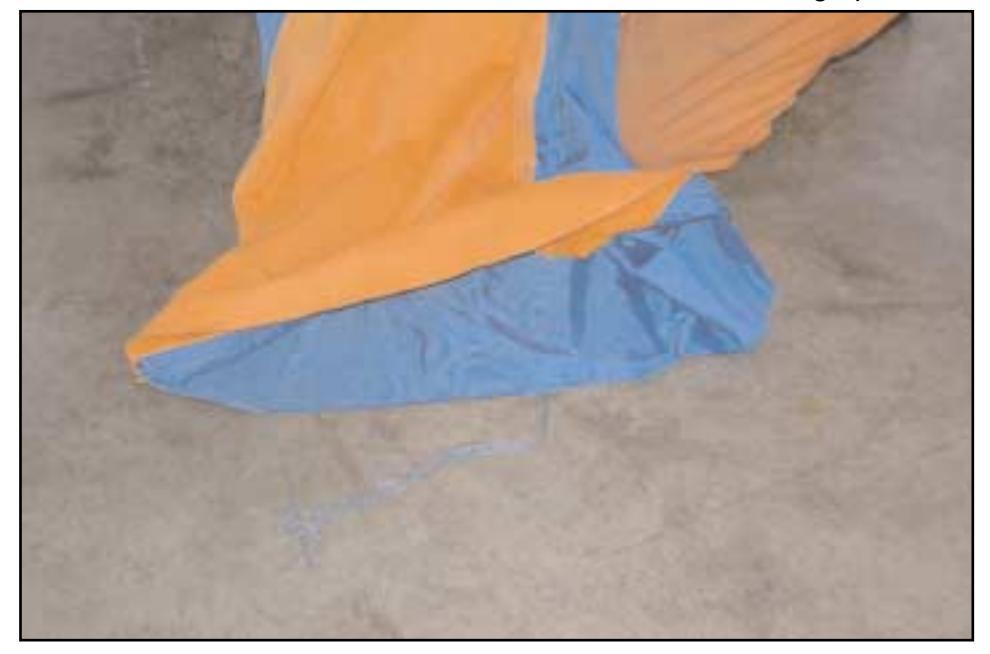
Photograph A1/20

- **Cell No.11** The blue fabric at the bottom of the sock has started to fray.
- **Cell No.12** The mid-height hoop attachment between bungee positions 1 and 2 is 10% detached. Between bungee positions 3 and 4 it is 10% detached, and between bungee positions 1 and 6 it is 100% detached (see photograph A1/20).

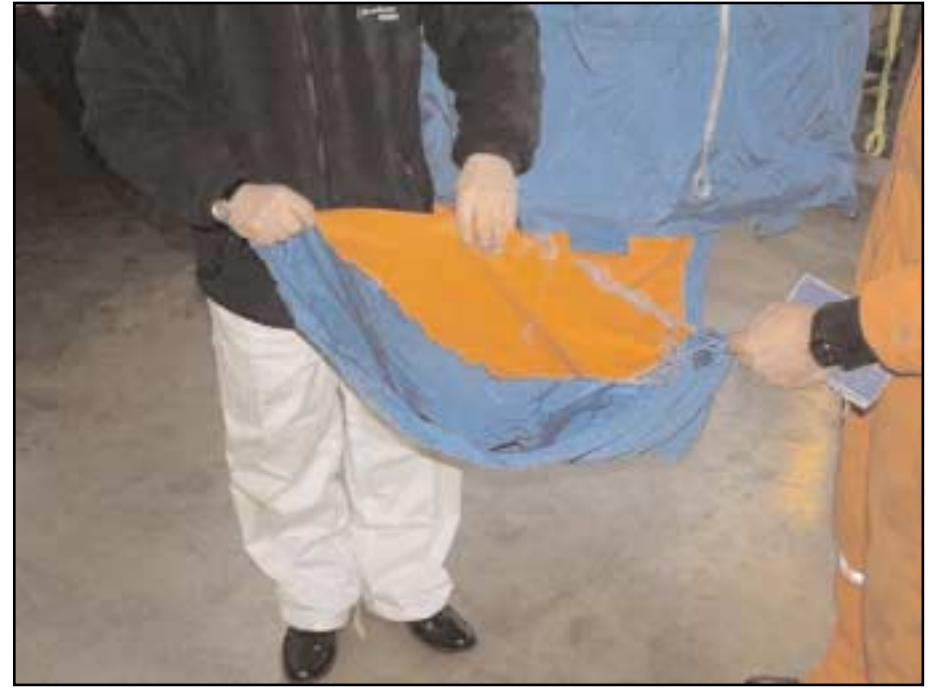
Photograph A1/25

There is fraying at the bottom of the blue fabric restraining panel, fitted over the elasticated panel. This is the only cell fitted with such a panel in the sock, and it is designed to take the initial shock load when an evacuee enters the chute (see photograph A1/25).

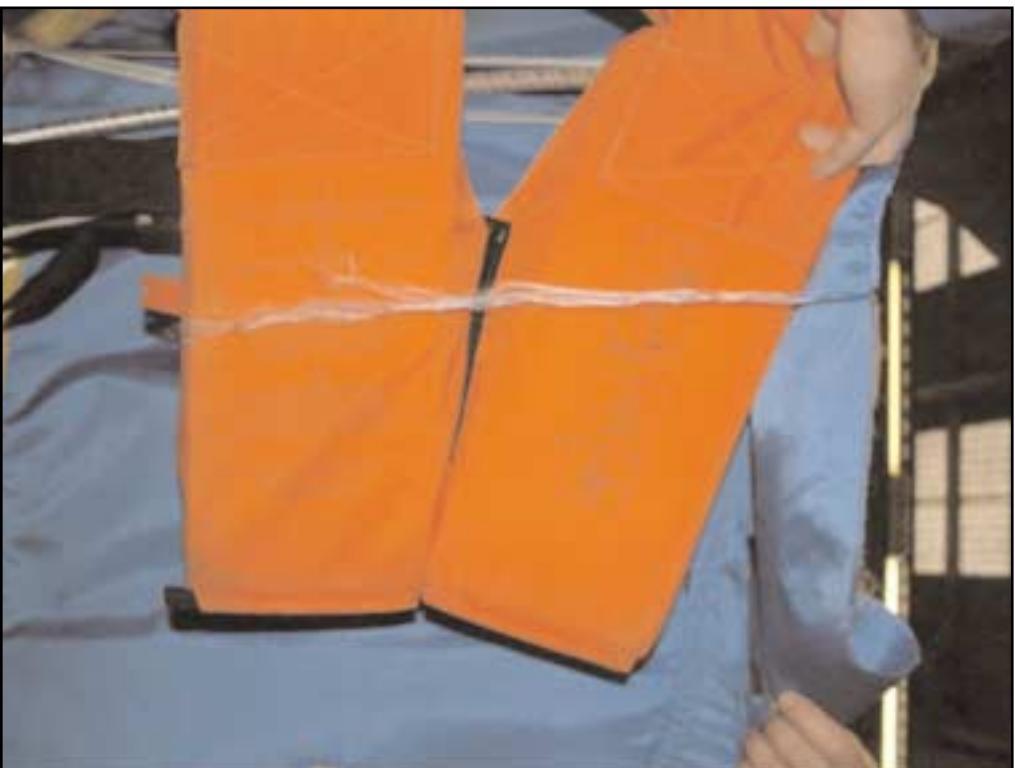
Photograph A2/6

During the reconstruction, it was found that, on catching a foot in this stirrup, it was broken easily under the weight of a person. **(See Photograph A2/6.)** Additionally, by the very design of the chute, the exit of the sock was hanging well into the next sock below, making it impossible to attain the piked position when a person's feet become caught in a stirrup.

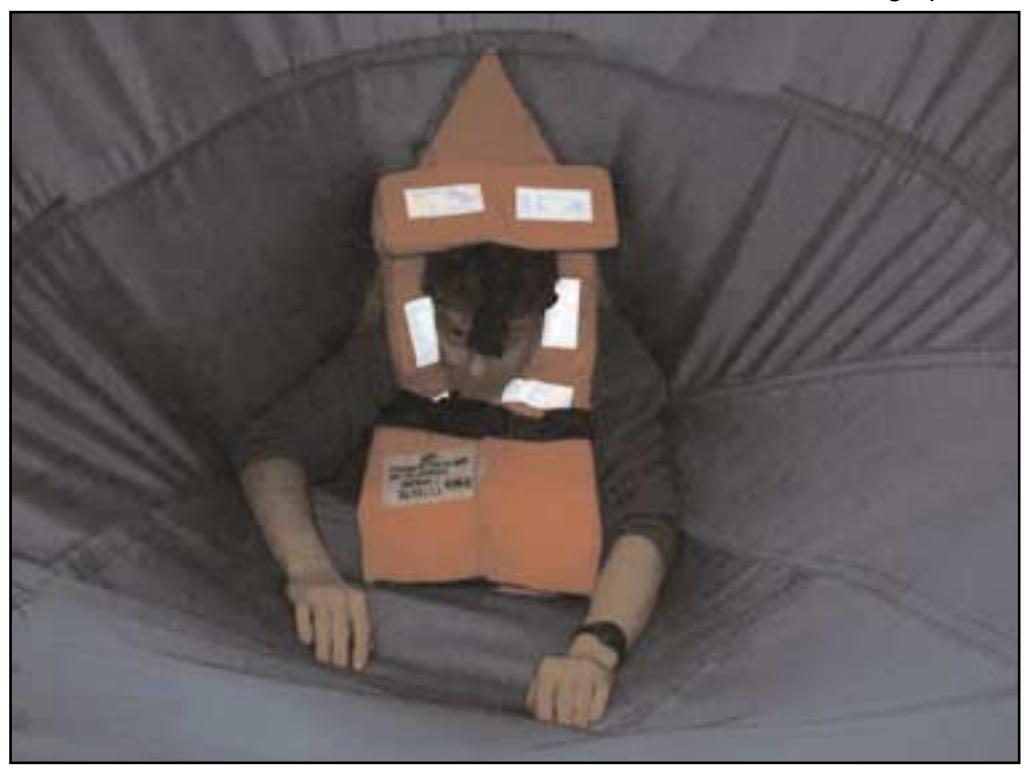
Photograph A2/8

After some trials it was found to be relatively easy for the lifejackets used in the *P&OSL Aquitaine* drill to ride up, while going down the chute. Female evacuees had a slightly higher incident rate than males (**see Section 1.9**) of lifejackets riding up, possibly because in some cases their lifejacket projects further out. It is quite conceivable that, while descending the chute, the bottom of the lifejacket would have become caught, because the chute narrows into the sock and effectively the lifejacket would have folded up around the wearer's head. (**See Photograph A2/8**.)

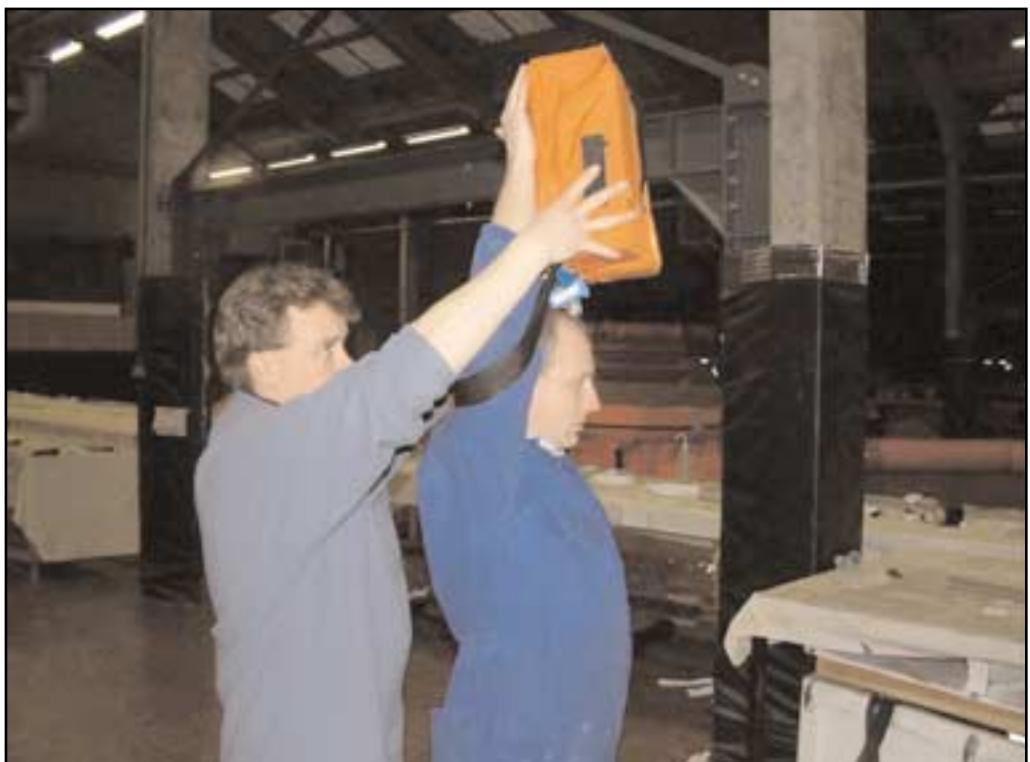
Photograph A2/9

This was very uncomfortable for the wearer, and it was easy for the lifejacket to pass over the head at this point. If the wearer also had their hands above their head, as instructed, while descending the chute, the lifejacket webbing would simply ride up the wearer's back and come off. **(See Photograph A2/9.)**
