Report on the investigation of the collision between the ro-ro ferry

Stena Gothica

and the eastern approach jetty at Immingham on 2 April 2002

> > Report No 39/2002 December 2002

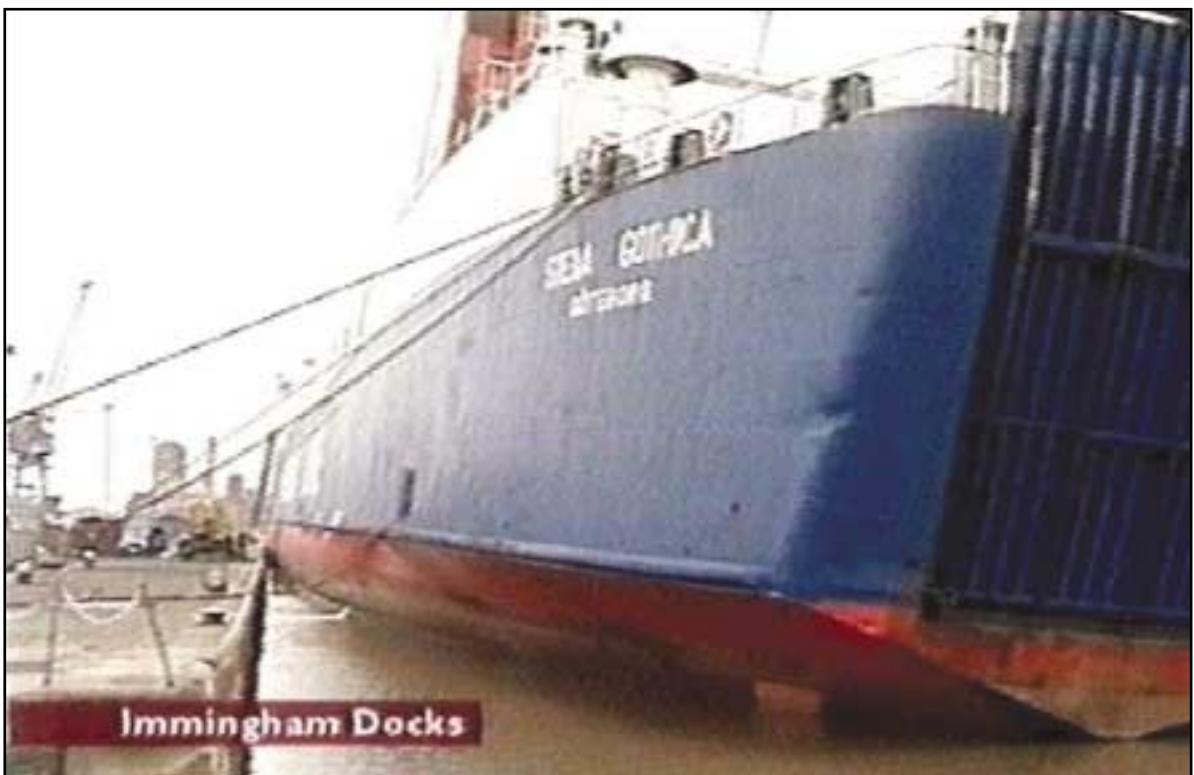
The vessel continued to list and reached a maximum heel of 14.5° at 0333, when there was about 2.5m of water in the starboard aft corner of the lower hold (see Figures 3 & 4). The firefighters and salvors were able to both slow the rate of ingress of water and, also, to lower the water level in the hold so that during the course of the morning the list was gradually reduced. *Stena Gothica* remained in the lock throughout this period.

Vessel listing in lock

- 11. The lower hold lift housing, located in the aft starboard corner of the hold, filled first, causing the vessel to list to starboard, bringing the damaged area closer to the waterline, and keeping the water already in the lower hold away from the damaged side. [2.5]

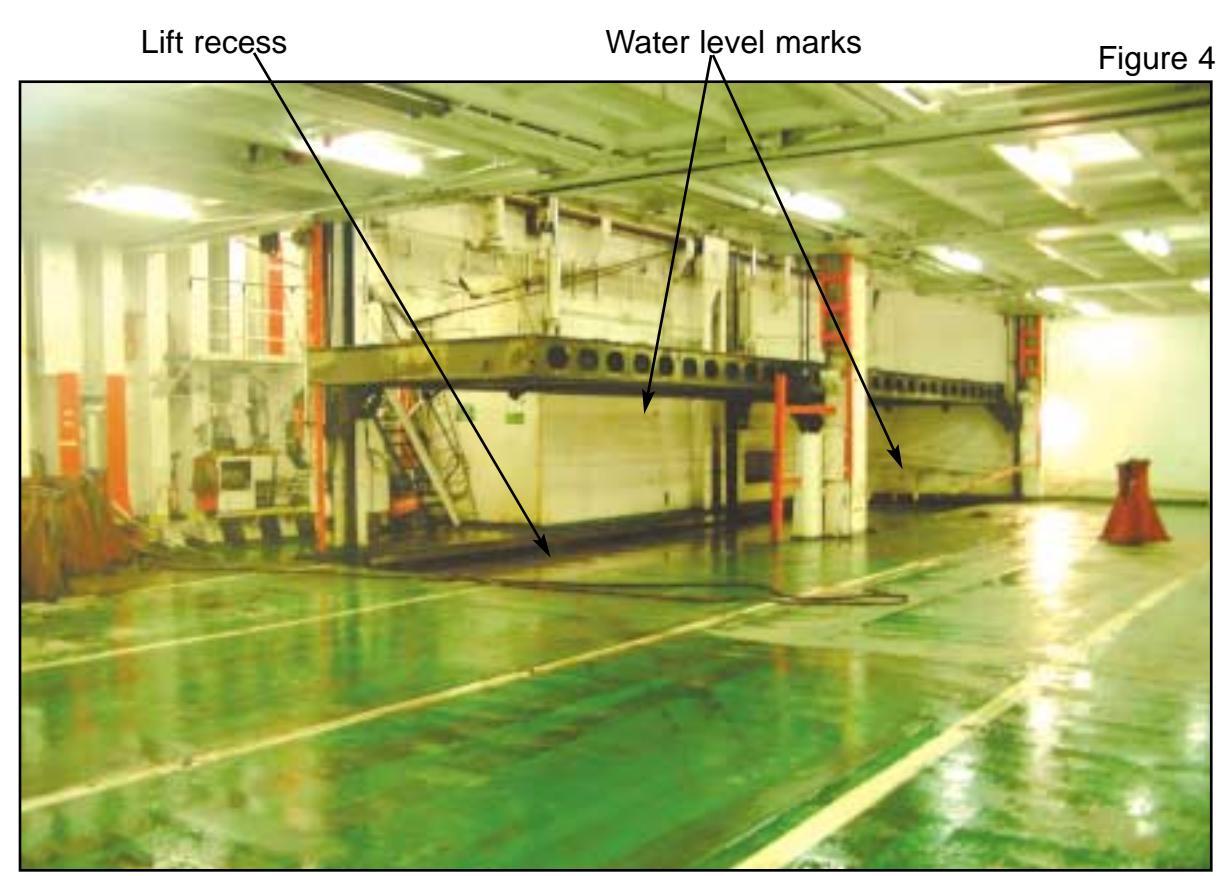
Lower cargo hold looking aft (taken 2/4/02 pm)

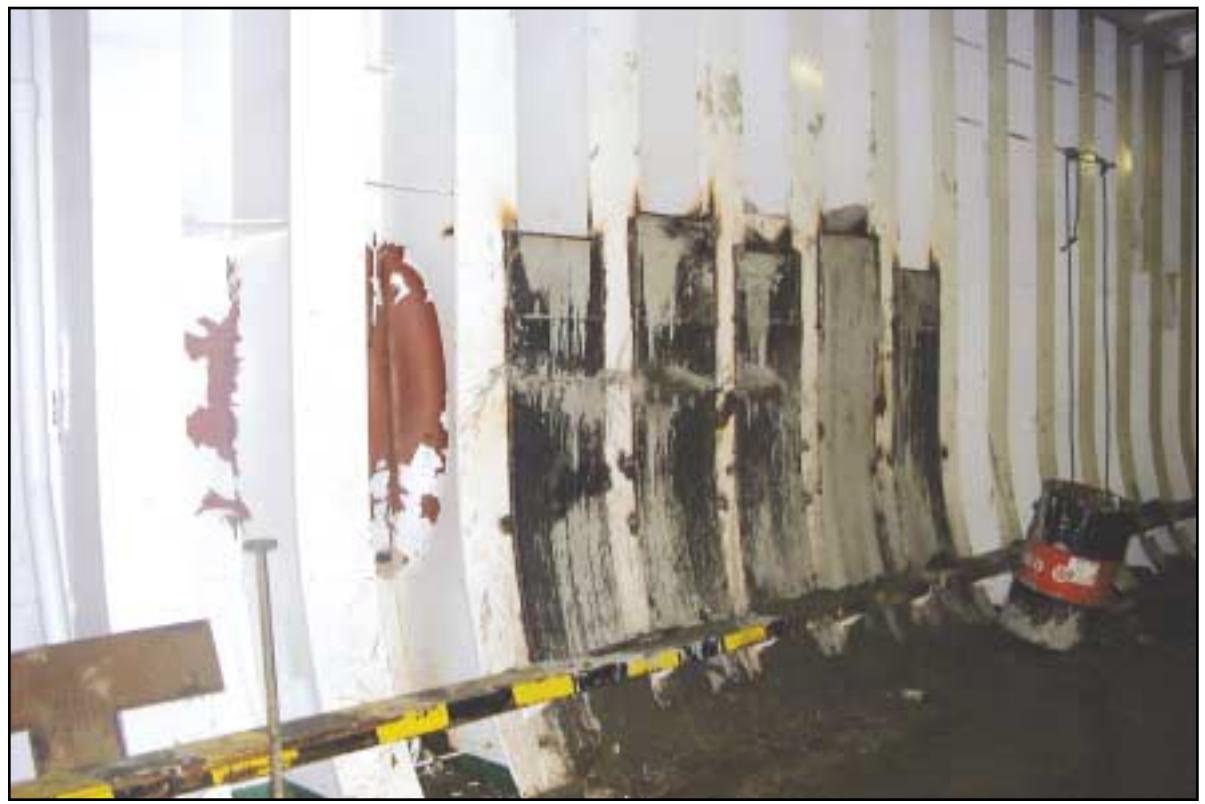
Figure 5

The officers in the engine room contacted the master and informed him that the vessel was taking on water. The vessel was then moved into the lock. The impact had caused a 3 metre gash in the port side shell plating, below the waterline just aft of midships in the vicinity of frame 100. This led to a large ingress of water into the lower cargo hold. The lower hold lift housing, located in the aft starboard corner of the hold, filled first. About 20 minutes after entering the lock the vessel started to list to starboard.

Temporary repair made to damage

After some temporary repairs using timber wedges and quick drying cement, the ingress of water was stopped completely and the vessel brought slowly upright as the hold was emptied.

In mid-afternoon the vessel was moved to berth No 4 where she was all fast at 1442. The cargo was discharged and further temporary repairs involving welding carried out **(see Figure 5)**. An MAIB inspector arrived at the vessel shortly after she berthed to start the investigation.

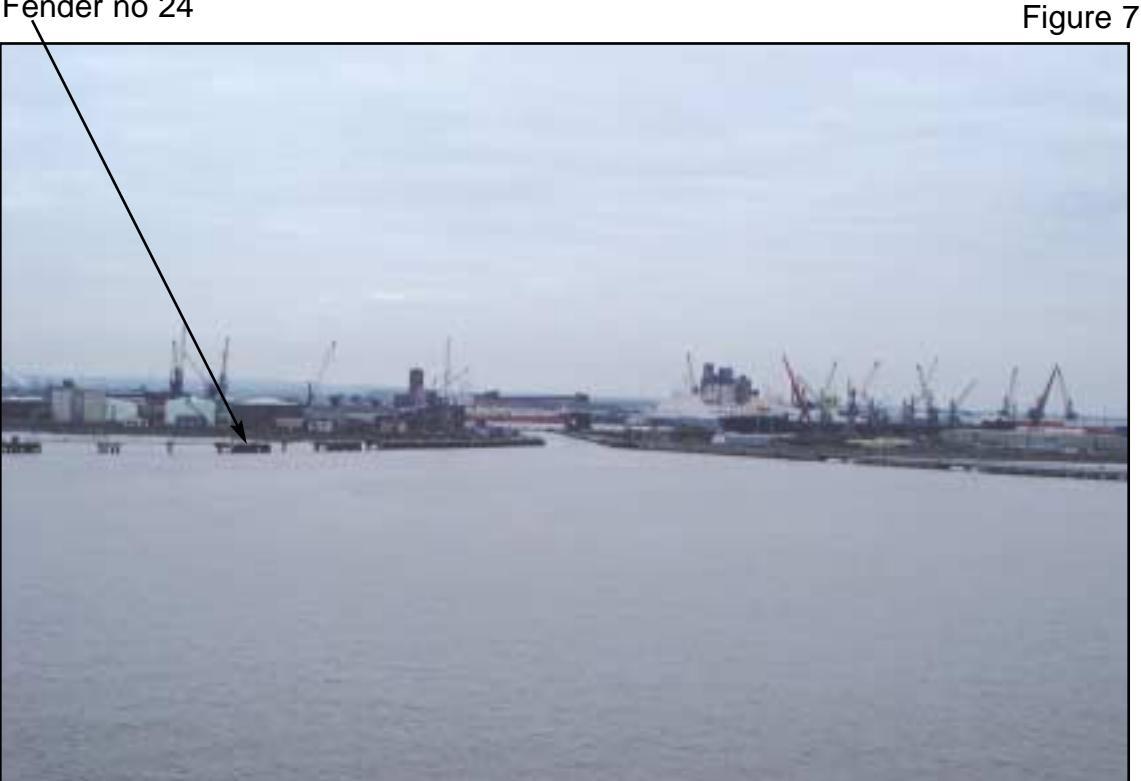
At the time of the incident the outermost fender on the second dolphin (No 24) from the lock was under repair and missing due to an earlier incident. The missing fender had scaffolding around it and was marked by a flag. The pilots had been informed.

Fender no 24

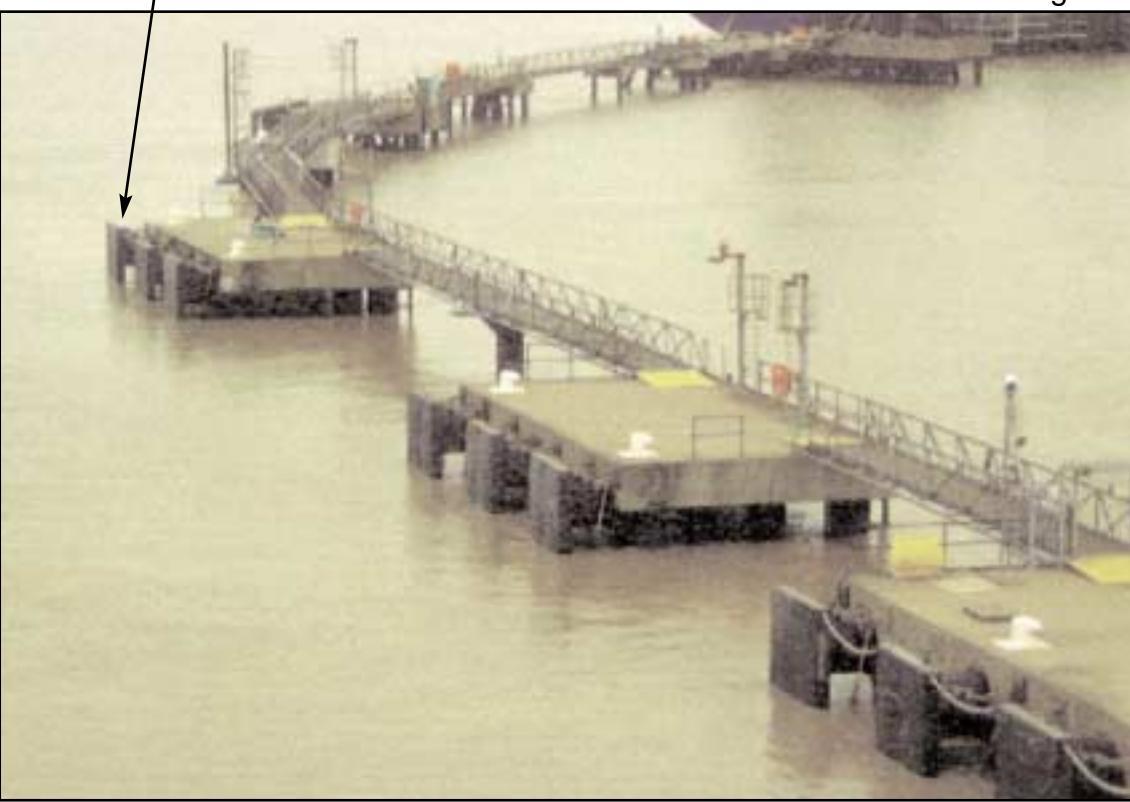
Eastern approach jetty (taken June 2002 after fender repaired)

Since the incident, the fendering has been fully repaired (see Figure 8).

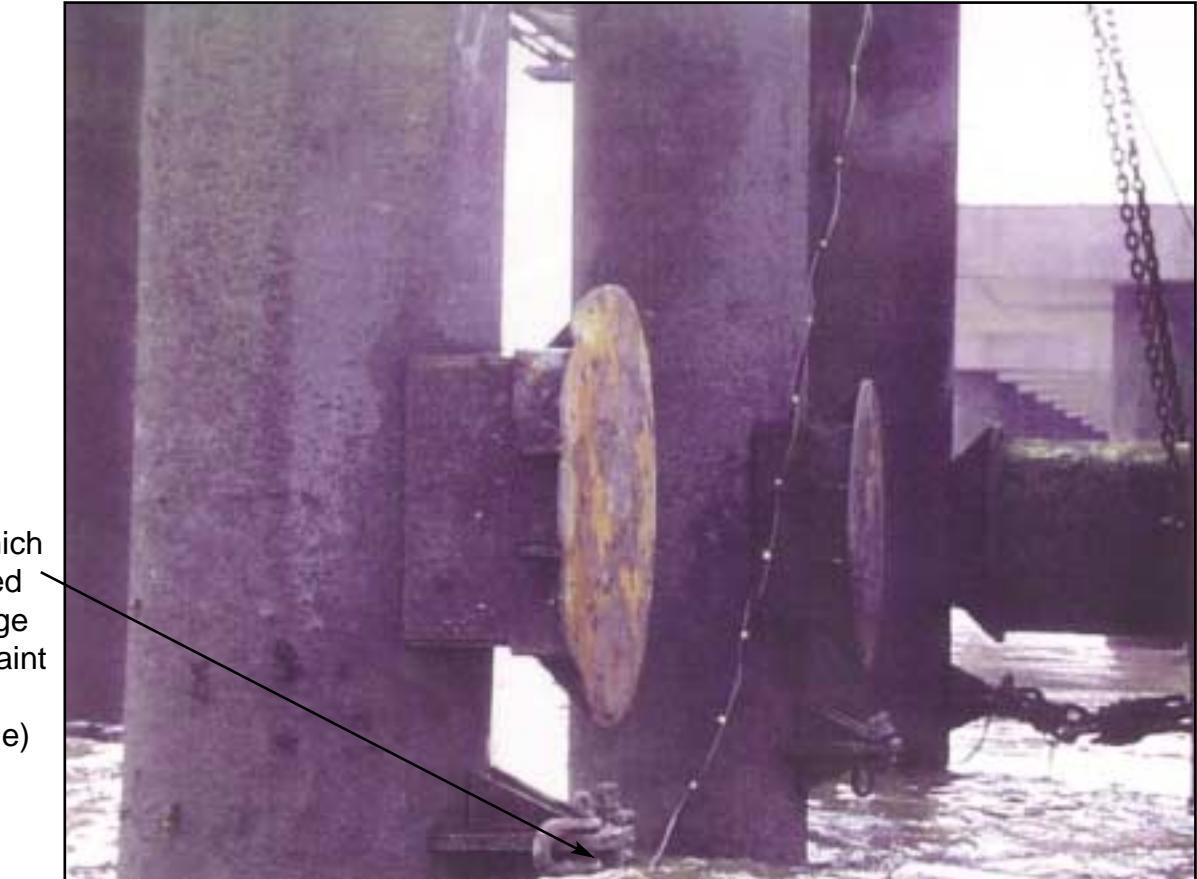
Figure 9

The damage to Stena Gothica was caused by the lug underneath the flange. In Figure 9, paint marks from the hull can be seen on one of the shackles attached to this lug. The middle fender (No 23) was also damaged as a result of this incident and was taken away for repair.

Lug which caused ~ damage (note paint on shackle)

Stena Gothica had the misfortune to impact the Eastern jetty at the location of the missing fender and sustained most of her damage from the lug under the flange shown in **Figure 9**.

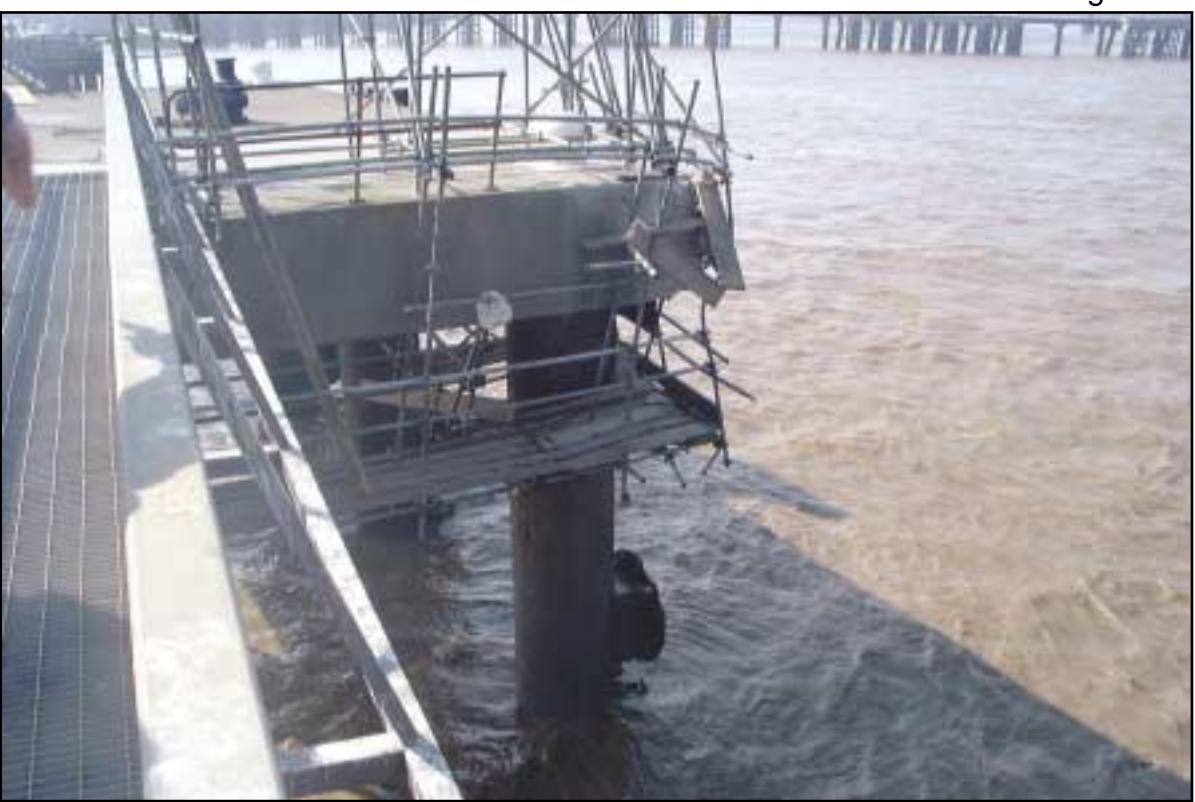
Fender 24 (note damage to scaffolding)

At the time of the incident, the outermost fender on the second dolphin (No 24) from the lock was under repair and missing because of an earlier incident. The missing fender had scaffolding around it and was marked by a flag, but was not marked at night. No temporary fendering had been put in place during the repair period. The pilot was aware that the fender was missing, but masters had not been notified. The pilot did, however, inform the master immediately before the contact, of an area of scaffolding on the jetty around the missing fender and that he could not land alongside this area.

- 3. Ensure that whenever control measures, such as fenders, are missing, masters are informed before their arrival at the port.
- 4. Ensure that whenever fendering is removed, for repair or any other reason, that it is replaced by temporary fendering of equivalent strength.
- 5. Emphasise the advantages of advanced planning among its pilots.
