Report on the investigation of

the cargo shift, abandonment, and grounding of

mv Kodima

> Report No 1/2003 January 2003

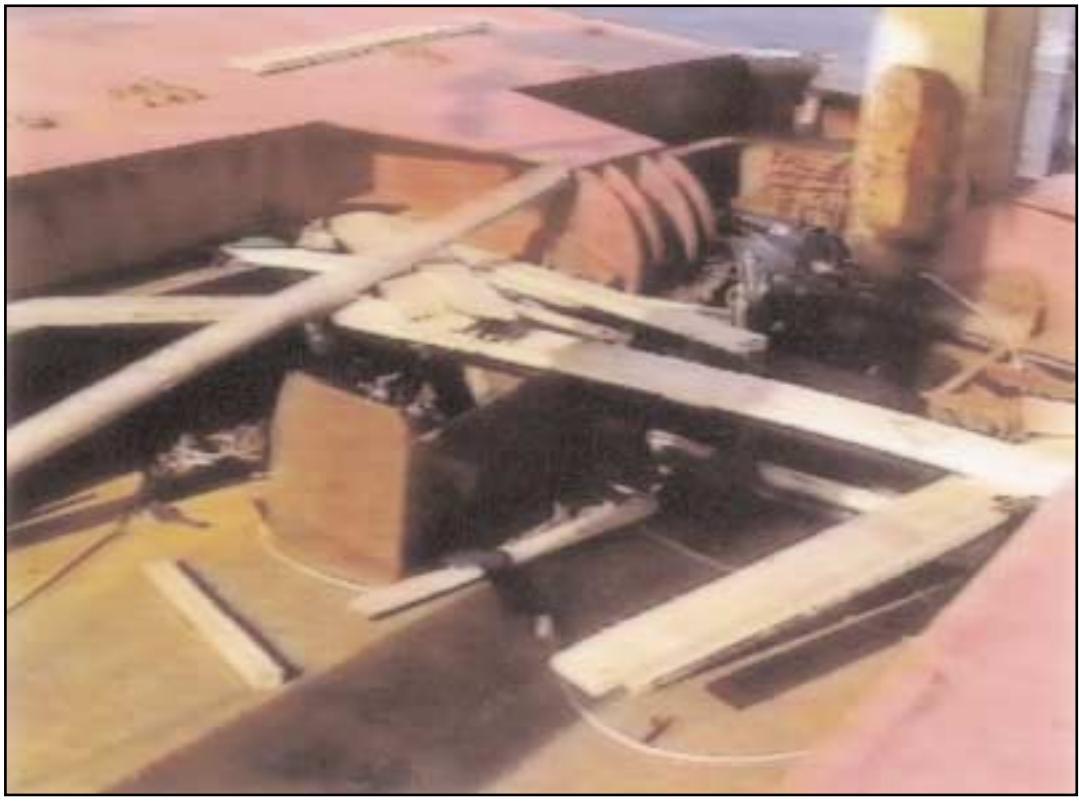
Photograph showing space between hatch hold covers

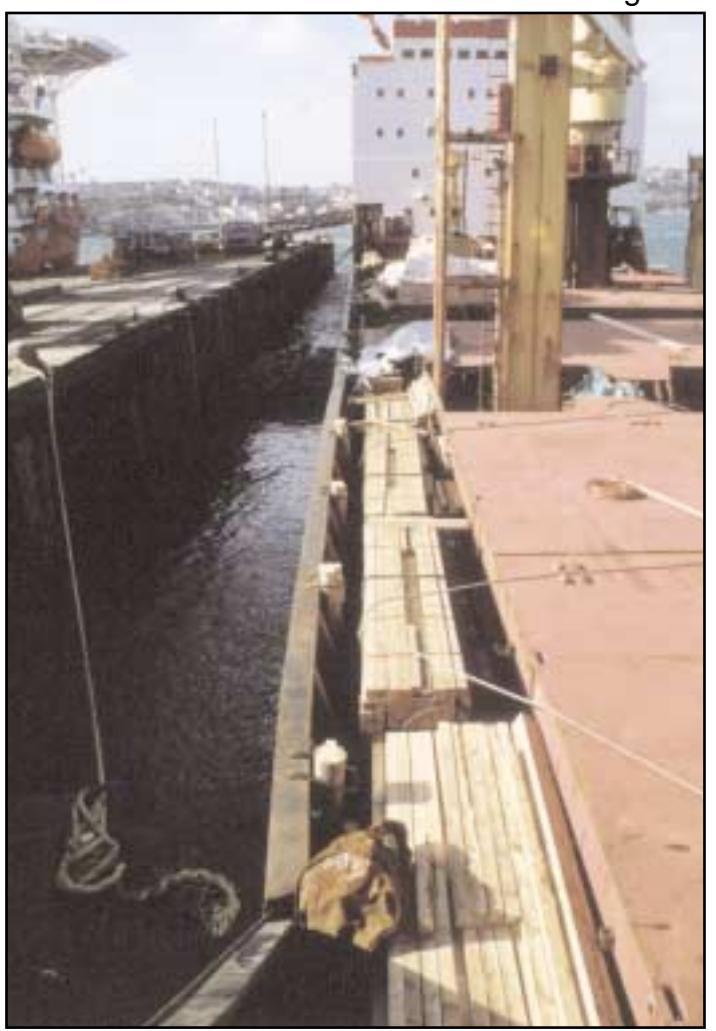
Figure 6

Photograph showing packages placed between the bulwark and hold hatch covers

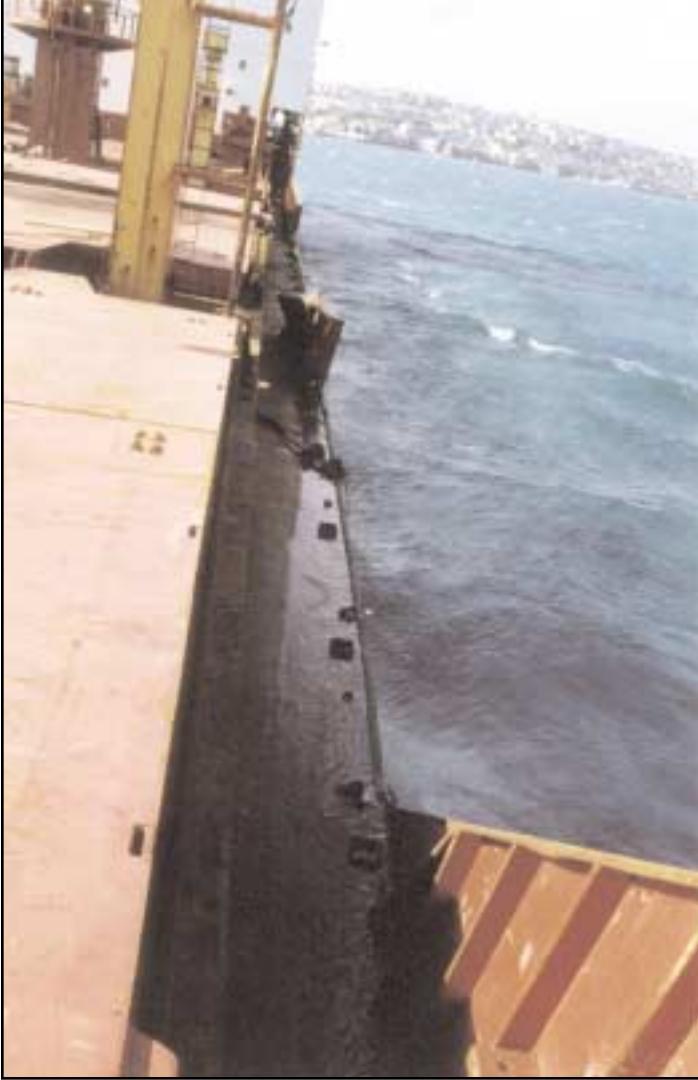
Figure 12

MAIB inspectors visited *Kodima* in Falmouth following the accident. Damage seen included the ship's side, where a large section of the port bulwark had been ripped away (**Figure 12**), deck fittings that had been sheered off, the hatch cover to hold No 3 had been lifted, and the hatch cover to hold No 4 was missing (**Figure 13**). The engine room had also been flooded after the ship had been abandoned because of its access hatch on the port aft first level superstructure deck (or poop deck) being carried away by heavy seas when the list was about 45° and the deck edge submerged. The water level had extended up to, and including, the middle levels of the engine room, as well as reaching close to the deckhead of the engine control room.

Photograph showing damage to port bulwark

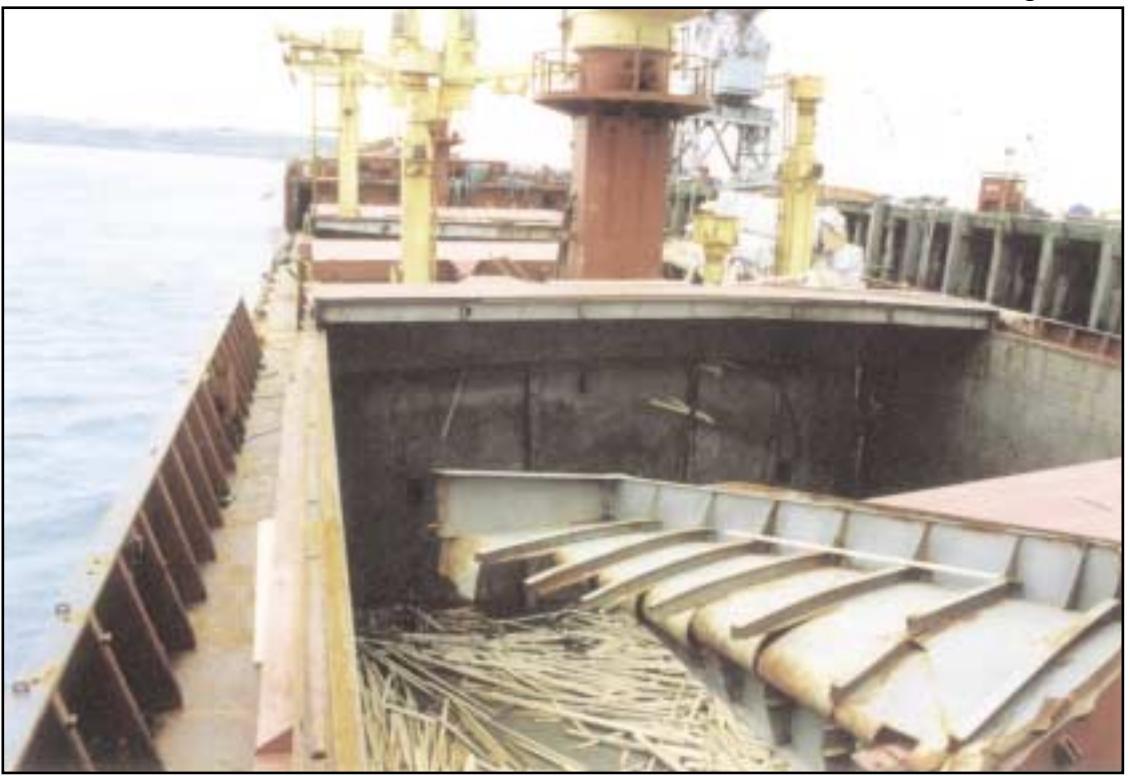
Figure 13

Photograph showing the damage to No 4 hold hatch cover

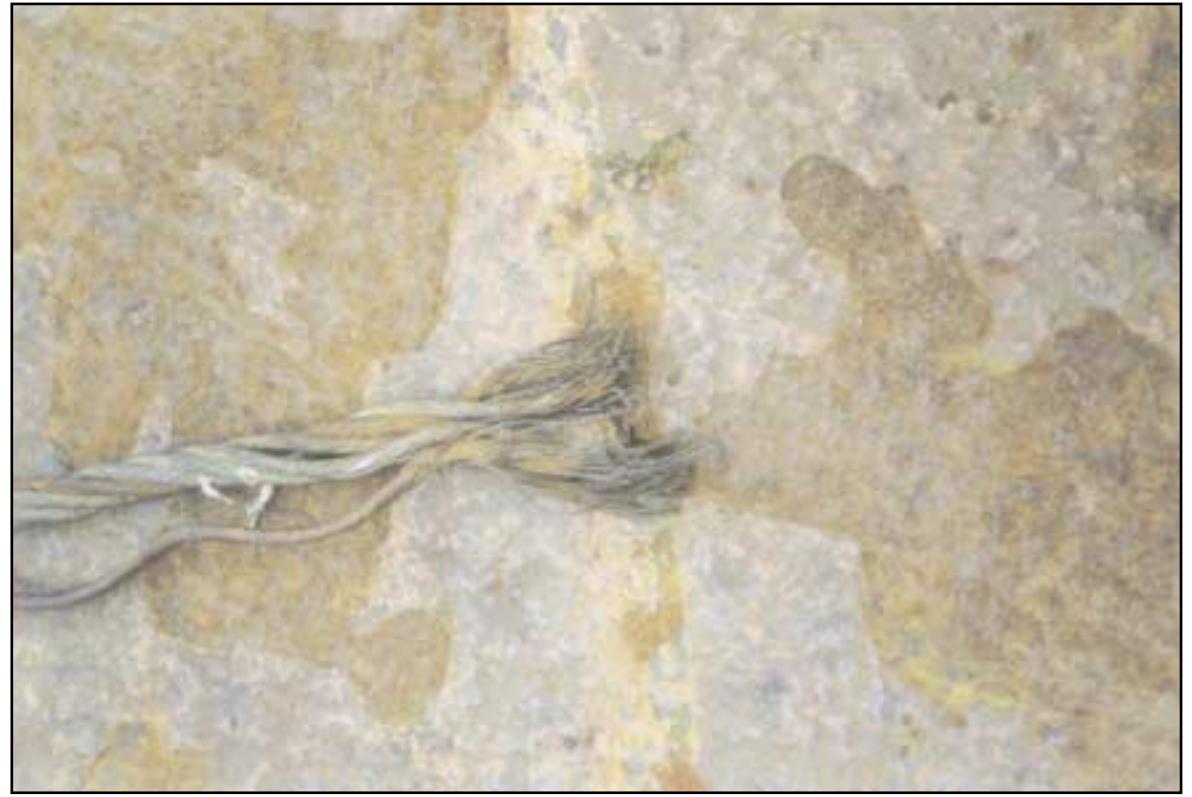
Although many of the wire lashings had been cut and moved during the salvage operation, five had a stranded appearance, indicating that they had parted **(Figure 14)**. There was also some evidence that some of the lashings might have failed at the turnbuckle. All of the lashings seen appeared to be in good condition.

Photograph of stranded wire lashing

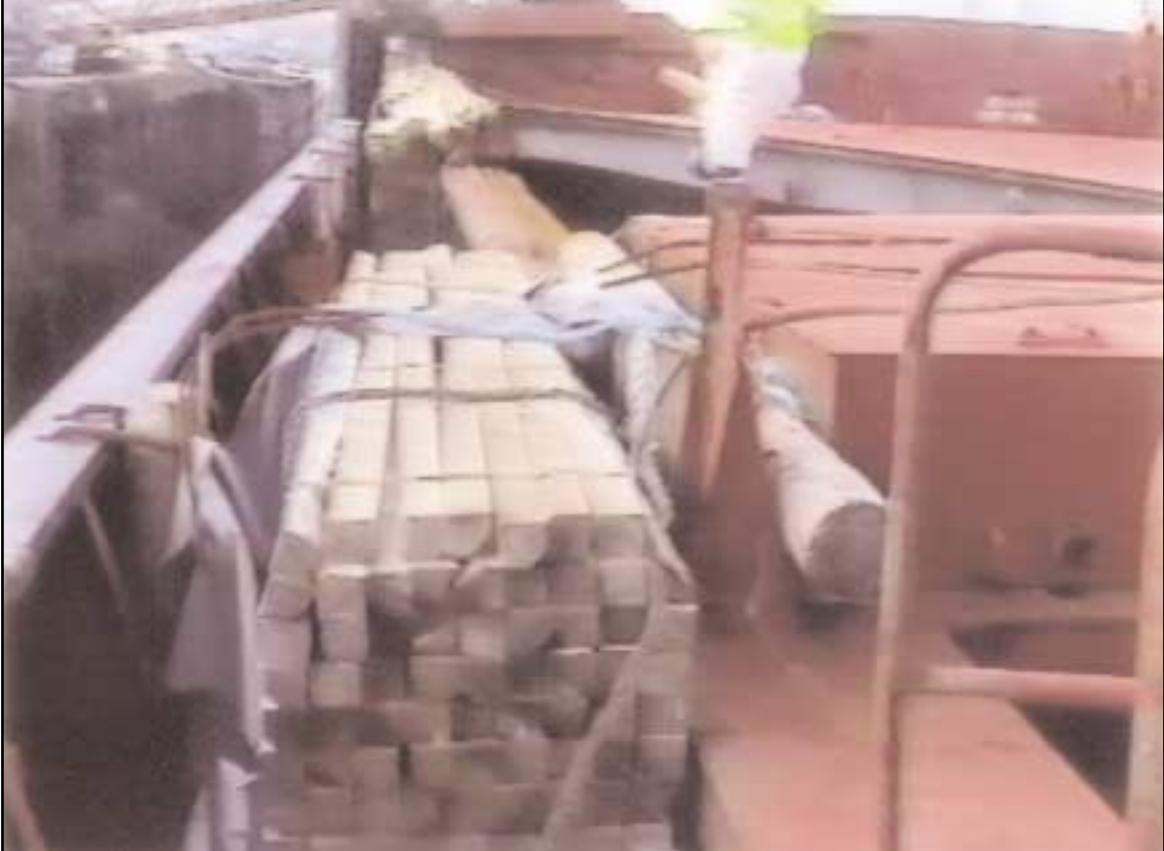
Figure 15

The achievement of a compact stow, when loading timber cargoes, is essential, but can also be extremely problematic. In this case, difficulties were caused by the difference in height between the deck and the top of the hatch covers **(Figures 6 and 15)**, the presence of the wells between the hatches **(Figure 8)**, the numerous obstructions in the stowage area **(Figure15)**, and the differing lengths of the timber packages. Although such difficulties made the presence of some void spaces unavoidable, appropriate measures to keep these to a minimum appear to have been taken, and there is no evidence to suggest that the stow was not compact. In particular, the repacking and placement of timber packages in the gaps between the bulwarks and hatch coamings was a prudent action to take.

Photograph showing deck obstructions and height differences
