Report on the investigation of

# European Tideway and Vrouw Grietje

in the North Sea

> Report No 25/2001 25 May 2001

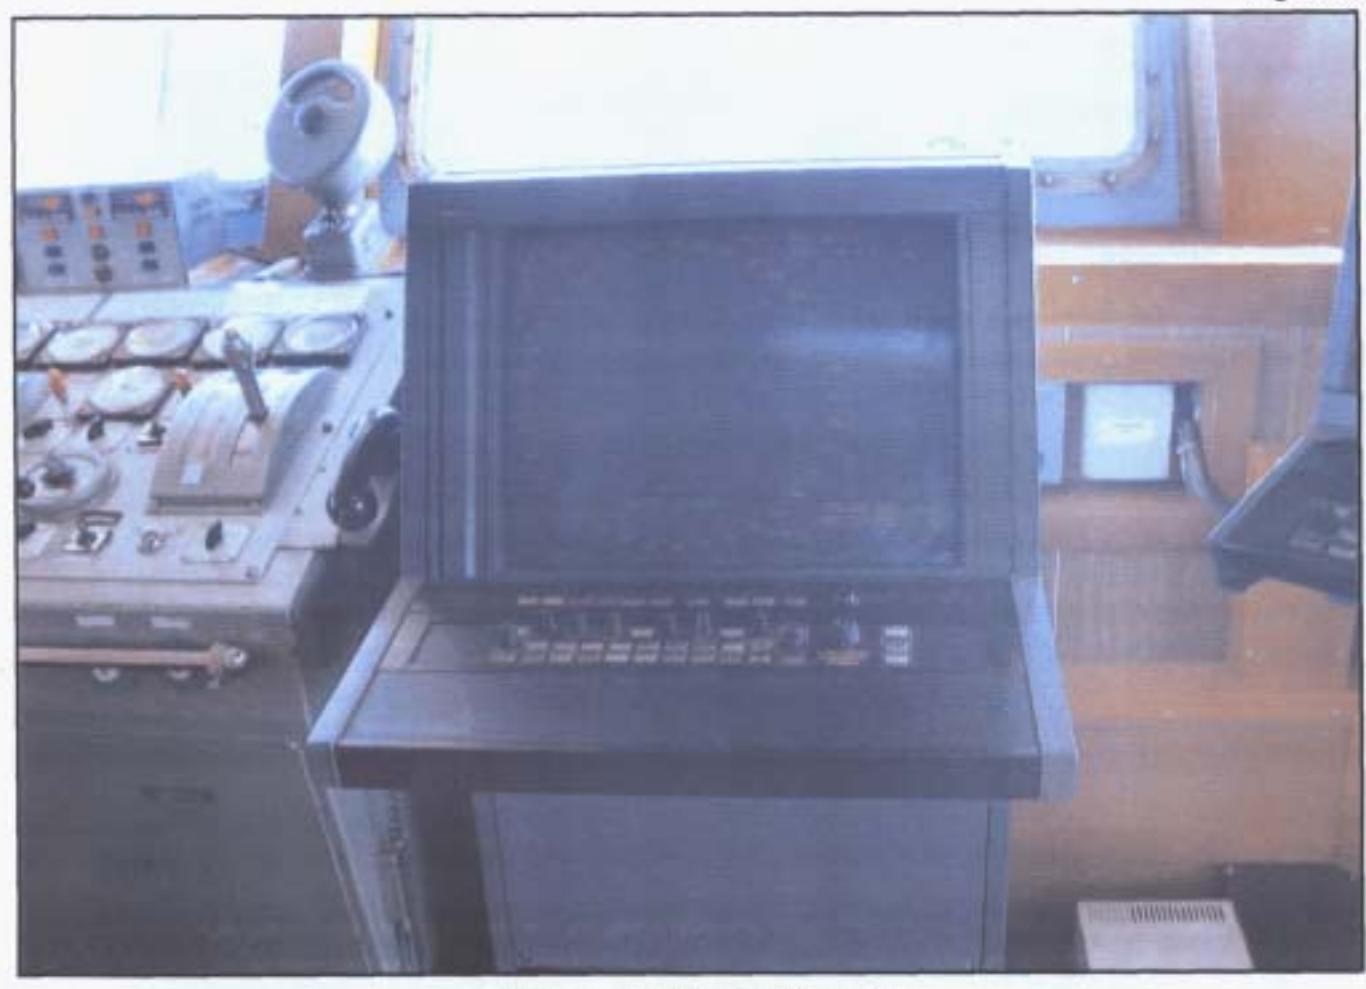
# Figure 3

ARPA on European Tideway

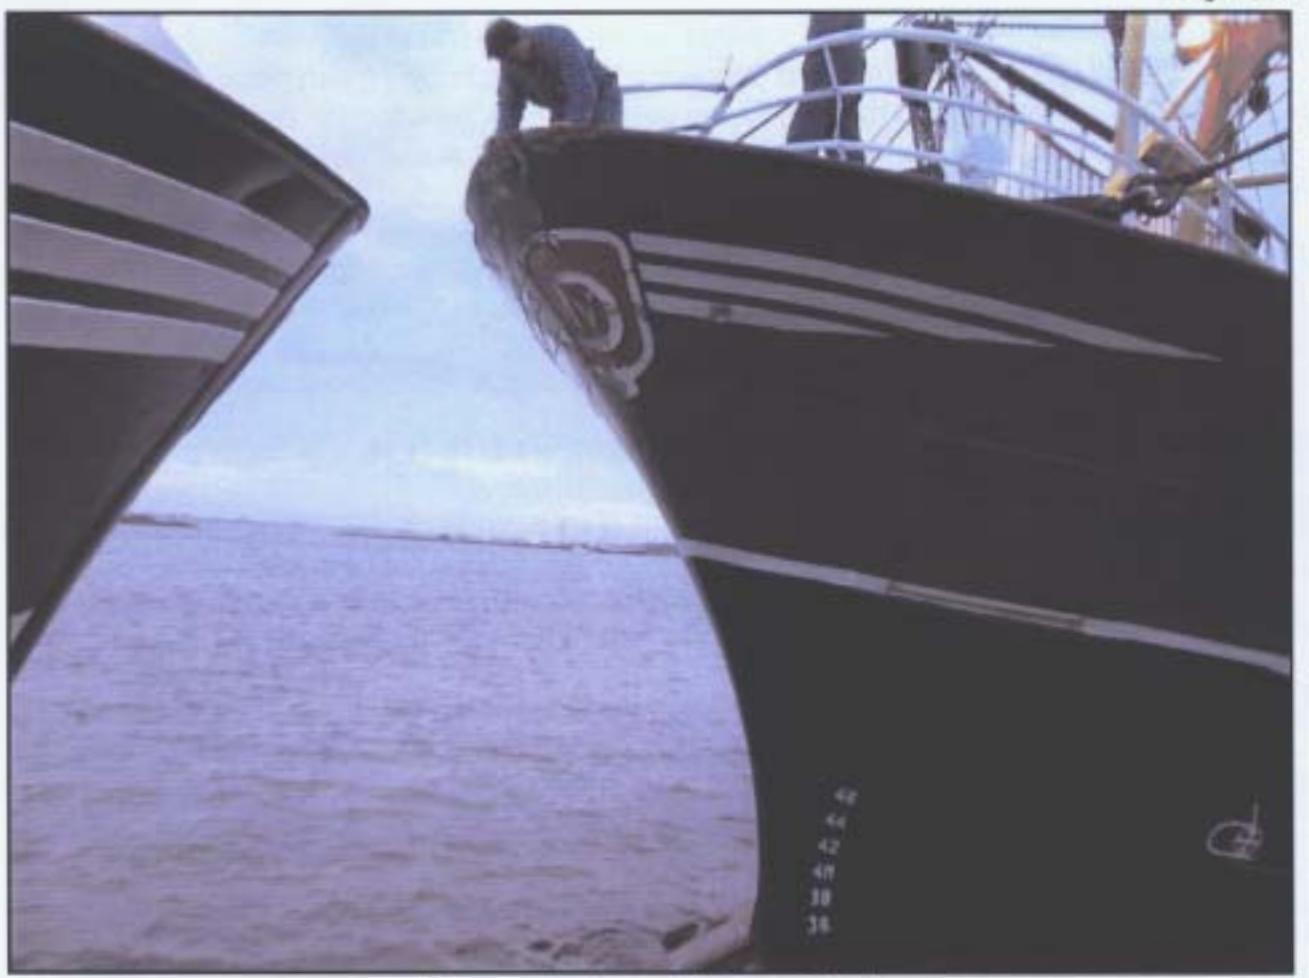
Vrouw Grietje suffered slight damage to her bow and forward handrails. European Tideway sustained a 6-metre long gash in her port bow above the waterline. There were no injuries and no pollution.

Thames Coastguard and P&O North Sea Ferries' office in Hull were contacted and informed of the collision. The vessel then continued to Felixstowe at slow speed. A 6 x 1.5m gash was found in the port bow of the ferry about 4m above the waterline. This was in way of the main car deck, (see Figure 4). *Vrouw Grietje* sustained only light damage to her bow and forward handrails (see! Figure 5). She continued fishing for the rest of the week before returning to port.

Damage to European Tideway (viewed from car deck)

Damage to bow of Vrouw Grietje

*European Tideway* discharged her cargo and then proceeded to Rotterdam for repairs, which were completed on 23 October when she resumed service.
