Report of the investigation of the fire on board the fishing vessel

### **BE READY**

while fishing 30 miles north-west of the Orkney Islands on 22 January 2000

> > Report No 30/2000

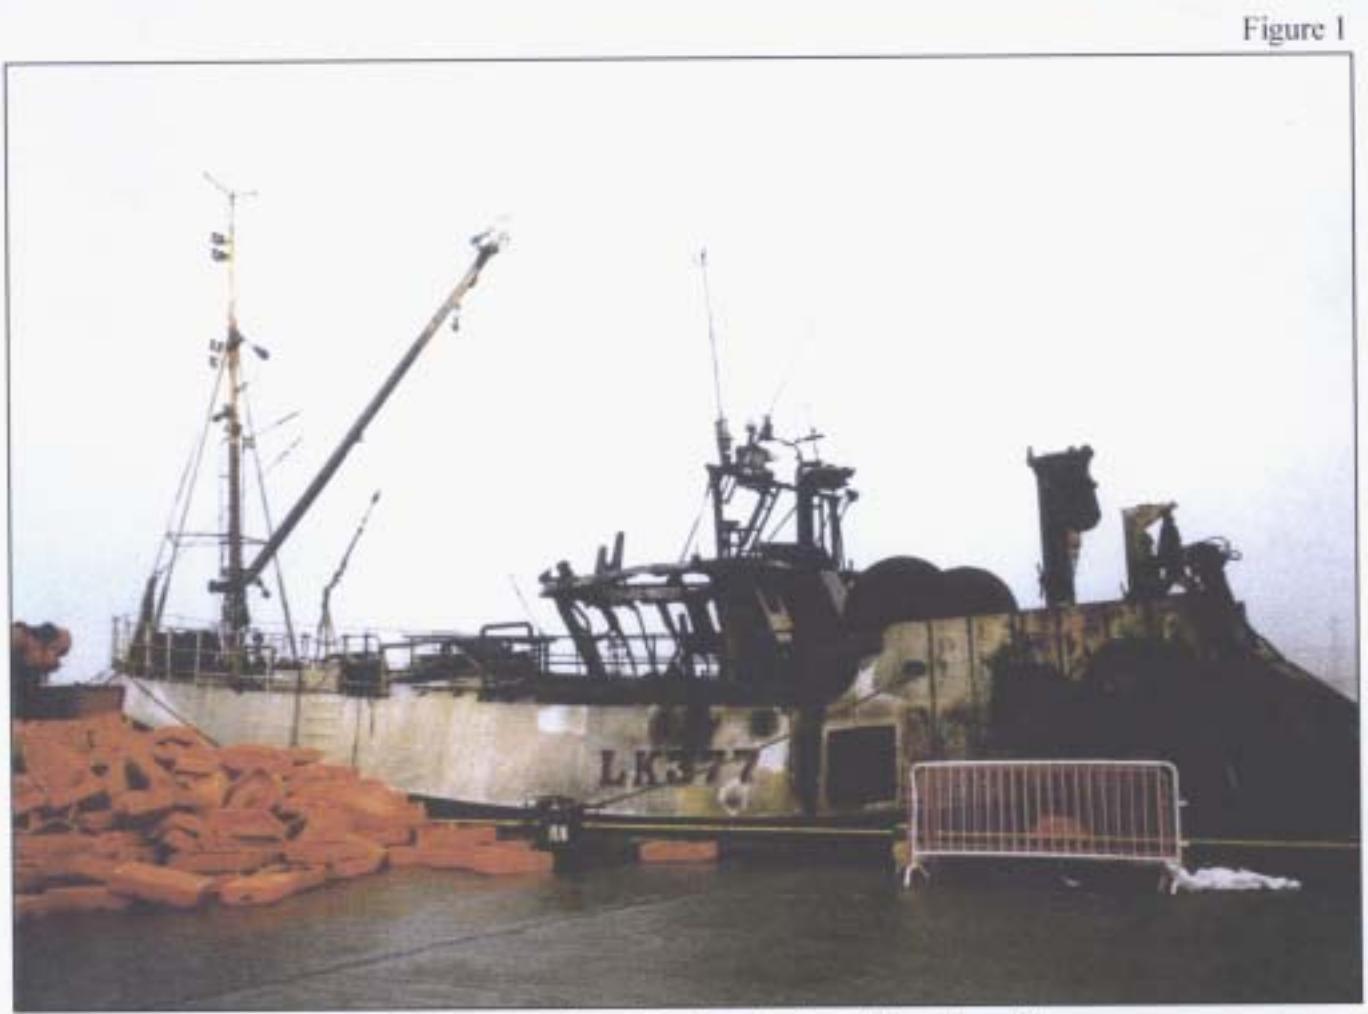
General view, port side, of Be Ready alongside at Lerwick

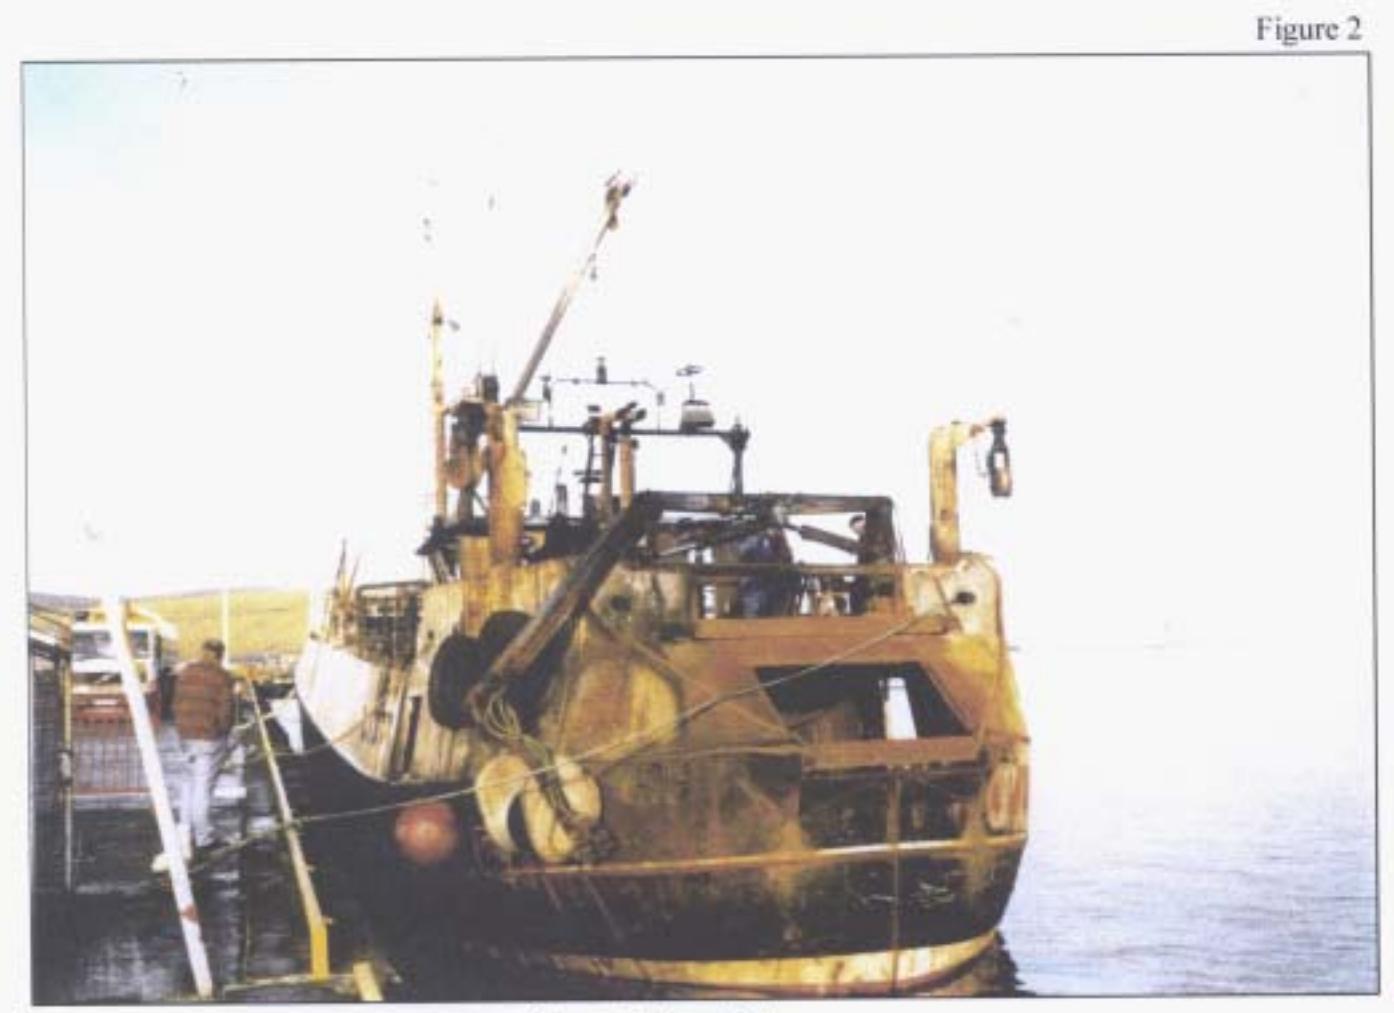
General view of stern

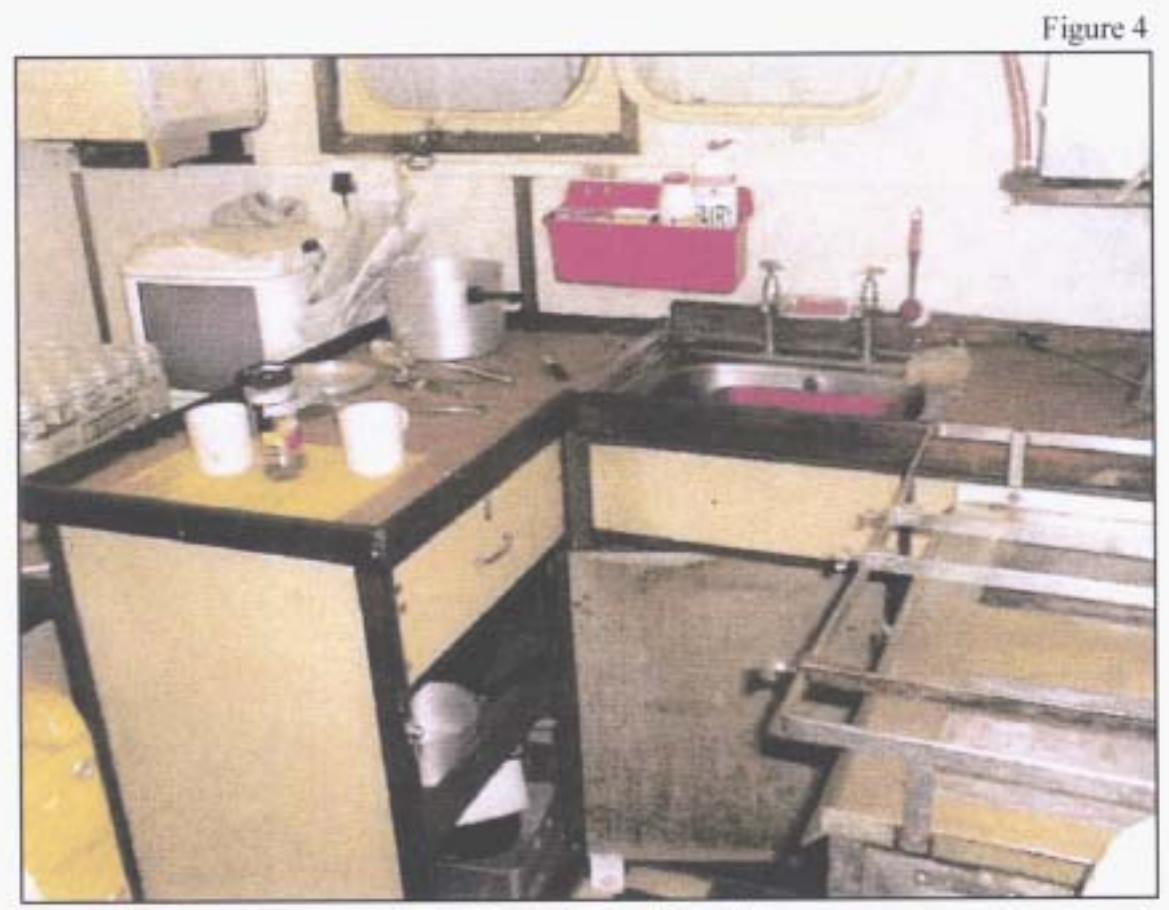
Galley with cooker and hot plates

- 2.1.2 Although there is no doubt that the fire originated in the galley, and on or in the vicinity of the cooker, the actual cause of the fire must be speculative. That speculation gives rise to the following scenario:

- a. A wet/damp drying towel is flung/hung over the string line secured above the cooker hotplate.
  - b. The deteriorating weather causes increasing vessel movement disturbing the position of the drying towel.

- c. The drying towel, now much lighter due to loss of moisture, is also affected by the draught coming through the open window from the starboard shelter deck.

- d. The drying towel falls down on to the hotplate, smoulders and catches fire.
  - e. Flames from the burning towel, fanned by the draught from the open window, spread on to the bulkhead behind the cooker and possibly on to clothes hung on the cooker isolating switch.

- f. Once the flames had established a hold, it was likely that the bulkhead itself would have started to burn, aided by accumulated oil and grease which would have adhered to the formica covering and in the cracks which would undoubtedly have been present in this age of vessel.

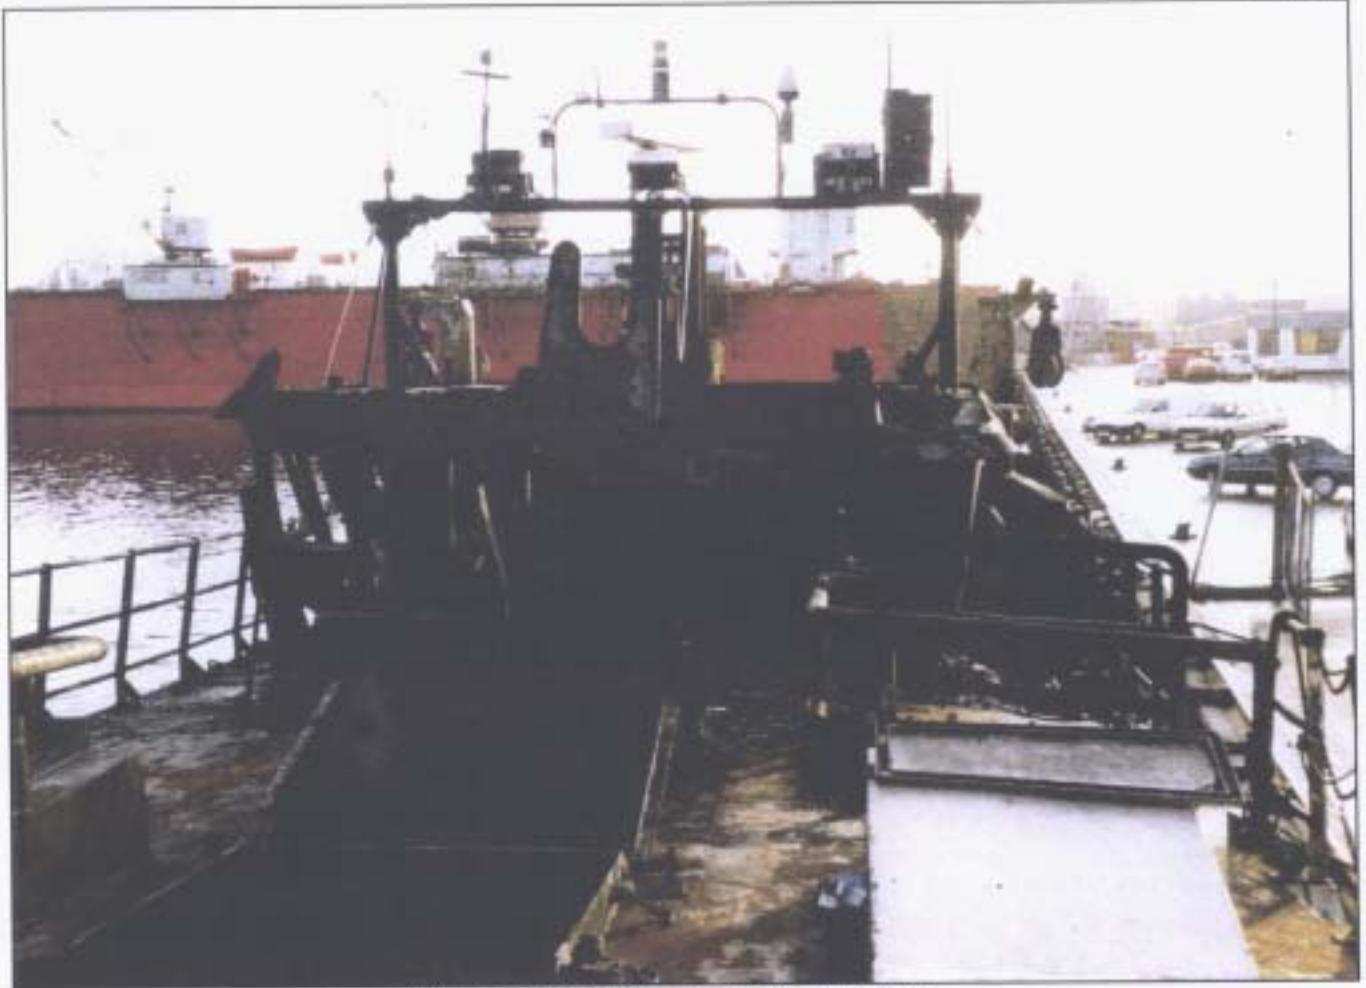
Figure 6

The aluminium wheelhouse was burnt out with melted aluminium and buckled steel structure. All wheelhouse equipment was destroyed.

View looking aft from top of whale back

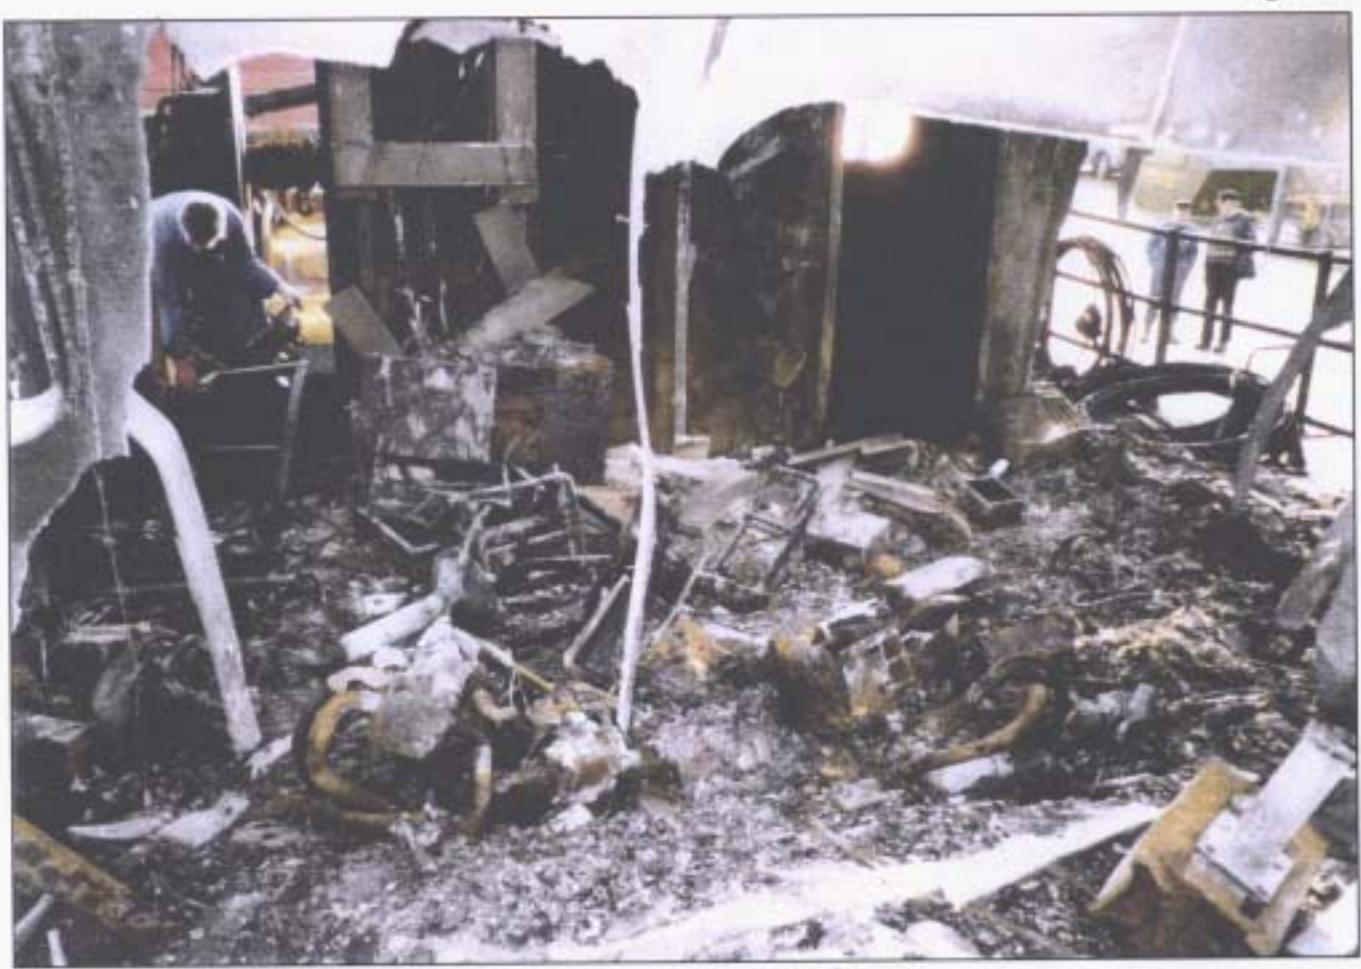
Looking aft from wheelhouse front

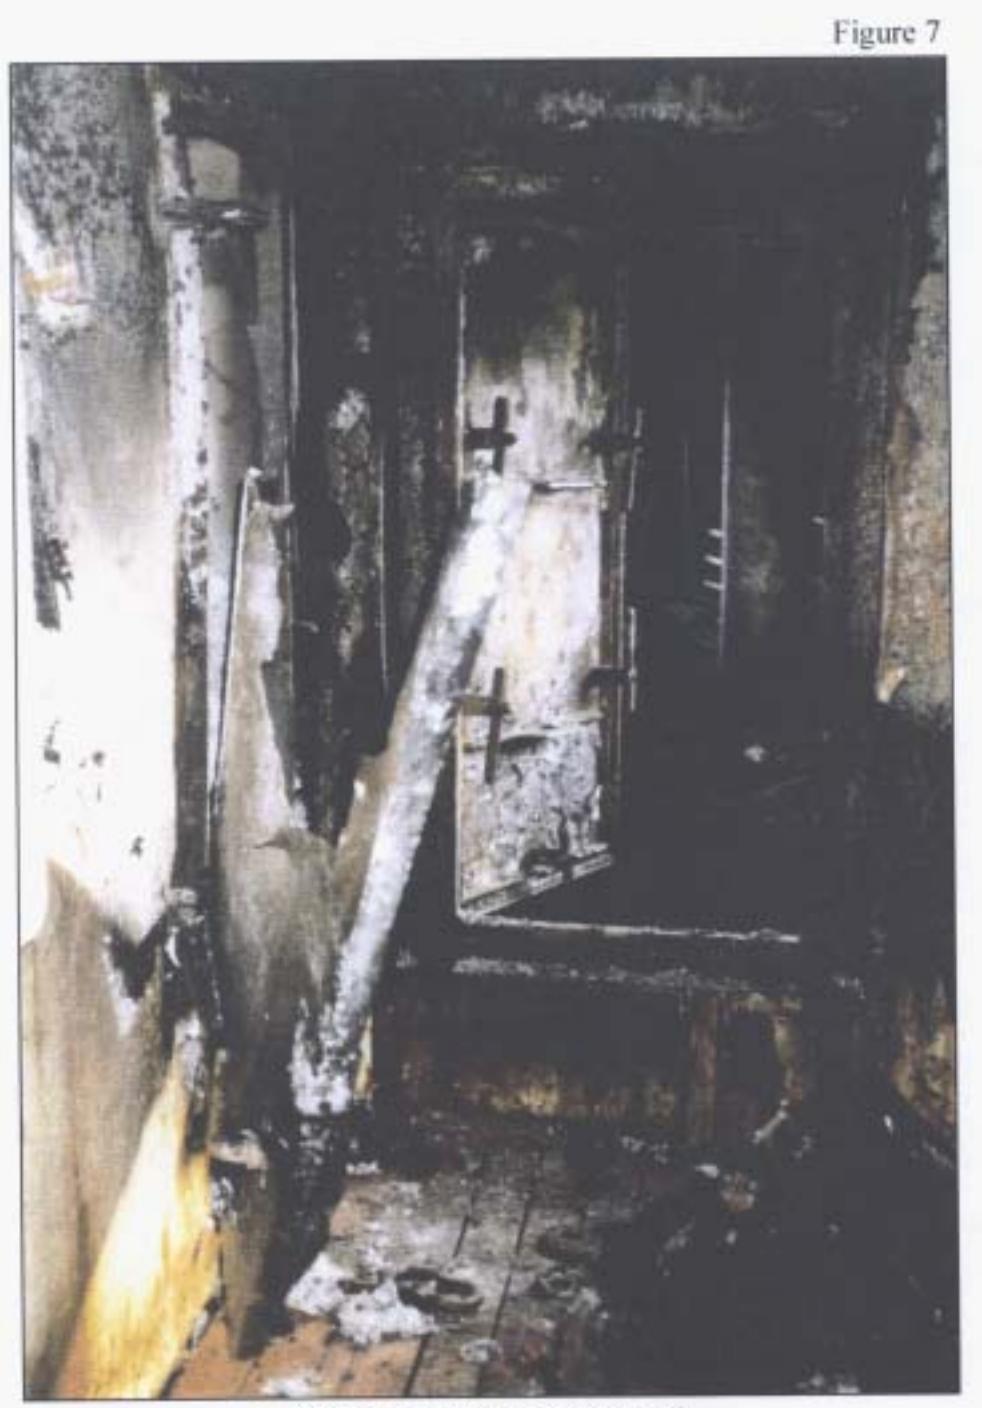
Main deck portside looking aft
