MAIB Safety Bulletin 1/2000

Foundering

## fv SOLWAY HARVESTER

with the loss of seven lives

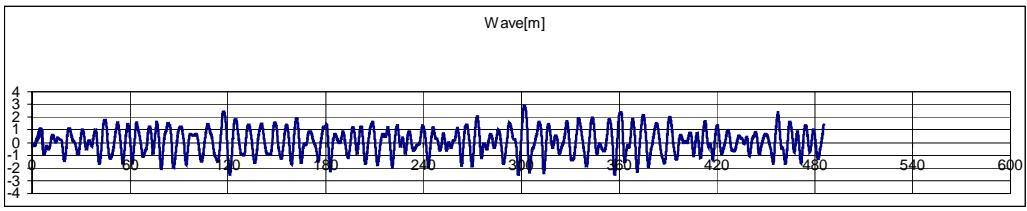
Figure A7.1 - Wave profile of run Rc12\_9

A large and steep wave at 300 seconds (Figure A7.1) caused rolling to exceed 25° (Figure A7.2), which initiated the cargo + spare gear shift. The cargo shifted over a period of 1.2 seconds, causing a heeling moment of 7.54tm. Resulting in an average heel of 20° to starboard, caused by asymmetric loading, water in the fish room, cargo + spare gear shift and flooding of the main deck, the winch space and the starboard passageway (after 360 seconds). Due to the large heel, more seawater accumulated on the working deck and in the winch space, causing the starboard passageway to flood at 360 seconds (Figure A7.4). Water drained from the working deck through the starboard open ice scuttle at an increasing rate. The average flow rate was approximately 0.8 tonne/min. By 450 seconds the amount of water in the fish room and bilge well had increased from 9.6 tonnes to 11.6 tonnes.

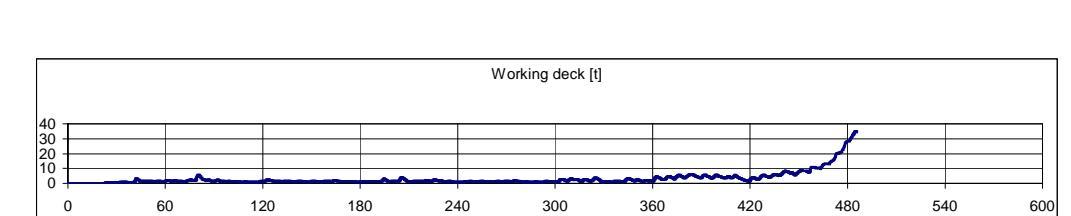
Figure A7.5 - Flooding of working deck, run Rc12\_9

There was no cargo shift. The vessel had a  $7 - 8^{\circ}$  starboard heel caused by the asymmetric loading and water in the fish room. There was constantly water on the working deck and in the winch space. On average there were 1.4 tonnes on the working deck (Figure A7.5) and 0.6 tonne in the winch space (Figure A7.3). The starboard passageway (Figure A7.4) was not flooded, although the watertight doors at the forward and aft end were both open. Water drained off from the working deck through the open ice scuttles (mainly on starboard side) at an average flow rate of 0.12 tonne/min. By 300 seconds the amount of water in the fish room and bilge well had increased from 9 tonnes to 9.6 tonnes.

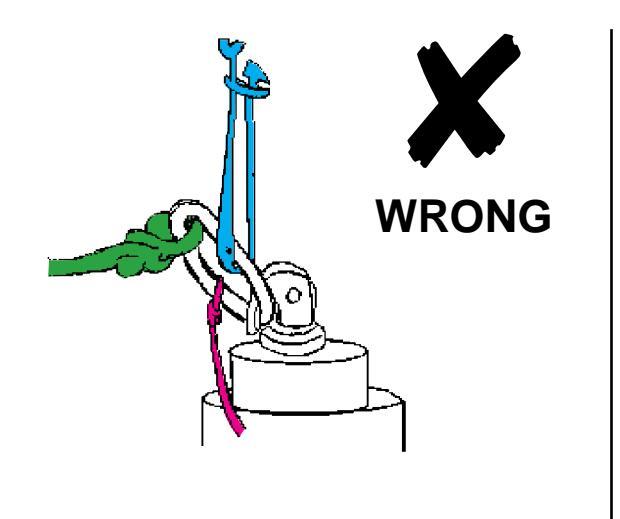
LIFERAFT WILL NOT RELEASE FROM CRADLE IF SHIP SINKS

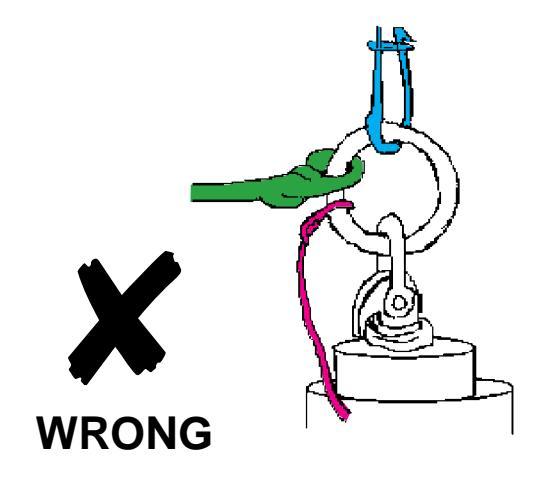
LIFERAFT WILL NOT RELEASE FROM CRADLE IF SHIP SINKS

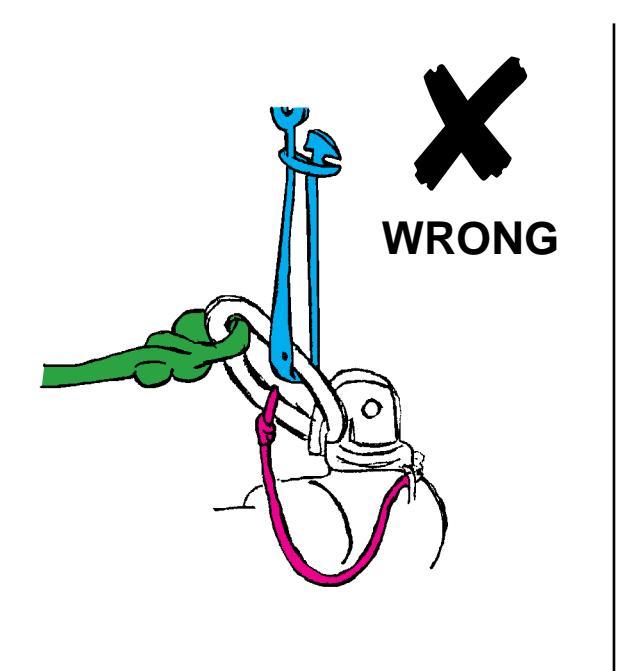
## LIFERAFT WILL NOT RELEASE FROM CRADLE IF THE VESSEL SINKS

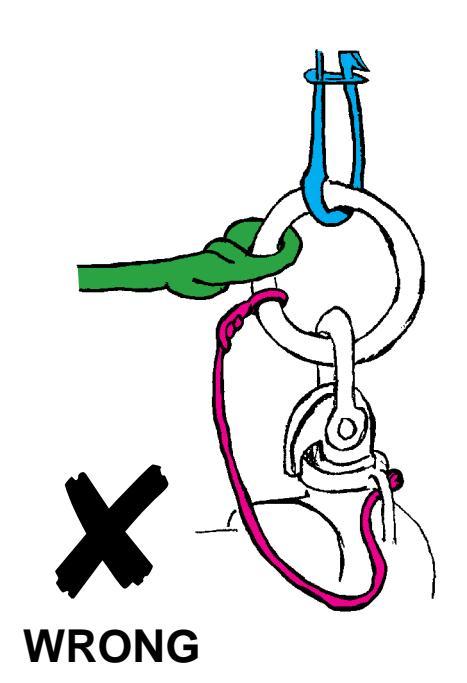
LIFERAFT WILL NOT RELEASE FROM CRADLE IF THE VESSEL SINKS

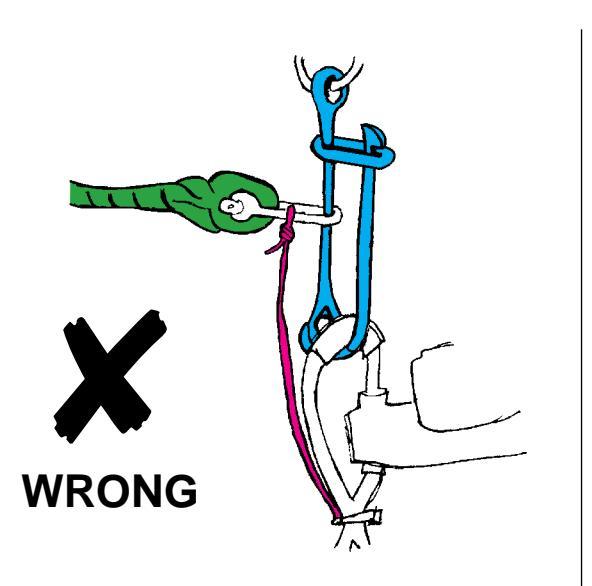
LIFERAFT WILL NOT RELEASE FROM CRADLE IF SHIP SINKS

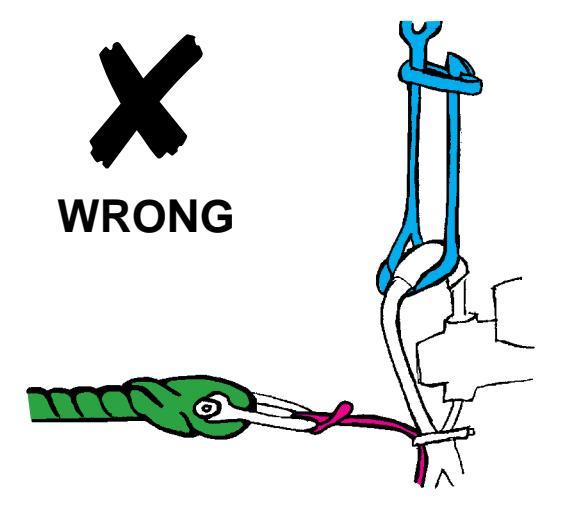
WILL WORK CORRECTLY ON AUTOMATIC RELEASE BUT THE LIFERAFT WILL ONLY BE SECURED BY THE WEAK LINK IF <u>THROWN OVERBOARD</u> - WEAK LINK MAY BREAK AND LIFERAFT WILL BE LOST

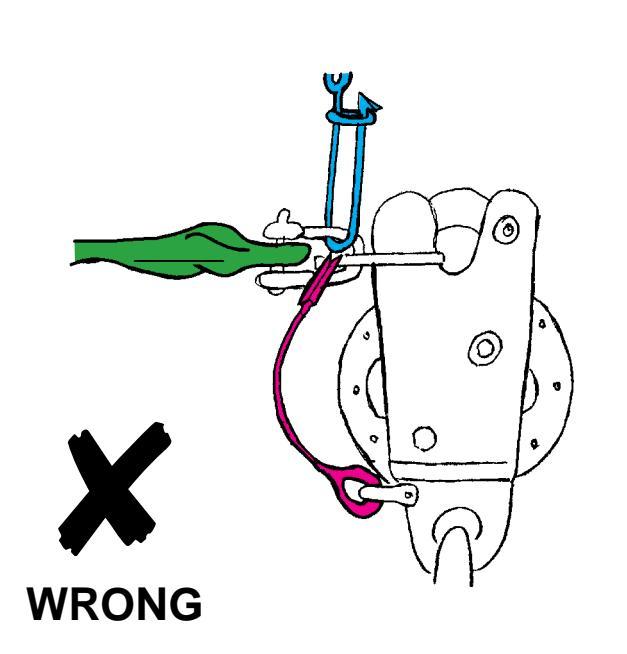
LIFERAFT WILL NOT RELEASE FROM CRADLE IF SHIP SINKS

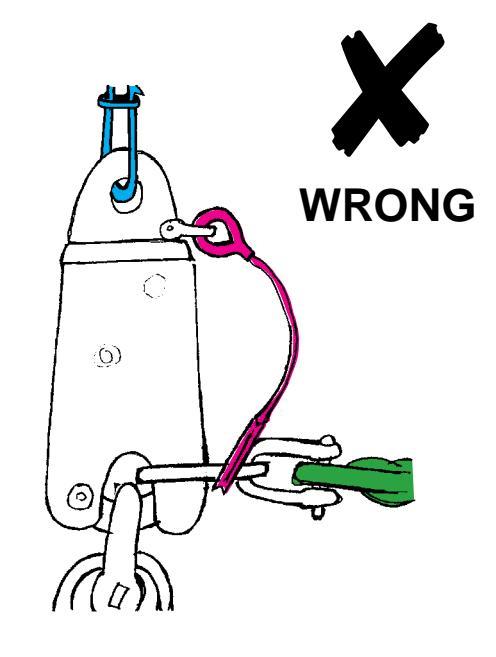
### MAY FOUL WHEN AUTOMATICALLY RELEASED
