Marine Accident Report 1/99

Report of the Inspector's Inquiry into the sinking of the Fishing Vessel

SAPPHIRE PD 285

with the loss of four lives on 1 October 1997

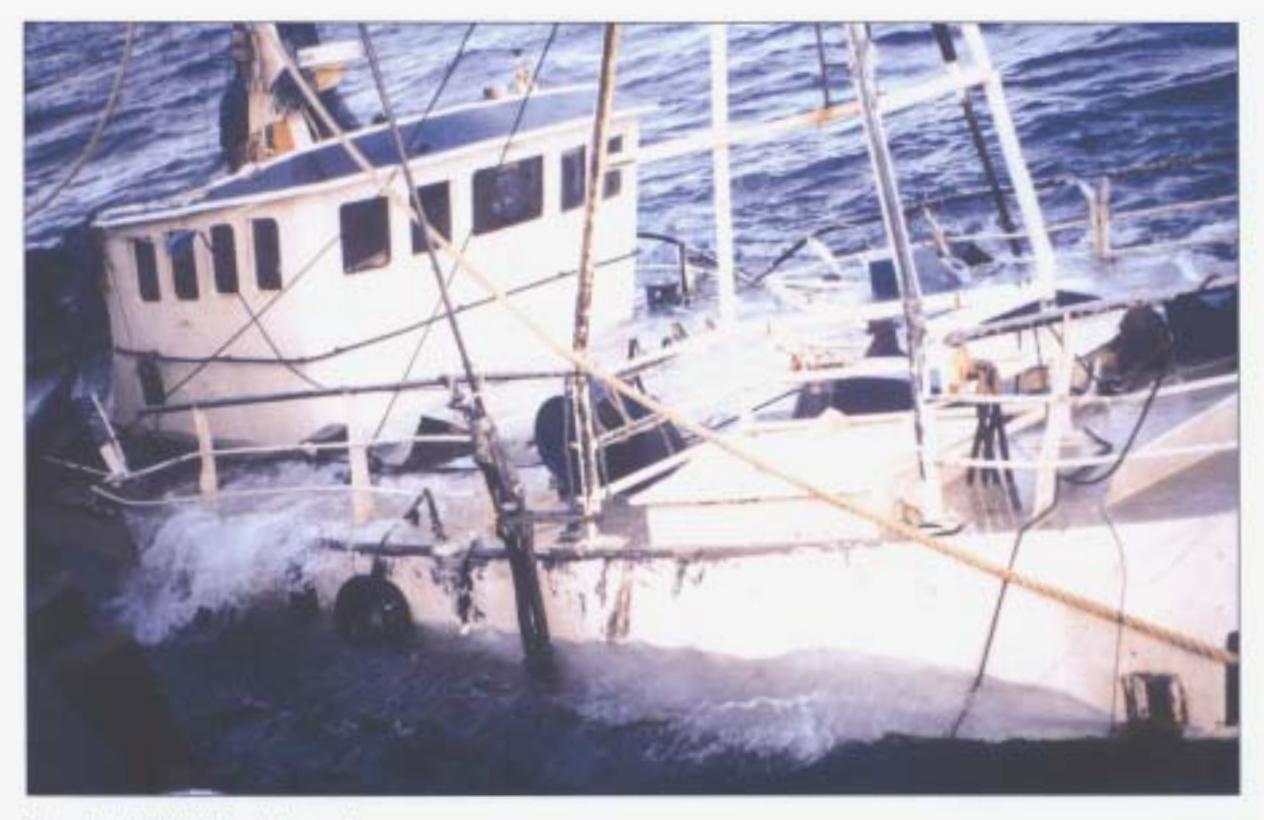
Figure 6: SAPPHIRE breaking surface

Because the ROV was used to handle and monitor the wires employed in the lifting operation, it was essential it remained in attendance at the wreck throughout all underwater operations. The ability to view and record all movements of the ROV via its on board camera linked to the surface, had the consequential advantage of allowing all surfaces of the wreck to be inspected at some stage. No damage or defect was seen on any underwater surface of the hull.

During the salvage some minor damage to the wreck occurred as follows: loss of foremast; damage to guard rails on the shelter; a puncture to the shelter on the starboard side; scarring to the starboard side of the wheelhouse top; loss of the starboard navigation light and the loss of several planks in the starboard bulwark. Apart from cosmetic damage to paint caused by wires during the salvage, there were no adverse effects to any part of the hull below main deck level.

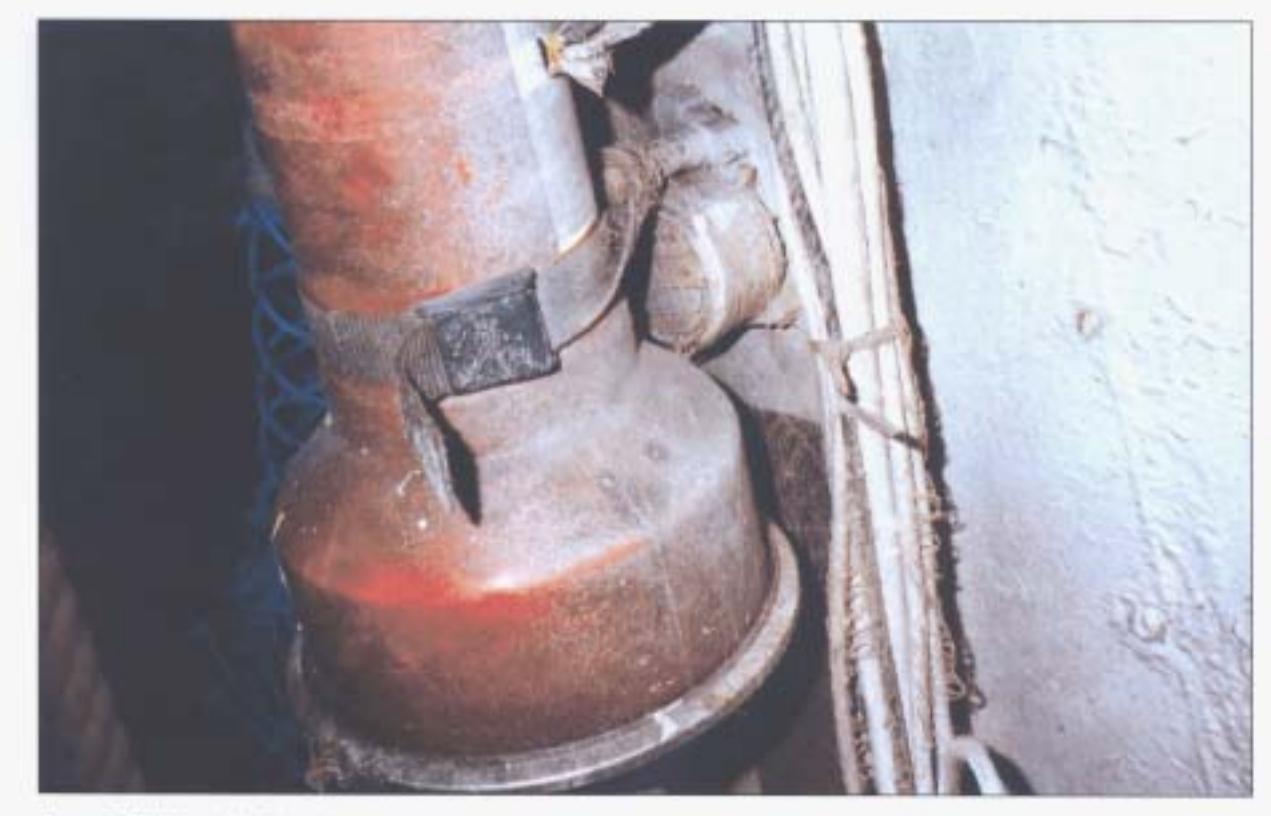
Figure 7: EPIRB and HRU on aft mast

The EPIRB was still in its mounting on the starboard side of the aft mast. Its Hydrostatic Release Unit (HRU) had activated but had not cut the plastic retaining bolt of the EPIRB's securing strap. The HRU's expiry date was marked as March 1997. The HRU was covered in white spray paint which obliterated the expiry date label and an instruction not to paint the unit.

The lens of the EPIRB's strobe light was also obliterated with white spray paint, as was much of the EPIRB's casing, including the label carrying details of the unit's battery replacement date (12/97).

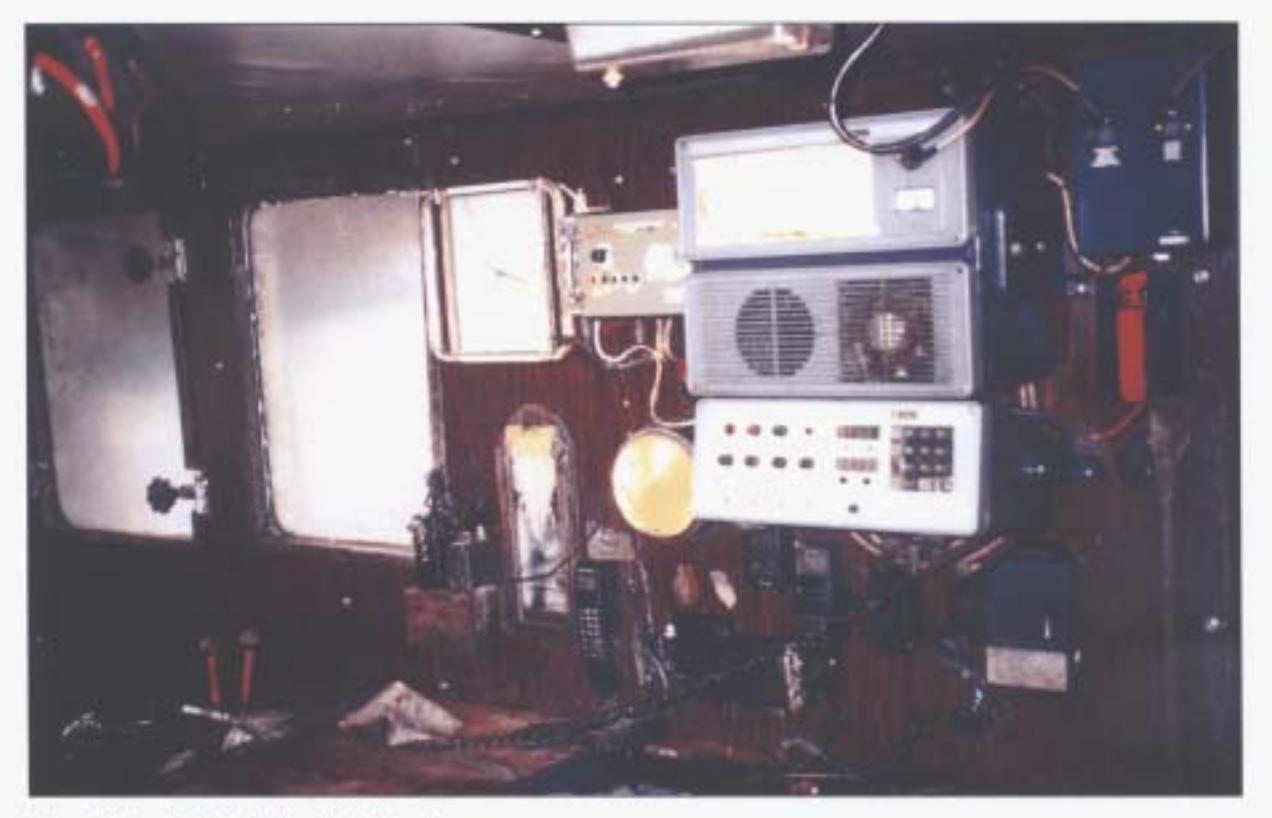
Figure 8: Chert table with clock left of centre

The analogue quartz clock above the chart table had stopped and indicated a time of **3.33** (Figure 8).

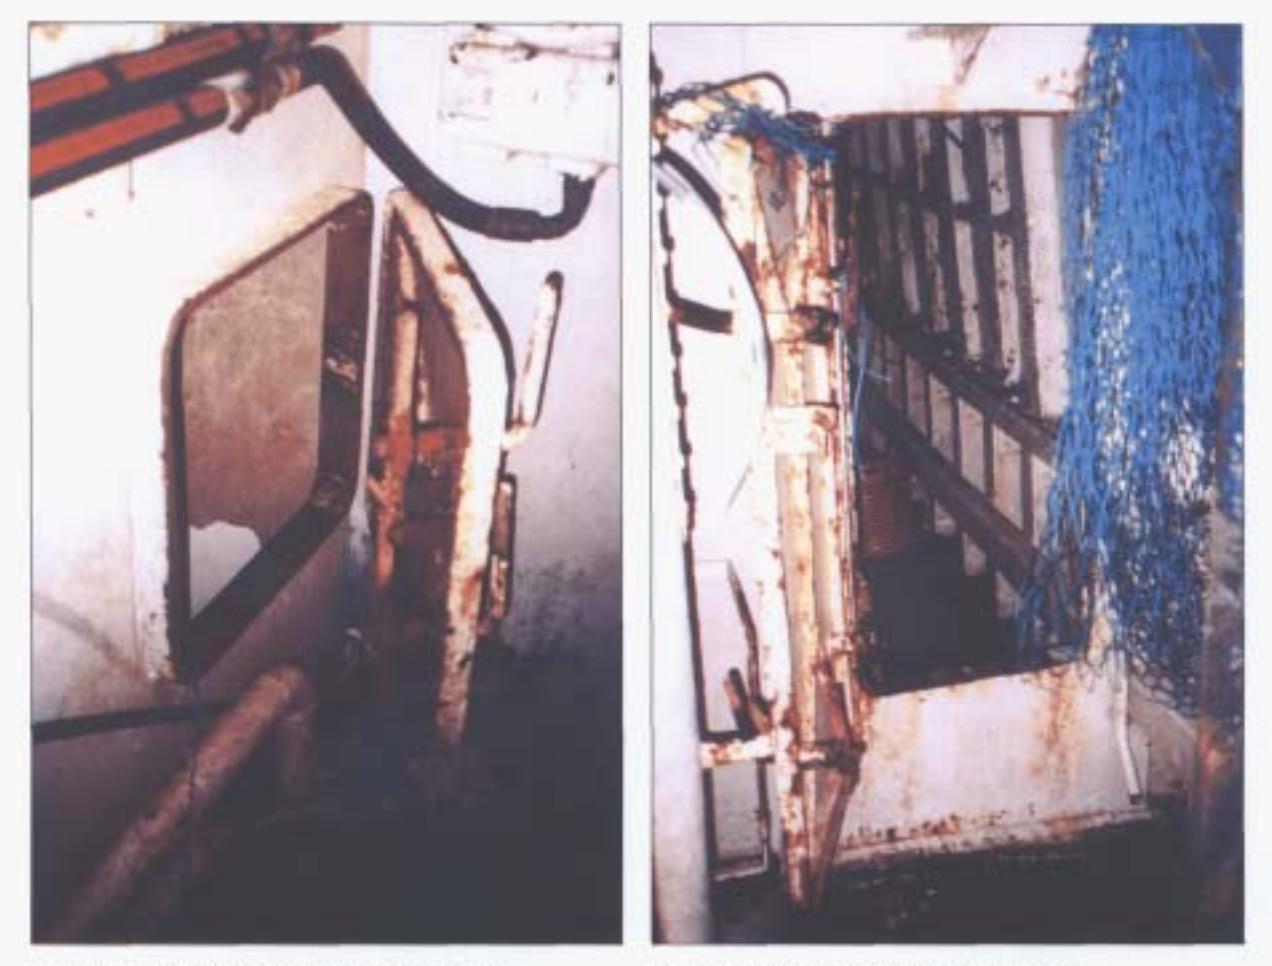
FIGURE 9: Engine room emergency escape hatch

The emergency escape hatch from the engine room was open. This had not been moved by salvors. The hinges were very stiff, as was the lower catch. There was corrosion and absence of paint on a small area of the hatch's upper edge where it made contact with an adjacent flexible hydraulic pipe. This contact was only possible with the door in the open position (Figure 9).

The weathertight door from the aft deck to the starboard passage was found secured in the open position. This door had not been moved by salvors (Figure 10).

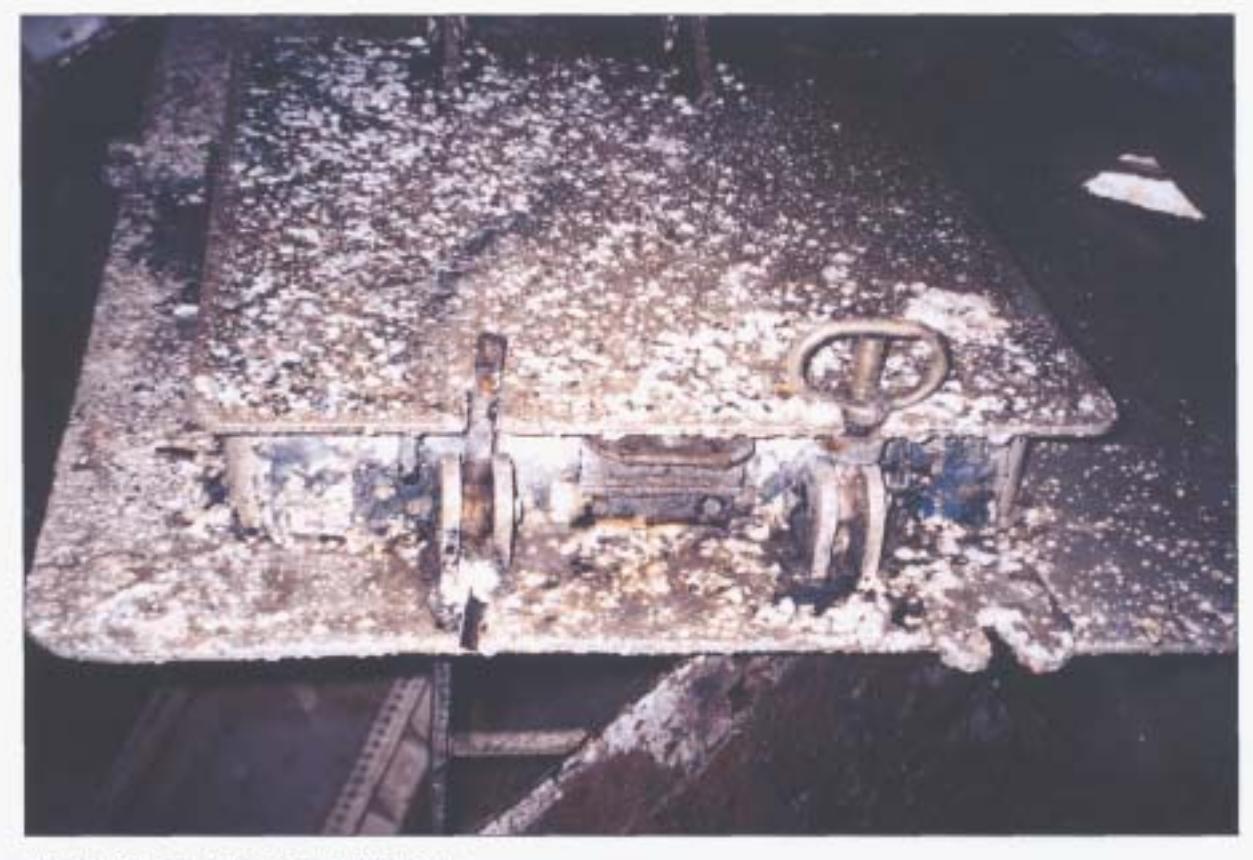
FIGURE 12: Main fish hatch cover (displaced)

The large cover to the main fish hatch was found displaced to starboard of its coaming by a distance approximately equal to the cover's width, about 1200mm. Securing toggles were in place on the coaming but were swung down. Neither cover nor toggles showed any signs of damage or distortion. This cover had not been intentionally disturbed during recovery (Figure 12).

The small hinged hatch cover, set within the main fish hold hatch cover, was in place and in the closed position. One toggle was in place securing this cover closed. The butterfly nut on the second toggle screw was missing.

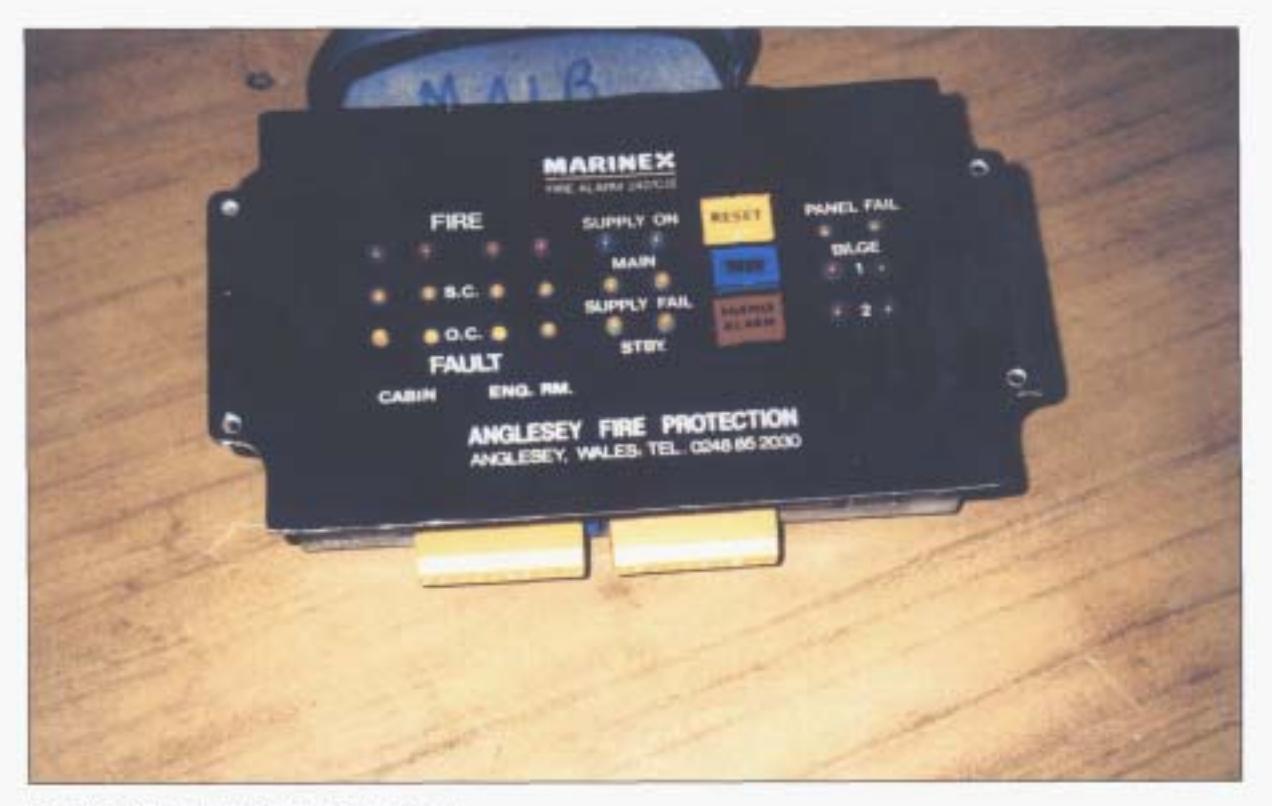
FIGURE 13: High-level bilge/fire alarm panel

The bilge alarm system served both the engine room and the fish hold, with float switches in each. Regulations required only that it served the engine room. This system had had a recent history of problems, extending intermittently over several months, and had required the services of electrical contractors.

Following the earlier on-board repair work, the control panel for these systems had, just prior to the vessel's loss, been removed by these contractors for repair in a workshop ashore. This unit had not been replaced, nor had a substitute system been fitted before Sapphire left Pkterhead on 29 September (Figure 13).
