Report of an investigation of lifting arrangement failure

ENAK / LOVELETTER

in Sunderland Docks on 9 May 1997 with loss of one life

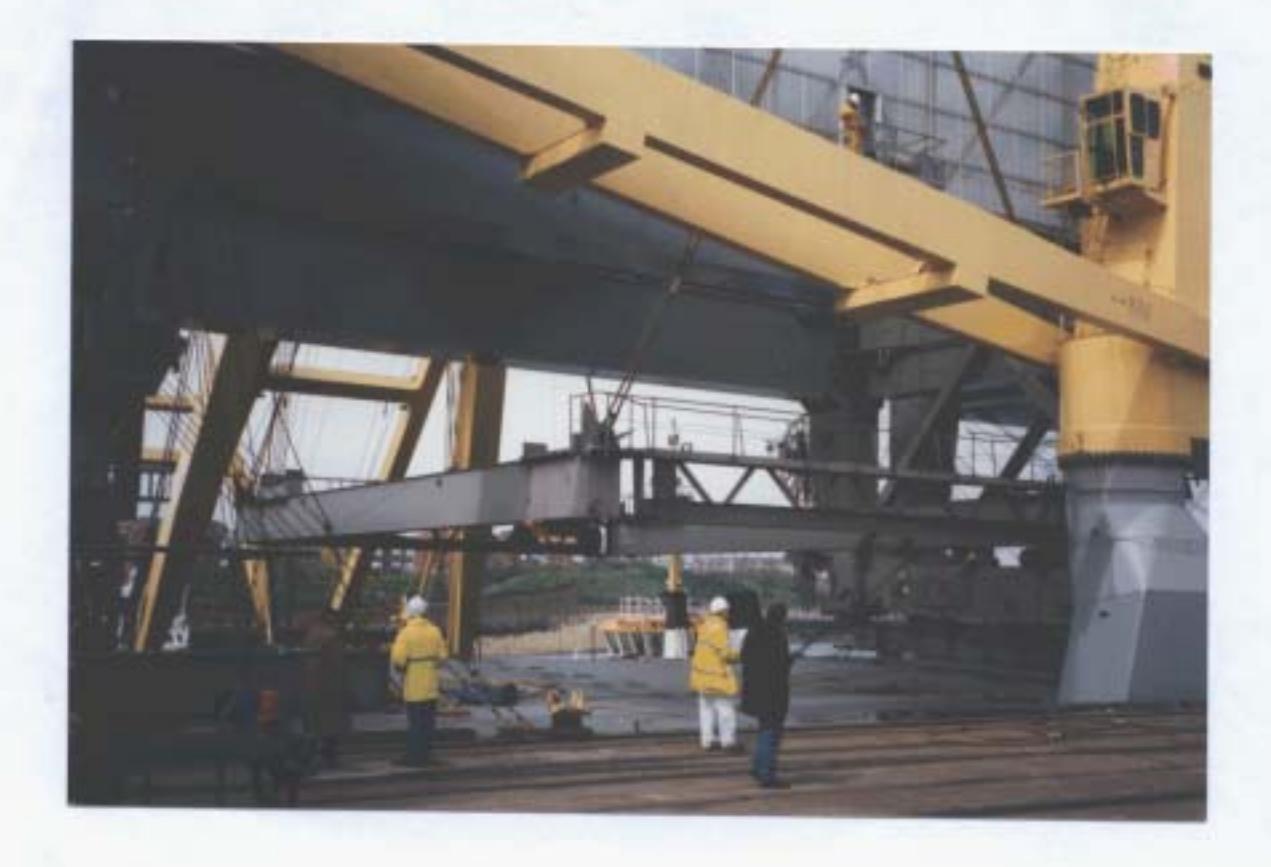
On 10 May 1997 the lifting frame on the forward gantry was removed and also transported to Liebherr Works, Sunderland. The procedure adopted for this operation was similar to that used the previous day, except that the 125t lifting eyes of the frame were used (see Figure 5).

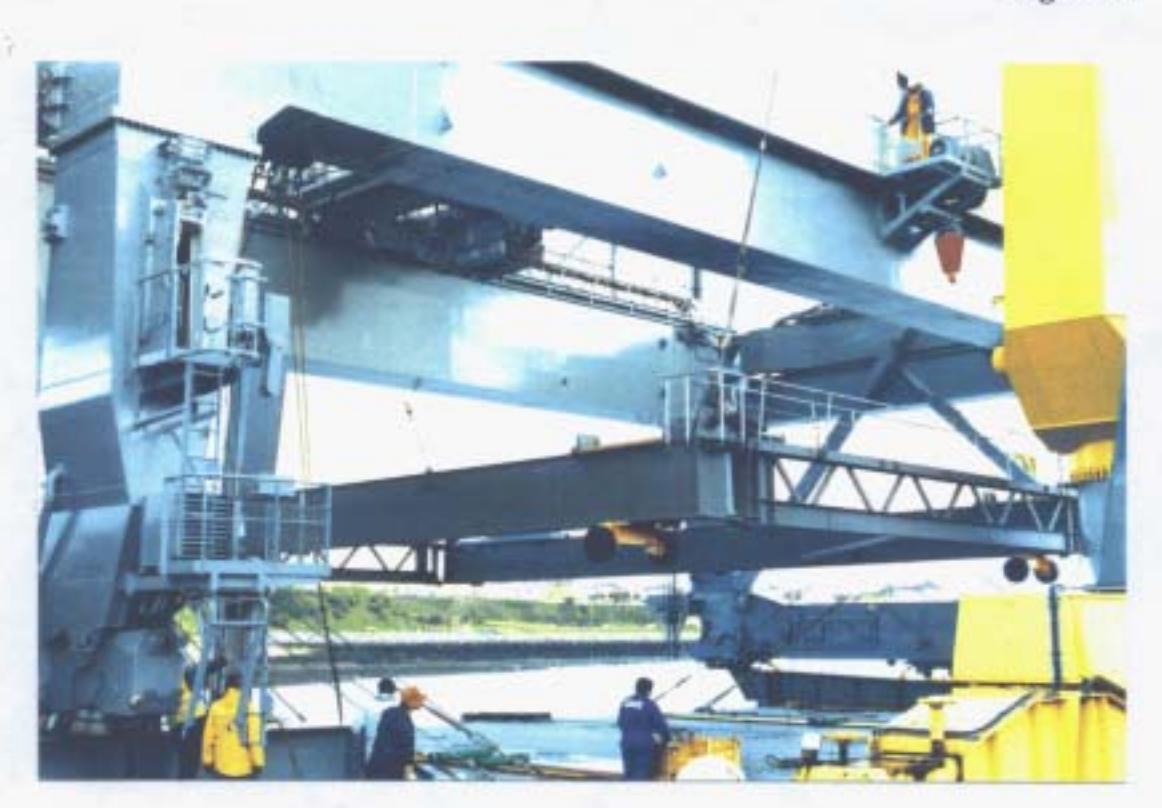
Figure 11

During the first set of frame removal operations in September 1995, the weight of each frame was taken on the designated 125tonne lifting brackets (Figure 11).

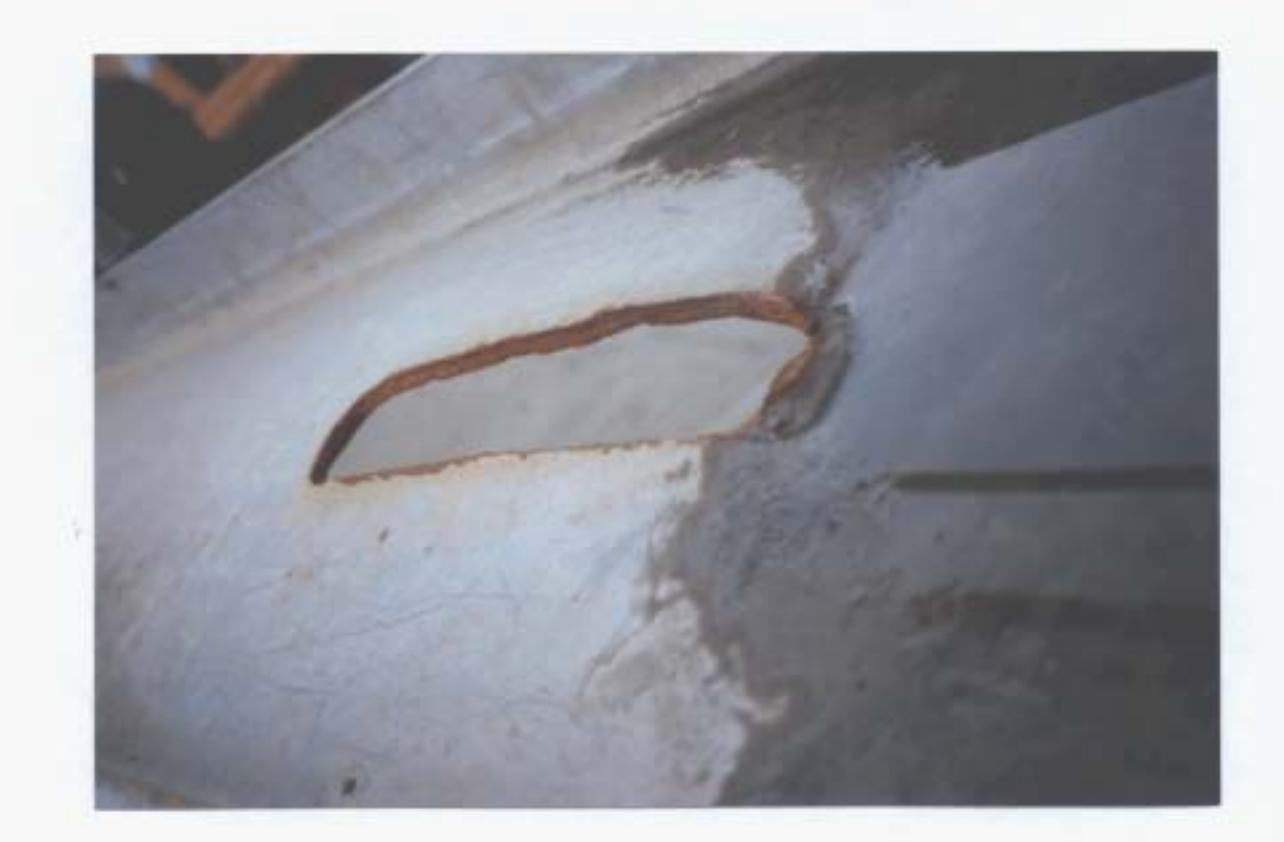
Figure 12

The damage to the starboard space frame girder consisted of rectangular tears at the strut stowage brackets, which had been torn away, having footprints slightly larger than the base sections of the brackets. The material of the girder's web surrounding these tears was deflected upwards approximately symmetrically (Figure 12).

A notable characteristic of the tears in the upper section of the starboard space frame, was the symmetrical upward deflection of the material surrounding each tear, indicating that any transverse component of loading was small. Failure was thus due to vertical and longitudinal components of forces.

It is therefore concluded that the starboard brackets fractured due to an applied load, through the lifting slings and shackles. This load was probably in excess of that due to the frame's weight alone. The integrity of the brackets may have been compromised by overloading on previous occasions.

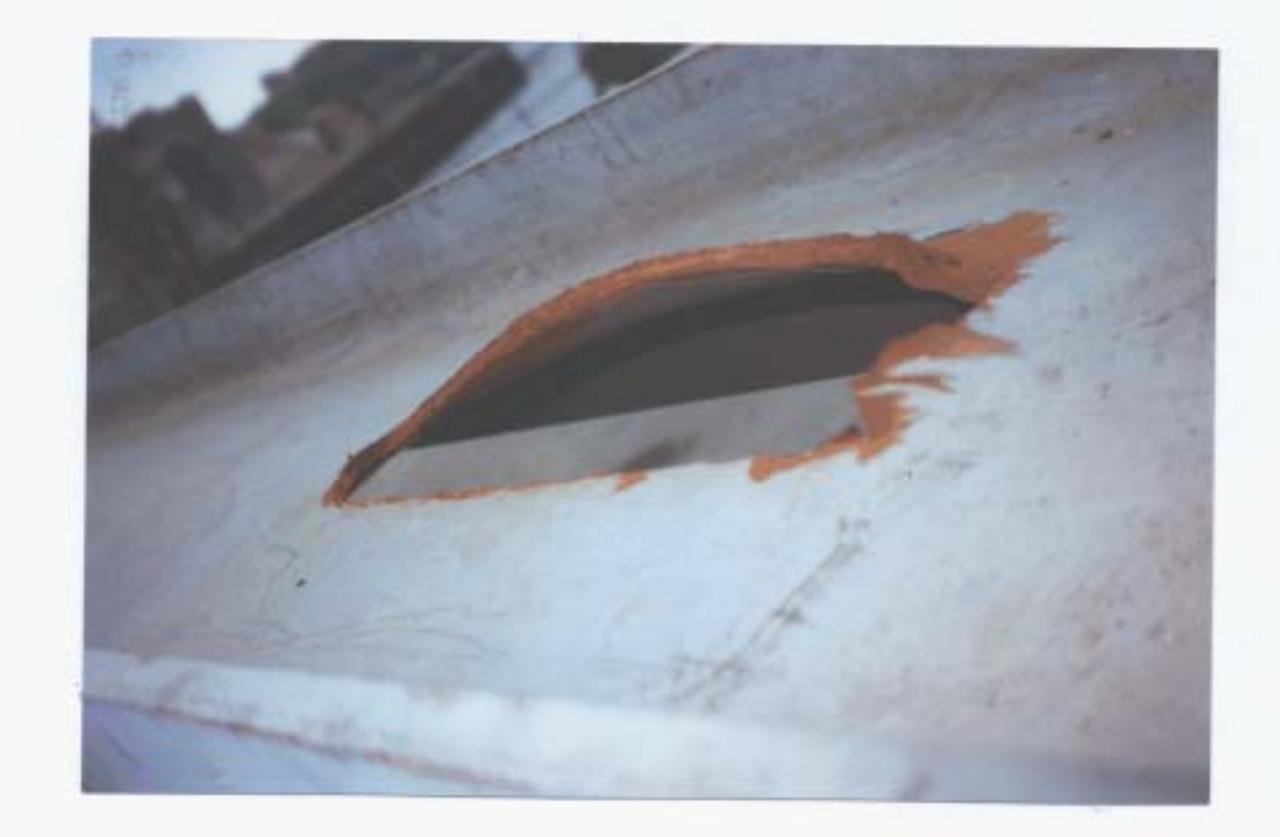
The damage to the port space frame was very similar, except that the girder web material surrounding the tears was not deflected symmetrically. In each case the material to the port side of the tear was highest (Figure 13).

The tears in the upper section of the port space frame, in way of the brackets, had their port edges significantly higher than their starboard edges. This is interpreted as indicating failure being due to a load having a significant transverse component, which the brackets were not designed to withstand. This load was generated by the frame sliding to starboard while the port side slings and shackles remained attached, after the failure of the starboard brackets. This interpretation is again consistent with witness evidence.

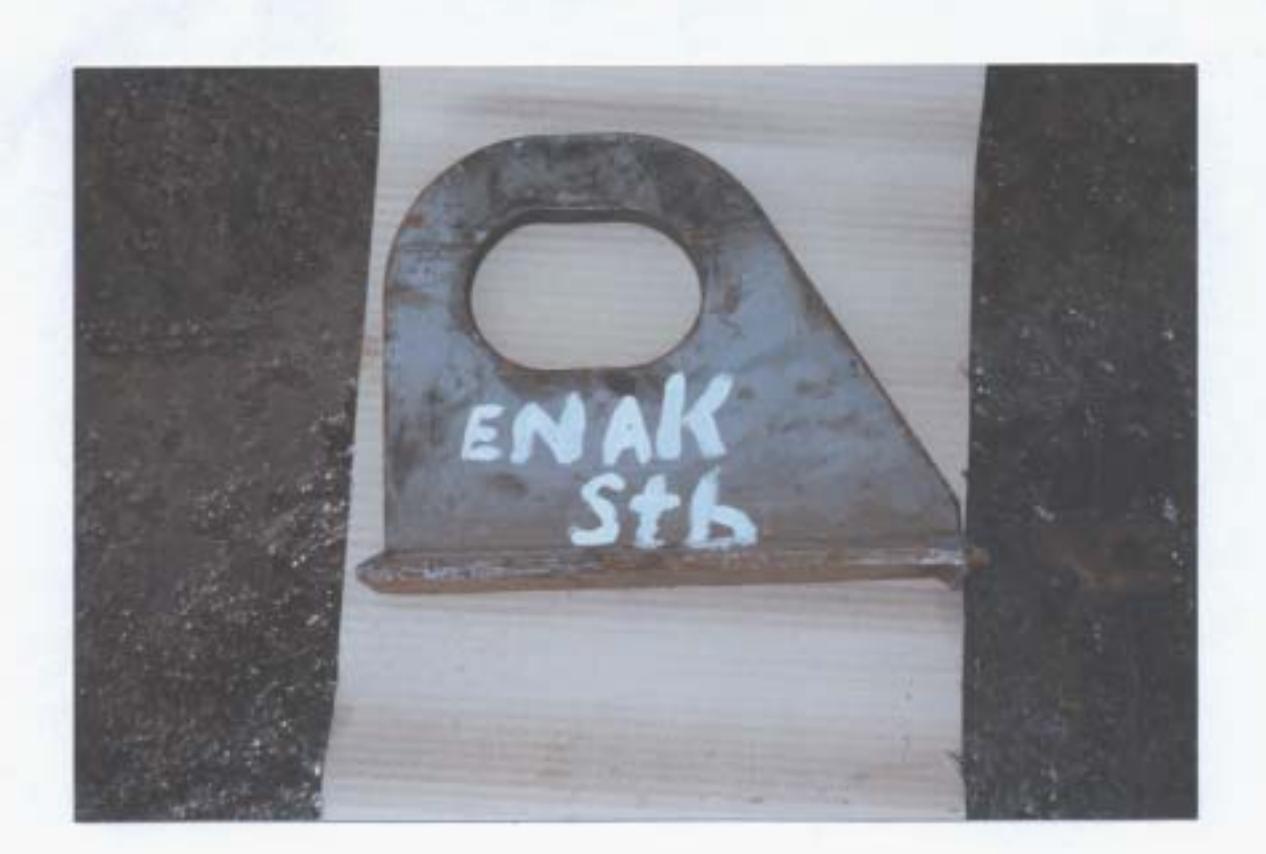
The material which had been torn from the girder, still welded to the bracket was attached to the base of each bracket (Figure 14).

Macroscopic examination of the failed brackets, which had been on ENAK's side of the aft lifting frame or starboard side of LOVE LETTER, showed they had been subjected to overloads on successive occasions, and that failure propagated from the vertical edge of each bracket.

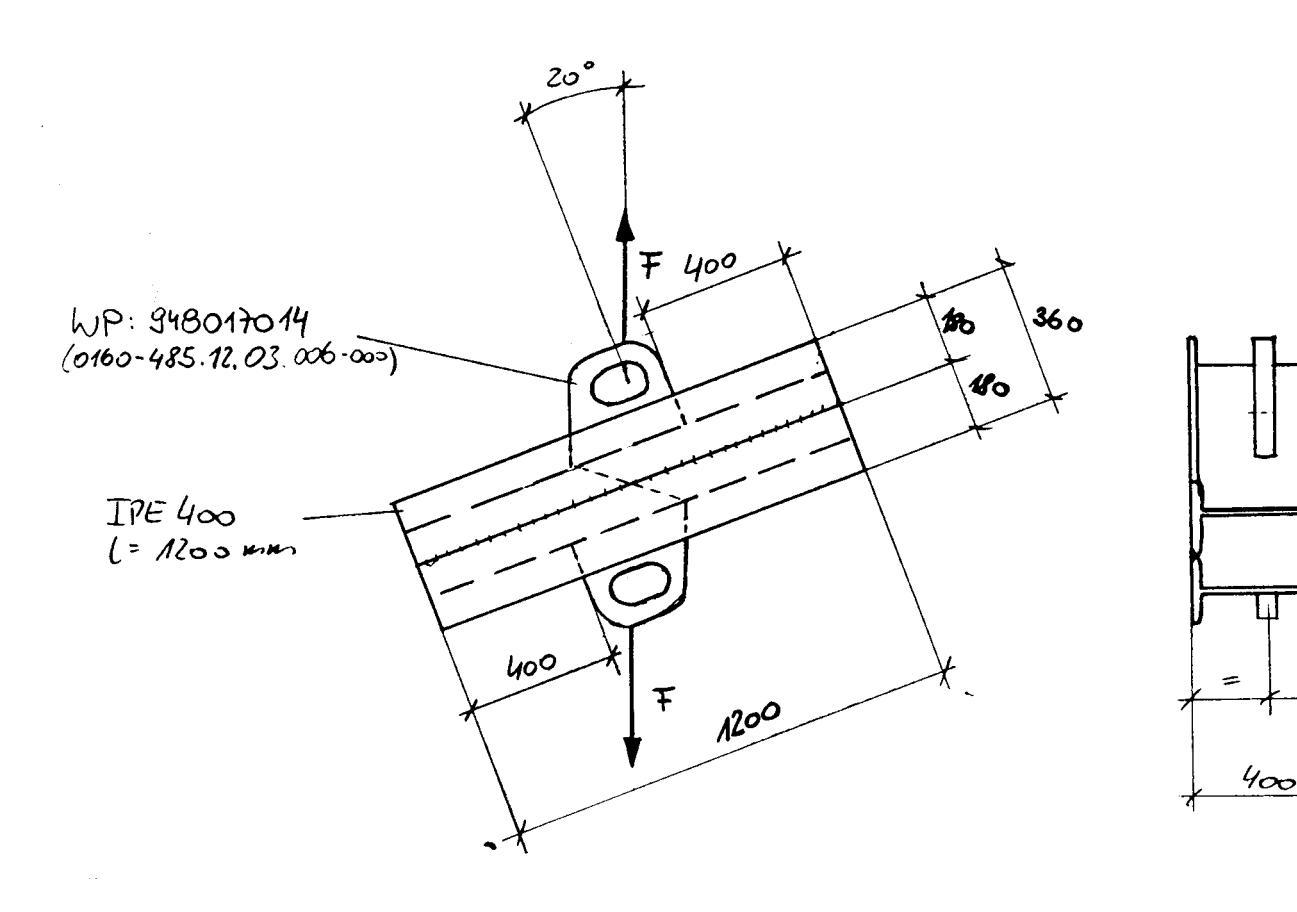
Figure 15

A pair of brackets, of similar design, material and manufacture, were subjected to a tensile test at the National Material Testing Station, Stuttgart University. Each bracket was welded to a length of 'I' section girder which were then welded together 'back to back'. Loads applied to each bracket produced a force system similar to that considered to have been applied to the first pair of brackets which failed on 9 May 1997. The applied test forces had a line of action 70° above the axis of the girder sections (Figure 15).

Breaking Load - 537kN Load when deformation first observed - 300kN Fracture behaviour - comparable to original bracket

Tensile tests, performed at Stuttgart University, attempted to replicate the loading of the brackets at the time of failure on 9 May. Applying load at the angle of the slings used that day, 20° to the vertical, the loading geometry is considered to be a reasonable representation of that applicable at the time. The test results indicate that deformation occurred at a load of about 30tonne; giving a vertical component of this load as 28.2tonne. Failure due to fracture occurred at 54.74tonne; with a vertical component of 51.4 tonne.

With each lifting frame weighing 40.5tonne, the nominal load taken by each of the four brackets would be approximately 10tonne. Comparing this to the weight at which the test bracket failed, 28.2tonne, indicates that a factor of safety was present, if the brackets had been designated as lifting points. This comparison also shows that the brackets had previously been subjected to loads greater than that which would have been imposed by the weight of the frames alone.
