Report on the investigation of the collision
between the container ship ***Ever Smart***
and the oil tanker ***Alexandra 1***

Jebel Ali, United Arab Emirates

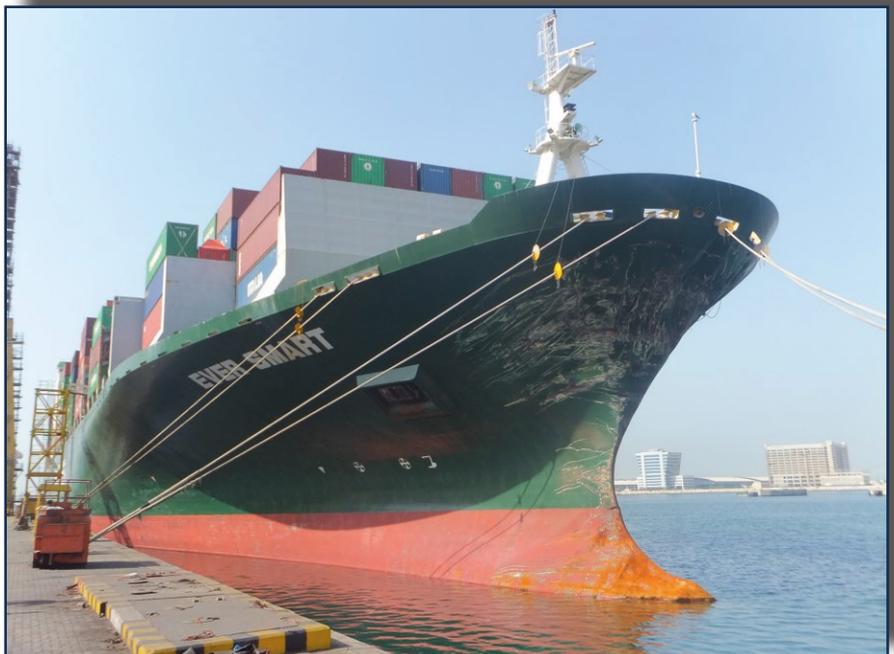
Extract from
The United Kingdom Merchant Shipping
(Accident Reporting and Investigation)
Regulations 2012 – Regulation 5:

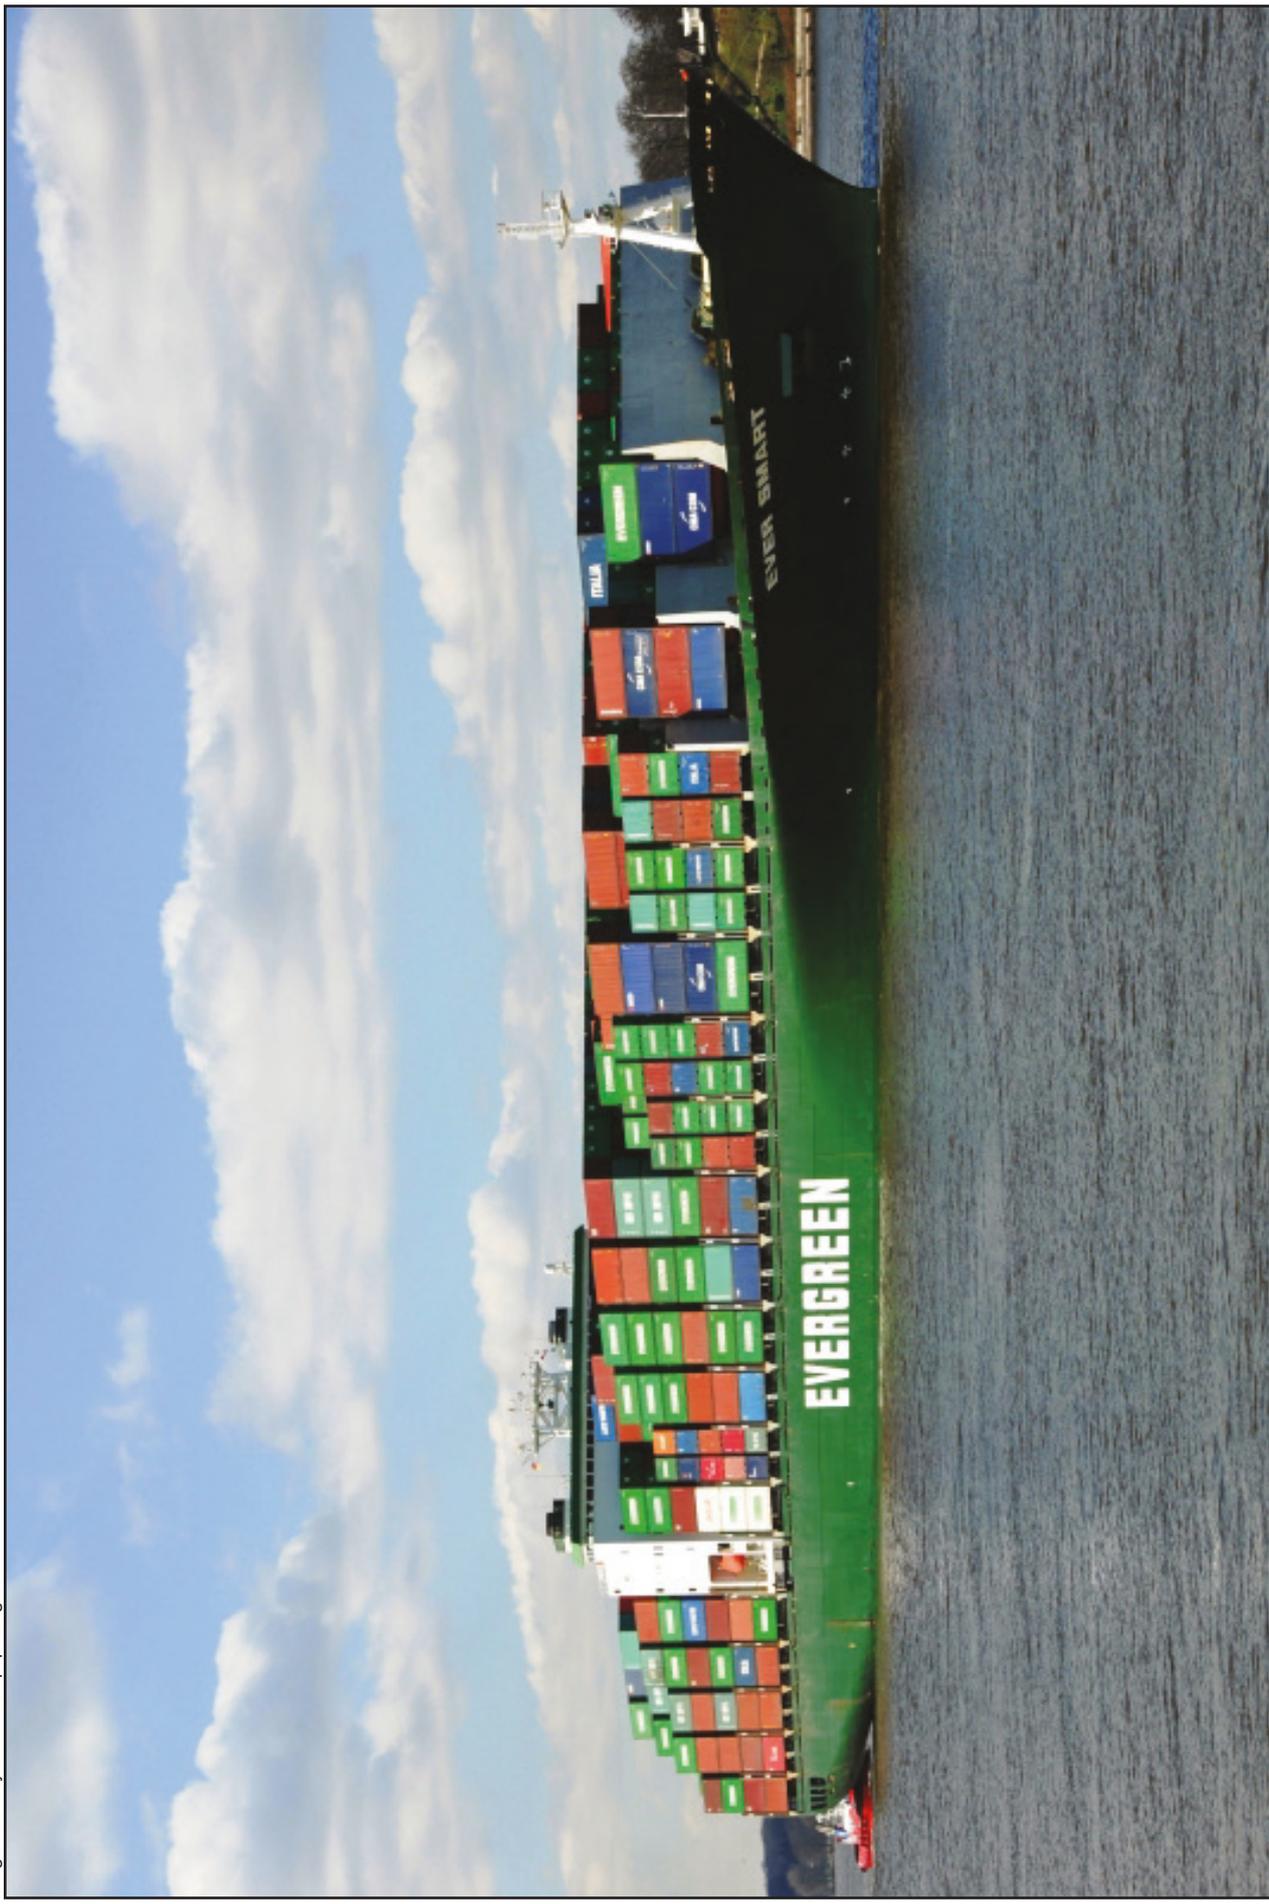
MARINE CASUALTY INFORMATION		
Date and time	11 February 2015 1942 UTC	
Type of marine casualty or incident	Serious Marine Casualty	
Location of incident	Jebel Ali, United Arab Emirates	
Vessel's name	<i>Ever Smart</i>	<i>Alexandra 1</i>
Place on board	Bow/forecastle deck	Bow/forecastle deck
Injuries/fatalities	None	None
Damage/environmental impact	Bow severely distorted and penetrated.	Bow and forecastle deck severely damaged.
Ship operation	On passage	On passage
Voyage segment	Transit	Transit
External & internal environment	Wind: 068° at 6 knots. It was dark with clear skies and good visibility. The sea was calm with a low swell. The tidal stream was south-easterly at less than 1 knot.	
Persons on board	21	28

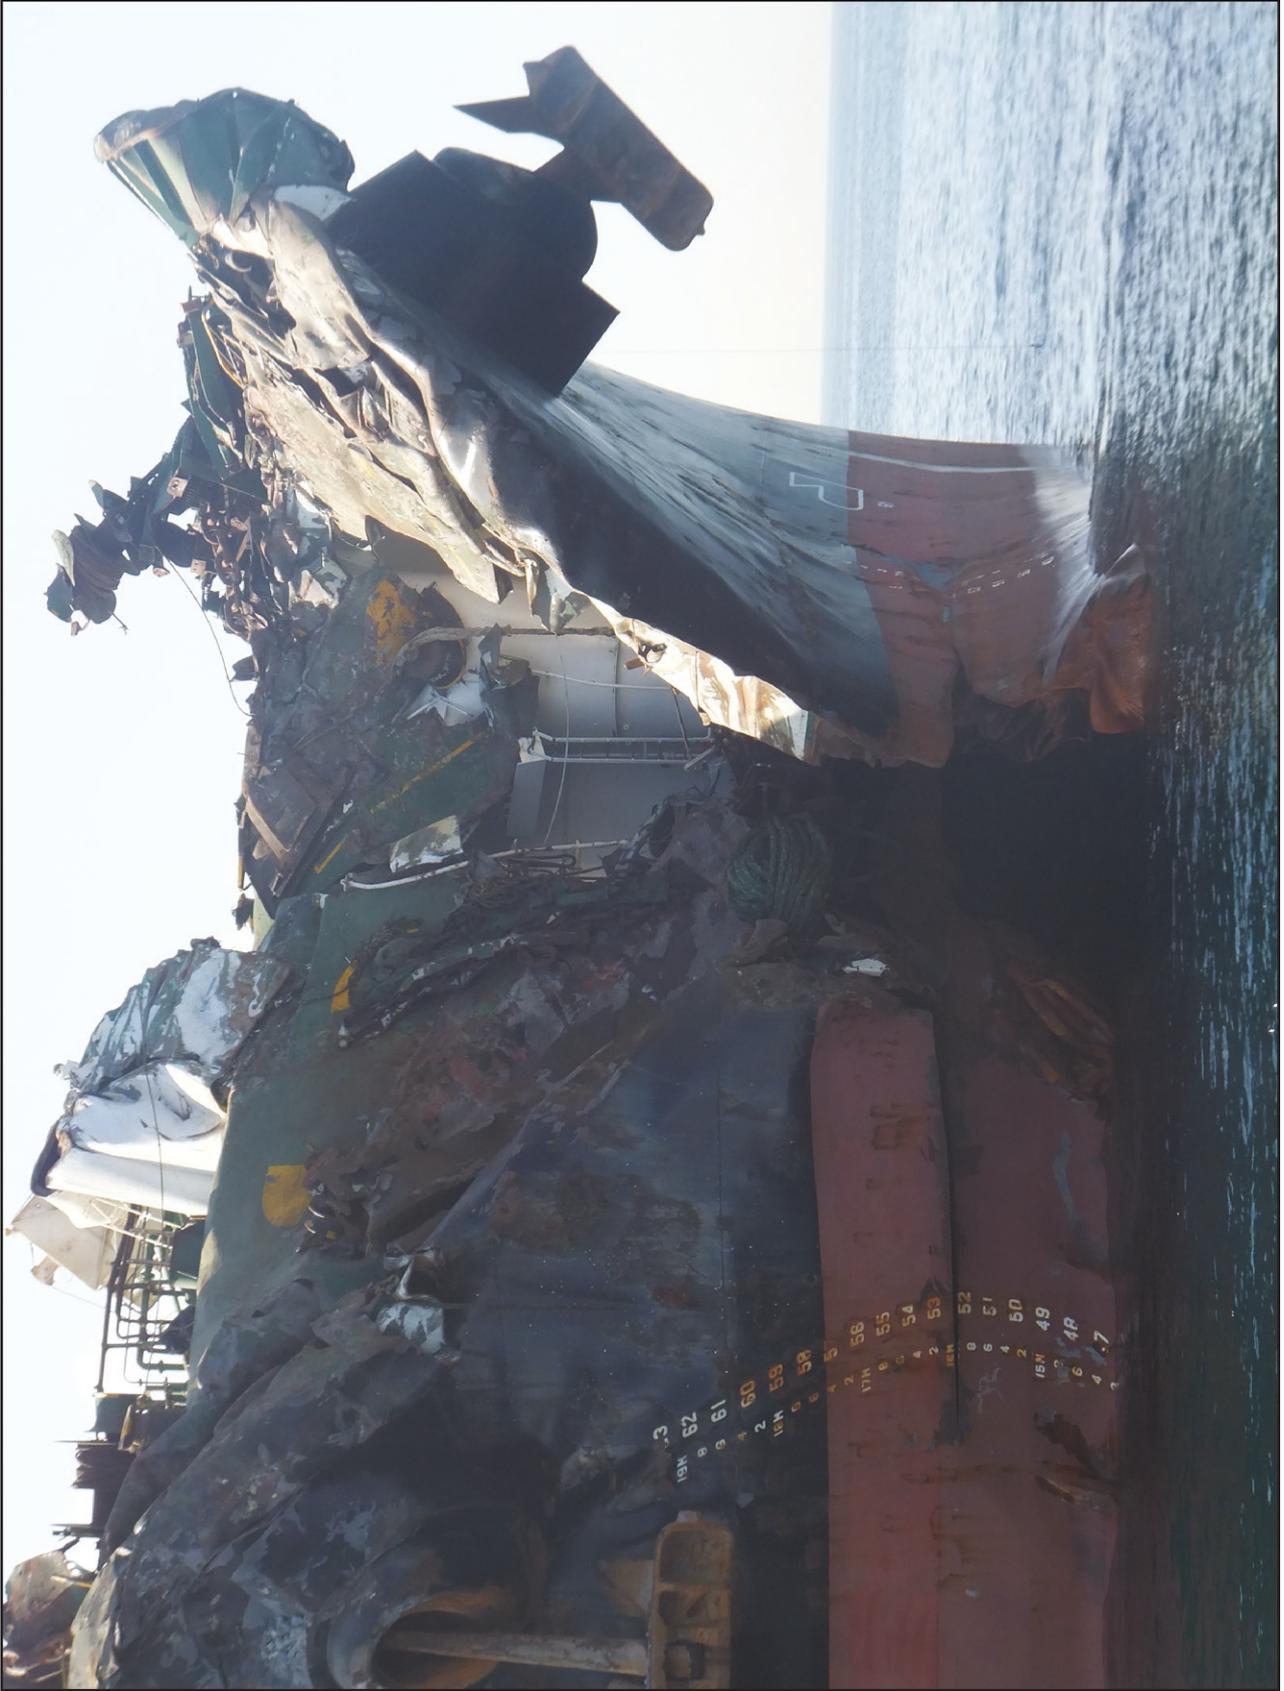
Figure 12: Alexandria 1's damaged bow

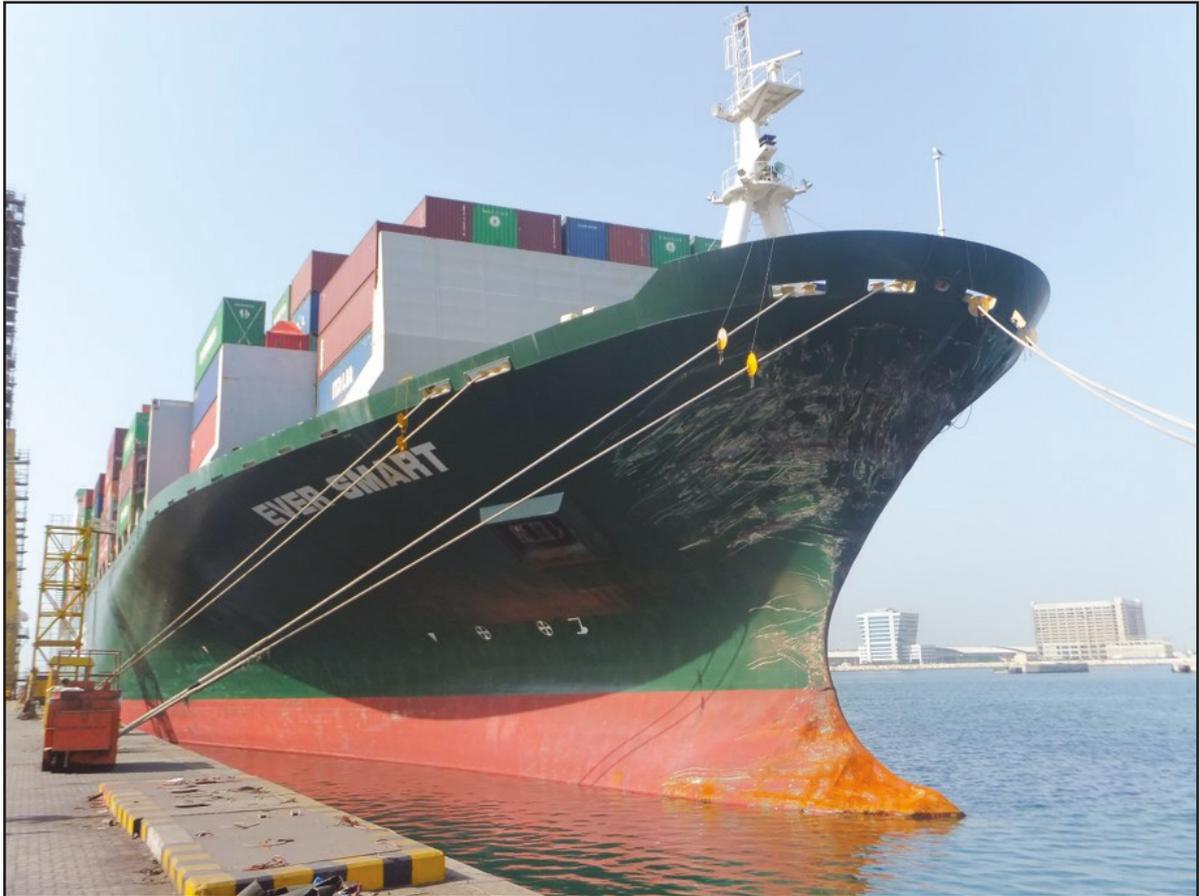
Figure 13: *Ever Smart's* damaged bow

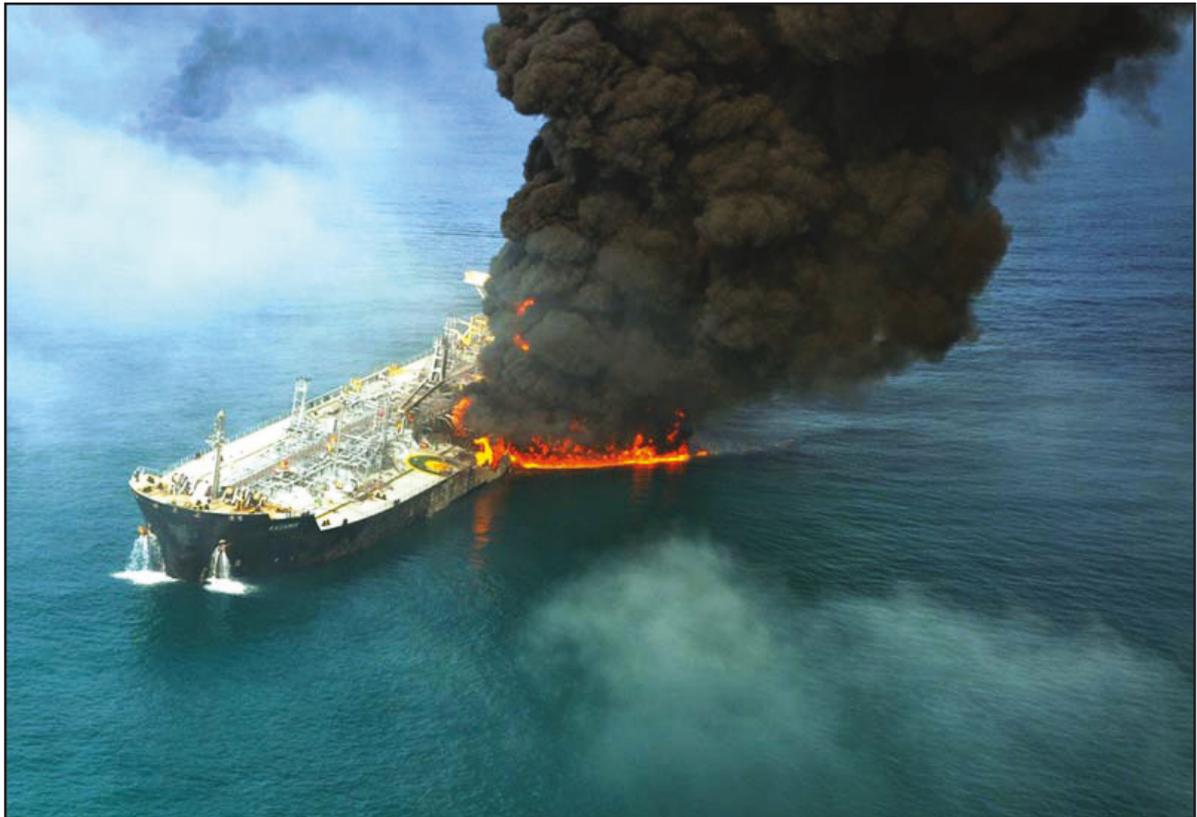
Figure 14: *Kashmir* on fire in the Jebel Ali approach channel
