AAIB Bulletin: 7/2016	G-OCRZ	EW/G2016/04/05
ACCIDENT		
Aircraft Type and Registration:	CZAW SportCruiser, G-OCRZ	
No & Type of Engines:	1 Rotax 912 ULS piston engine	
Year of Manufacture:	2008 (Serial no: PFA 338-14668)	
Date & Time (UTC):	13 April 2016 at 1225 hrs	
Location:	Firs Farm, Newbury, Berkshire	
Type of Flight:	Private	
Persons on Board:	Crew - 1	Passengers - None
Injuries:	Crew - None	Passengers - N/A
Nature of Damage:	Nose leg detached, left main landing gear damaged and propeller destroyed	
Commander's Licence:	Light Aircraft Pilot's Licence	
Commander's Age:	76 years	
Commander's Flying Experience:	518 hours (of which 102 were on type) Last 90 days - 2 hours Last 28 days - 1 hour	
Information Source:	Aircraft Accident Report Form submitted by the pilot

Synopsis

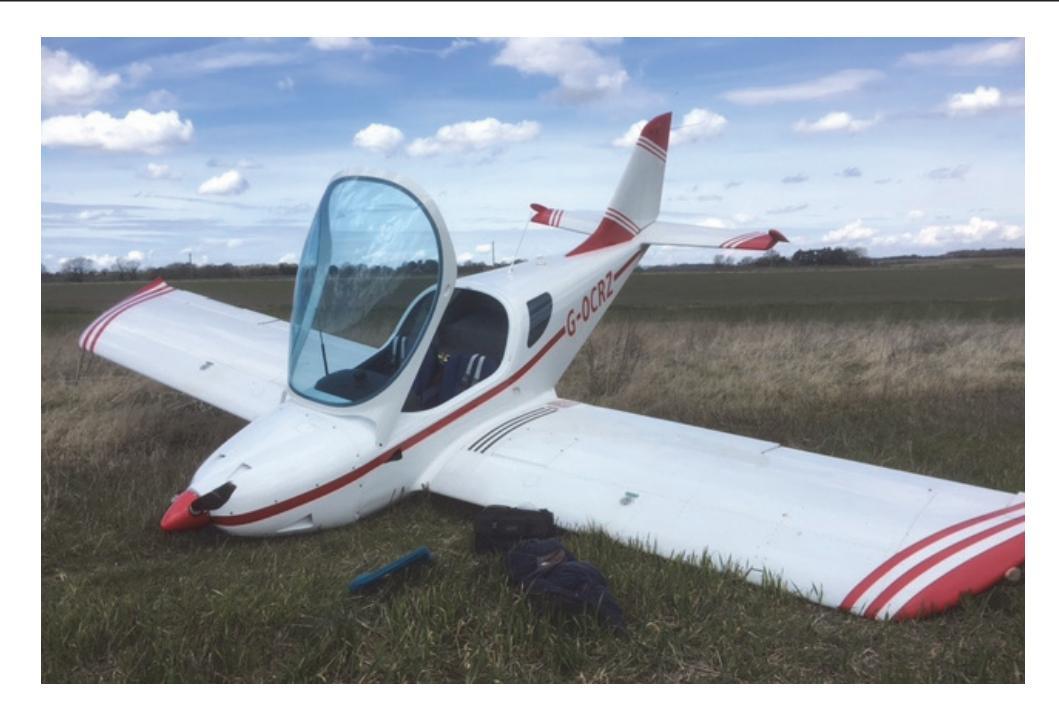
The pilot misidentified the runway and flew an approach to an adjacent, visually distinct but uncultivated strip of rough ground. He realised his mistake on touchdown, when the nose leg collapsed and the propeller struck the ground. The aircraft came to a halt nose-down and left wing low but the pilot vacated without difficulty.

The nose leg immediately collapsed and detached, and the propeller struck the ground. As the aircraft slowed, the left main landing gear collapsed and the aircraft came to a halt with its nose and left wing resting on the ground (Figure 1). The pilot turned the master switch OFF and vacated the aircraft without difficulty.

Figure 1 G-OCRZ after the landing accident

The pilot was amazed that he had misidentified the runway in good weather and without any distraction. He noted the runway was a similar colour to the adjacent green crop on the north side, while the rough strip on the south side was a contrasting, yellowish colour, shaped like a runway. At first sight it looked like a runway, so, even though he had prior knowledge of its existence, he accepted it was the runway. During the circuit and approach the pilot concentrated on making a smooth landing and had no reason to query the strip for which he was aiming. He did not spot the real runway to the right of his approach path because he was not expecting to see it there; an error which he later recognised as confirmation bias¹.

White markers are now in place to make the runway outline more obvious to approaching aircraft.
