Back Analysis of Previous Constructed Low Volume Rural Roads in Mozambique

AFCAP/MOZ/001/G Final Report CPR1612

June 2013

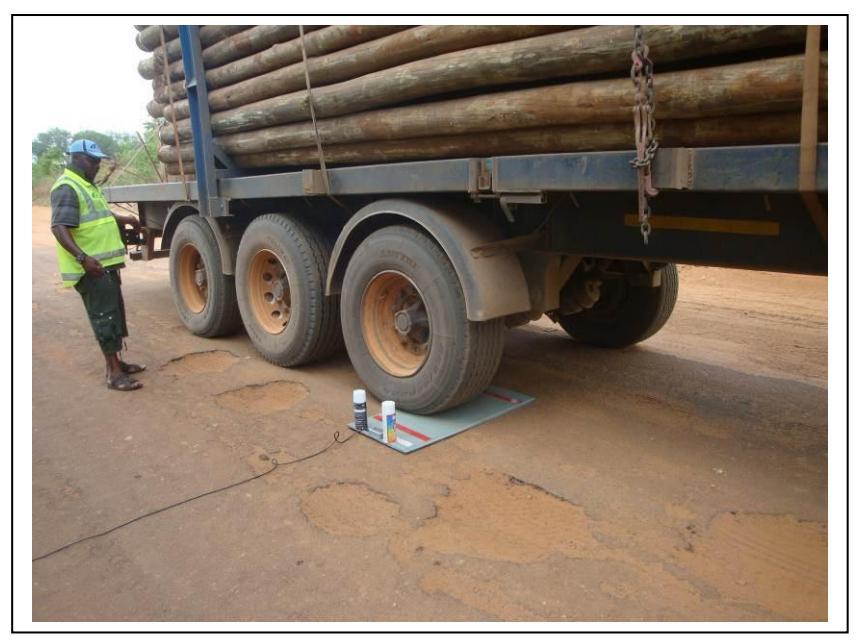
Figure 4-1 Axle load survey – heavily loaded truck with single tandem axles

It is possible that such overloading, and the resulting high wheel loads, could have devastating effects on the performance of the low-volume roads where low strength or marginal materials and thin surfacings may have been used. The damage by a single truck can be significant leading to premature failure even at low traffic volumes. Figure 4-1 shows an overloaded truck on a low-volume road with single tandem axles.

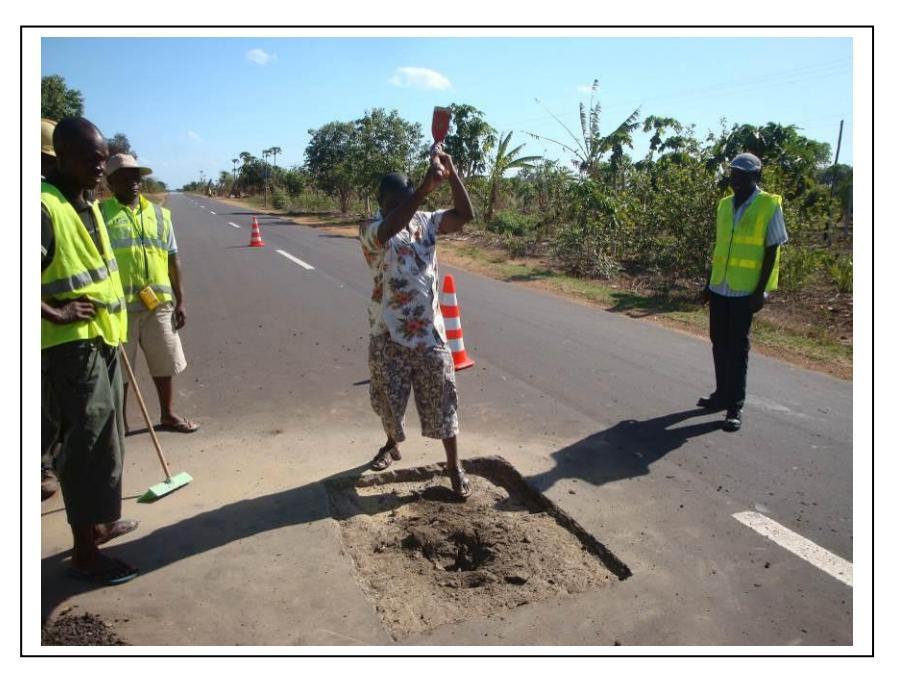
Figure 5-6 Hot sand asphalt surfacing over cement treated base on the Pambara Rio Save road

The pavement structure consisted of a single base layer 150mm thick overlying a red silt subgrade. Red silt was also used for the base and stabilised with cement. This is a typical low volume road design where material is poor and cannot be used untreated. The content of cement used for stabilisation is unknown. The condition of the section is illustrated in Figure 5-6 and described in Table 5-4.

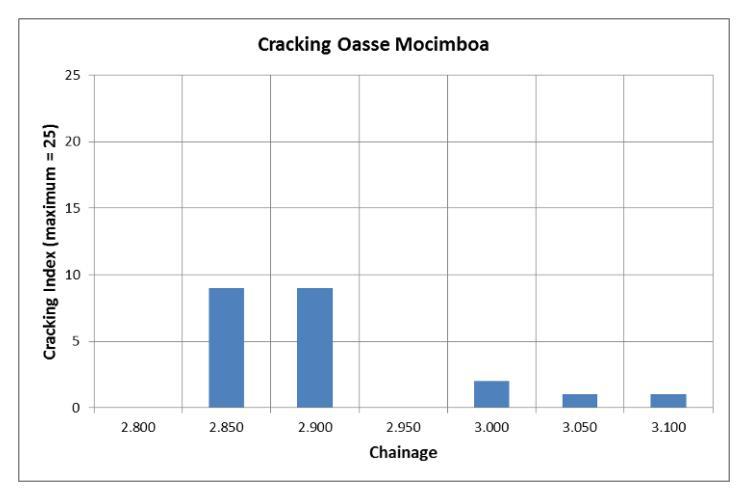
Figure 5-10 Cracking on Section 2 of the Oassie Mucimboa road

Section 2 also shows some cracking (Figure 5-10) but the rut depths, Figure 5-11, are slightly higher than expected and could indicate a weakness The DCP data in Table 5-7 shows that the road is strong.

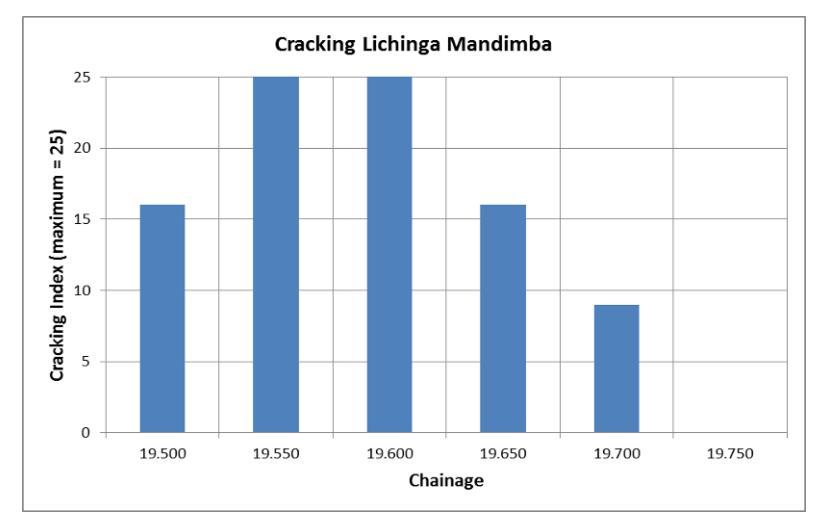
Figure 5-17 Cracking on Section 2 of the Lichinga Mandimba road

The second section from 19+550 to 19+850 had failed with excessive potholing and patching (Figure 5-17) and a deep rut at the beginning, otherwise deformation was slight and in the outer wheel tracks.

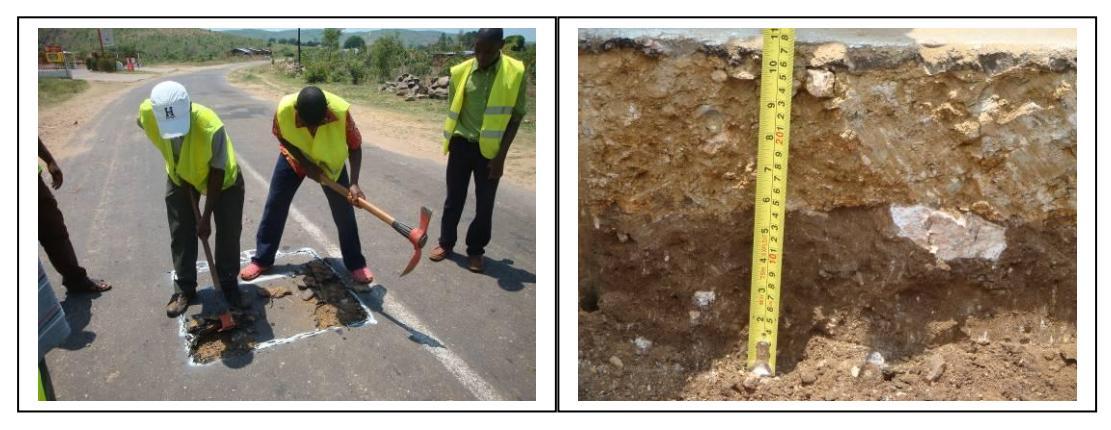
Section of Metangula Maniamba

The Maniamba Metangula Road had been excluded from the final selection because of the low traffic volume (approximately 50 vpd). The road was constructed using some shale gravel and surfaced with an Otta seal. The road is still in very good condition. However the section that was selected was showing the beginning of surfacing failure and distress. It was also in a low lying area with poor drainage.

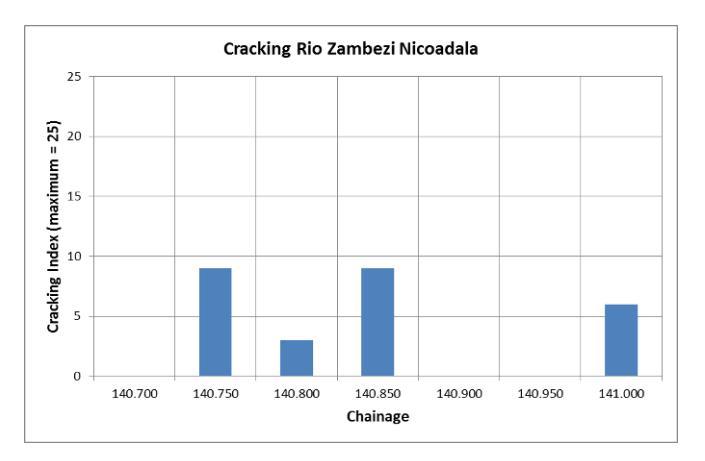
Figure 5-27 Cracking on Section 1 of the Rio Zambezi Nicoadala road

Figure 5-27 and Figure 5-28 shows that there was a moderate amount of cracking on Section 1 but virtually no rutting that could not be attributed to slight densification under traffic.

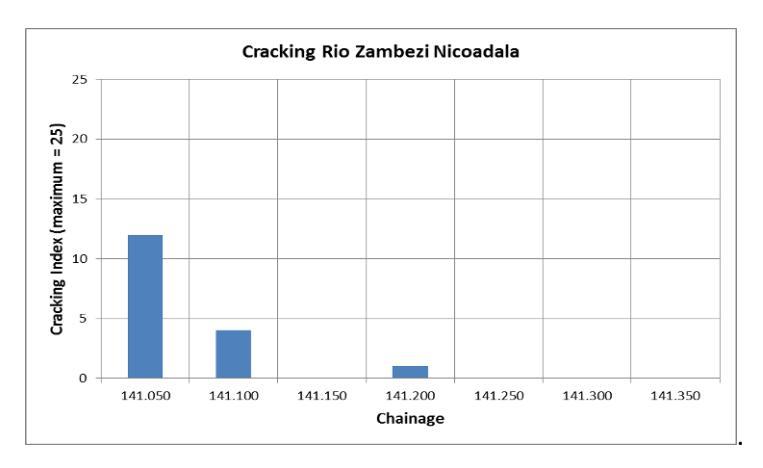
Figure 5-29 Cracking on Section 2 of the Rio Zambezi Nicoadala road

Figure 5-29 shows some cracking on Section 2 (slightly less than on Section 1 but no real difference). Similarly there was no significant rutting, Figure 5-30.

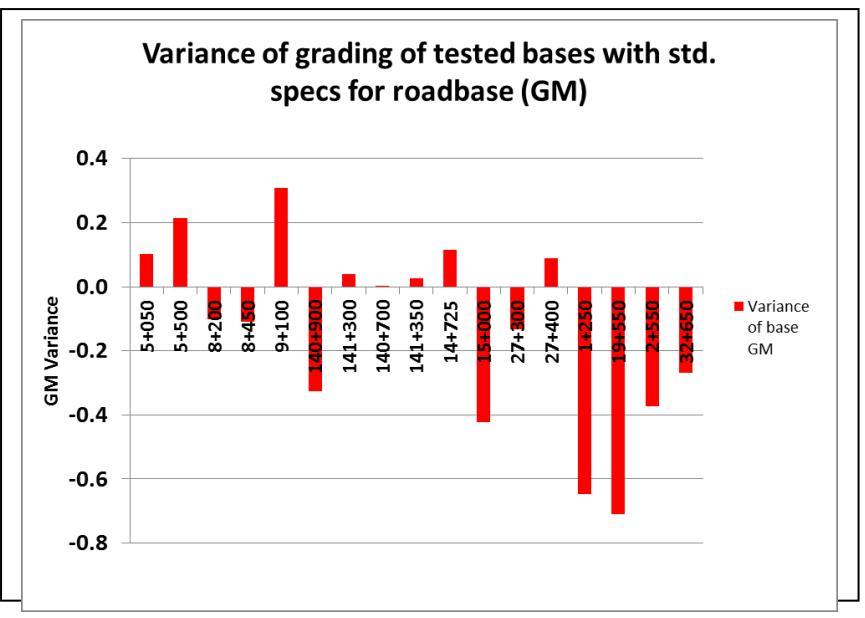
Figure 6-13 Variance of grading modulus (GM) for the bases tested

The variance of the GM values compared with minimum GM specification for roadbases are shown in Figure 6-13. The chart shows that more than half of the bases did not meet the minimum specifications of GM for roadbase material and that 5 bases differed considerably and yet they performed well.

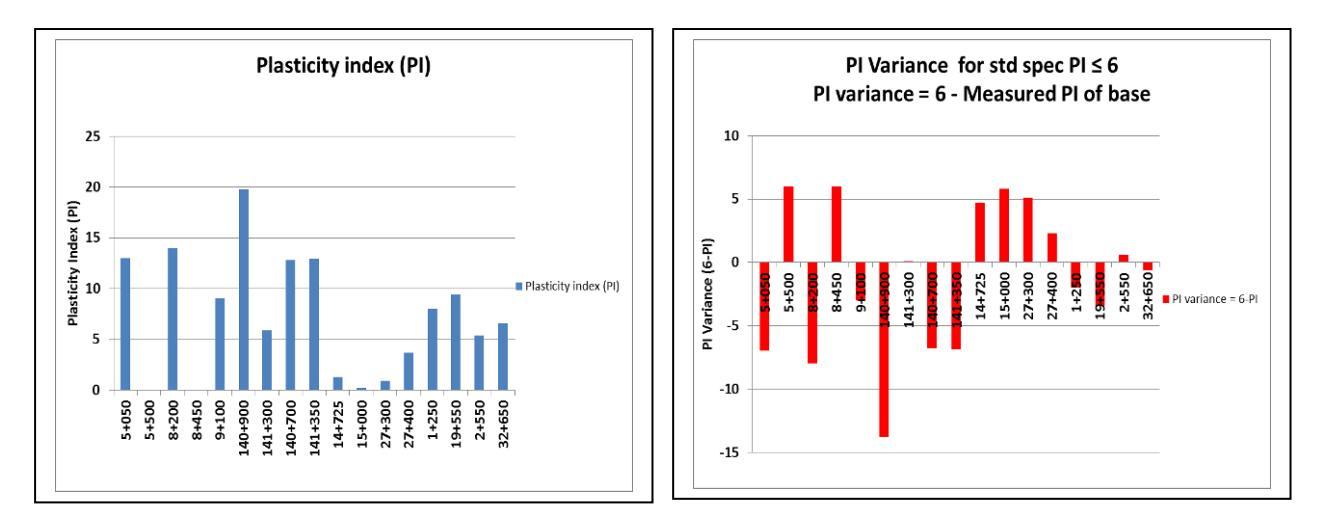
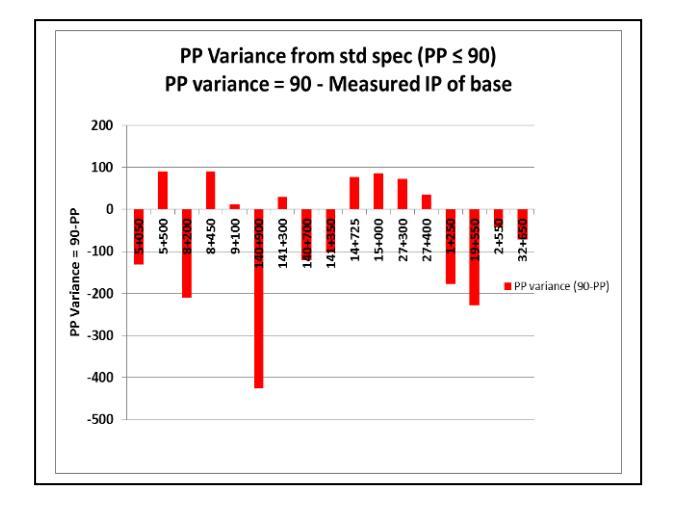
Figure 6-14 Plasticity Indices (PI) for all bases tested Figure 6-15 PI variance from std. spec PI<6

The results show that 9 bases out of 17 failed to meet the standard plasticity specifications but still performed well in-service. The highest plasticity values recorded were on the section on the Rio Zambezi Nicoadala Road which is part of the N1 North-South Highway. This section of road carries heavy trucks and the performance has been very satisfactory. The effect of plasticity on performance identified here will contribute to the review of specifications.

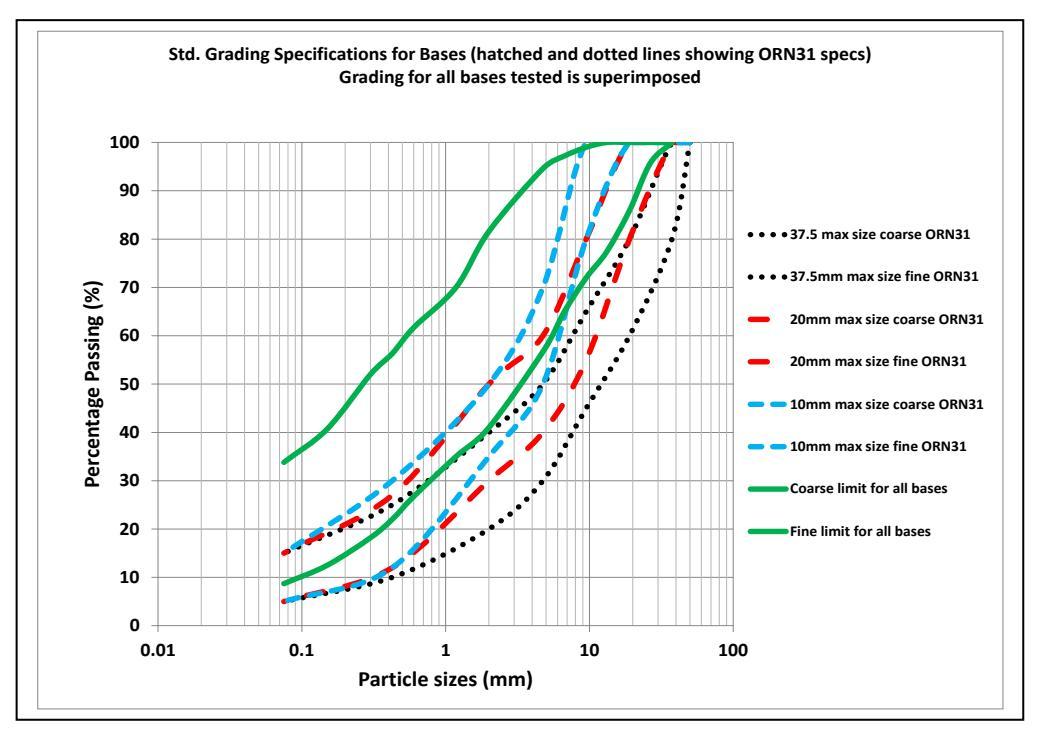
Figure 7-6 Grading of roadbases tested superimposed on TRL ORN31 specifications

The natural materials that were used for the construction of the bases were much finer than the standard specifications, (Figure 7-6), yet the sections still performed well. This shows that for low volume roads the grading specifications can be relaxed and envelope given in Figure 7-7 is recommended.
