**AFCAP/MOZ/054/B**  
**USE OF ROAD WORKS TO ENHANCE COMMUNITY**  
**WATER SUPPLIES IN MOZAMBIQUE**

**INCEPTION REPORT**

*December 2012*

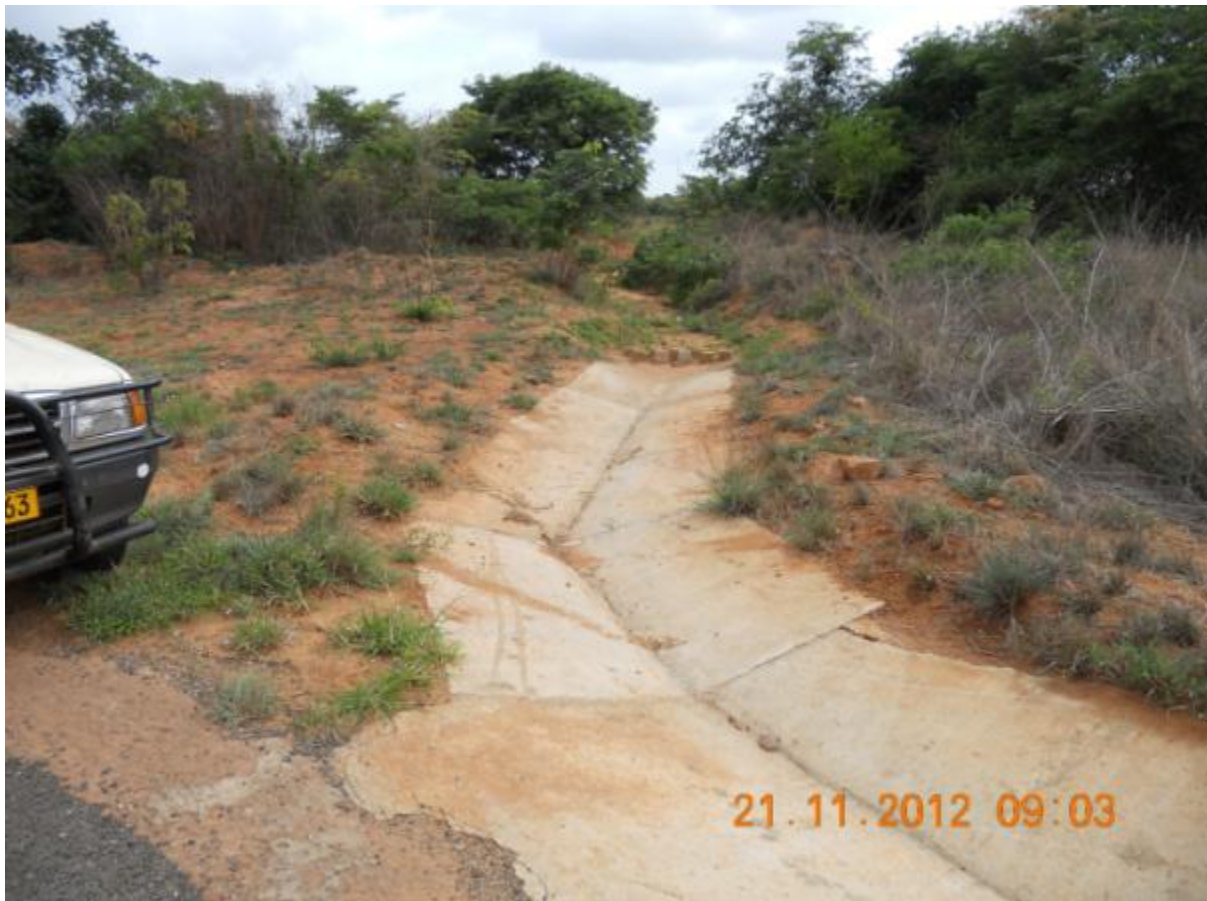
**Photo 1** illustrates the potential to divert the side drain.

*Photo 1: Nhambuica: Improved Borrow Pit:  
Lined side drain from the N1 can be diverted into the pit,  
which can be glimpsed in the background.*

For sand borrow pits to retain water in Inhambane Province, of necessity the pit will need some form of lining. The use of HDPE lining, as in the ARA-Sul Mucuíne (Funhalauro) and Panga excavated reservoirs, is considered to be prohibitively expensive. An alternative, currently under investigation, is to seal the pits by mixing bentonite into a top layer of compacted sand. A local bentonite producer, MIMOC at Mafuíane Quarry near Maputo, has been identified in this regard. The suitability and cost effectiveness of the product will be assessed during the detail design stage of the assignment.

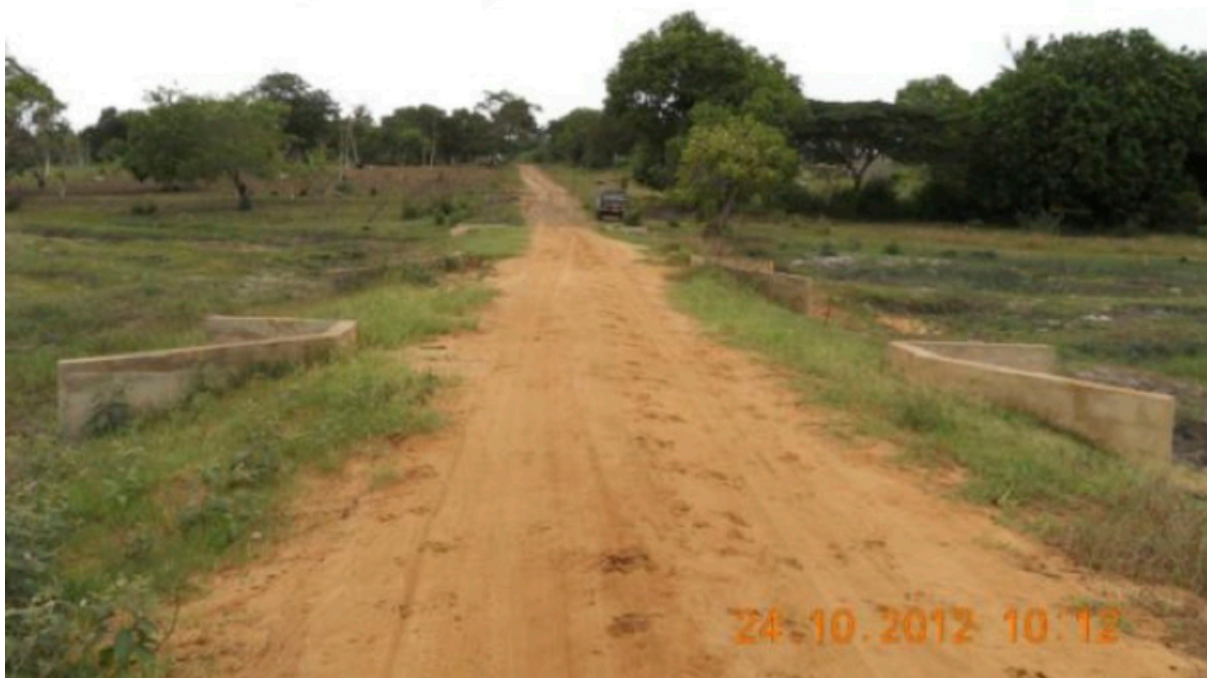
Local knowledge indicates that during the rains water may rise to the top of the existing embankment and in extreme storms it may actually overtop the embankment. As water levels subside shallow ponds of variable depth form both upstream and downstream of the embankment. The proposed road dam would provide a more consistent water depth and therefore reduced evaporation losses

*Photo 2: Tambajane: Proposed Road Dam:  
Existing embankment, incorporating three culverts,  
across the Rio Tendele drainage line is to be raised*

- Catchment area – 25 to 30km<sup>2</sup>
- Full Supply level (FSL) – 107.0mamsl
- Storage capacity – 23,116m<sup>3</sup>
- Length of embankment to be raised – 220m
- Finish Road Level (FRL) of embankment – 108.0mamsl
- Invert Level (IL) of existing [lowest] culvert – 105.16mamsl
- Freeboard – 1.0m
- Maximum water depth – 1.8m
- Maximum height of embankment – 2.8m
- Spillway type – Drop inlet of approximately 30m length discharging into the existing pipe culverts – see **Figure 2**

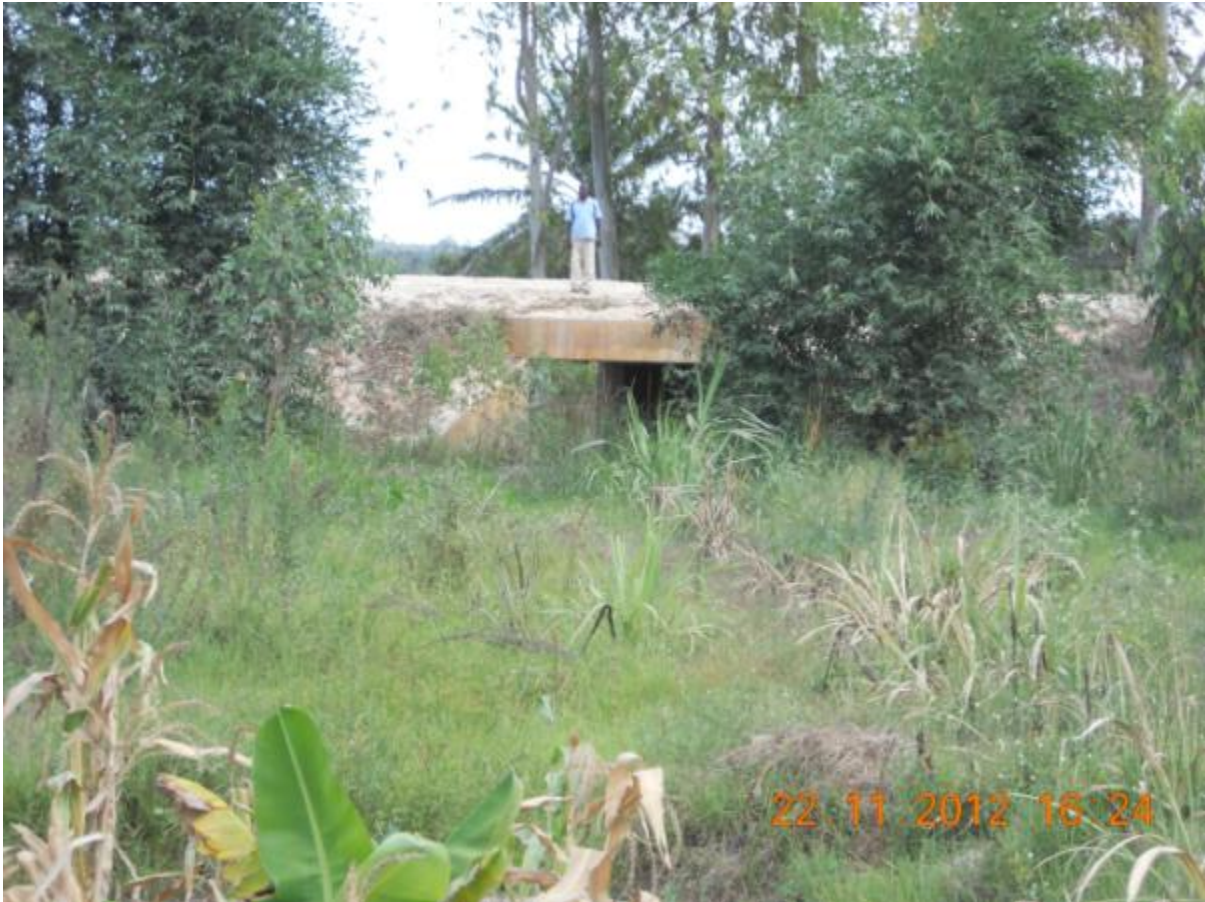
*Photo 3: Inhamussua: Proposed Road Dam*

*An existing embankment with box culvert can form a road dam without raising*

- Catchment area – 5km<sup>2</sup>
- Full Supply level (FSL) – 11.0mamsl
- Storage capacity – 20,000m<sup>3</sup>
- Length of embankment to be raised – Nil
- Finish Road Level (FRL) of embankment over the box culvert – 12.3mamsl
- Invert Level (IL) of existing box culvert – 8.39mamsl
- Freeboard – 1.3m
- Maximum water depth – 2.6m
- Maximum height of embankment – 3.9mm
- Spillway type – Drop inlet of approximately 10m length discharging into the existing box culvert

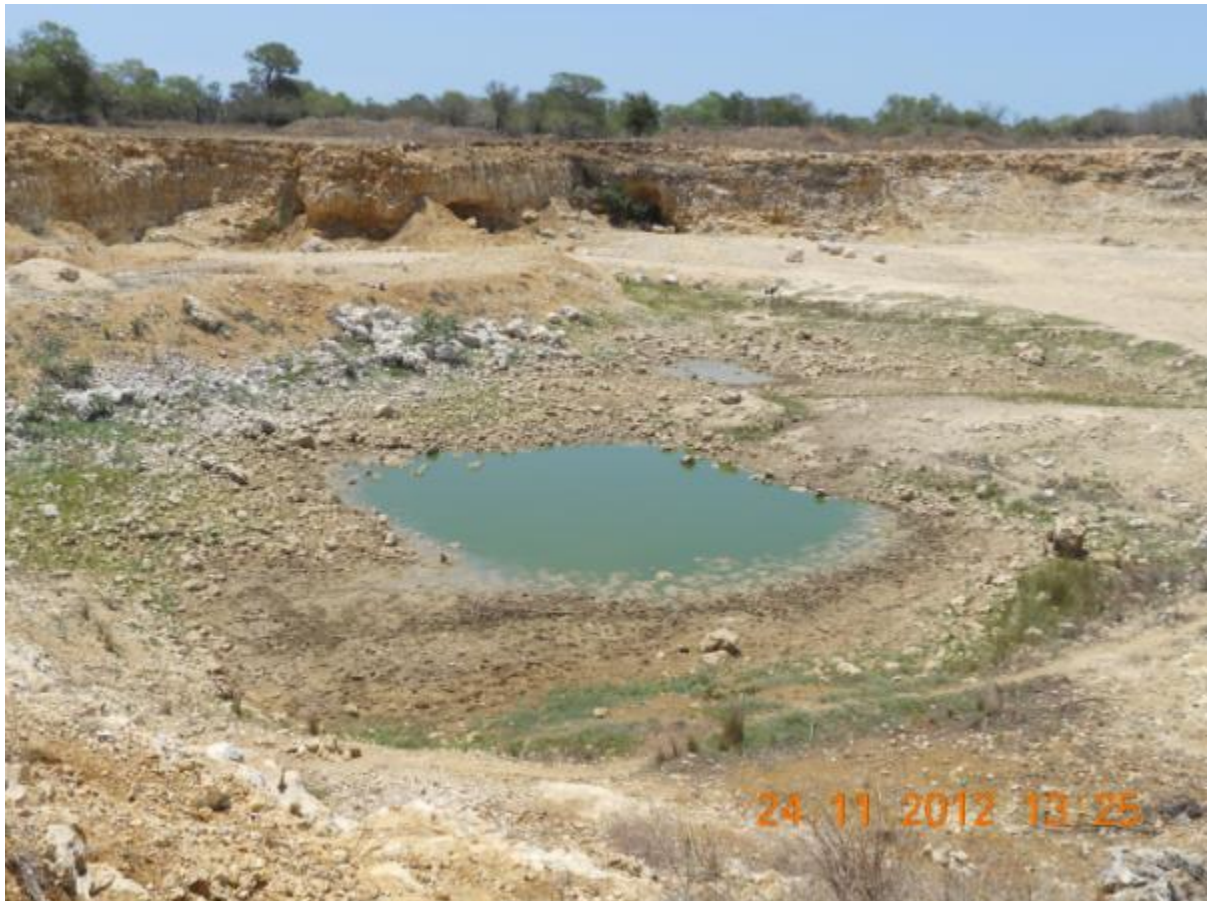
Depressions in one corner of the Pambarra calcrete quarry retain water throughout the year, which is used by transient villagers working in the area for drinking, bathing and livestock watering. At the time of the field reconnaissance in late November 2012, two ponds, both heavily polluted from livestock, were in use with drinking water being obtained from two small natural wells on one side. The wet season high water mark indicates that the ponds have a capacity of up to 2,340m<sup>3</sup>. **Photo 4** illustrates the site and the topographical survey is included in **Appendix A**.

*Photo 4: Pambarra Calcrete Quarry: Improved Borrow Pit  
The larger pool is approximately 19m x 15m in extent*

As a source for domestic and livestock water supply, improvements to the overall water quality can be achieved at relatively low cost by the installation of draw-off arrangements that separate the current multiple uses (drinking, bathing, laundry and livestock watering). Improved draw-off arrangements would comprise installation of the following works:-

- Fencing
- Piped outlet in a filter medium to a concrete lined well fitted with a hand-pump
- Separate laundry plinth
- Separate livestock watering trough (fed from the hand-pump)

The hand-pump, laundry plinth and livestock watering trough would be positioned so as to eliminate waste water draining into the pond(s).

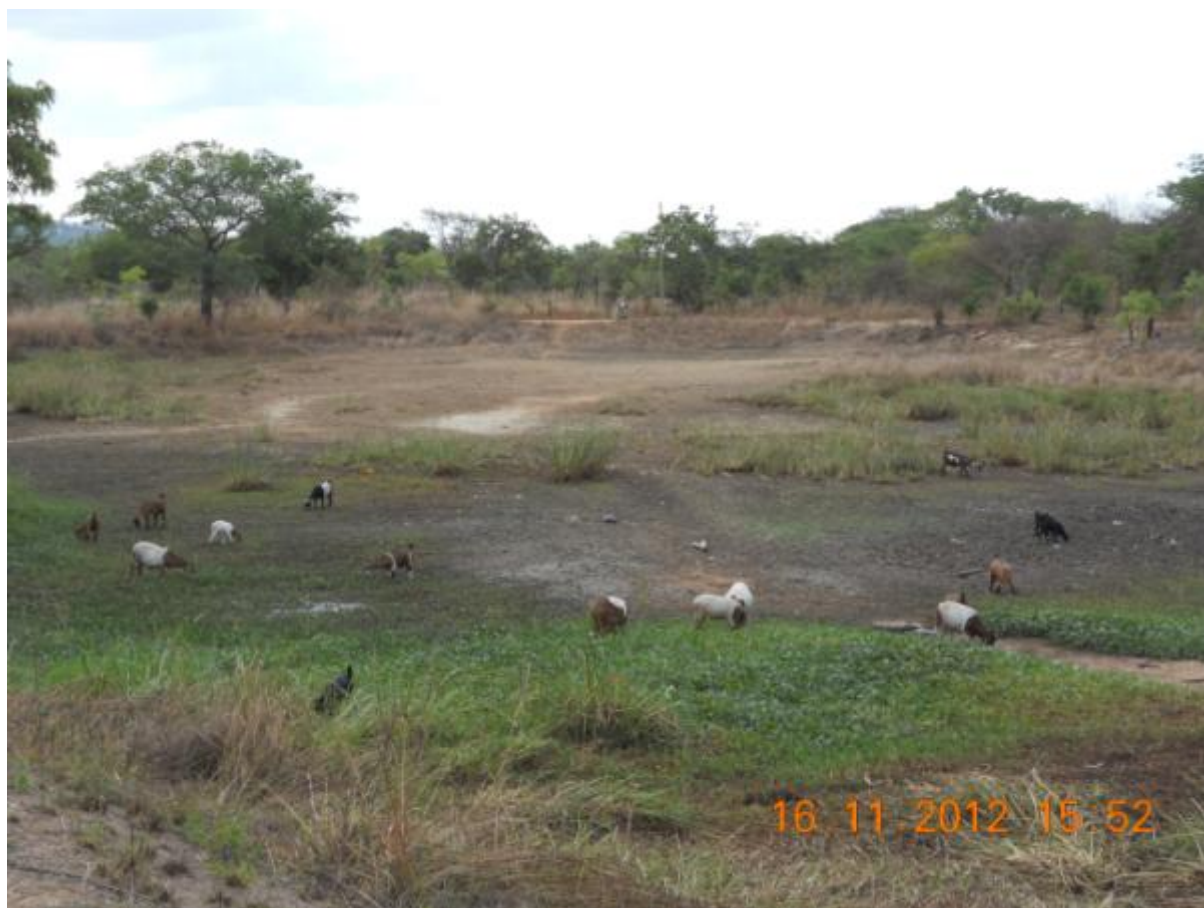
*Photo 5: "Gravel": Improved Borrow Pit*

*Water retained into November is used for livestock watering. On the far side is the N261.*

Local knowledge suggests the borrow pit fills during the rainy season. Short lengths of road side drain are also diverted into the pit. In the event, at 1.5m depth the capacity of the pit is 5,610m<sup>3</sup>.

A nearby borehole is under increasing pressure from multiple uses. Water retained in the pit complements the borehole supply especially for laundry, cultivation and livestock watering. Improvements to the pit with draw-off arrangements that separate uses would result in less pollution. These improvements would be similar to those at Pambarra, viz:-

- Fencing
- Piped outlet in a filter medium to a concrete lined well fitted with a hand-pump
- Separate laundry plinth
- Separate livestock watering trough (fed from the hand-pump)

The handpump, laundry plinth and livestock watering trough would be positioned so as to eliminate waste water draining into the pit.

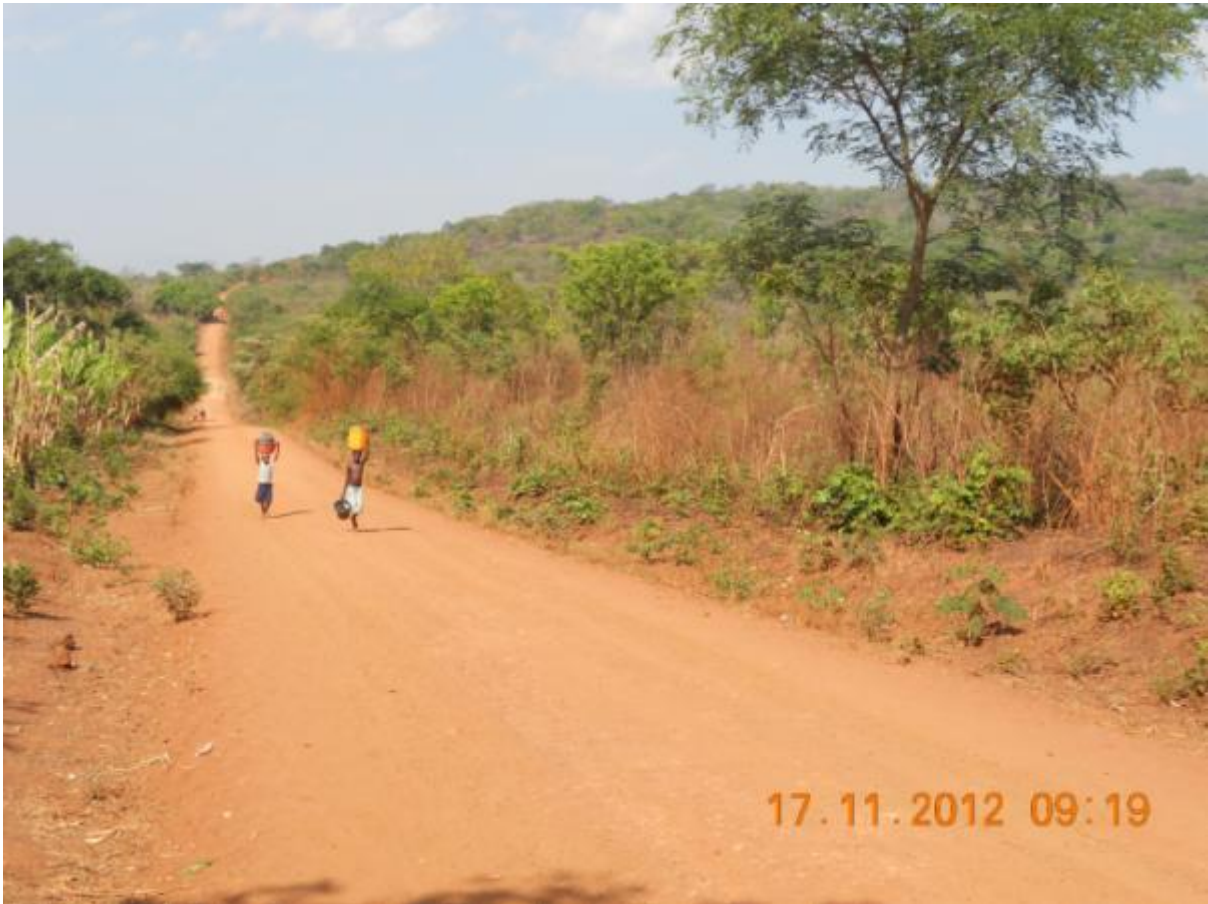
*Photo 6: Dunda: Proposed Road Dam*

It is apparent that there has been a previous attempt to store water at this site with an earth embankment or “barrage”, as shown on the topographical survey, constructed downstream of the road by Caritas in 2008. Inexplicably the barrage is not located on the watercourse and consequently it has never filled.

Of interest also, and shown on the topographical survey, is an isolated twin 1.0m arch culvert approximately 80m downstream of the road. It is apparent this was constructed many years ago as a prelude to upgrading the road. At 16m, the length of the culvert indicates that an embankment of at least 3m height was anticipated at this location.

*The site with an existing culvert is in the sag. Note Dunda Mountain to the right.*

- Catchment area – 1.5km<sup>2</sup>
- Full Supply level (FSL) – 729.0mamsl
- Storage capacity – 30,172m<sup>3</sup>
- Length of embankment to be raised – 310m
- Finish Road Level (FRL) of embankment – 730.0mamsl
- Invert Level (IL) of existing twin 800mm dia. culvert – 724.0mamsl
- Freeboard – 1.0m
- Maximum water depth – 5.0m
- Maximum height of embankment – 6.0m
- Spillway type – Drop inlet of approximately 10m length discharging into the existing twin pipe culvert

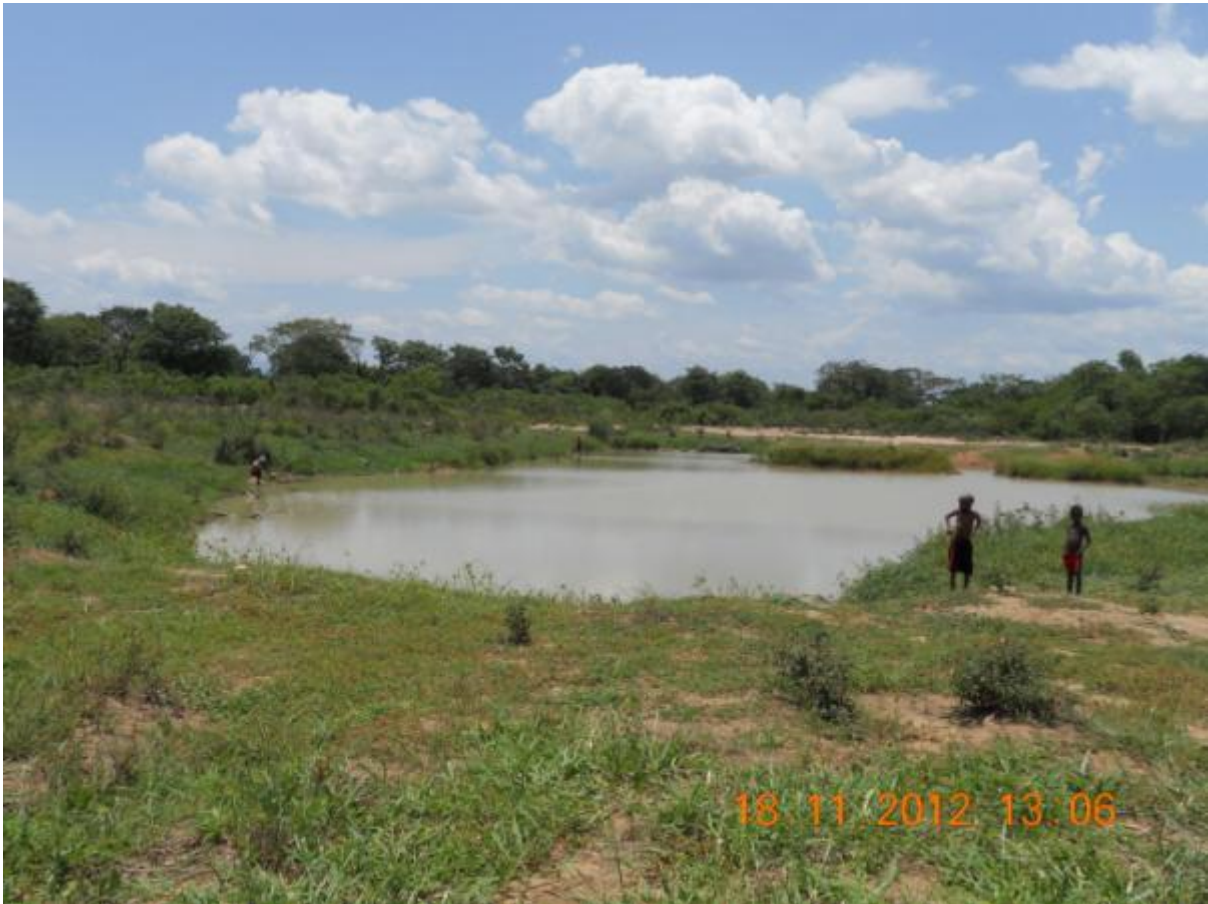
A number of households surround the pit. However, towards the end of the dry season, they refrain from using the water in the pit because of pollution and a bad smell. Much of the pollution results from multiple uses, especially bathing and laundry activities, which progressively increase the pollution load in the diminishing water volume, and from livestock watering.

*Photo 7: Magaro (Dombe): Improved Borrow Pit  
A relatively large, reportedly perennial body of water used for laundry,  
recreation and livestock watering*

Improvements to the pit with draw-off arrangements that separate uses would result in less pollution. These improvements would be similar to those at Pambarra and “Gravel”, viz:-

- Fencing
- Piped outlet in a filter medium to a concrete lined well fitted with a hand-pump
- Separate laundry plinth
- Separate livestock watering trough (fed from the hand-pump)

The hand-pump, laundry plinth and livestock watering trough would be positioned so as to eliminate waste water draining into the pit.

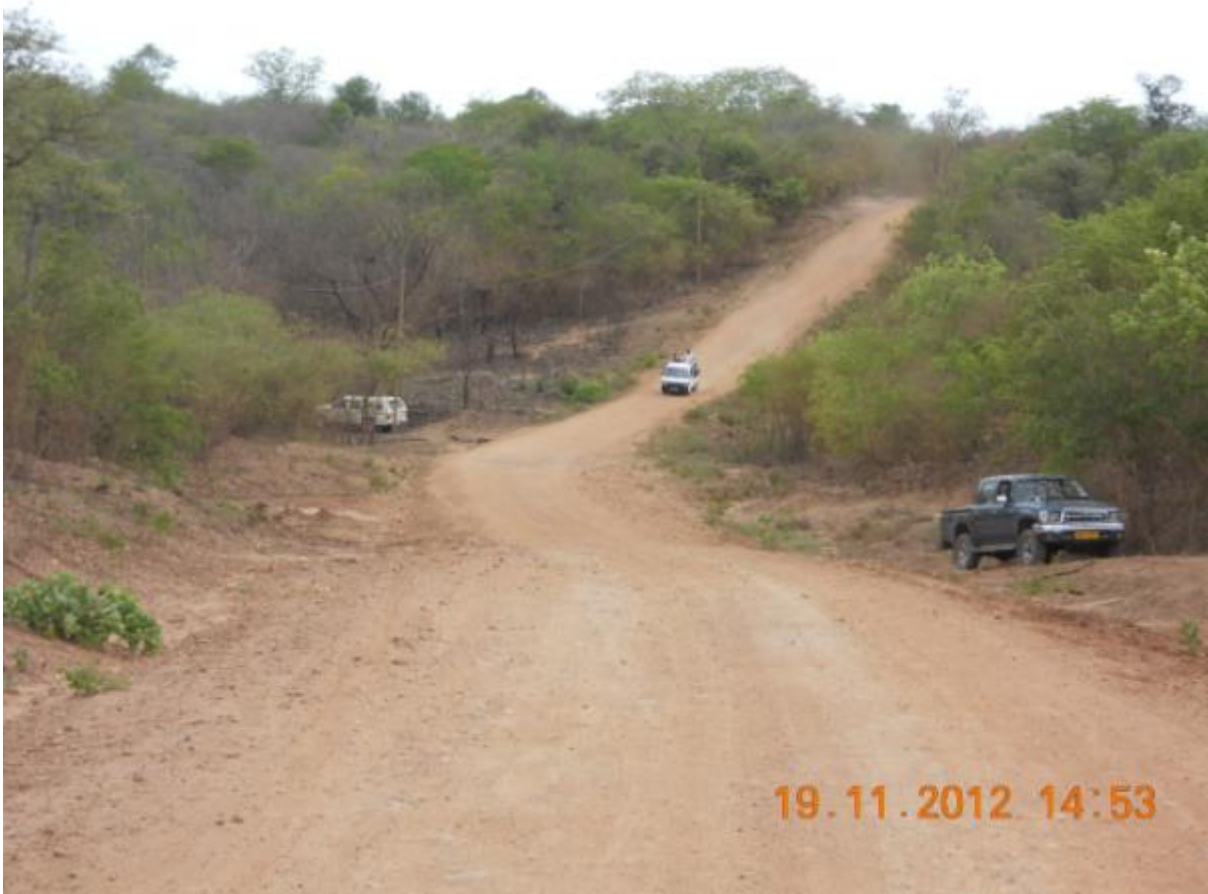
*Photo 8: Guezanhe: Proposed Road Dam  
R521 crossing of Rio Tomere headwaters in a triple 800mm dia. culvert.  
Note the very good approach gradients for raising the embankment.*

There has been a previous attempt to store water at this site with an earth embankment or “barrage” constructed approximately 200m downstream of the road culvert. It is reported the embankment was breached on first-filling, most probably due to poor compaction and / or the lack of or an undersized spillway. The breach was repaired in 2006 with a masonry wall financed by the Government of Belgium. However, although there is evidence of the barrage spilling, it is reported not to retain water for more than 2 – 3 days, the water most likely being lost through seepage beneath the masonry wall, which does not have a positive cut-off.

There has been a previous attempt to store water discharging from the pipe culvert at Guezanhe by dozing-up a barrage about 200m downstream of the culvert. This failed on first filling, most probably due to the lack of, or an undersized, spillway and/or because the barrage was un-compacted. Repairs in 2006 comprised a masonry wall, 1.5m in height incorporating a “spillway” or overflow of 4 nr x 200mm dia. AC pipes set at a high level, which have spilled. However, the “barrage” does not hold water for more than a couple of days, presumably because of seepage occurring beneath the masonry wall.

- Catchment area – 3.0km<sup>2</sup>
- Full Supply level (FSL) – 272.0mamsl
- Storage capacity – 28,237m<sup>3</sup>
- Length of embankment to be raised – 170m
- Finish Road Level (FRL) of embankment – 273.0mamsl
- Invert Level (IL) of existing triple 800mm dia. culvert – 266.8mamsl
- Freeboard – 1.0m
- Maximum water depth – 5.2m
- Maximum height of embankment – 6.2m
- Spillway type – Drop inlet of approximately 15m length discharging into the existing triple pipe culvert

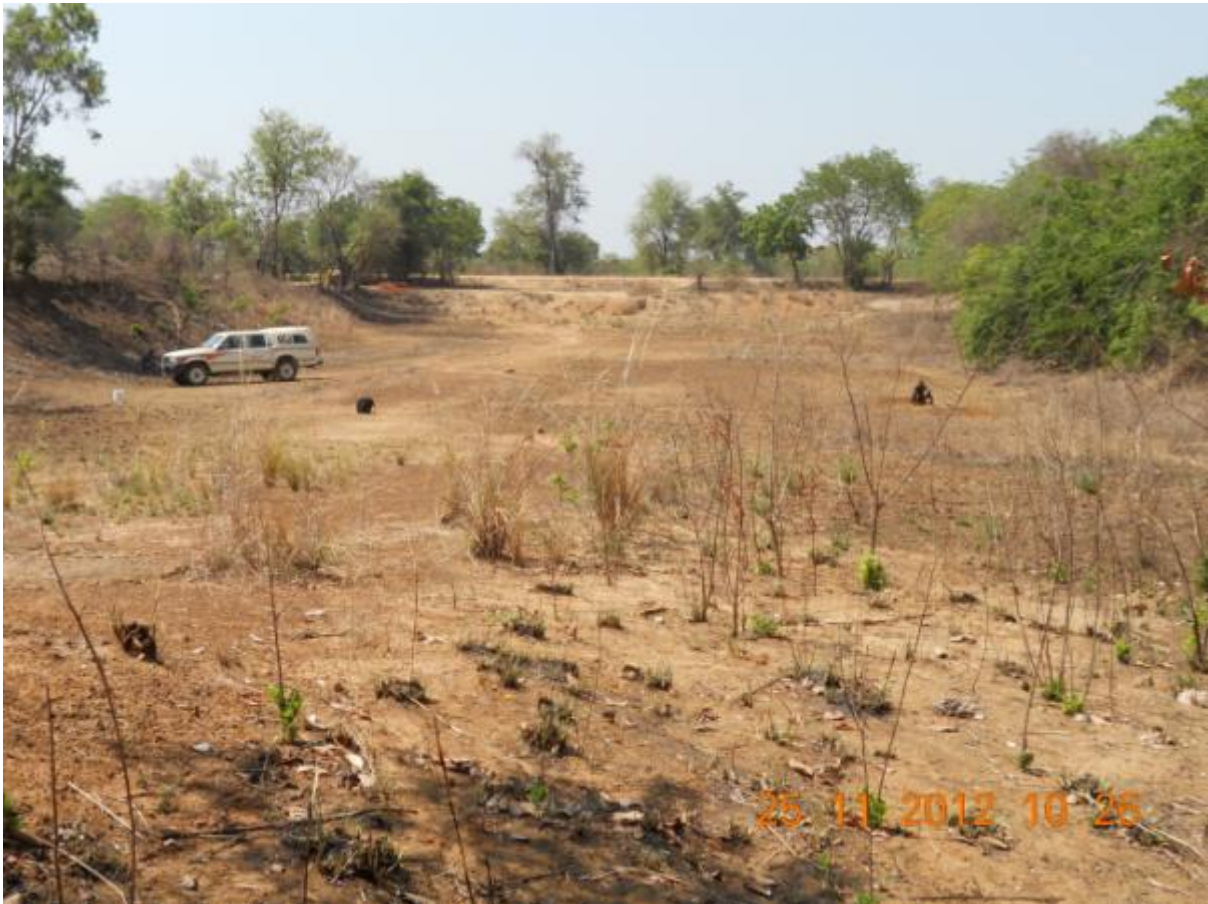
*Photo 9: Tucene: Proposed Off-River Storage in an Existing Borrow Pit*

A trial pit excavated to a depth of 2.1m in the base of the borrow pit indicates that the underlying material is a hard yellowish / grey clay. Consequently, seepage losses are likely to be minimal.

Off-river storage would take the form of an excavated reservoir by deepening the existing borrow pit, similar to the ARA-Sul scheme at Mavanza. Although the river bed is lower than the base of the borrow pit, i.e. 121.0mamsl and 122.0mamsl respectively, it appears feasible to excavate a channel, approximately 200m in length, from a bend in the river to the borrow pit. Of necessity the borrow pit would have to be deepened in order to provide off-river storage capacity. Deepening by 4.0m would provide an estimated storage capacity of approximately 6,000m<sup>3</sup> below the river bed level of 121.0mamsl.
