# PERFORMANCE MONITORING OF LOW VOLUME RURAL ROADS IN NORTHWEST LAOS PDR (SEACAP 17-002)<sup>1</sup>

Dr J R Cook; OtB Engineering Ltd, UK

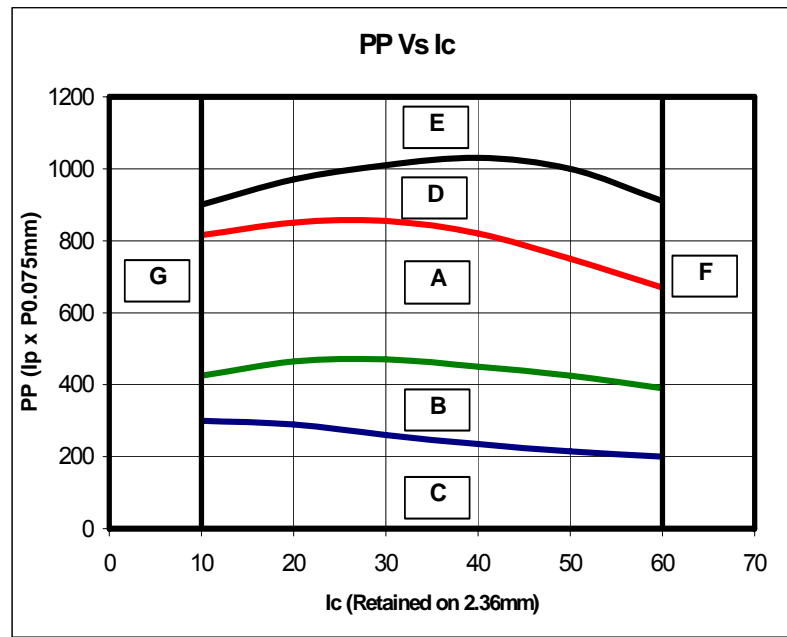
- A: Good performance under wet and dry conditions
- B: Good performance under wet conditions; corrugates in dry conditions
- C: Lacks cohesion: rapid deterioration with traffic
- D: Good in dry conditions; slippery in wet; potholes/erosion
- E: Poor in both wet and dry conditions
- F: Too coarse: erodes badly; difficult to maintain
- G: Too fine; traffickability problems in wet and very dusty when dry

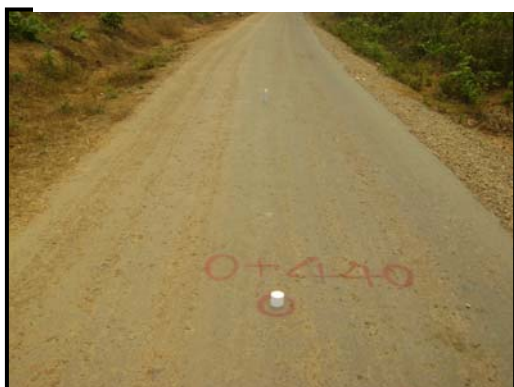
**Figure 4, Seal erosion and shallow potholes - Road 1032.01**

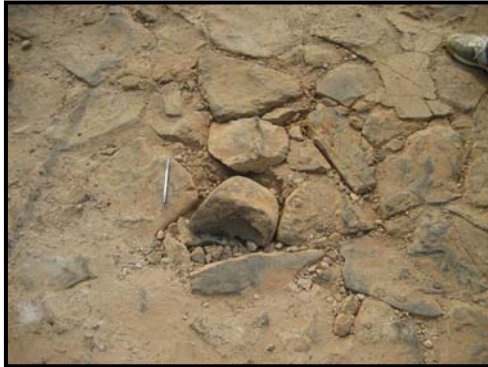
**Figure 6, Traffic using shoulder rather than rough carriageway.**

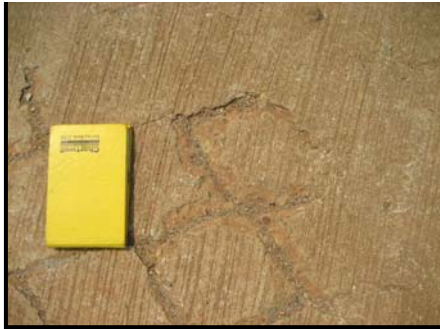
**Figure 8, Cracks in surface screed following cell boundaries.**

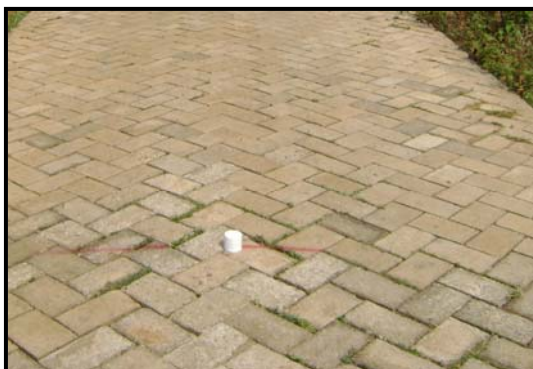
**Figure 10, Eroded badly spaced joints with one cracked block**

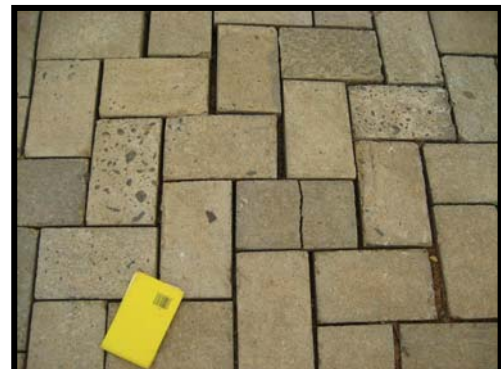
### ***Bamboo reinforced concrete***

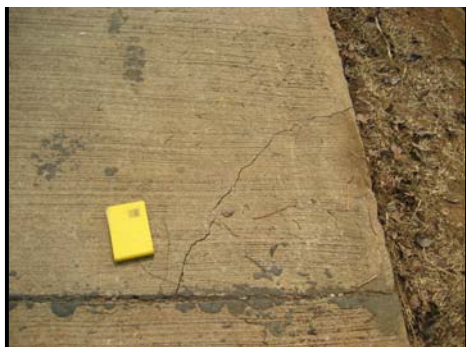
## **5 Lao Gravel Assessment Programme Discussion**

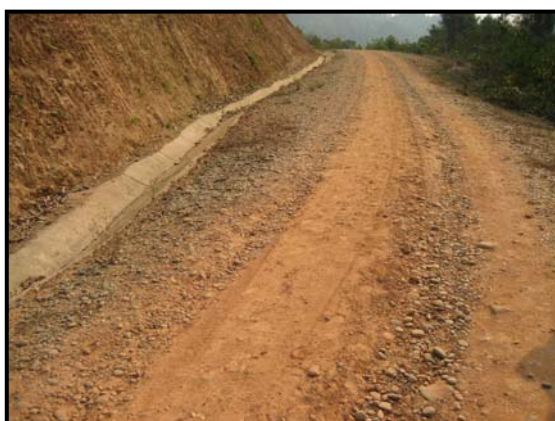
Figure 15, Eroded gravel on steep section of NEC package II road 201. Shape prevents run-off into well constructed drain.
