SLOPE STABILISATION TRIALS ON ROUTE 13N KASI – PHOU KHOUN – LUANG PRABANG AND ROUTE 7 PHOU KHOUN – LUANG PRABANG/XIENG KHUANG BORDER

MODULES 2 & 3 REPORT

September 2008

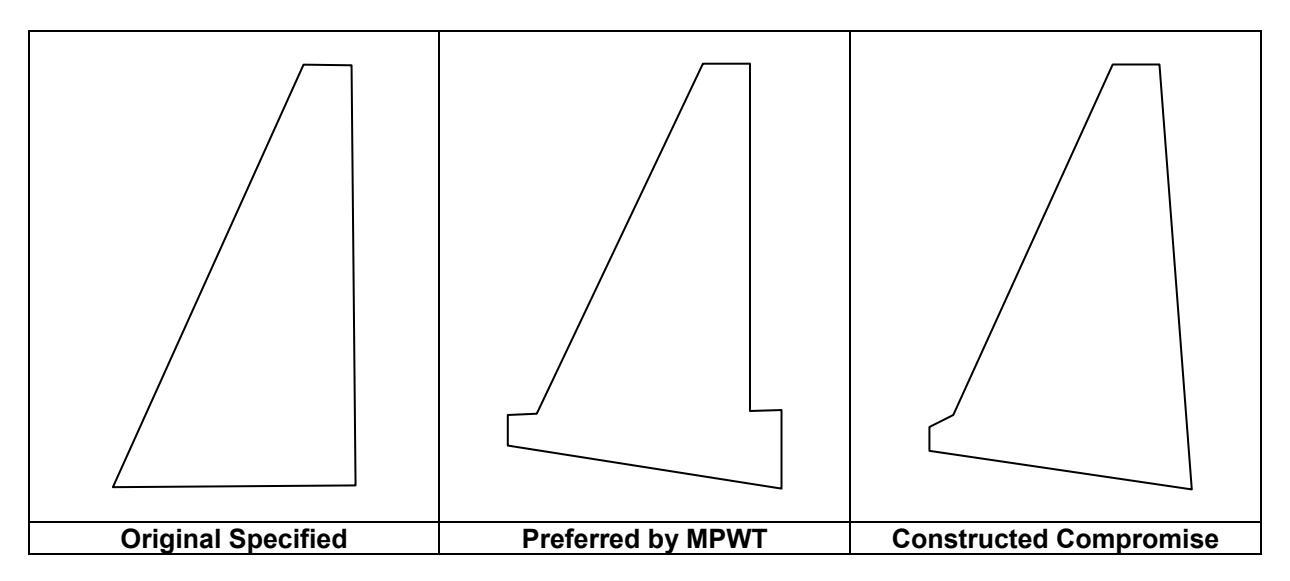
The figure below shows the original shape of the masonry retaining walls as specified on the construction drawings, the shape preferred by MPWT and instructed to the contractor, and finally the compromise shape suggested by the Consultant.

Wall type	Advantages	Disadvantages
Originally Specified	Horizontal excavation easy to construct. Little danger of water ponding at the base of the wall.	Lower resistance to sliding compared to a sloping base.
Preferred by MPWT	Greater resistance to sliding and overturning compared to a horizontal base. Front step will reduce the effects of surface runoff from undermining toe.	Sloping excavation more difficult to construct. Some danger of water ponding at the base of the wall. Rear step will crack under load and cannot be relied upon to reduce overturning forces
Recommended compromise	Greater resistance to sliding and overturning compared to a horizontal base. Front step will reduce the effects of surface runoff from undermining toe. Sloping rear face reduces overturning compared to vertical rear face.	Some danger of water ponding at the base of the wall if no drainage provision incorporated at base of wall.
