AAIB Bulletin: 11/2016	N186CB	EW/C2015/11/01
ACCIDENT		
Aircraft Type and Registration:	Piper PA-46-350P Malibu Mirage, N186CB	
No & Type of Engines:	1 Lycoming TIO-540-AE2A piston engine	
Year of Manufacture:	1990 (Serial no: 46-22085)	
Date & Time (UTC):	14 November 2015 at 1134 hrs	
Location:	Buttles Farm, Churchinford, Somerset	
Type of Flight:	Private	
Persons on Board:	Crew - 1	Passengers - 3
Injuries:	Crew - 1 (Fatal)	Passengers - 3 (Fatal)
Nature of Damage:	Aircraft destroyed	
Commander's Licence:	Private Pilot's Licence	
Commander's Age:	56 years	
Commander's Flying Experience:	600 hours (of which 260 were on type) Last 90 days - 17 hours Last 28 days - 4 hours	
Information Source:	AAIB Field Investigation

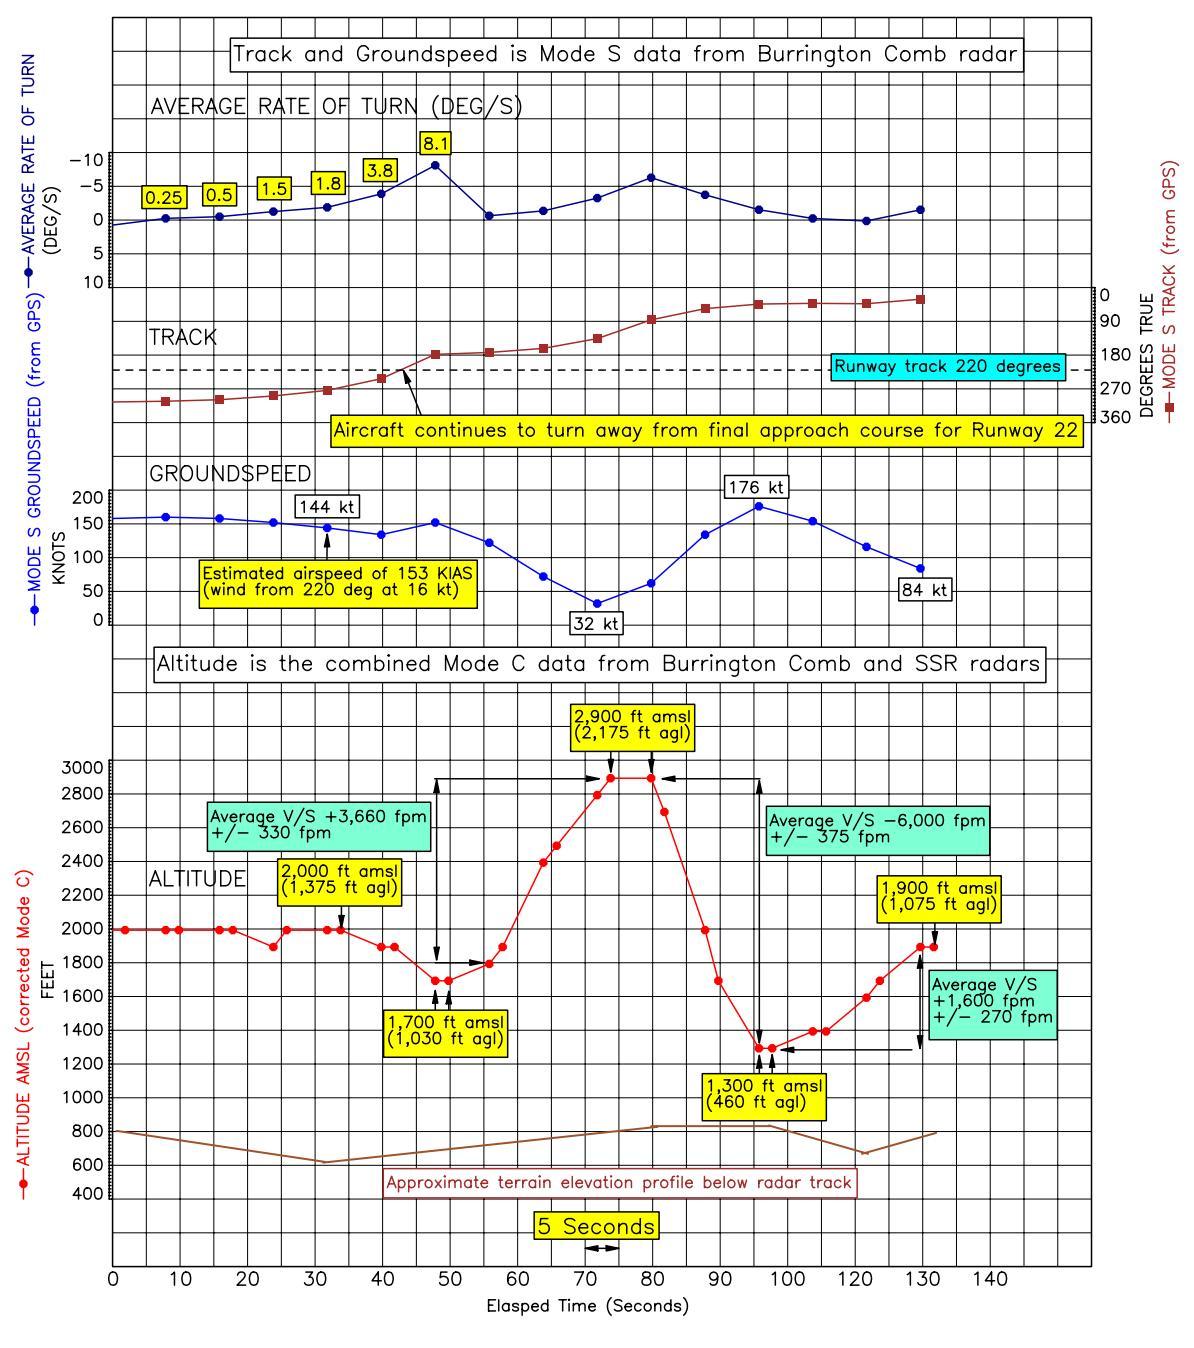
Accident flight radar data from Burrington Comb and SSR radar heads

During the series of final manoeuvres shortly before the aircraft struck the ground, the aircraft had descended to a minimum indicated height of about 460 ft agl. The aircraft did not strike the ground at this time and therefore, if a discrepancy had existed within the altimeter or its static input that caused it to overread, the maximum error could not have been greater than 460 ft.

In the middle of the figure, under the altitude '2,900 ft amsl', the height should read '**2,175** *ft agl*', not '1,175 ft agl' as originally stated. The supporting text, analysis and conclusions were unaffected by this error.

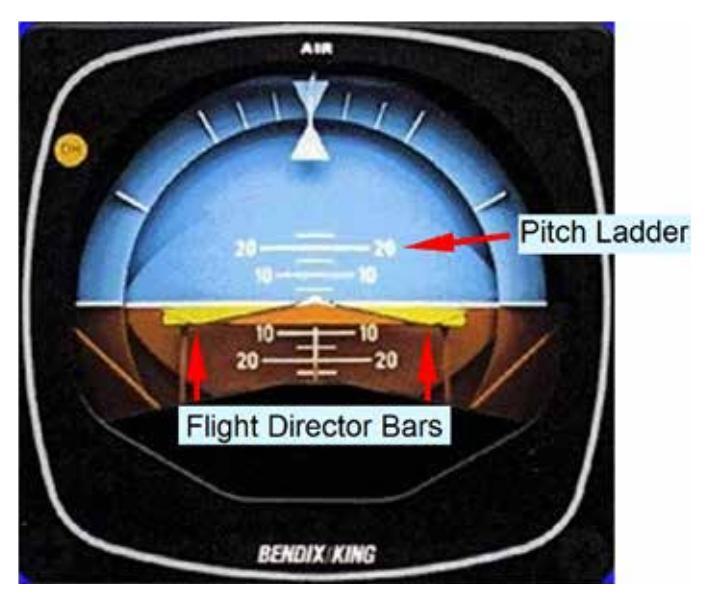
Figure 6 Bendix/King KI256 Flight Command Indicator (attitude indicator)

The KI256 Flight Command Indicator (Attitude Indicator) was too badly damaged to test so it was strip-examined by the manufacturer under the AAIB's supervision. The rotor inside the gyroscope did not exhibit any rotational scoring, which would have been indicative of rotation at impact, nor did it exhibit any static witness marks which would be indicative of a stationary rotor at impact. No anomalies inside the instrument were noted and the as-found indication of the instrument was 30° nose-down and 2° left wing low, which was similar to the forward fuselage's final resting attitude. Both engine-driven vacuum pumps driving the KI256 instrument were strip examined and neither had any indications of a pre-impact failure.

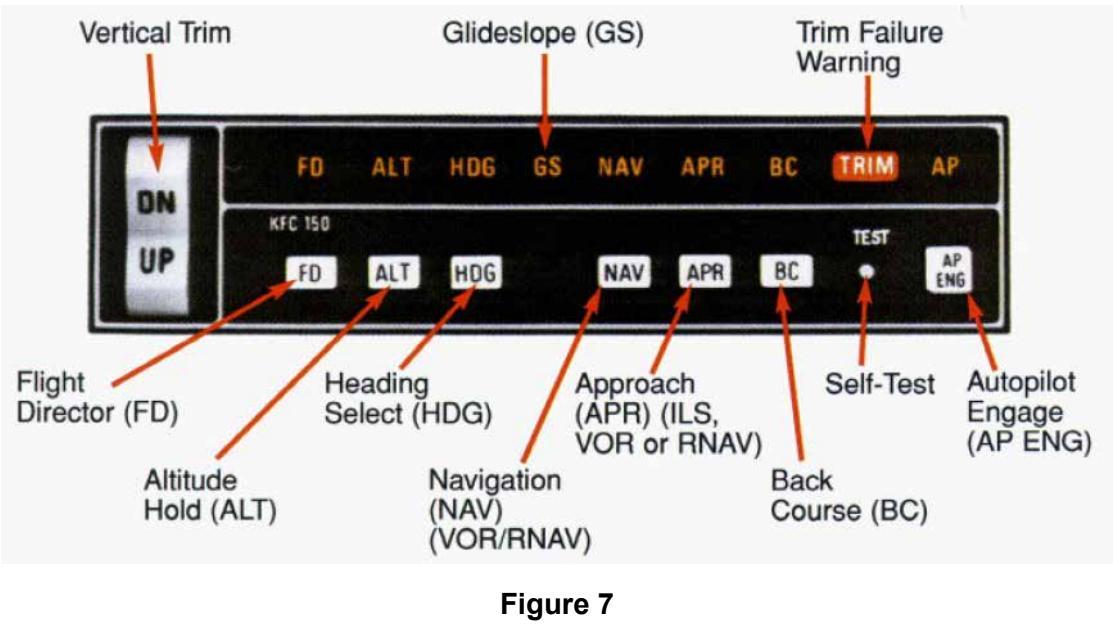
KC192 Flight Computer (autopilot control panel) (YD yaw damper caption not shown but it was to the left of the FD caption) (image copyright Honeywell)

The KC192 Flight Computer was too badly damaged to test. The circuit boards were examined and no anomalies were detected that could not be attributed to impact damage. The bulbs which provide the YD, FD, ALT, HDG, GS, NAV, APR, BC, TRIM and AP captions were examined under the microscope. The YD and FD bulbs had filaments which were significantly stretched and the ALT bulb had a filament with three areas of stretch. The HDG bulb filament exhibited some crossover and some minor stretch. All the remaining bulb filaments had no indications of stretch and all had broken, except for the TRIM bulb. It was concluded that the YD, FD, ALT and HDG bulbs were likely all illuminated at impact and the other bulbs, including the AP, were extinguished.

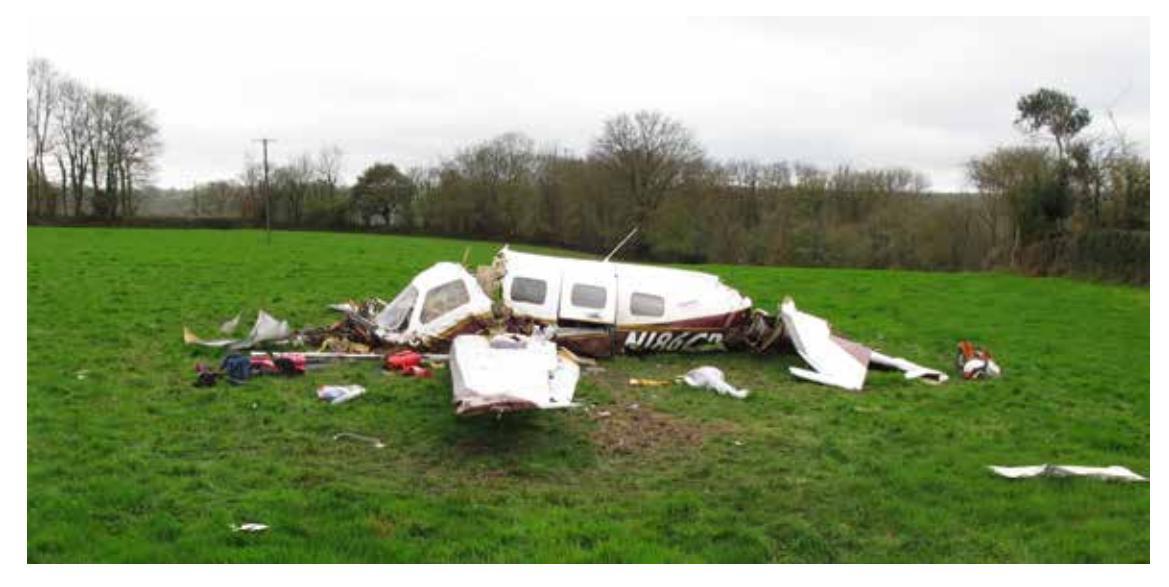
# Figure 9 Accident site

The aircraft wreckage was found in a field, 175 m north-east of the aircraft's last radar position. The aircraft had struck the ground at an elevation of 820 ft amsl, in a nose-down attitude, with a high rate of descent and at low forward speed (Figure 9). The orientation of the fuselage was in the direction 123°(M) and the fractured forward fuselage was resting at a nose-down attitude of about 25°. Damage to the undersides of the wing was consistent with the aircraft's flight path having been steeper than its nose-down attitude, suggesting that the wing was at a high-angle-of-attack, probably stalled, on impact. The aircraft had missed 6.5 m high power lines, which were 2.1 m aft of the aircraft's tail, and the left wing had travelled forward about 1 m from its initial impact point. The right wing had failed at the rear attachment and was angled forward. The tail section had failed in downward bending and the vertical tail had failed in forward and sideways bending. All external components of the aircraft were accounted for.

The propeller hub had fractured and its mounting flange had failed at the engine crankshaft attachment due to impact forces. One blade, which had detached from the failed hub, had suffered significant damage and was buried in the ground underneath the nose of the aircraft. The remaining blade, still attached to the hub, had suffered minimal damage with some chordwise scoring. The flaps and landing gear were in the retracted position.

The accident site revealed that the aircraft had struck the ground in a steep nose-down attitude and at a high angle of attack, consistent with an aerodynamic stall. The aircraft's final trajectory was probably about 60° to 70° below the horizon, as indicated by it missing the nearby power lines, its negligible forward movement after impact and the accident site's close proximity to the final radar point. The evidence suggested that the aircraft was probably in a spin when it struck the ground, although there were insufficient indications in the ground marks and fuselage damage to identify the spin direction.

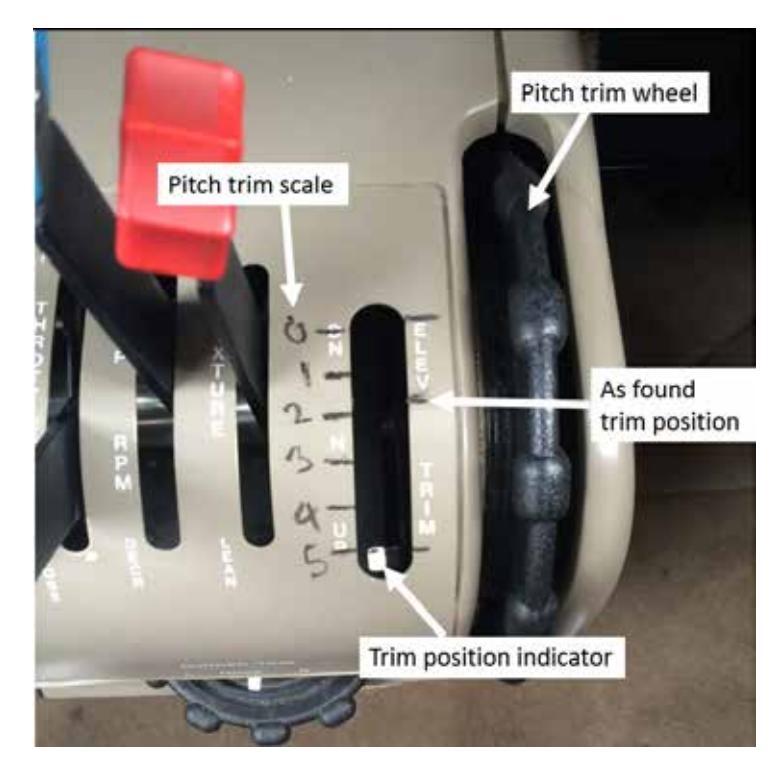
Figure 10

In order to determine the corresponding trim position relative to the aircraft's airspeed, the trim wheel in the cockpit was graduated with five positions, evenly distributed across the range of trim movement available. Position 0 was full forward (nose-down) trim and position 5 was full aft (nose-up) trim (Figure 10). It was found that 19 mm extension of the elevator trim actuator equated to a position of 1.7 on the trim wheel scale. The flight evaluation revealed that, with an aft CG, in level flight, at a stabilised airspeed of 150 KIAS (which was the estimated airspeed of N186CB shortly before it climbed rapidly) and the aircraft 'in trim', the trim wheel position was about 0.9.

The aircraft was found with 1.7 units of trim on the trim wheel but it is possible that the initial pitch-up event was caused by a pitch trim of up to 3.5 units and, in the subsequent manoeuvres prior to the impact with the ground, the trim was reduced to the position in which it was found.

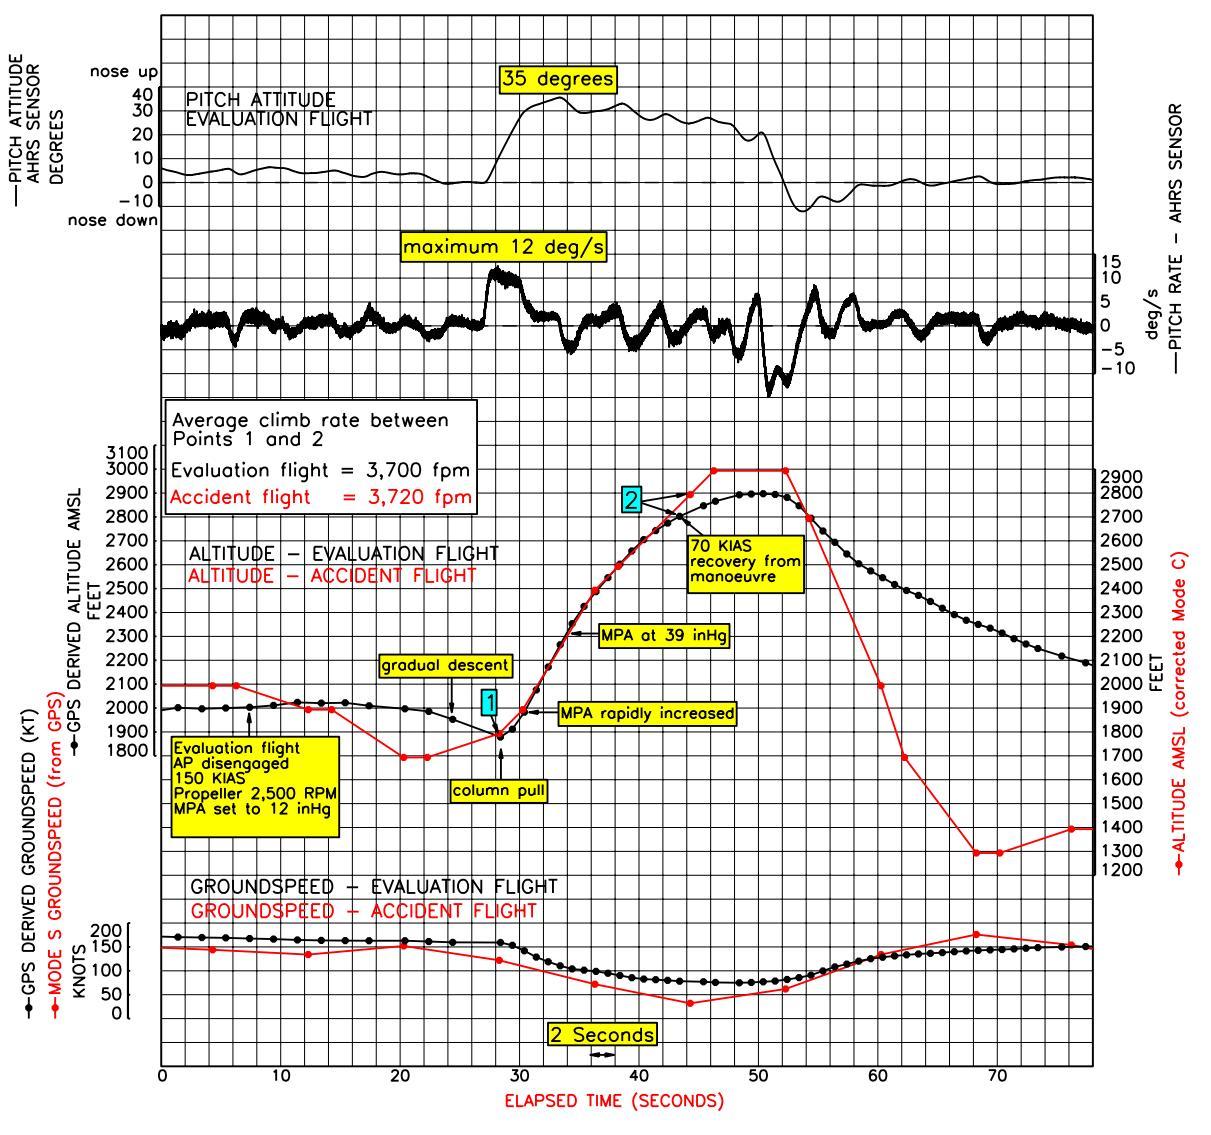
Figure 11

Comparison of accident and evaluation flight (autopilot disengaged then climb at same rate as accident flight)

The test pilot considered that the high nose-up attitudes and pitch rates achieved during these manoeuvres would be extremely disorientating for a pilot, especially in IMC conditions. He also considered that the control column forces required to override the autopilot quickly became so large, that it was unlikely a pilot would continue to oppose them without re-trimming.

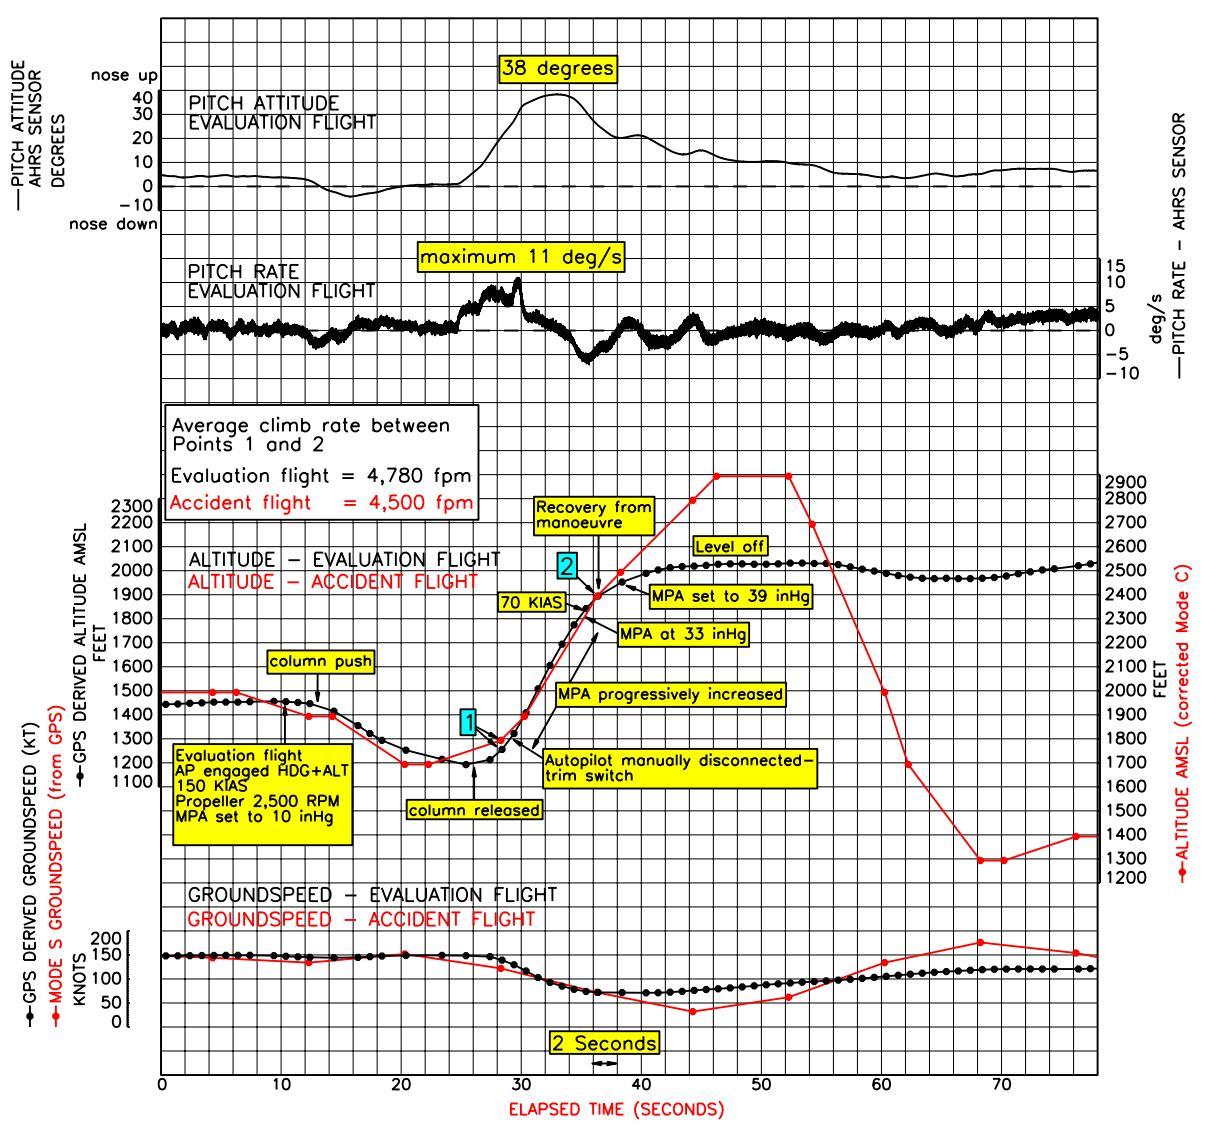
Figure 12

On subsequent tests, the test pilot pressed the pitch trim switches, disengaging the autopilot, when he considered the control column force was excessive. This occurred at approximately 300 ft below the set altitude. It was noted that the pitch trim had reached a setting of 3.5, which equated to a significant nose-up trim position for the weight and CG.

Comparison of accident and evaluation flight (autopilot engaged in heading and altitude hold, with control column pushed and then released)
