ACCIDENT REPORT

REPORT NO 5/2017

Fatal man overboard accident from the scallop dredger *King Challenger* (BA 87) south-west of Scalloway, Shetland Islands 23 June 2016

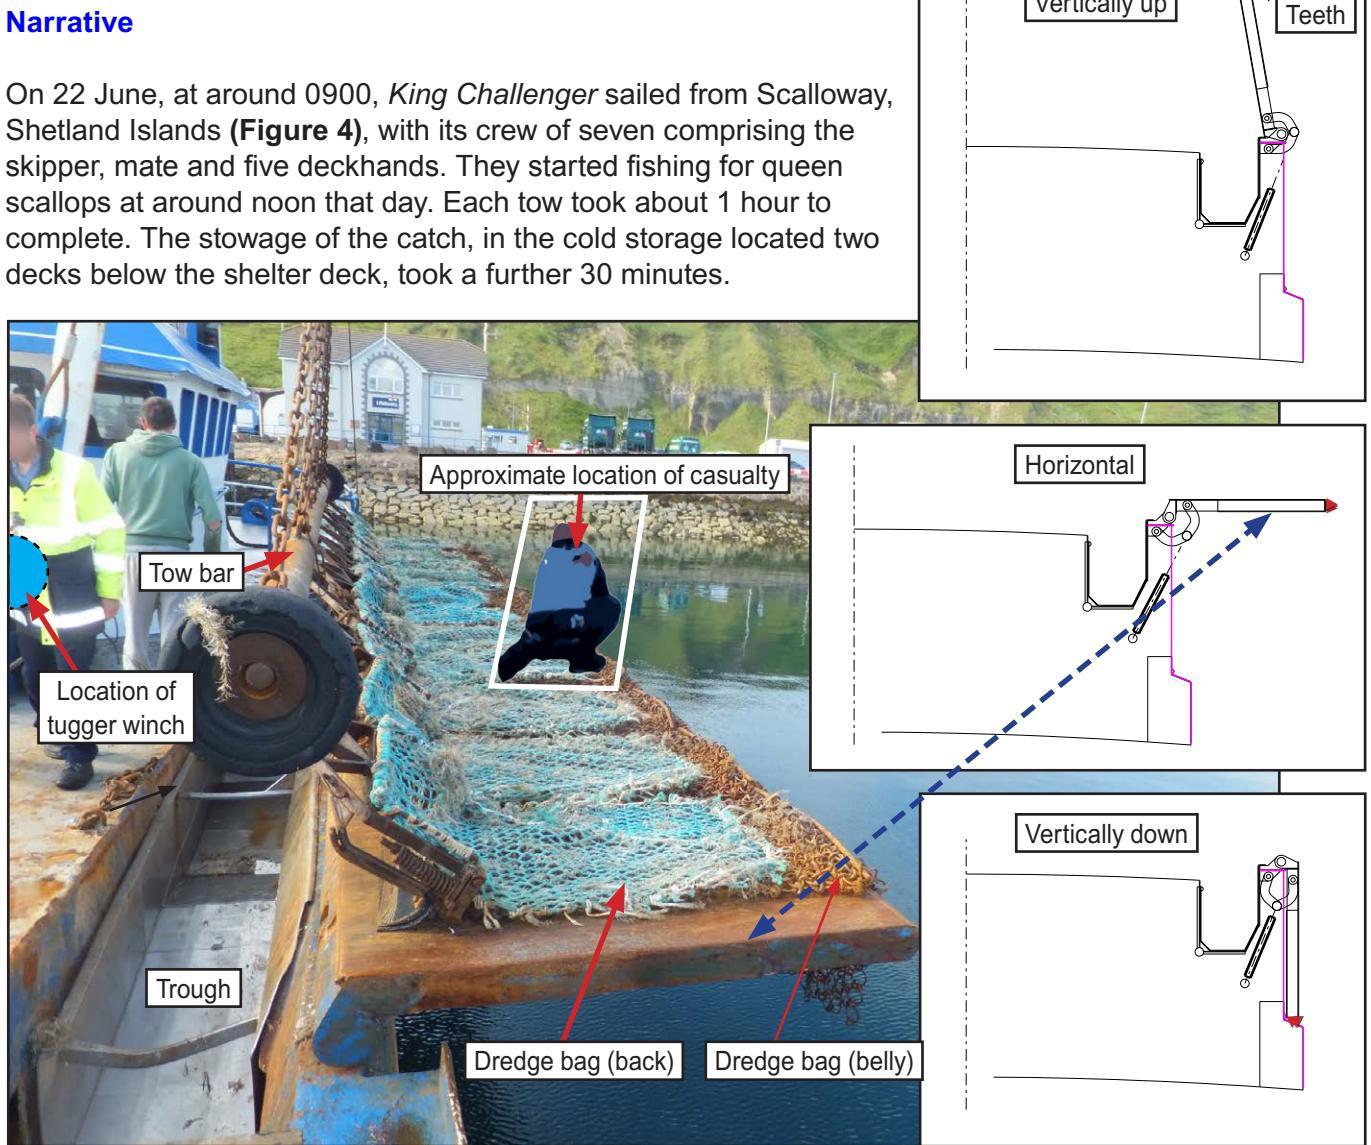
King Challenger was fitted with hydraulically activated tipping doors (Figure 2) for emptying the scallop dredges when it was built in 2006. The tipping door is a rotating bulwark that is used to invert the dredge bags to empty the catch. Steel rings at the bottom of the dredge bags hook on to teeth on the end of the door (Figure 3). In operation the door has three positions: vertically down, horizontal and vertically up. The doors are controlled from the bridge, so the crew can remain clear of the moving equipment.

Figure 2: Hydraulically activated tipping doors in the horizontal position (inset: door working positions)

Scott had climbed onto the horizontal tipping door to unhook the damaged dredge bag from the end of the door. His wellington boots would not have offered much traction against the wet polypropylene back of the bags, and it is possible that when the vessel rolled, he lost his footing and fell overboard. He was not secured to the vessel by a safety line and, as there was nothing within his reach to grab hold of when he slipped, it is not surprising that he was unable to prevent the fall.

Following Scott's accident, *King Challenger*'s owners prohibited all their vessels' crews from climbing on the tipping doors at any time, unless they were wearing a lifeline. They also introduced a new method for repairing the bags in which the defective bag was hauled onto the deck for repair with the doors being left in the vertically down position throughout.

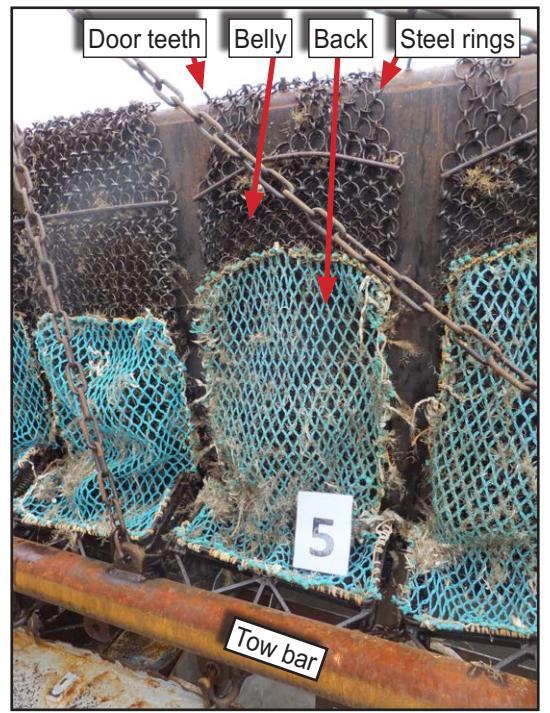
Figure 3: Dredge bag shown 'vertically up'

King Challenger was equipped with 12 dredge bags on each side. Each bag consisted of a lower half, called the belly, constructed of interlinked steel rings, and an upper half of polypropylene net known as the 'back' (**Figure 3**).

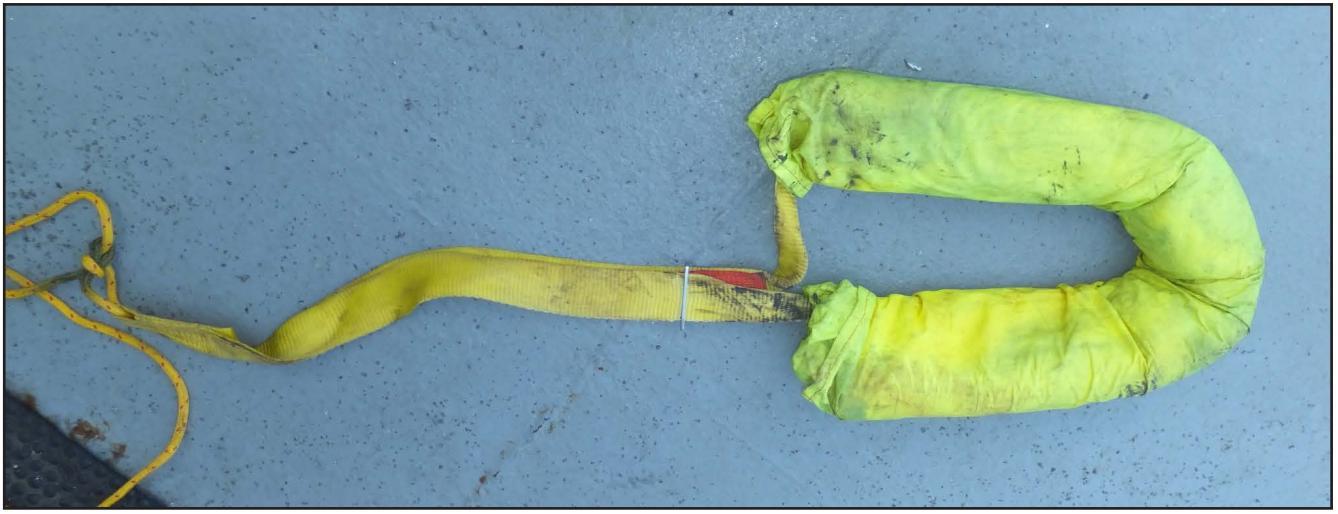
Figure 5: 'Moby' manoverboard recovery harness

Scott was a strong swimmer, and initially was able to swim towards the vessel. However, after only 4 minutes in the cold water, he lost the ability to keep hold of the Moby harness and, soon afterwards, became unresponsive.

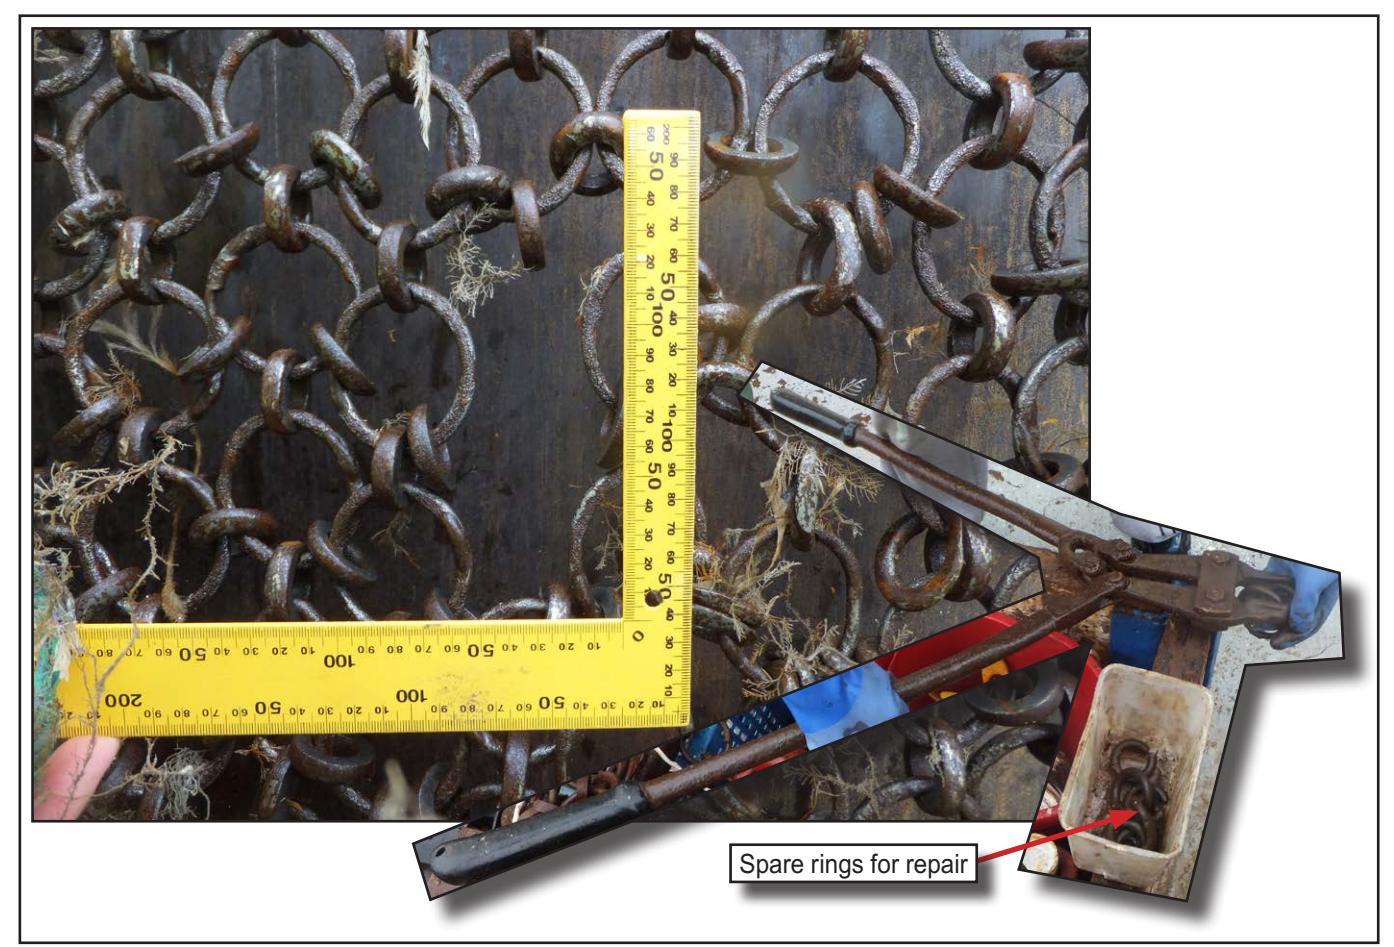
The most common damage to the bags was the breaking of one of the metal rings that makes up the belly. The loss of a single ring would result in an opening on the bag nearly 15cm in diameter, and cause most of the catch to fall out of the bag. Consequently, it was the usual practice on board to repair any such damage before the next trawl. The repair was carried out by crimping a new steel ring in place using a special tool (**Figure 6**).

Figure 6: Damaged bag (inset: Repair tool and spare rings)
