Report on the investigation of the failure of a mooring line on board the LNG carrier **Zarga** while alongside the South Hook Liquefied Natural Gas terminal, Milford Haven

resulting in serious injury to an officer

on 2 March 2015

**REPORT NO 13/2017**

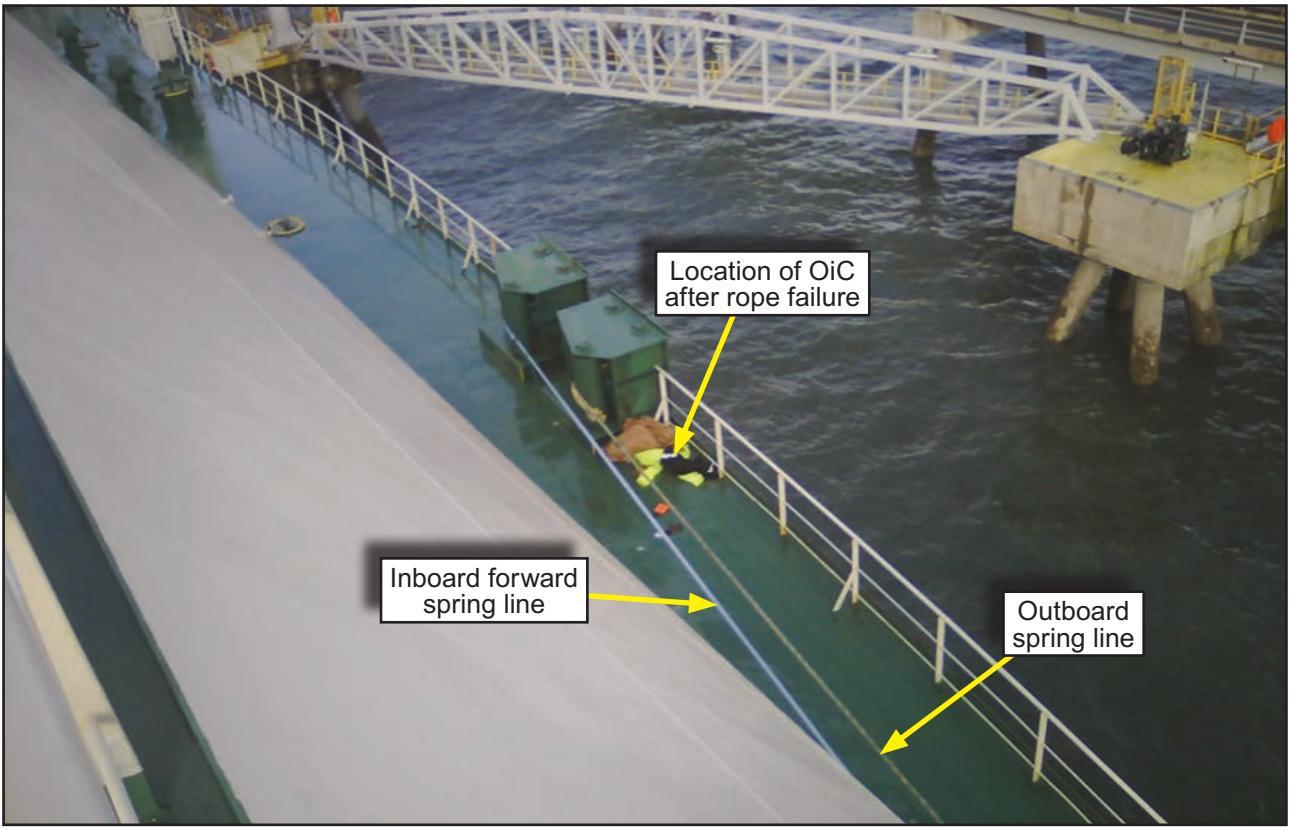
Figure 6: Location of OiC found after rope failure

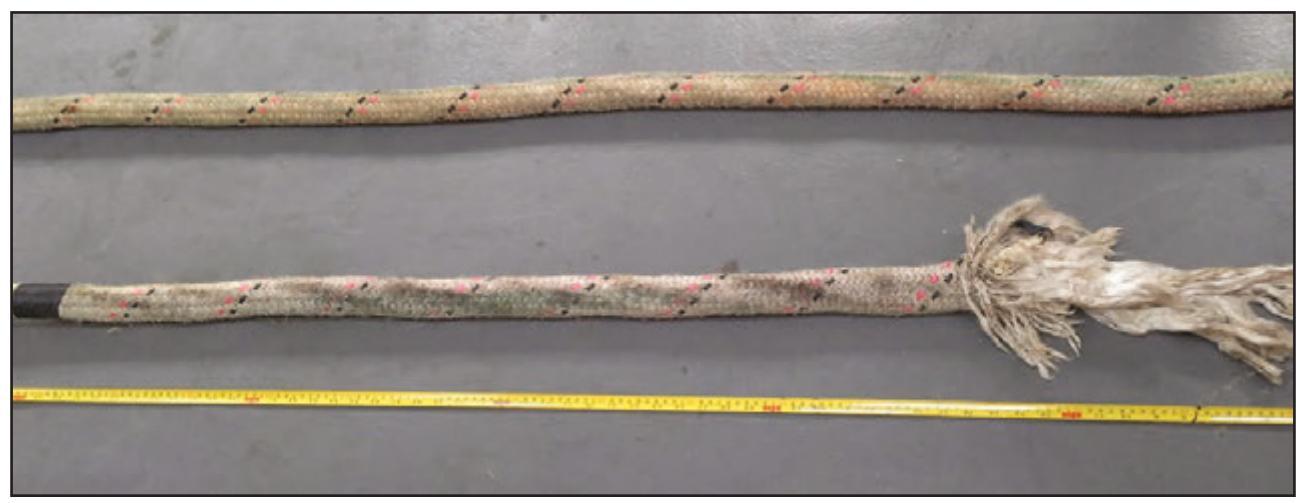
TTI was contracted **(Annex I)** to conduct a laboratory examination of the rope and break testing of its yarns. Close visual examination of the break site identified that the yarn fibres had suffered localised fusing and hardening, and that the failure had been caused by tensile overload. Away from the break site, the rope **(Figure 28)** appeared to be in generally good condition.

Figure 28: Initial visual examination of failed rope

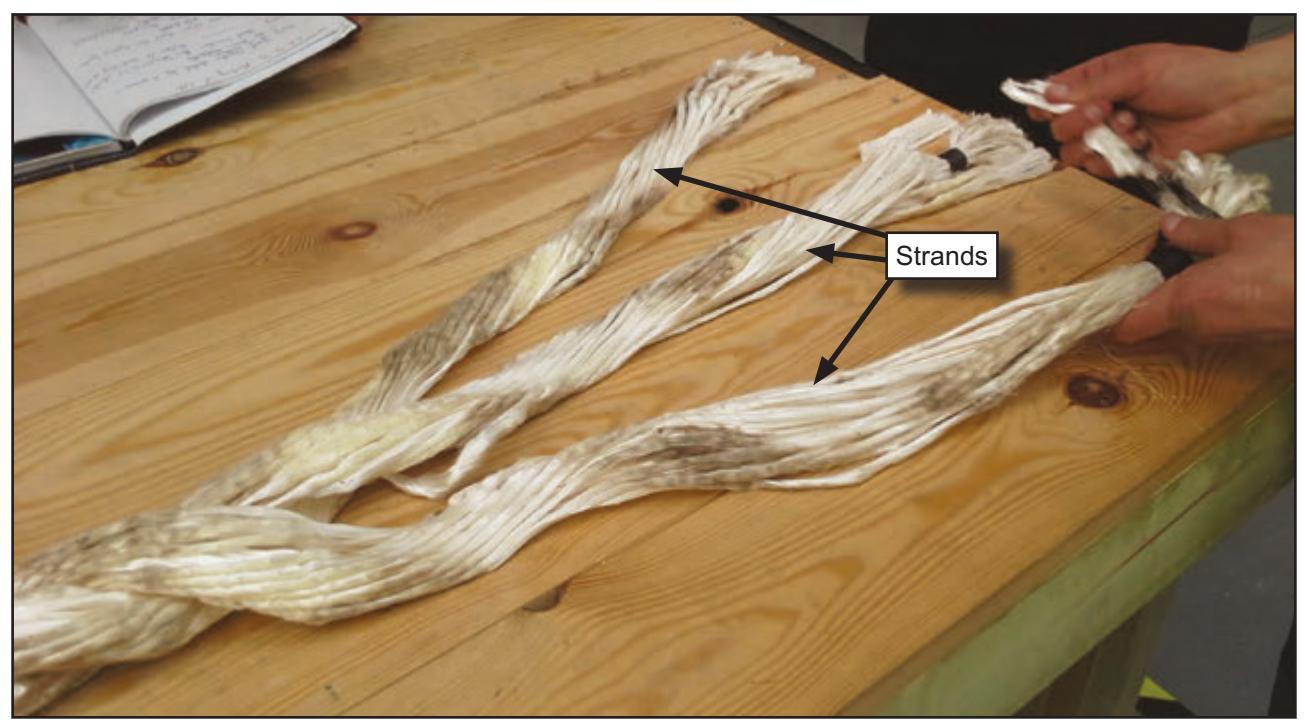
Having recognised that the yarns were failing at kink locations, and that the kinks in the inner yarns were significantly more severe than those in the outer yarns, a further 32 yarns from the shore end rope sample were tested. This time six inner and six outer yarns were used from each strand. The calculated residual strength of the sample dropped from 79% to 61% of the specified MBL.

Figure 29: HMPE load bearing 3-strand core of failed rope

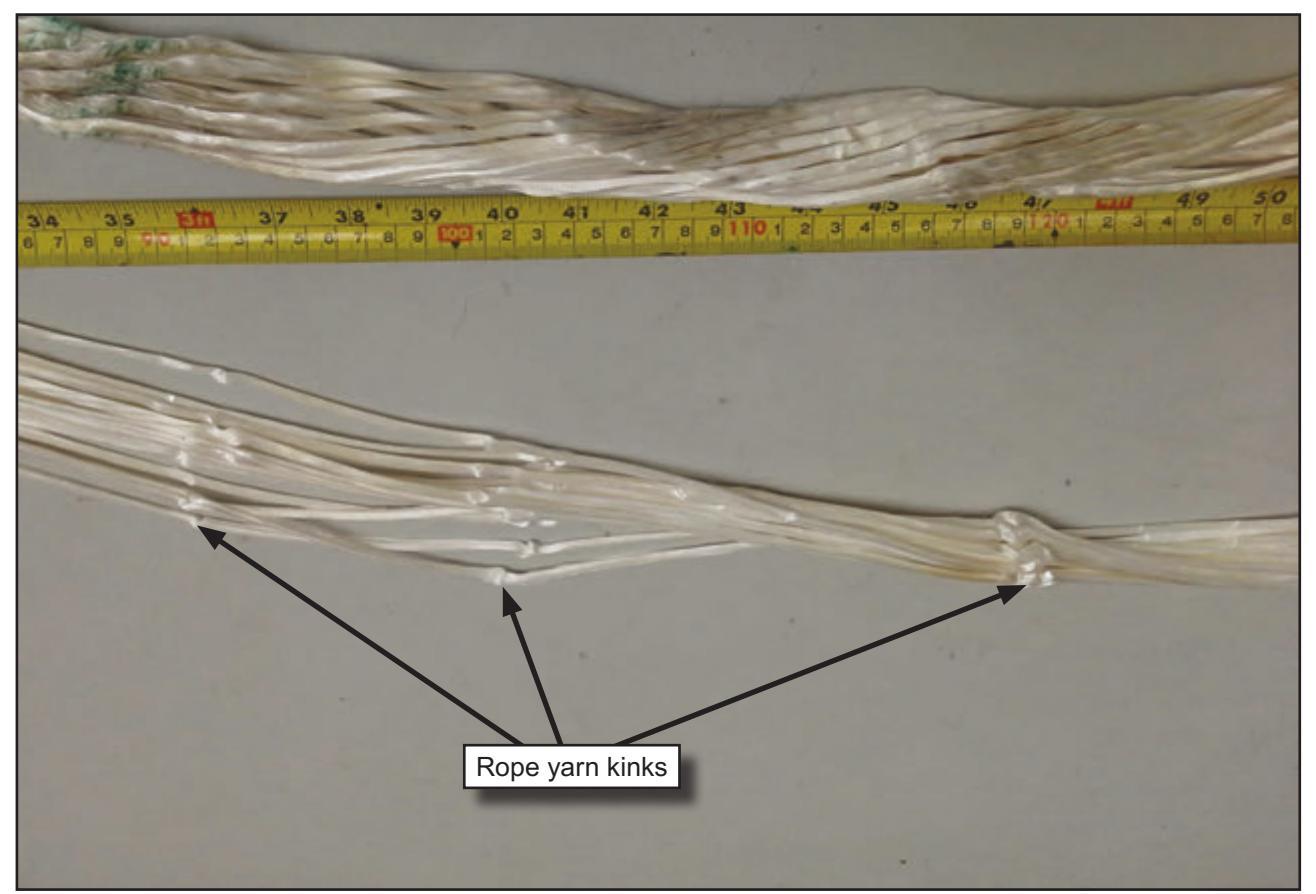
Figure 30: Rope yarn kinks in the strands

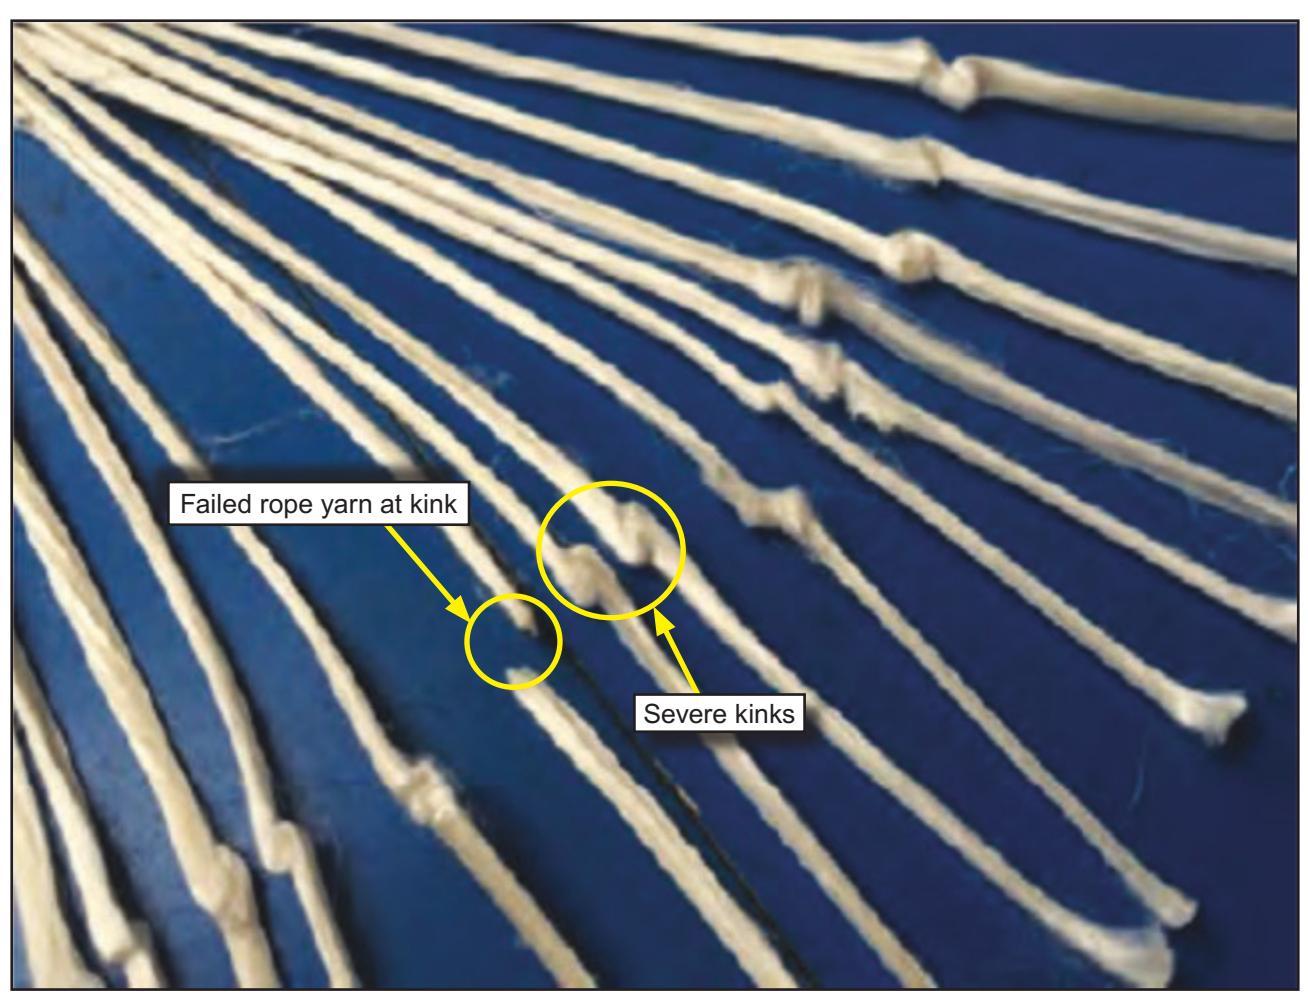
Figure 31: Severe kinking within the inner rope yarns

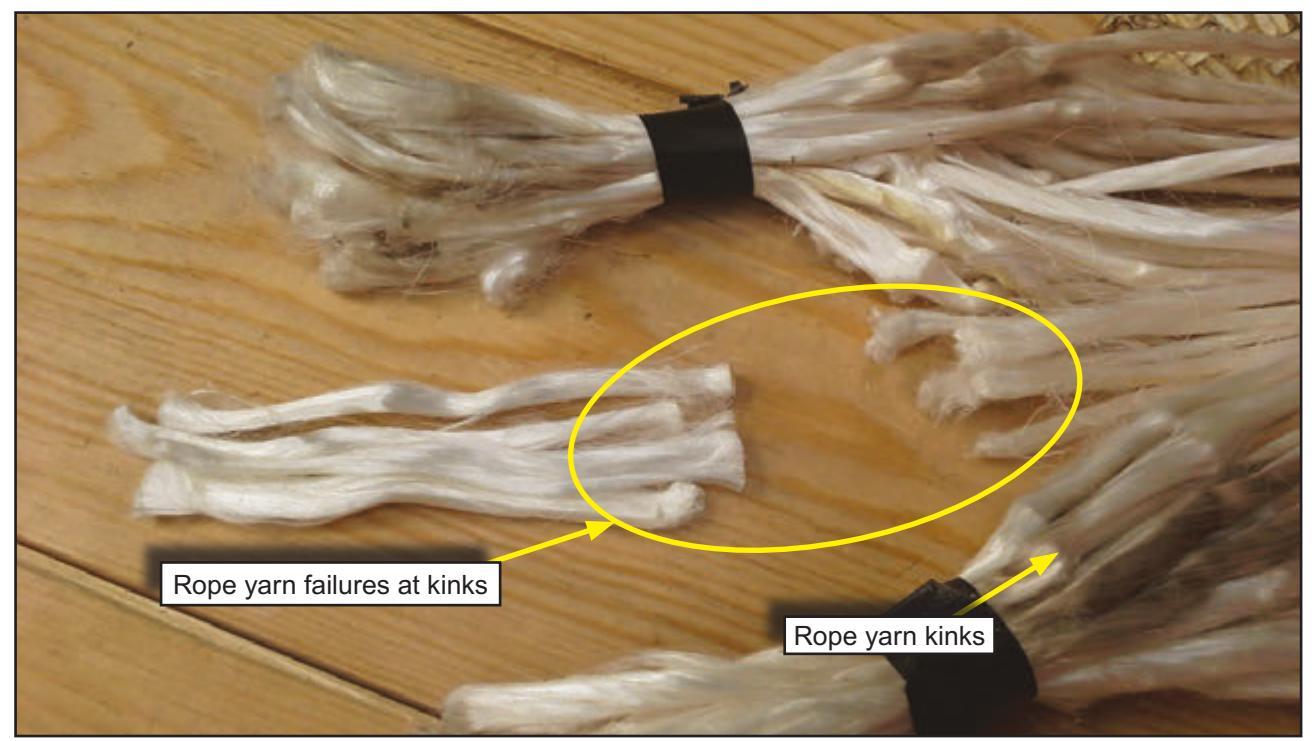
Figure 32: Sheared rope yarns at kinks

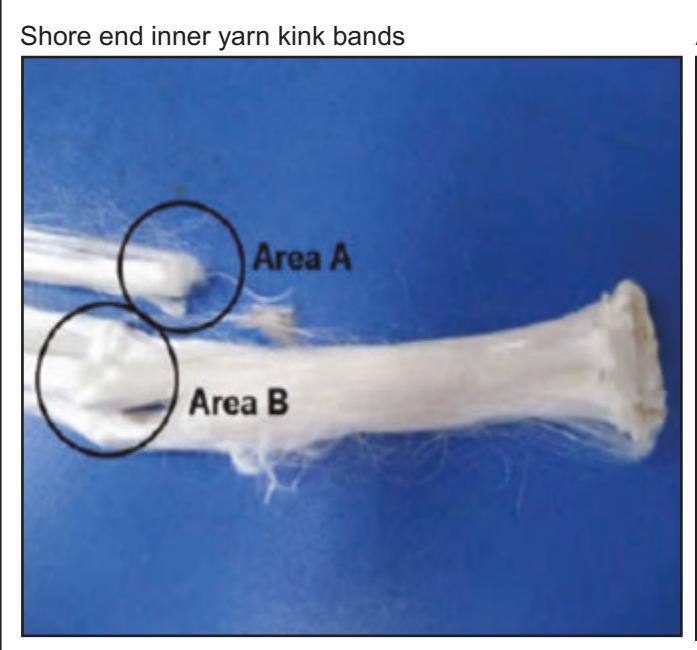
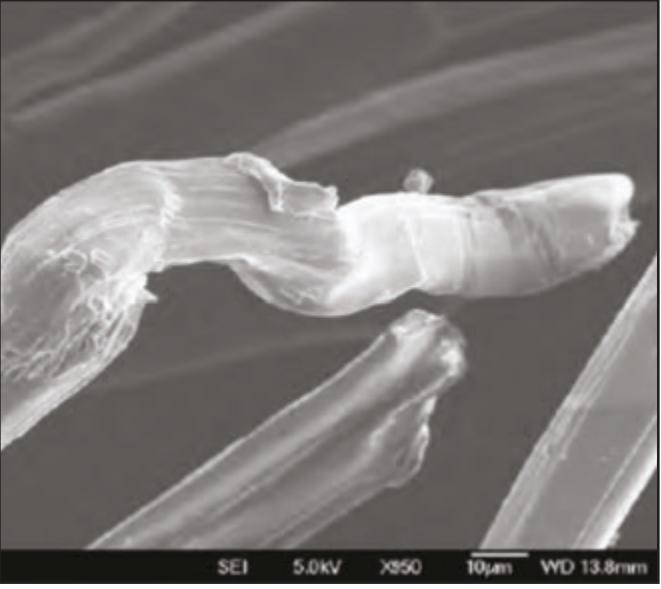
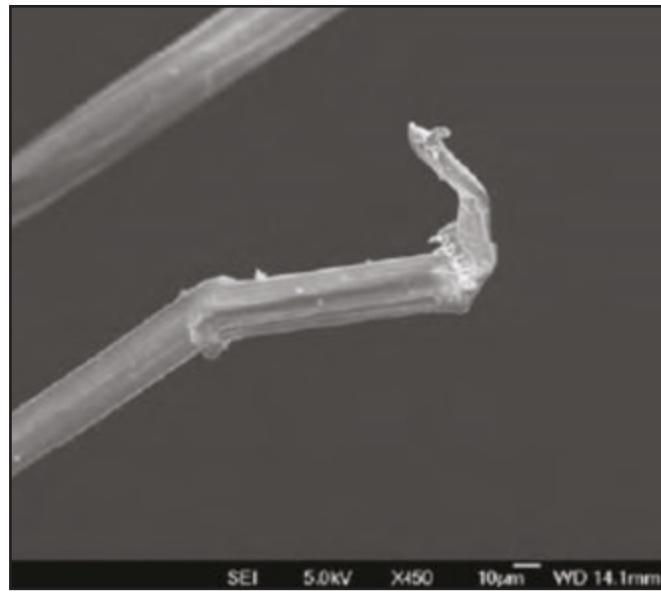
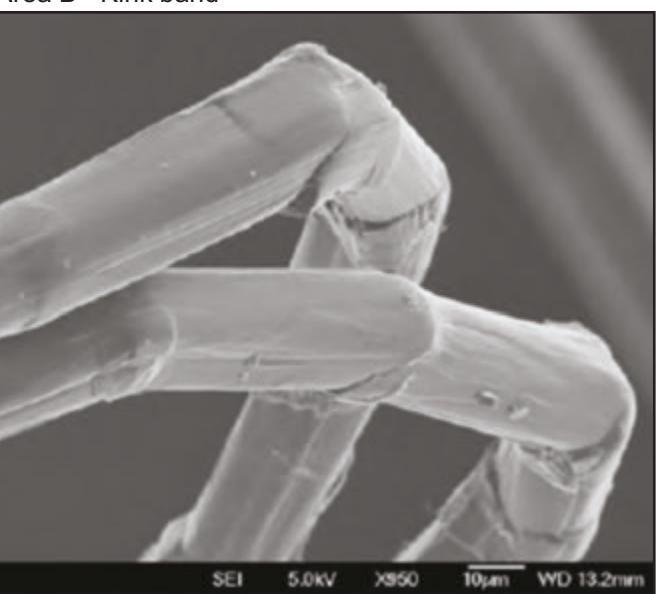
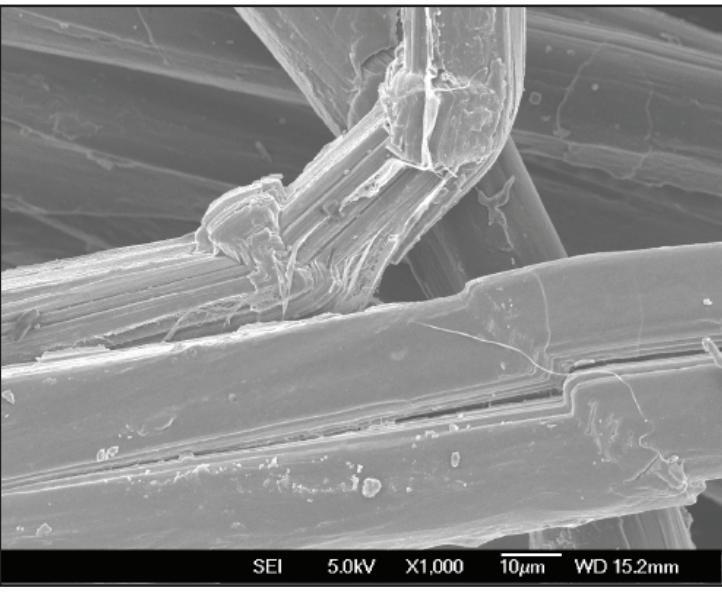
Area A - Kink band filament failure

Area B - Kink band

Bend and Z kinks in flilaments

Figure 33: SEM examination of yarn kinks and fibre kink bands

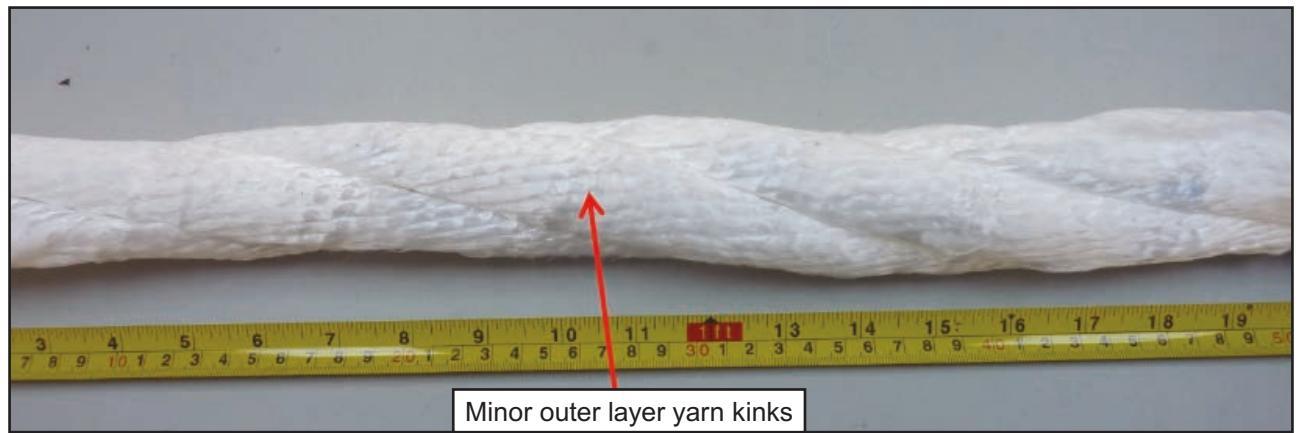
Figure 37: New rope minor kinks in outer yarns

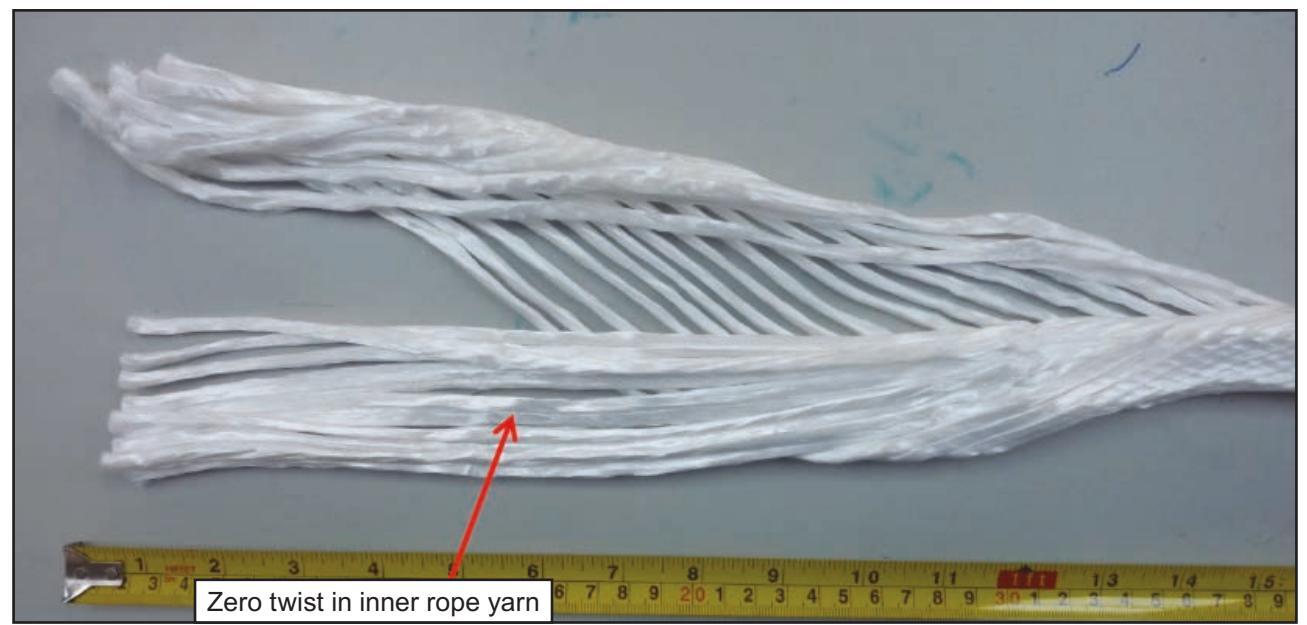
Figure 38: Inner rope yarns with zero twist

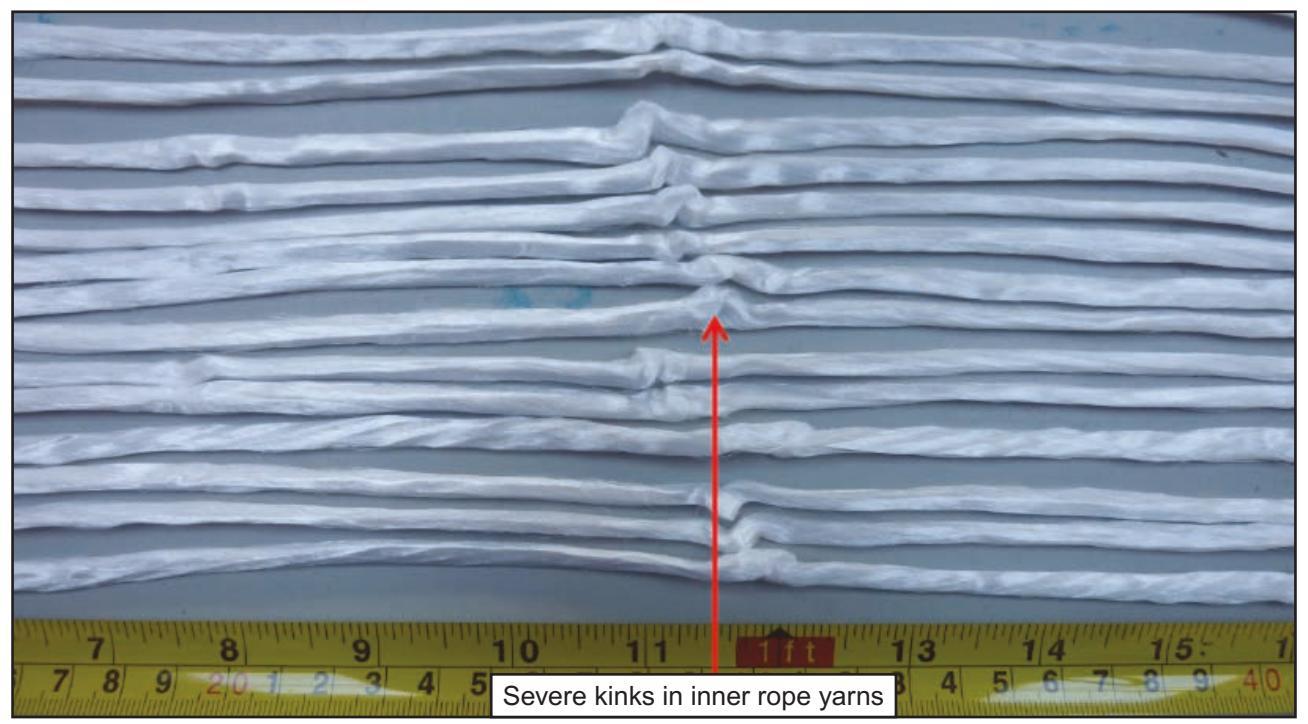
Figure 39: Severe kinks in inner rope yarns

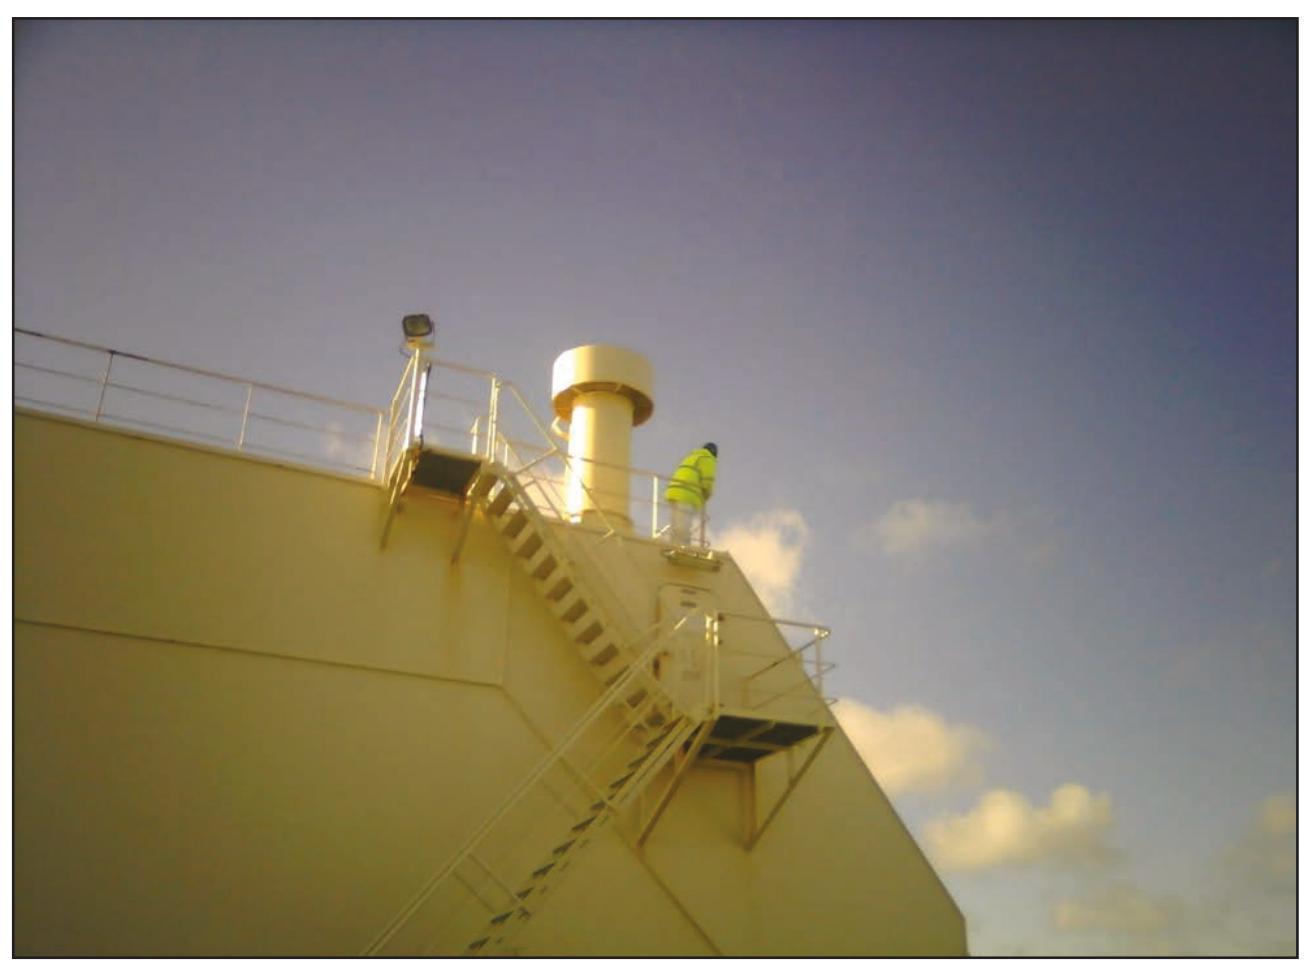
Figure 41: Alternative position, outside snap-back danger zones, for coordination and control of mooring line operations
