AAIB Bulletin: 2/2018	G-GARB	EW/C2016/09/01	
ACCIDENT			
Aircraft Type and Registration:	EV-97 Teameurostar UK (Eurostar), G-GARB		
No & Type of Engines:	1 Rotax 912-UL piston engine		
Year of Manufacture:	2013 (Serial no: 2013-4104)		
Date & Time (UTC):	18 September 2016 at 1058 hrs		
Location:	Near Builth Wells, Powys		
Type of Flight:	Private		
Persons on Board:	Crew - 1	Passengers - 1	
Injuries:	Crew - 1 (Fatal)	Passengers - 1 (Fatal)	
Nature of Damage:	Destroyed		
Commander's Licence:	National Private Pilot's Licence (Microlight)		
Commander's Age:	55 years		
Commander's Flying Experience:	316 hours (of which 316 were on type) Last 90 days - 58 hours Last 28 days - 22 hours		
Information Source:	AAIB Field Investigation

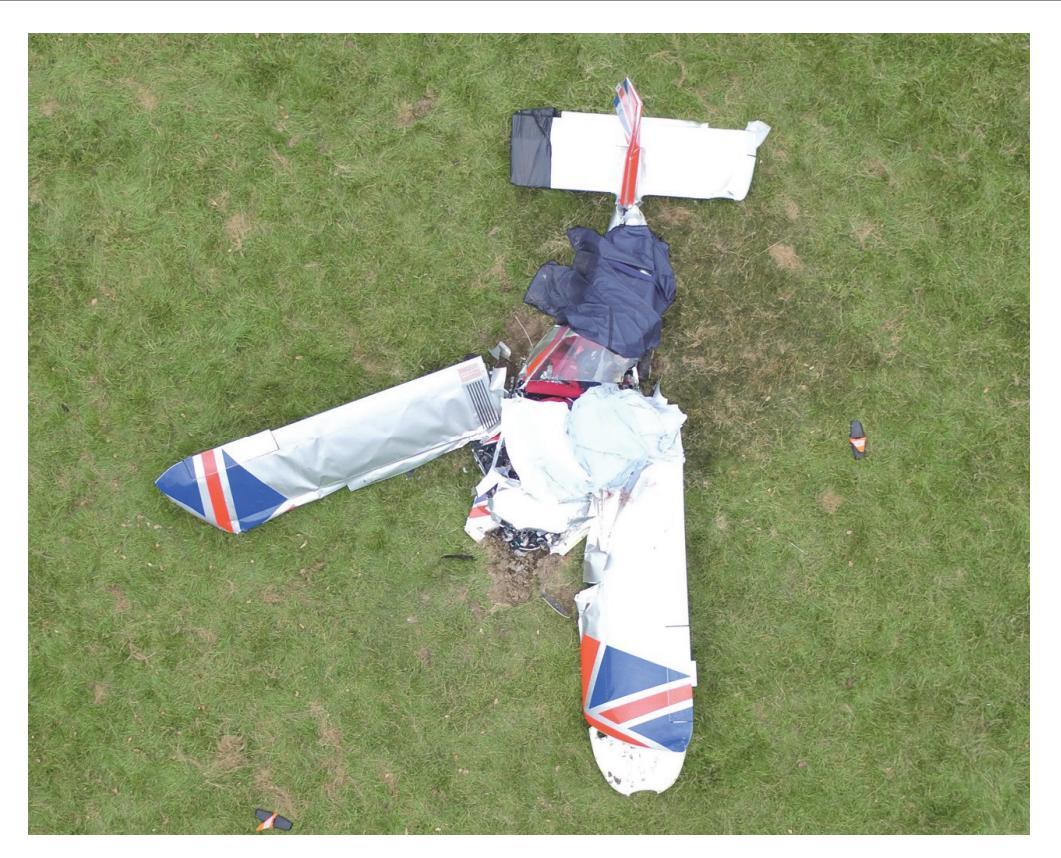
Figure 2
Overhead view of the aircraft wreckage at the accident site

The aircraft wreckage was found in a field near Builth Wells, about 360 m and 102° from the last recorded radar return. The wreckage was resting in its initial impact crater, indicating that it had a high vertical speed and low forward speed at impact (Figure 2). The left wing had folded forwards and had sustained significant impact damage to its leading edge near the root but no damage to the outer portions. The right wing had suffered leading edge compression damage along its entire length, and there was an imprint from the right wing in the ground, indicating a steep nose-down impact. Behind the tail, about 50 m away, was a section of the left wing belly fairing (Figure 3). Between this point and the main wreckage site there were no other parts of wreckage.

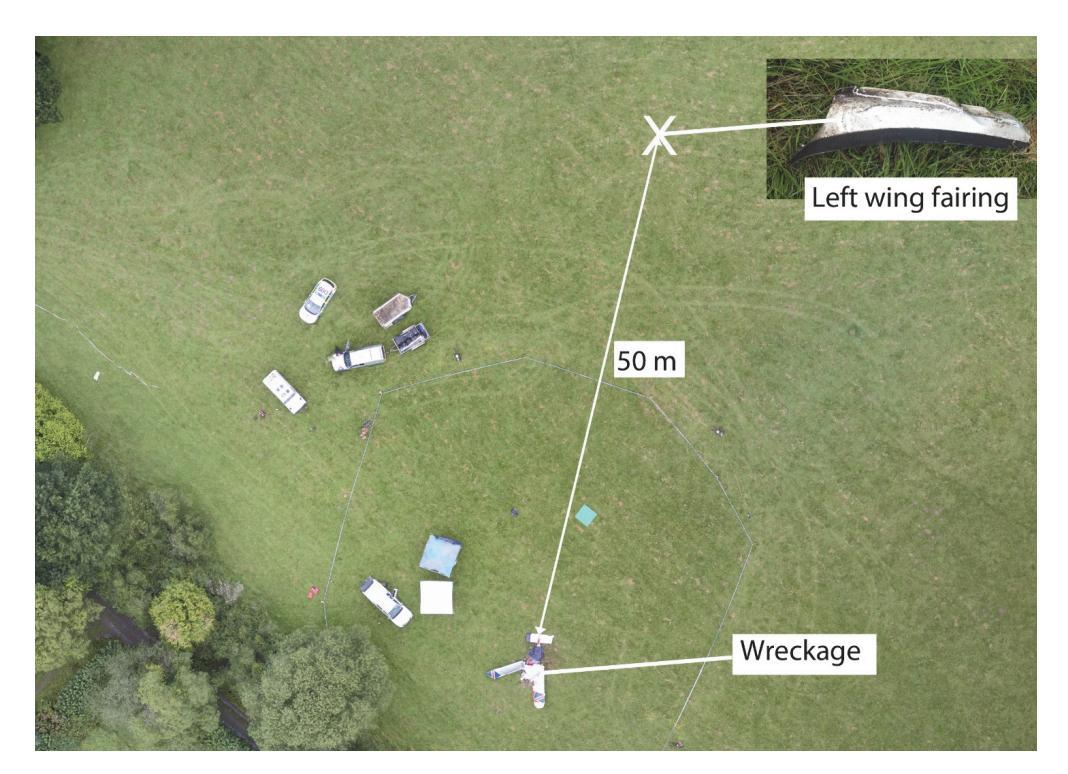
Figure 3

Overhead view of the accident site showing distance to the left wing lower fairing

The left wing belly fairing was found 50 m aft of the main wreckage which indicated that it almost certainly detached in flight. An upwards bending of the wing in flight, while the fairing was initially snagged on the flap control rod, would create the tears around the holes seen in the fairing and there was no other practical explanation for this fairing damage or for its location. This physical evidence, from the upward bending failure and the belly fairing, combined with the evidence from a number of eye witnesses who reported observing something wrong with one wing as the aircraft descended, resulted in the investigation concluding that the left wing failed in upwards bending in flight. This would have caused a spinning-type descent as observed by the witnesses.

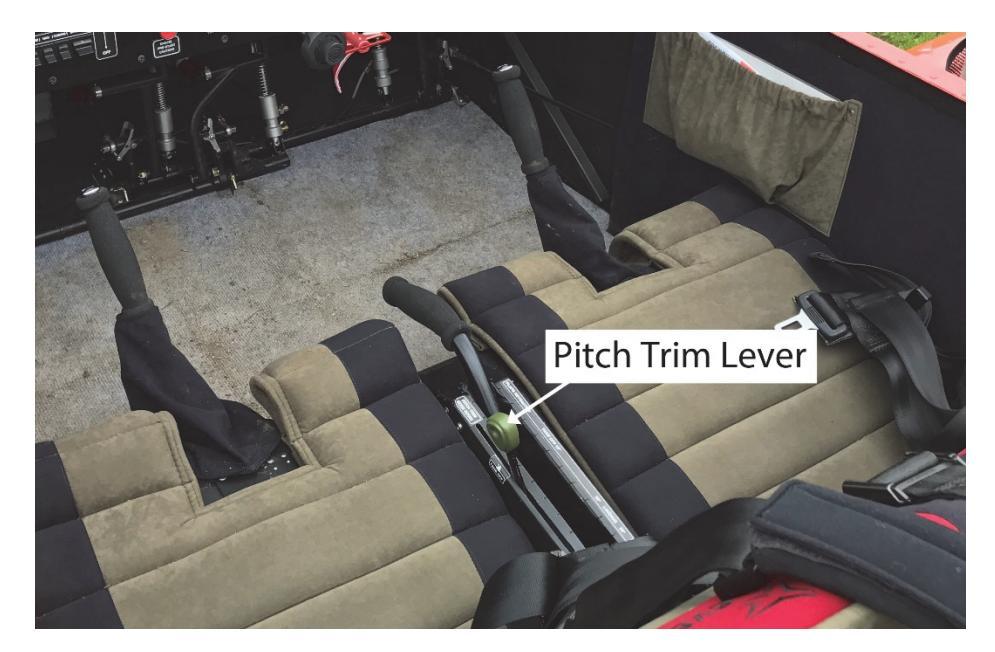
Figure 6 Pitch trim lever on another EV-97 aircraft

The elevator had a trim tab which was operated via a 'Bowden-type' cable and a lever mounted between the seats (Figure 6). This trim lever was pushed forward to generate nose-down trim and pulled aft to generate nose-up trim.

It is possible to envisage a number of events which could have startled the pilot and led to an instinctive action on the controls. The position and design of the elevator trim control is such that it is possible to move the lever accidentally through a large part of its range and, anecdotally, this has occurred in the past. The flight evaluation revealed that this can cause a significant nose drop in a short period of time. During the flight evaluation the nose drop was expected so the test pilot could respond to it quite quickly, but if it occurred unexpectedly a pilot would react more slowly and the nose attitude could drop further, with further speed increase. A natural reaction by a startled pilot would be to apply an immediate corrective control input by pulling back on the control stick, and if he was aware that the trim lever had been knocked forward, he might pull the trim lever aft rapidly as well. Moving the trim lever aft in these circumstances would have the effect of reducing the aft stick forces and, in conjunction with a pull back on the control stick, reduce the feedback leading to a greater possibility of an excessive aft control input.

It is recommended that the Civil Aviation Authority require the Light Aircraft Association, the British Microlight Aircraft Association, Light Sport Aviation Ltd and Evektor to conduct a joint review of the design and location of the pitch trim mechanism on the EV-97 Teameurostar UK, and the amateur-built EV-97 Eurostar, to identify whether modification is required to prevent inadvertent, improper or abrupt input.

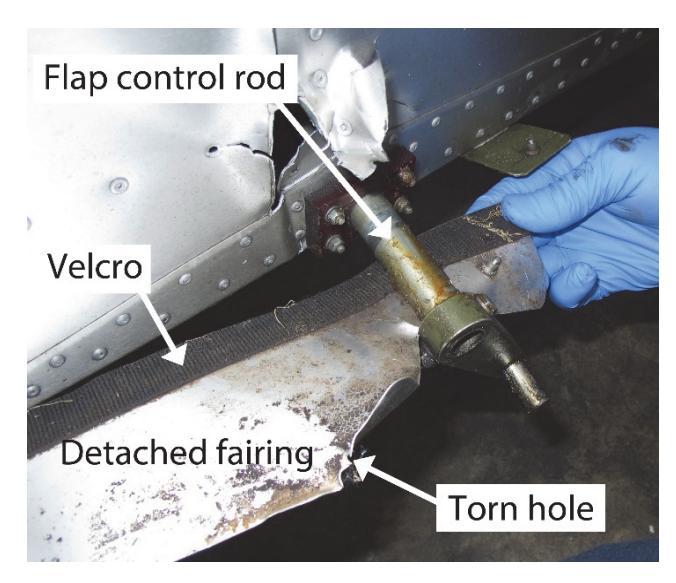
Figure 7 Detached left wing belly fairing held alongside the left fuselage of a different EV-97 aircraft

The section of left wing belly fairing, which was found 50 m away from the main wreckage, had torn holes where it had been attached by screws to the underside of the left wing. This fairing is not physically attached to the fuselage, but rests against its underside with a strip of Velcro to avoid fretting. There was an indentation in the fairing consistent with it having been pulled against the flap control rod (Figure 7).

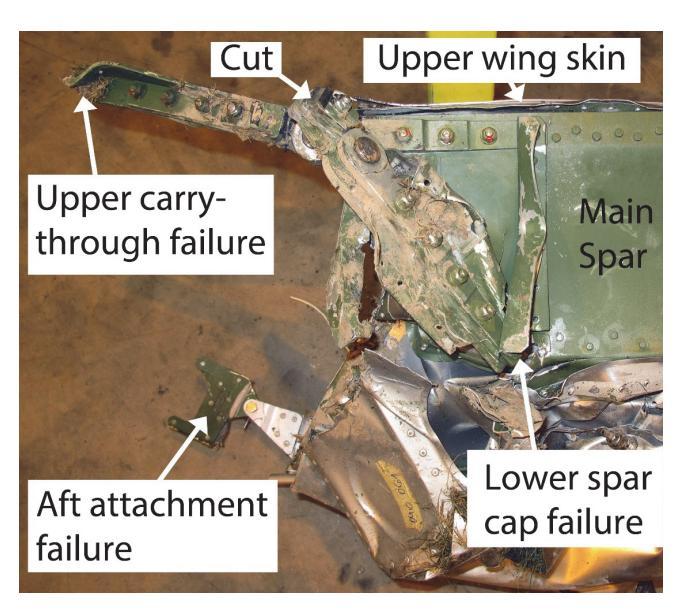
Figure 8

The right wing had remained attached and had suffered some internal damage as a result of crushing damage along the length of its leading edge. The left wing had suffered from a structural failure of its lower spar cap and the upper 'carry-through' spar cap in the fuselage had also failed (Figure 8). Both the upper and lower 'main-spar-to-fuselage' attachment fittings were intact; the lower fitting was cut on the fuselage side to enable the wing to be removed. The left wing aft attachment fitting had separated from inside the fuselage. These parts were sectioned and taken to a forensic organisation for detailed metallurgical examination.

View of the forward face of the left wing main spar showing the three failure locations and where the lower forward fuselage attachment was cut in order to remove the wing

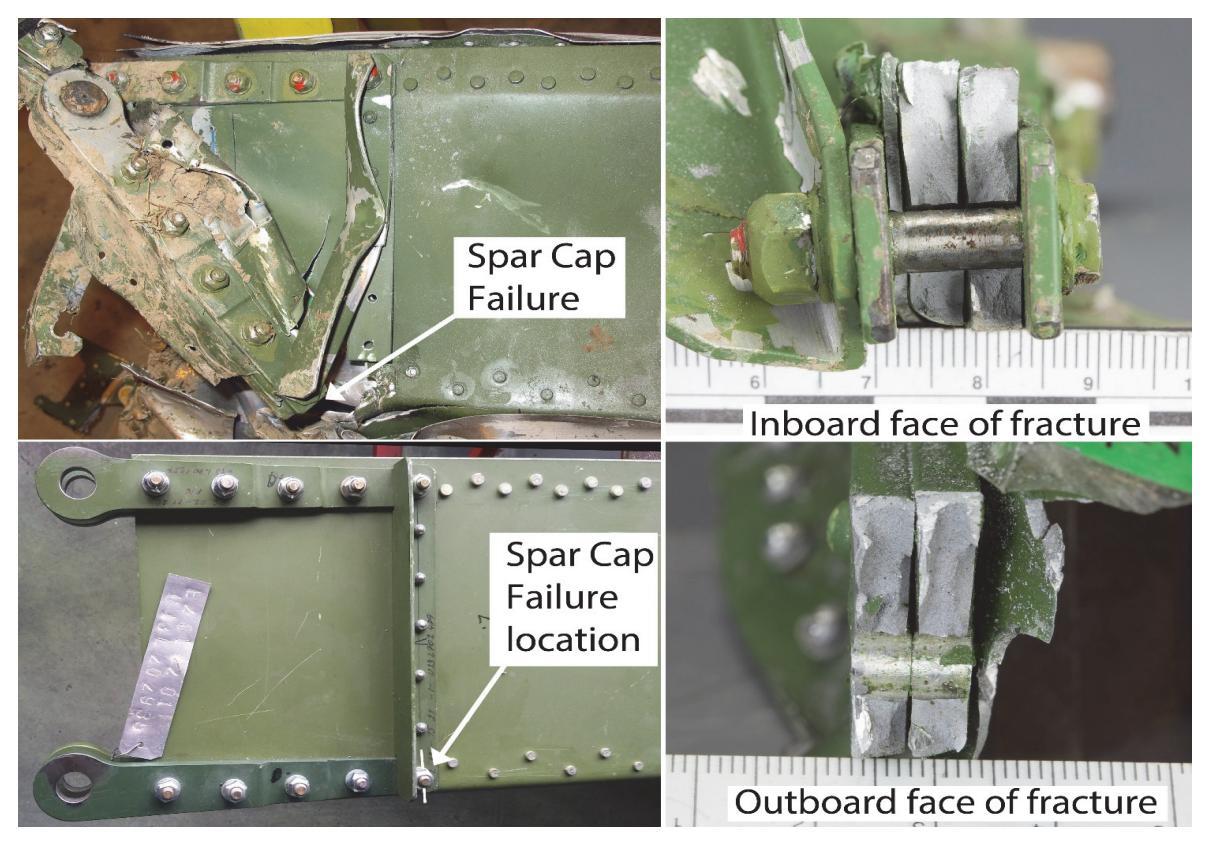
Figure 9

The lower wing spar cap consisted of two strips of 2024 T3 aluminium plate fastened together. Each strip had a cross-section of 25×5 mm, with the forward facing strip, known as the 'long cap', having a machined radius on one edge. The aft facing strip was known as the 'short cap' due to its shorter length. At the inboard end of the cap, the two strips, along with the web, were sandwiched between two steel attachments which were held together by five 6 mm diameter bolts. The fracture of the spar cap had occurred at the fifth outer bolt (Figure 9).

There was mechanical damage on the forward face of the web in the area of the fracture which suggested that there had been forward movement of the outboard section of the spar cap relative to the inboard section after failure, when the outboard section of spar was inclined upwards by about 25°. Both spar cap fracture surfaces were found deformed in a manner consistent with upwards bending, and there was 'necking' which is characteristic of overload failure. The fracture surfaces were examined in a scanning electron microscope (SEM) which revealed that both had failed in tensile overload with no evidence of fatigue or corrosion.

Top left: view of spar cap failure. Bottom left: location of spar cap failure on a new main spar. Top right: View of spar cap fracture looking inboard. Bottom right: View of spar cap fracture looking outboard

Metallurgical examination showed that the lower spar cap had failed in upwards bending as a result of a load that was in excess of its material strength. However, the outer portions of the left wing were found undamaged and all the impact damage was more consistent with aft loading, rather than an upwards bending load, at impact.

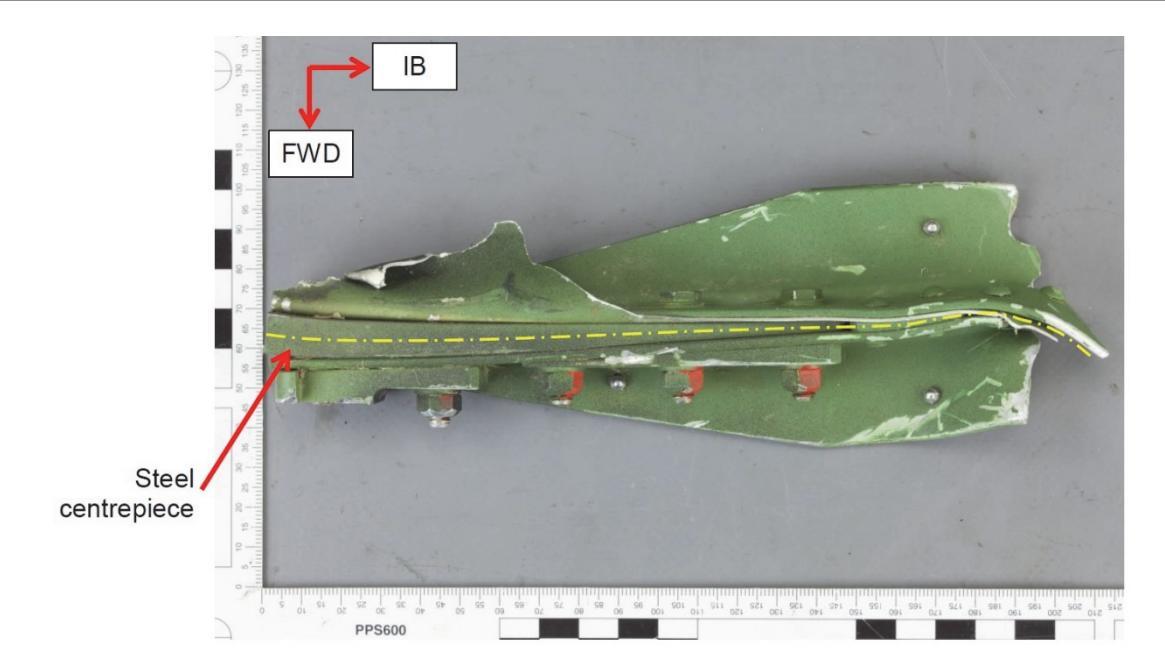
Figure 10

The upper carry-through spar had failed inside the fuselage beneath the left pilot's seat and this area had suffered significant crushing damage during the impact after the landing gear collapsed. There was extensive deformation of the lightweight aluminium structure around the fracture, which was consistent with the left wing moving forward. The steel centrepiece (Figure 10) was also found deformed, with an 'S' shape characteristic of buckling. However, SEM examination revealed that the fracture surfaces had ductile 'dimples' characteristic of tensile overload failure with no evidence of shear or compression. It appears that the upper spar was deformed in compression before failing in tension. There was no evidence of fatigue or corrosion.

Lower surface of upper carry-through spar. Cut on left side and fractured on right side. Centre section is made of steel. Fractured parts are aluminium

The upper carry-through spar may have suffered some compression damage in the air, but this was not conclusive and the final failure of the upper carry-through spar could have occurred in flight or at impact with the ground. The aft wing attachment probably pulled out at final impact when the wing was thrown forwards, although it may have also been damaged by the landing gear leg moving aft at impact.

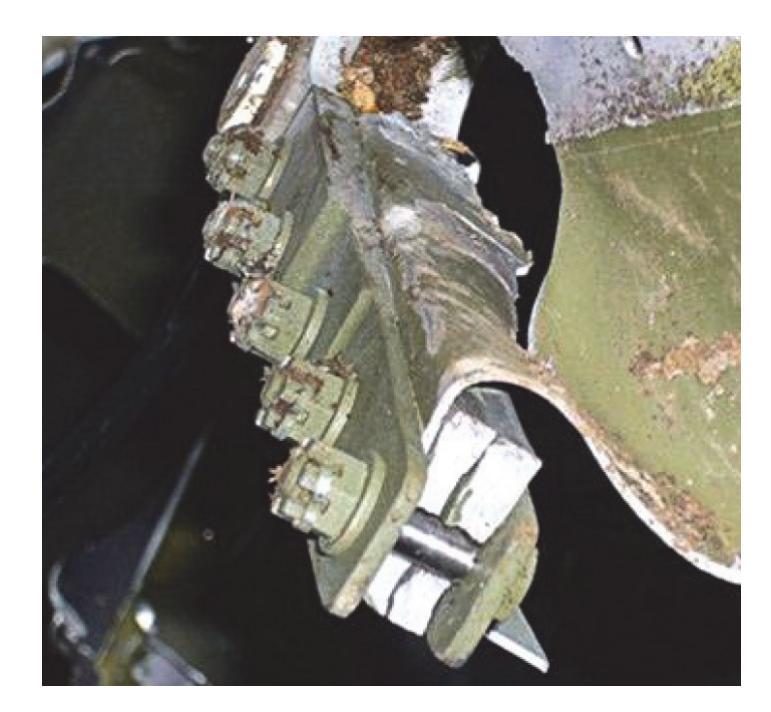
Figure 11

The Swiss investigation identified that there was an 'extrusion weld' in the short cap in the area of failure which would have weakened the strength properties of the material. The material strength at the failure location could not be determined but several hardness tests and tensile tests were performed away from the failure location which revealed a UTS range of 437 to 522 MPa. This aluminium material was different from that on G-GARB and was designated PA 7. According to the material manufacturer it was specified to have

Left wing lower spar cap failure of EV-97 registration 9-249 in Switzerland in 2006

According to the Swiss investigators the wings on 9-249 did not exhibit any signs of buckling. The lower spar cap had failed in tension, and although the fracture face of the upper carry-through spar had not been examined, they stated that it had not failed in compression.

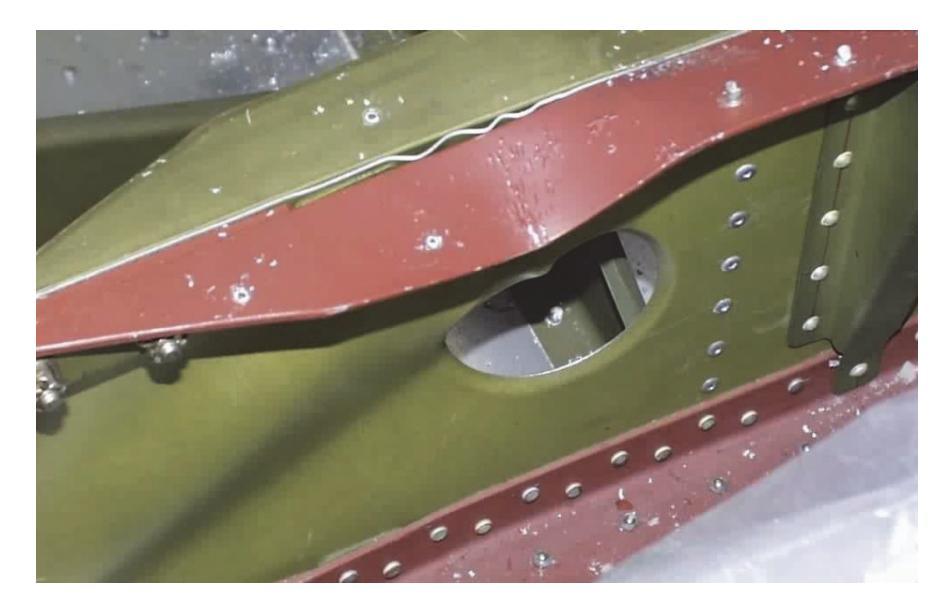
Figure 12

In 1999 the manufacturer conducted a wing strength static test to evaluate whether the wing design met the increased strength requirements to increase V_D from 156 mph (250 km/h) to 186 mph (300 km/h)¹¹ for its model 99 EV-97. One of the load cases involved a symmetric load to 4g at V_A and a mass of 480 kg. The fuselage was secured to the ground while a lifting force was applied to a series of collets around the left wing and an anti-drag force¹² was applied using load bags attached via cables and pulleys to the leading edge of the collets.¹³ No permanent deformations were found after unloading from the limit load and no permanent deformations were found after unloading from the ultimate load (1.5 times higher than limit). The load was then further increased until, at 1.6 times the limit load, the upper carry-through spar buckled (Figure 12).

Upper carry-through spar buckling which occurred at 1.6 times limit load during the wing strength static test

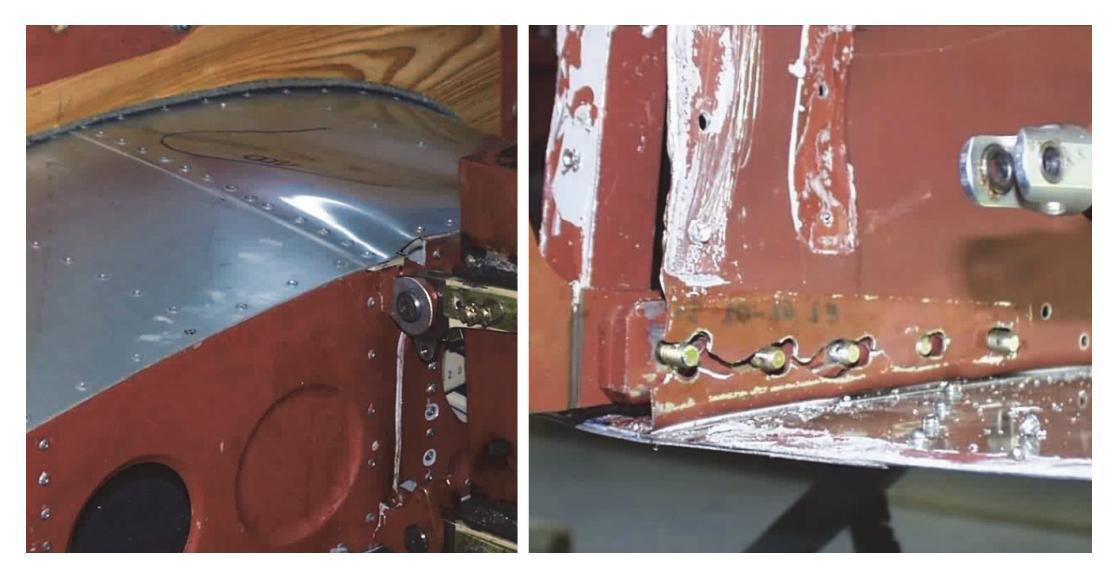
Figure 13

Upper wing skin buckling (left) and main spar web failure (right) at 1.68 times limit load during the wing strength static test
