KIT!

A quarterly guide to equipment care

Issue 79 | 2012

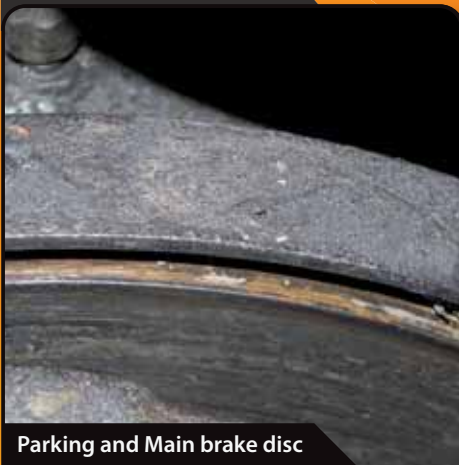
Parking and Main brake disc

A recent CVRT fire was caused by a seized parking brake cable – the parking brake lever was in the released position but the externally contracting brake band was still firmly clamped to the brake disc.

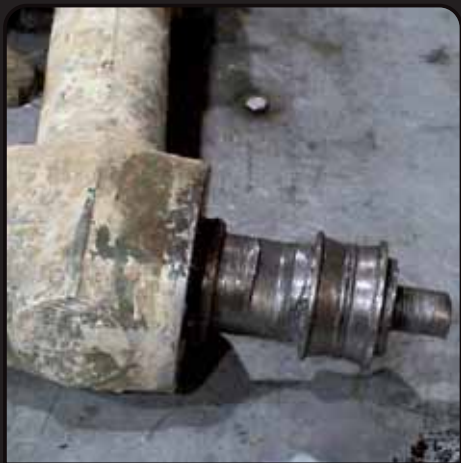
The damage to this stub axle, which the road wheel hub is mounted on, was caused by a lack of lubrication. The wear was so severe that the road wheel and hub were only retained on the vehicle by the track horns.

This is a direct result of a deficiency in the CVRT maintenance schedule, AESP 2350-T-220-601 which states that the road and idler wheel hubs should be checked for leaks.

There is currently no requirement to check the hub oil levels. Table 12 (500 mile track examination) will be amended to include a physical check of the road and idler wheel hub oil levels.

Units are advised to include this check in advance of the AESP amendment

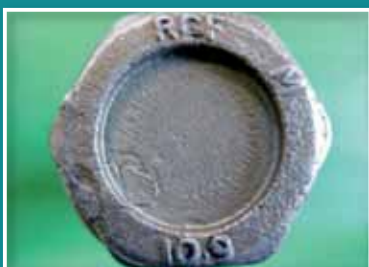
This bolt – which does not have the FV No. stamped onto the head is not compliant with the FV drawing and should not be used. These bolts do not have sufficient tensile strength to withstand the loads imposed

by a tightening torque of 700 Nm (CR2) or 730 Nm (T2) and have been known to stretch beyond the elastic limit.

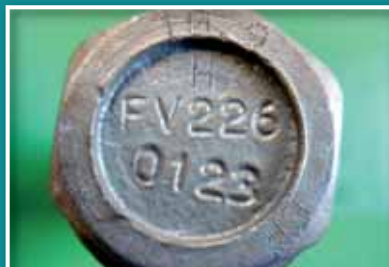
This picture shows the correct bolt with the FV No. plainly visible. Units are requested to examine all stocks of the sprocket bolt and reduce to scrap any holdings of the incorrect bolt.

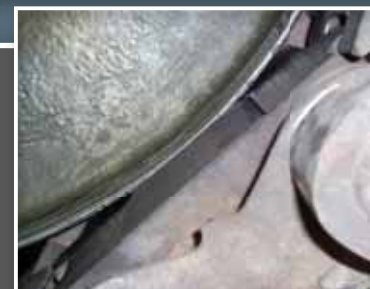
The crew reported that the LH idler wheel was running hot. With the HTT ram fully retracted it was noted that the track was still under tension. The idler wheel bearings were examined and the inner bearings had collapsed.

A new track had recently been fitted to the vehicle (80 links per track) and a link had been removed prematurely so that the tracks contained 79 links - which was acceptable when the suspension units were cold. The suspension units warmed up when the vehicle was used, increasing the track tension so that there was insufficient travel in the HTT ram to completely de-tension the track – the tracks were too short.

The excessive track tension was discovered because the idler wheel bearings were running hot. There will have also been less visible damage to the final drive bearings, the track end connectors, the sprockets and the hull of the vehicle which would have had to withstand the excessive forces that were trying to tear the final drive, top rollers and idler arm bracket away from the hull.

The picture shows an excessively worn idler wheel – the rate of wear increasing as the track tension increases.

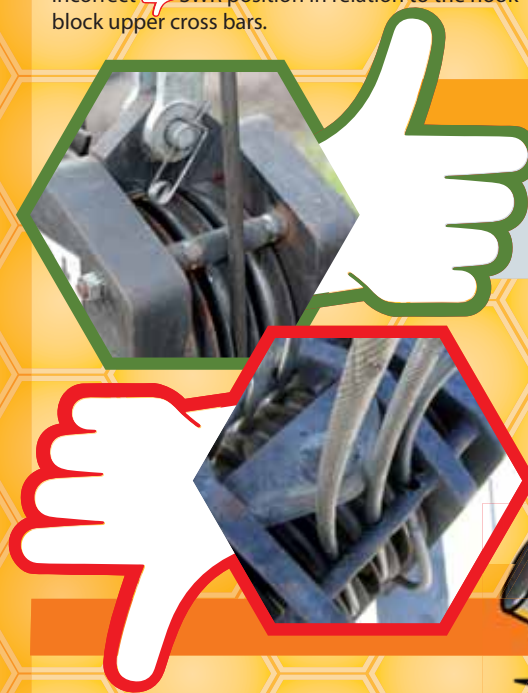
photograph clearly shows the heating and cutting effect which the SWR has upon the upper cross bars; however, what the photograph CANNOT show is the potential damage to the integrity of the SWR.

In the event that an operator has any doubt about the correct reeving procedure then they should consult the relevant AESP or seek further advice.

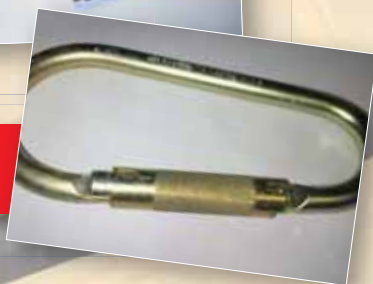
It is presumed that the leading edge of the track failed to ride over the single track roller, causing a sudden increase in the track rope tension. The Karabiner has a Safe Working Load (SWL) of 2000 kg; this exceeds the SWL of the track rope - which should have failed before the karabiner.

The karabiner, which had been used on many occasions, suffered from a fatigue failure.

Karabiners must not be used if there are any visible defects and should be destroyed to prevent inadvertent use.
