KIT!

Welcome to KiT! 83 Spring 2013

KIT 83 | 2013

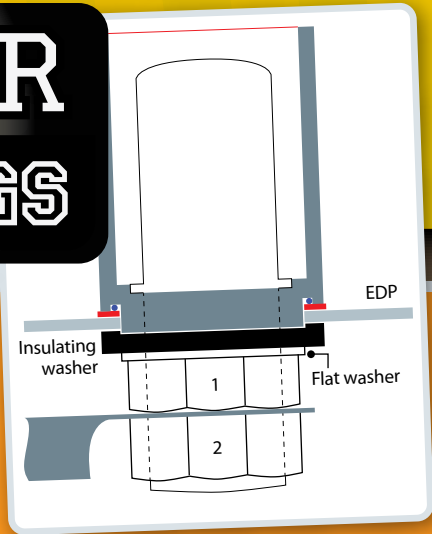
The Sotax quick release connectors are used to facilitate removal and replacement of the power pack. There have been many instances of catastrophic failure, caused by one or more of the following faults:

- Poor contact between the conducting surfaces. Caused by wear.
- Failure of the locking mechanism - Caused by wear.
- The harness securing nut (2) working loose through vibration.
- The connector securing nut (1) working loose.
- Physical damage to the connector - Caused by impact.
- High electrical resistance causing the connector to overheat and ignite.
- Incorrect assembly.

Electrical resistance - the generator positive connections share the load, which can be 500 amps. It is critical that the resistance across the connection, when made is a maximum of 0.05 Ω.

A resistance of 0.1 Ω at a load of 50 amps will cause a volt drop of 5 V (which is compensated for by the generator control unit) but will cause a build up of heat and an increased load on the generator or batteries.

There are various checks that should be carried out to ensure that the connector is serviceable:

- The connector is securely attached to the Engine Disconnection Plate (EDP).
- The silver plated securing nut (1) should be tight; do not attempt to hold the connector with pliers etc to prevent rotation as the plastic shield may be damaged. An additional steel washer (G1C 5310-99-946-7018), coloured red in the diagram can be fitted between the EDP and the connector (if the connector remains loose with the nut tightened).

- The washer is 1 mm high and only this washer should be used.
- The **insulating washer** should be in good condition, the recess in the washer should engage with the bottom of the connector plastic shield when fitted to the EDP.
- The silver plated **flat washer** should be fitted between the nut (1) and the insulating washer.
- The eyelet in the harness should be in good condition.
- The harness securing nut (2) should be tightened against the connector securing nut (1), which should be held with a spanner to prevent damage to the connector.

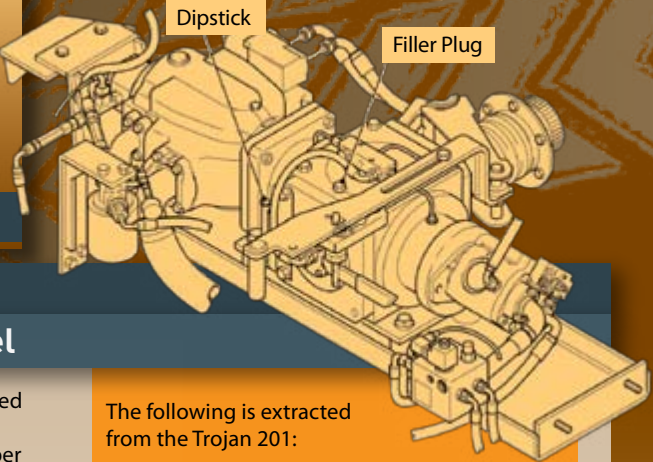
Trojan Bevel Gearbox Oil Level

The Trojan bevel gearbox oil level is checked during mission maintenance (IAW AESP 2350-F-101-601). There have been a number of failures of the gearbox and experience from Bovington suggests that, as the oil heats up during use, the lack of a breather allows the pressure within the gearbox to increase and blow the oil seals.

Work is in hand to fit a breather to the gearbox and as an interim measure it is recommended that the bevel gearbox oil level is checked as part of before use maintenance when the oil is cold. Any bevel gearboxes that require regular topping up should be reported to REME for investigation.

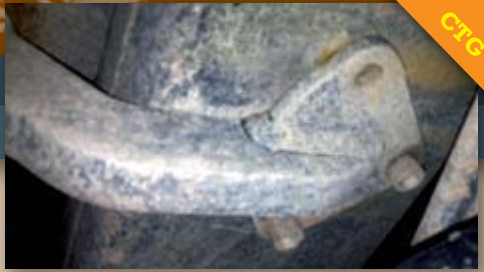
BV206d Notice - please check, monitor and report incidents on the supporting track arm fitted on both sides of each car on BV206 tracks for signs of sheared or rusted in bolts.

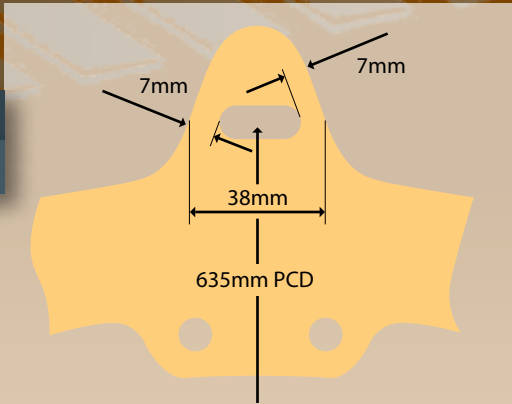
The sprockets are changed when the tooth profile contacts the wear indicator, which is machined into one tooth.

The indicator was introduced in 2005 when the sprocket drawing was uplifted to Issue 1. There are older versions of the sprocket in stock that do not have the wear indicator; these sprockets are at Issue M.

The drawing shows the positioning of the indicator so that the tooth wear can be measured. An EFR is NOT required to report sprockets that don't have the indicator.

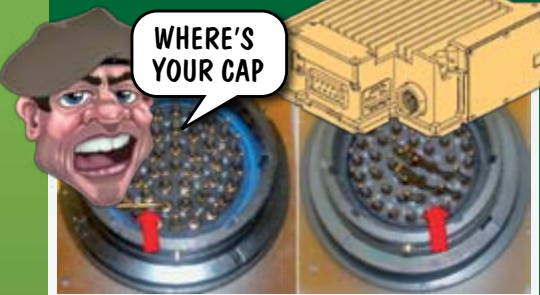
Trend analysis by the Original Equipment Manufacturer (OEM) identified there is a growing trend of, P1 connector failures on the VHF UKPRC355 and UKPRC358 radios. The majority of the P1 interface connector failures on the VHF radio chassis are due to the pins being damaged, bent or sheared. All VHF UKPRC355 and UKPRC358 radio users are to ensure that the protective dust cap is in place when the connector is not in use.

Damaged P1 connectors can be replaced at Level 3 following instructions in the IETP.

Equipment > Radios > UKPRC355/UKPRC358 > P1 (System) Connector - Change (remove and install)

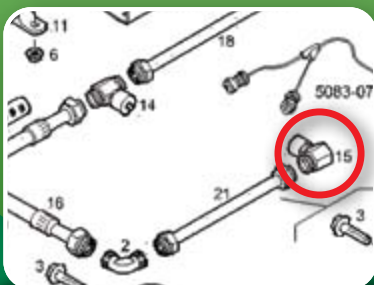
The Panther Project Team advise that the driver's side extinguisher nozzle in the engine compartment (Item 15, Spray Final) can become loose and hang down pointing to the ground. Units are asked to check the orientation and security of the nozzle.

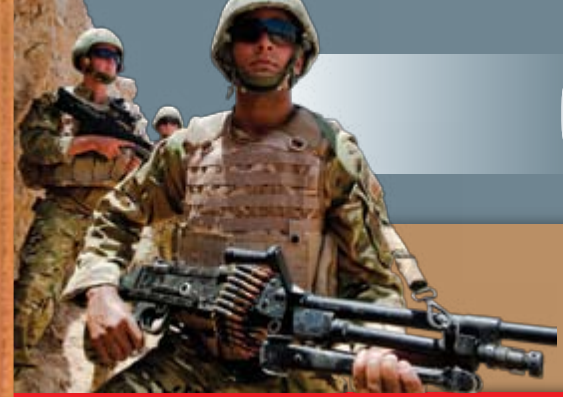
Ruptured cartridge in barrel

A reminder to all maintainers and users:
There has been a recent increase in reported GPMG breech explosions. Subsequent SEFIT inspection reports have identified a trend of fitted incorrectly matched barrels.

Correct CHS is critical to the safe functioning of the GPMG weapon system and preventing possible injury to the user or catastrophic equipment failure.
