Enhancing the Whole Life Structural Performance of Multi-Storey Car Parks

September 2002

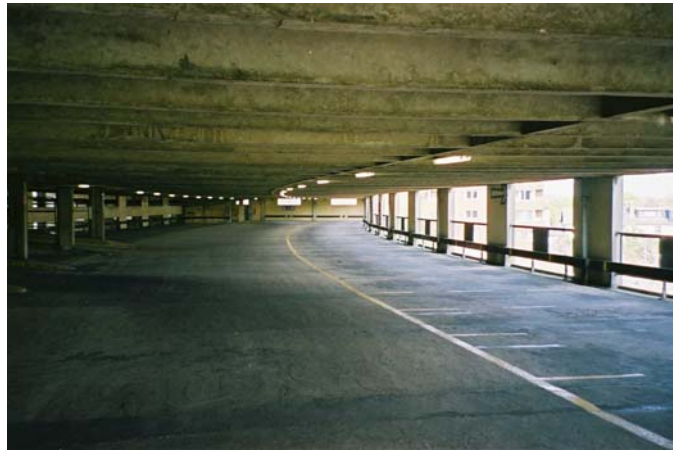
Photograph 1 Wide spans & few supports

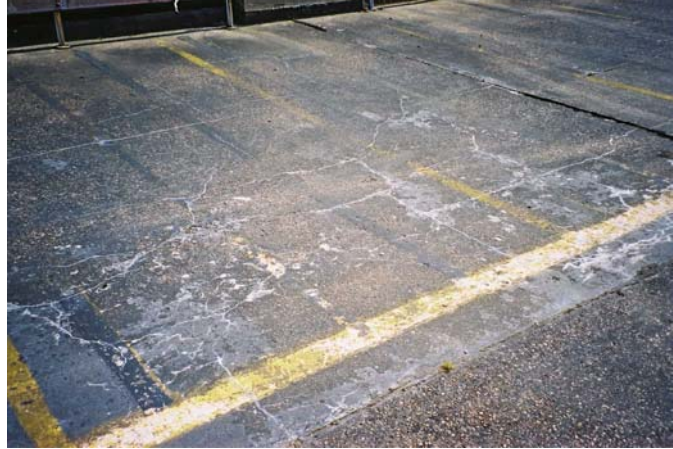
Photograph 2 Typical example of combined erosion/abrasion and frost damage of a concrete deck.

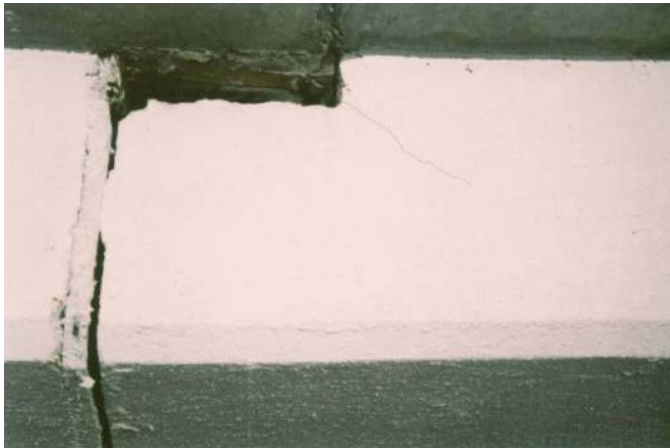
Photograph 3 Typical example of an under-reinforced half joint

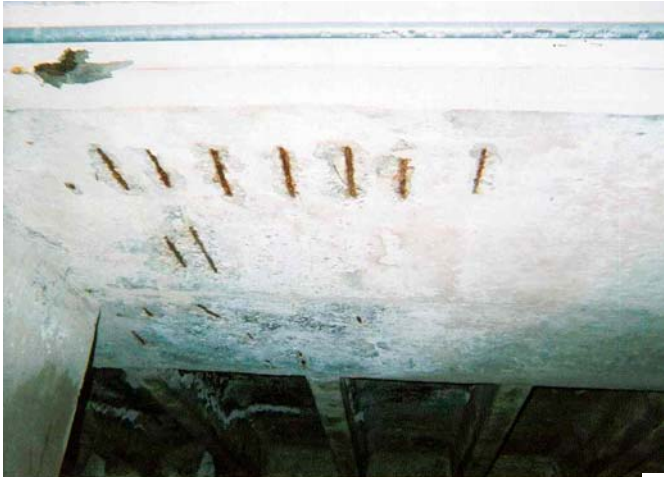
Photograph 4 Example of sagging reinforcement, low cover & corrosion spalling

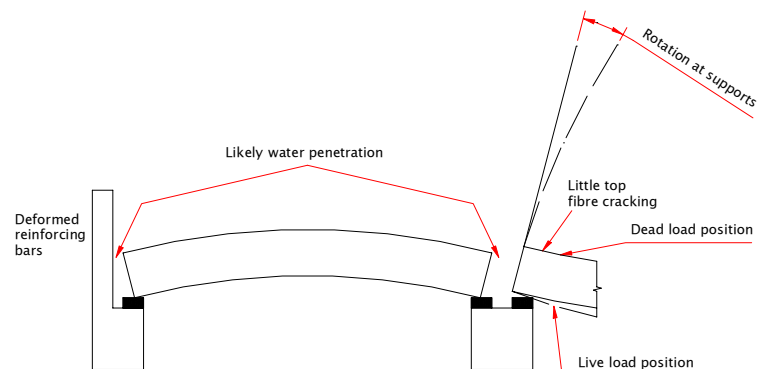
Figure 1 Schematic drawing of type of cracking & deformation due to hogging and creep in pre-stressed elements

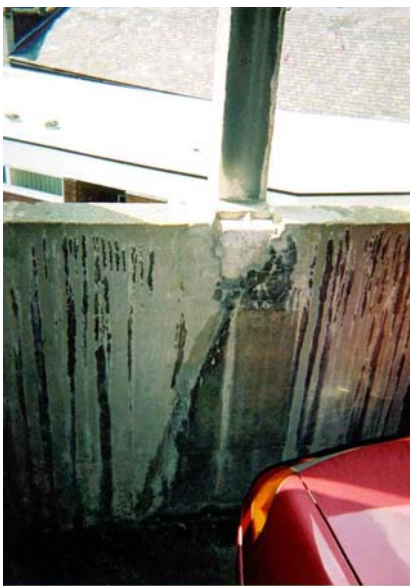
Similar defects occur when poorly cast fixing pockets for external cladding (such as pre-cast concrete mullions) crack and spall.

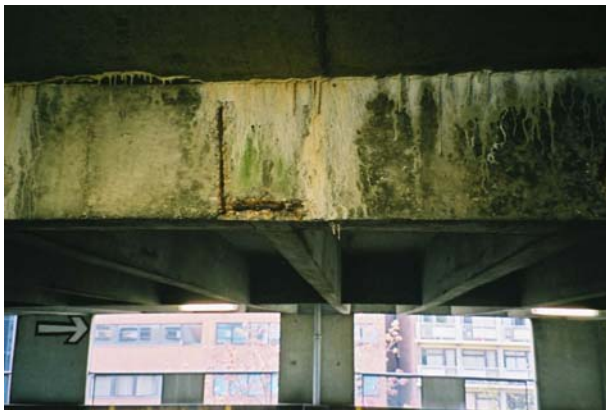
Photograph 6 Typical example of poorly placed reinforcement leading to low cover and corrosion spalling

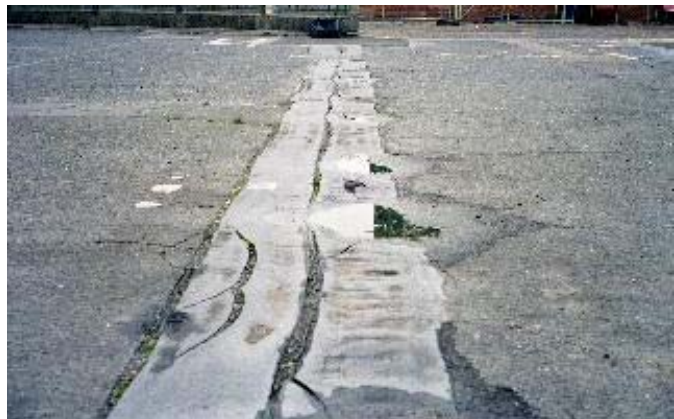
Photograph 7 Typical example of poorly constructed movement joint suffering premature deterioration

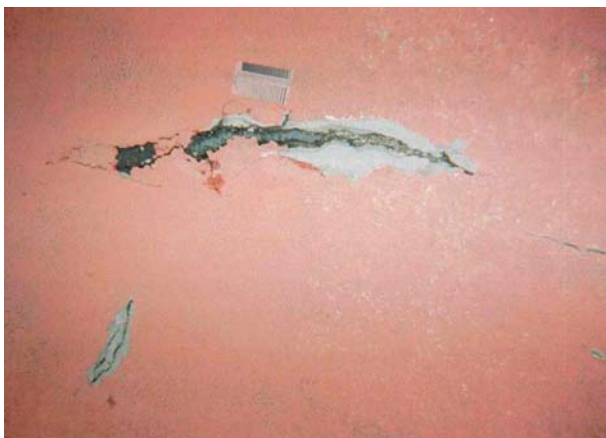
Photograph 8 Typical example of premature deterioration of a waterproof membrane due to defective installation & inadequate crack bridging capability

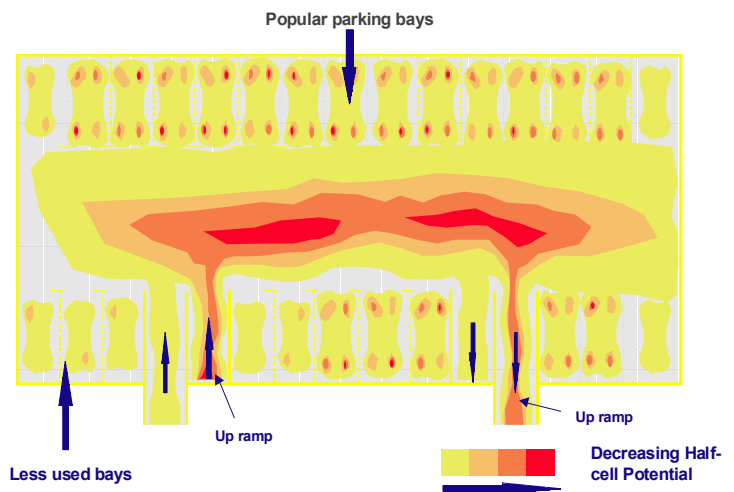
Figure 2 Areas of chloride concentration beneath vehicle tracks

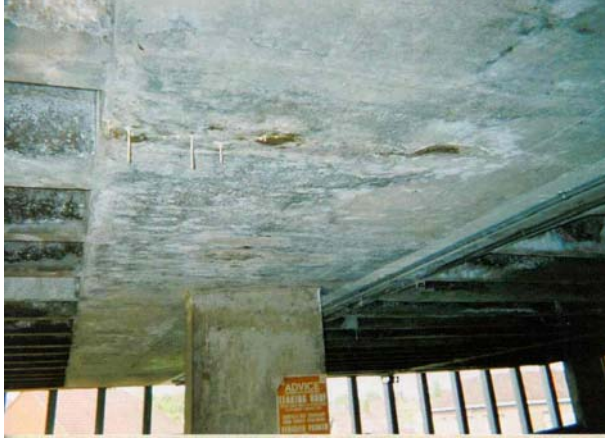
corrosion tends to develop in patches leading to spalling and delamination. Where the concrete is saturated and chloride ingress is localised, pitting corrosion (black rust) can develop leading to localised and rapid corrosion of reinforcement.

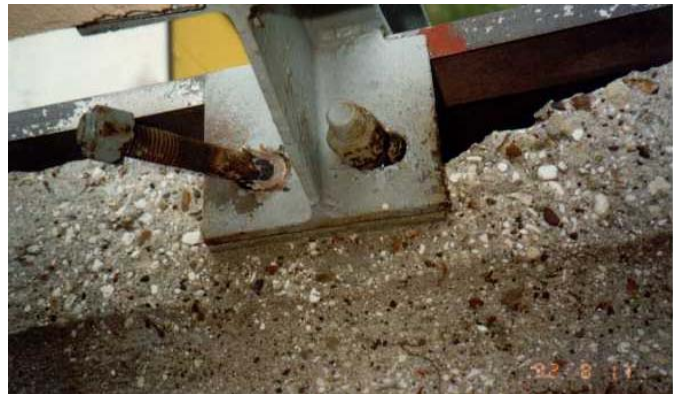
Photograph 10 Typical example of chloride-induced corrosion of fixing bolts for cladding.

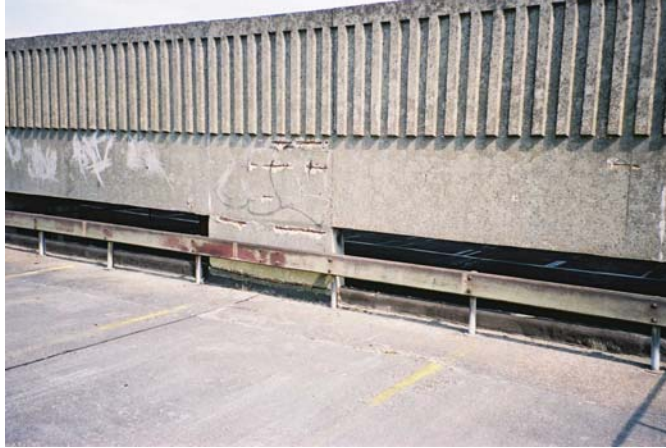
Photograph 11 Typical example of carbonation-induced corrosion of reinforced concrete

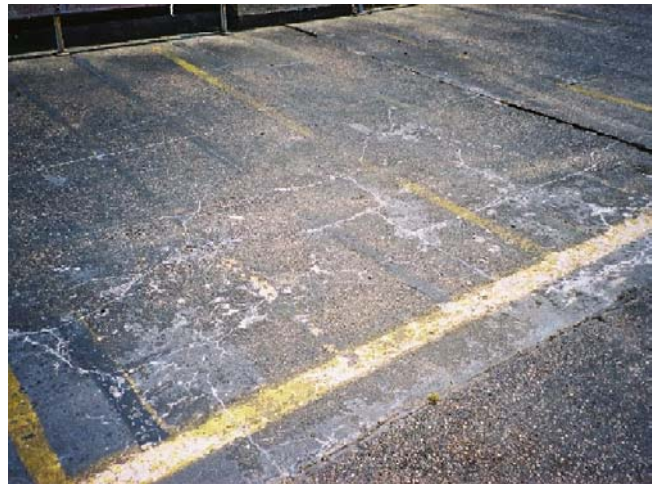
Photograph 12 Typical example of frost damaged deck slab on unsurfaced car park roof

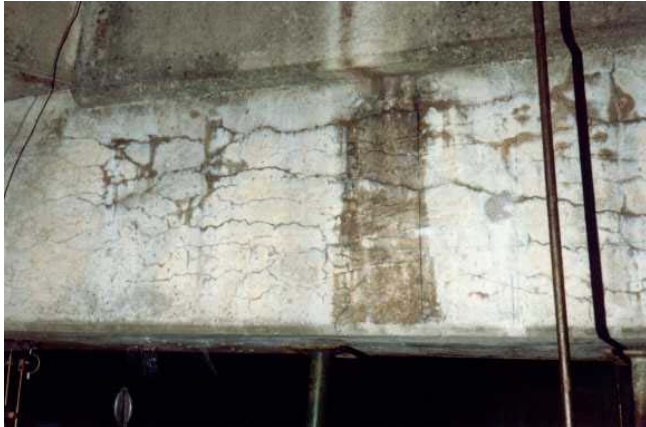
Photograph 13 Typical example of ASR damage of a reinforced concrete beam

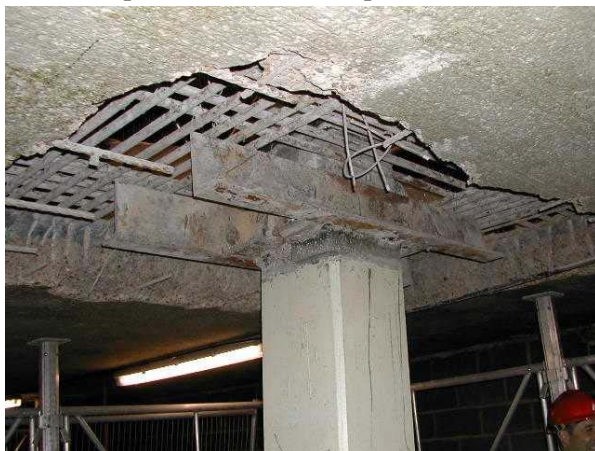
Photograph 14 ‘Opening-up’ of column in a lift slab structure where bottom reinforcement does not extend to the lifting collar, nor is it properly anchored

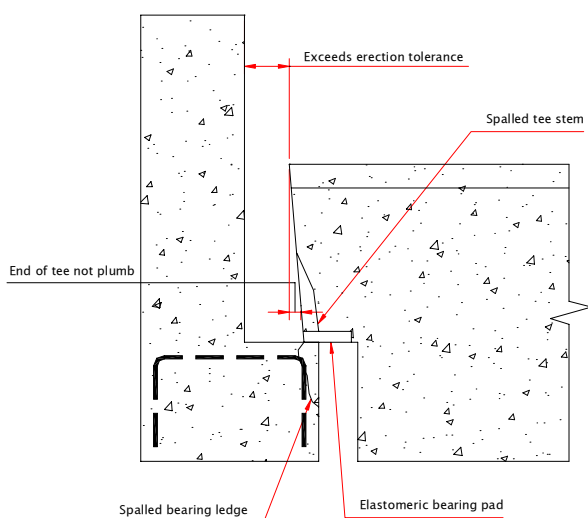
Corrosion of the bottom steel of pre-stressed or reinforced beams with limited seating onto a ledge can split along the reinforcement creating a risk of the beam ‘falling off its perch’ (see Figure 3). Corrosion and spalling in the corbel or ledge may aggravate this. The preferential corrosion at the corners of column stirrups can lead to failure and loss of bond over the critical lap length.

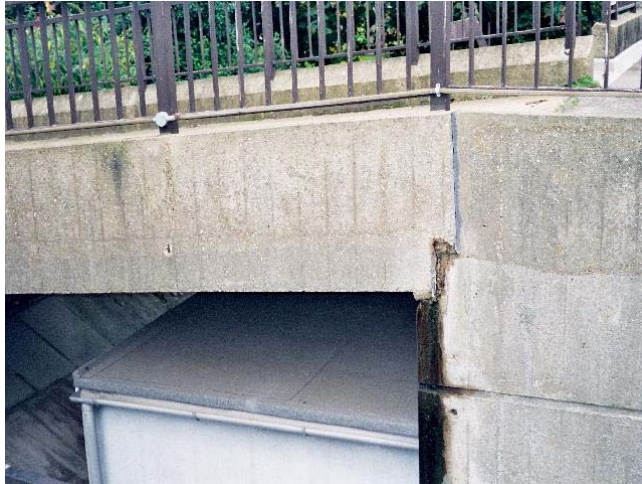
Photograph 15 Typical example of a seeping half-joint

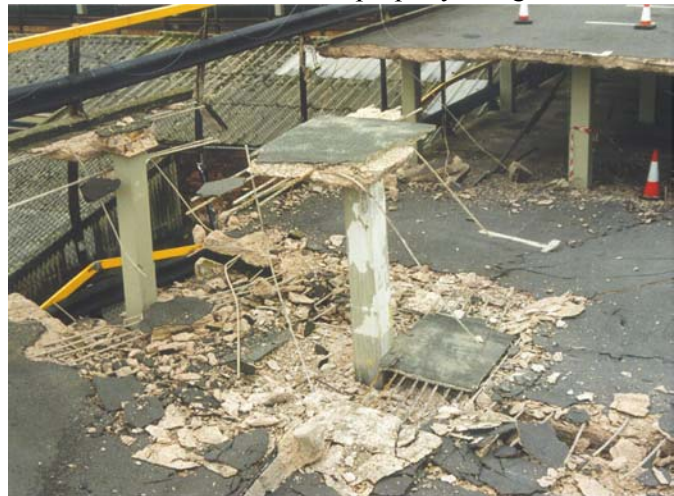
Photograph 16 Example of column head shear failure at Piper's Row

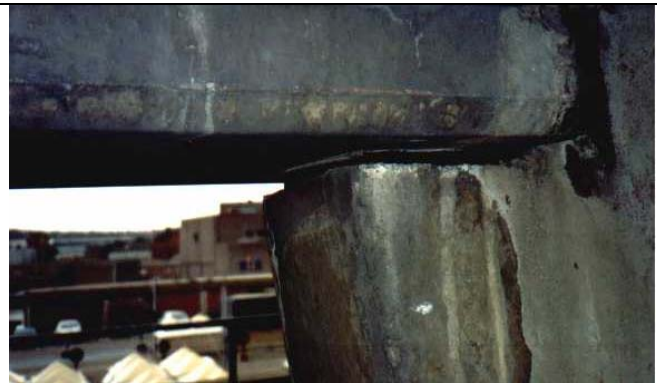
Photograph 19 Typical example of joint seepage & corrosion on a bearing shelf

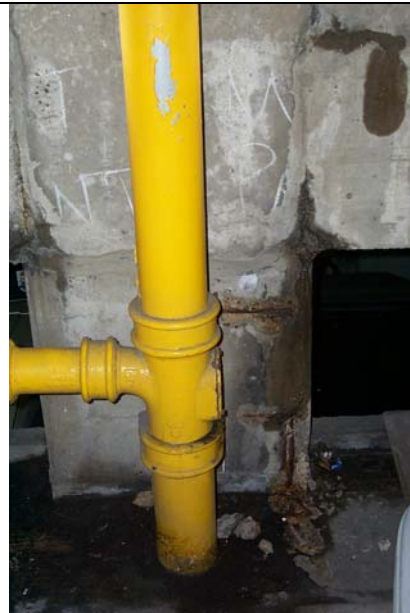
Photograph 20 Typical example of corrosion within the bottom area of a column

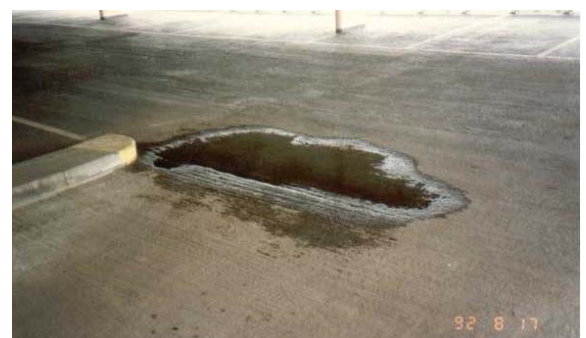
Example of water ponding

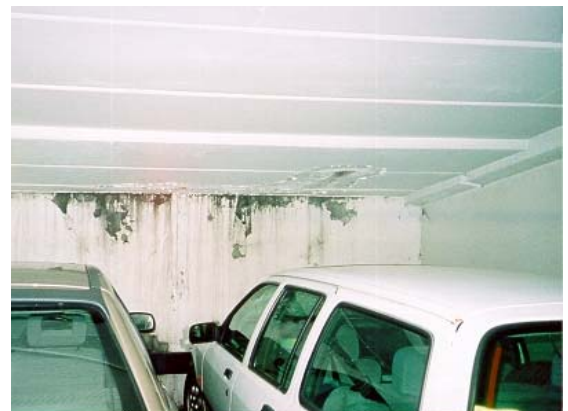
Example of seepage between precast beam & in situ wall

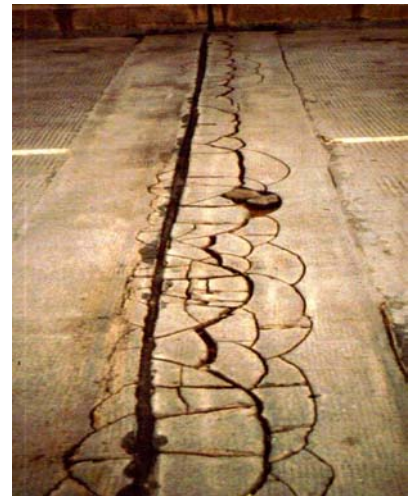
- Carry out visual inspections of the structure in wet conditions, if possible, and note seepage and discolouration.
- Also use a boroscope in areas which are not exposed to view.

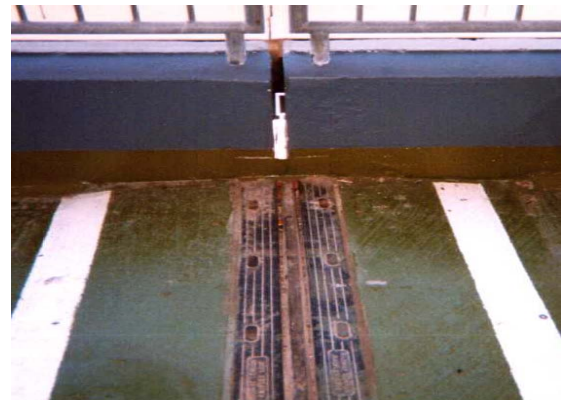
Raised joint prevents water runoff from entering the joint

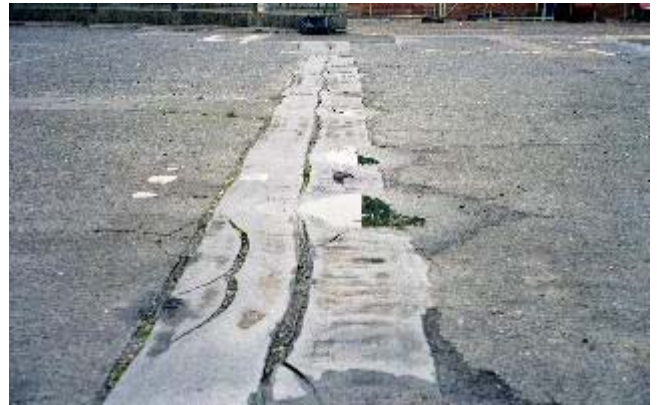
Failed joint with water ponding

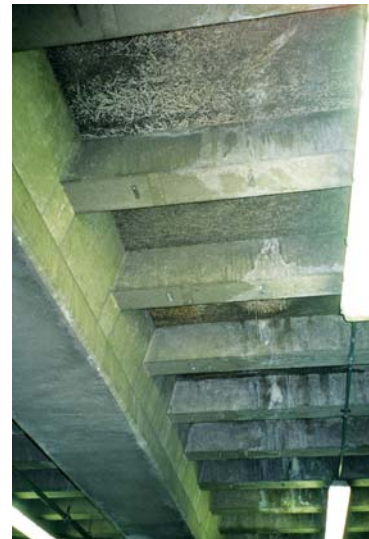
Water leakage from failed joint as viewed from the underlying soffit.

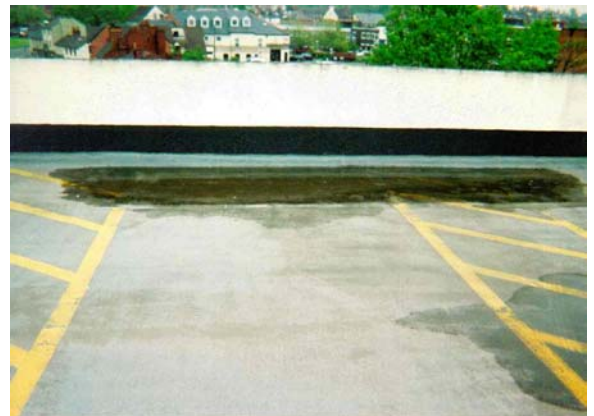
Water ponding on roof due to incorrectly fitted drainage gully

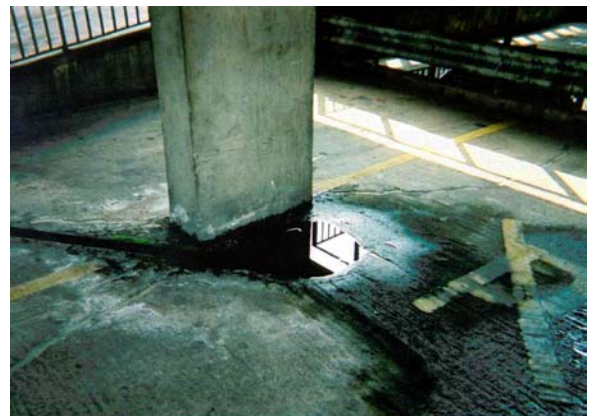
Example of water ponding around the base of a column due to ineffective gully outlet.

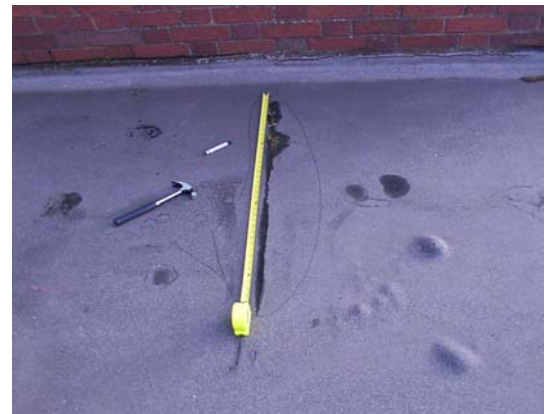
Blistering and failure of waterproofing membrane

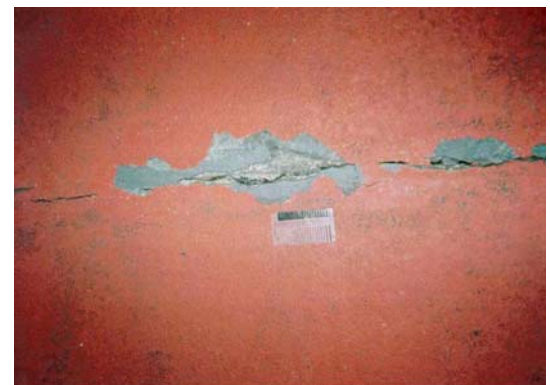
Typical example of failed membrane caused by its inability to bridge existing cracks in the underlying concrete.

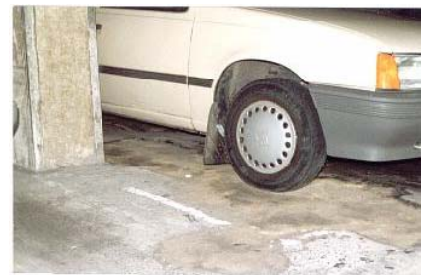
Patch repair of spalled concrete deck

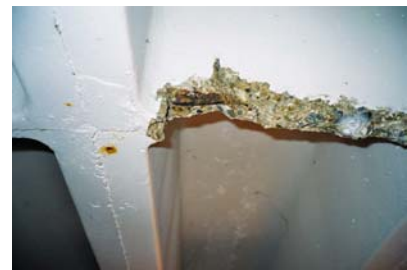
Corrosion and spalling of rib of “waffle” slab

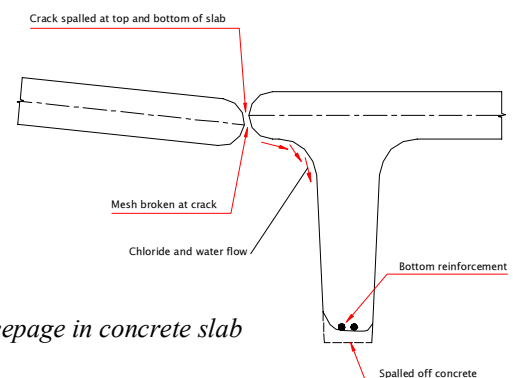
Cracking and seepage in concrete slab

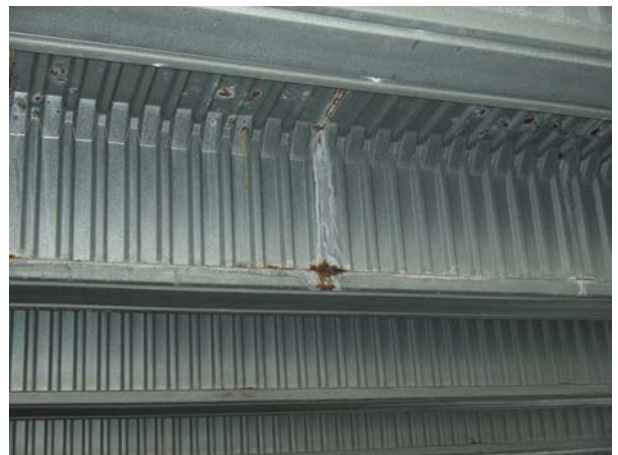
Corrosion of in-situ metal decking

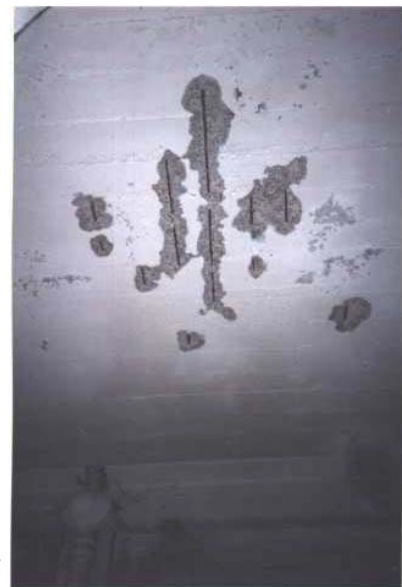
Typical soffit spalling of precast concrete “fillgree units”

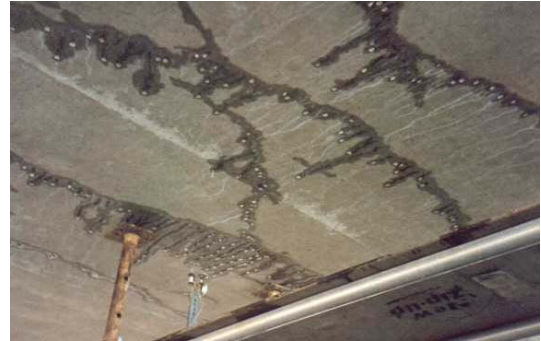
Typical example of leakage through shrinkage cracks in reinforced concrete deck slab

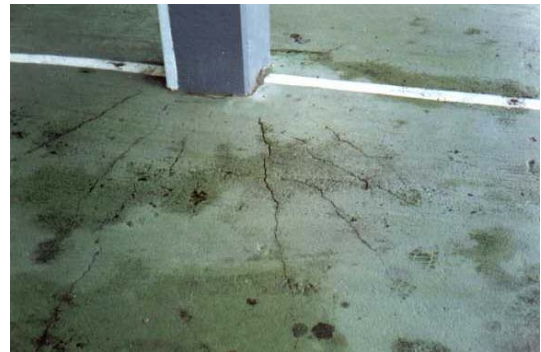
Typical example of radial cracking from around a column associated with flat slab.

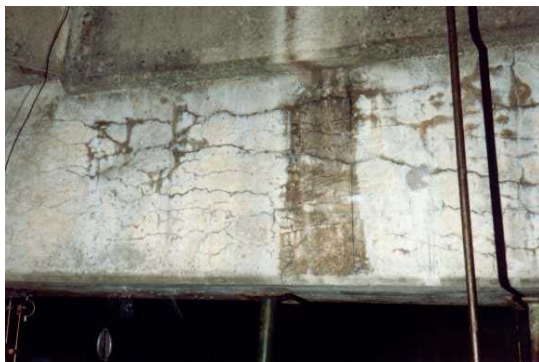
Typical example of ASR-related cracking & damage.

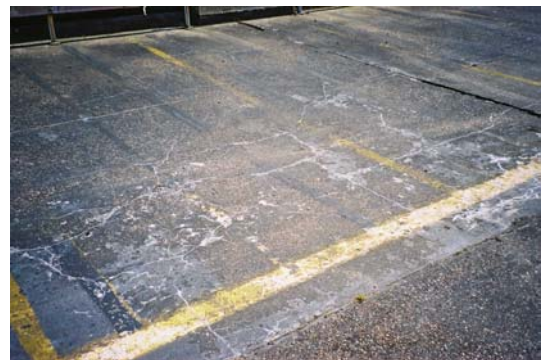
Typical example of freeze-thaw damage & cracking.

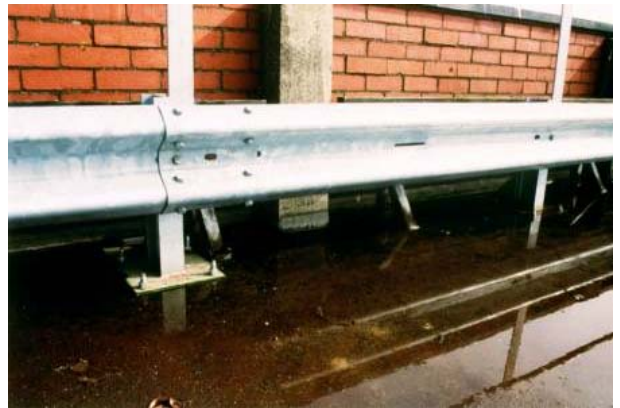
Ponding of water around base plates and holding down bolts.

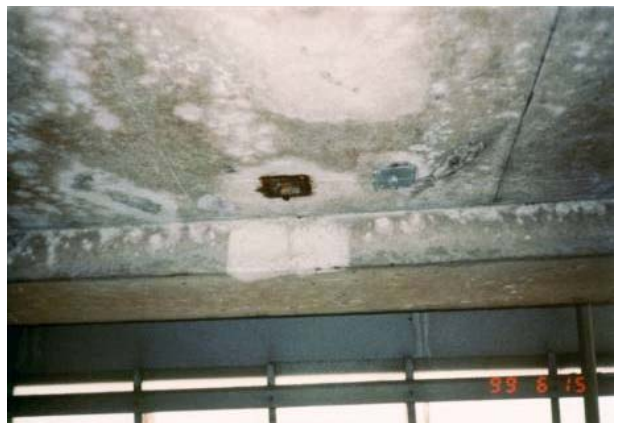
Corrosion of galvanised holding down bolts

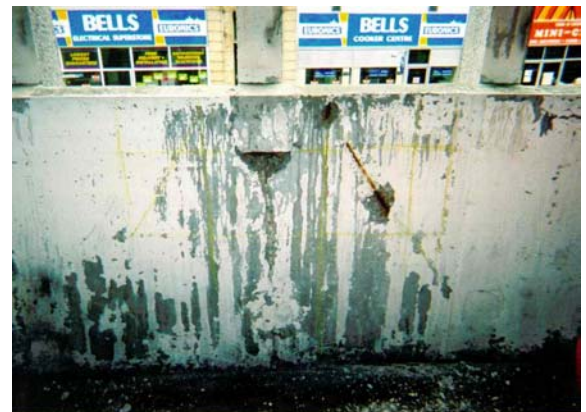
Corroded reinforcement exposed by spalling of the internal face of a parapet.

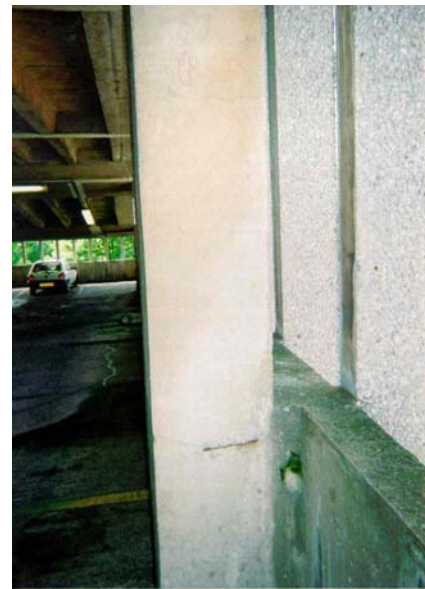
Corrosion of reinforcement & cracking

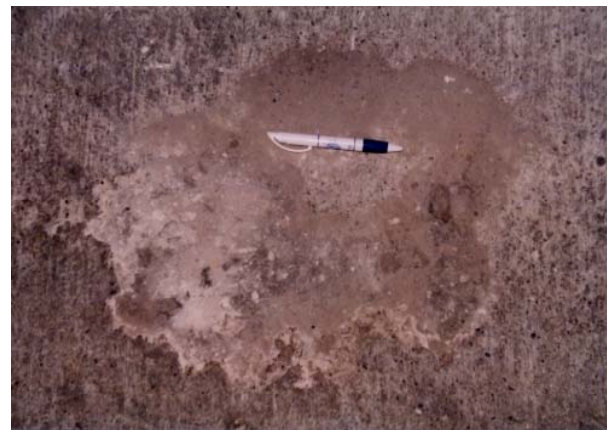
*Surface damage to concrete driving aisle
(Picture courtesy of BRE Limited)*

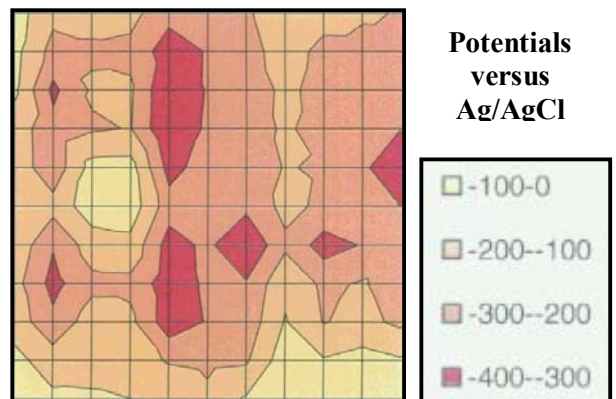
*Iso-potential map for parking bays
(Iso-potential plot courtesy of BRE Limited)*

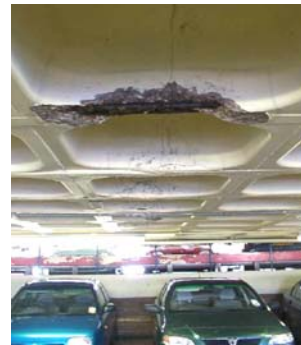
Large sections of soffit have spalled away due to rusting of the reinforcement beneath.

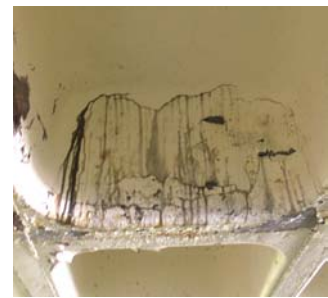
Rust staining resulting from corroding reinforcement caused by carbonation of concrete combined with the ingress of water.

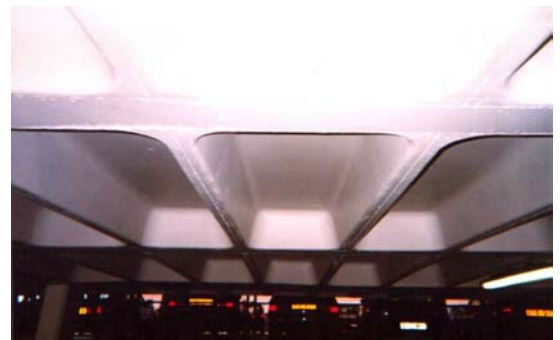
Conductive overlay CP system on an area of soffit.

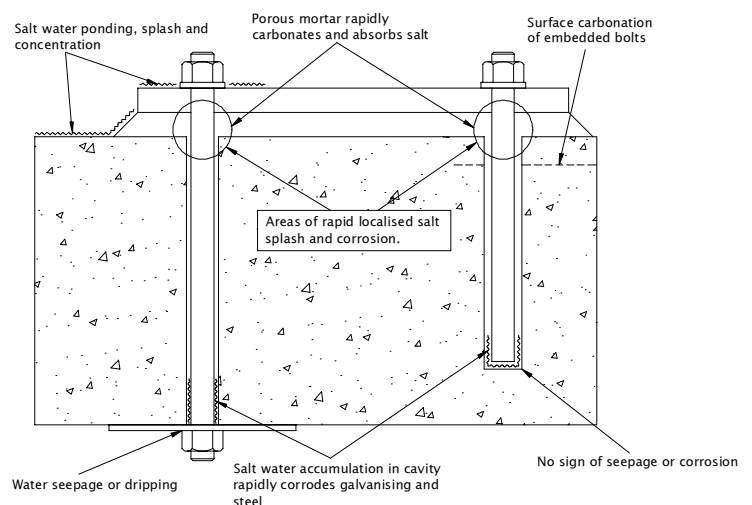
Figure 4 Schematic sketch showing two types of 'uninspectable' hold-down bolt.

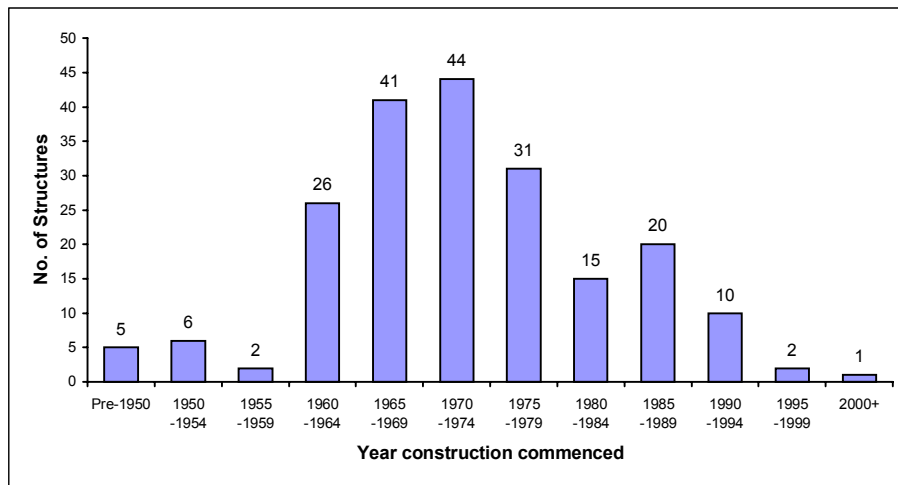
Figure A.1 Dates of construction of car park structure case studies

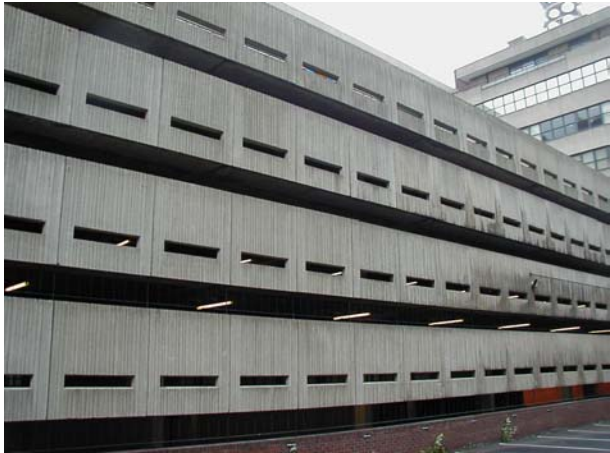
Photograph 21 Typical example of in-situ reinforced concrete frame and slab structure
