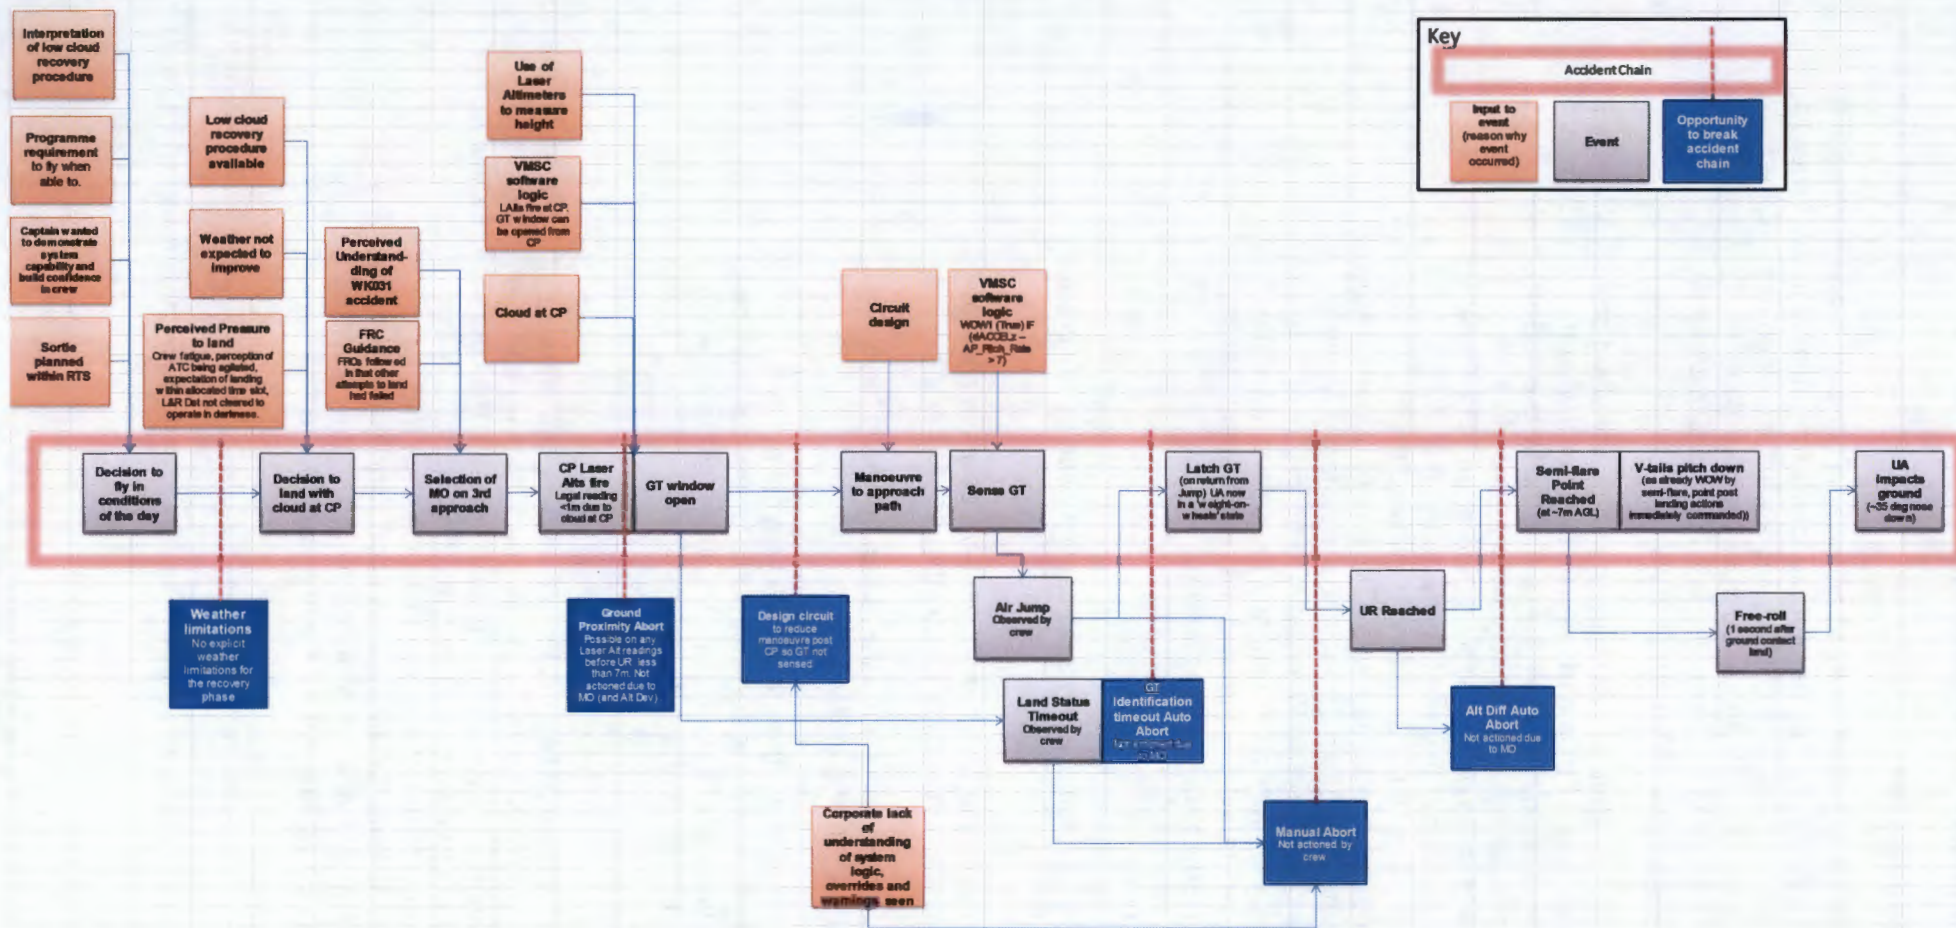
Figure 8 – Accident sequence

1.4.1.61. **Accident sequence.** To ensure that all causal and contributory factors were analysed within the context of the accident sequence the Panel produced the diagram at Figure 8. It can be seen that the accident chain contains human decisions, software logic and pre-programmed events. The Panel considered the reasons why each event occurred and labelled it as an 'input' to the event. Design safety measures and human interventions that could have broken the accident chain were also considered.

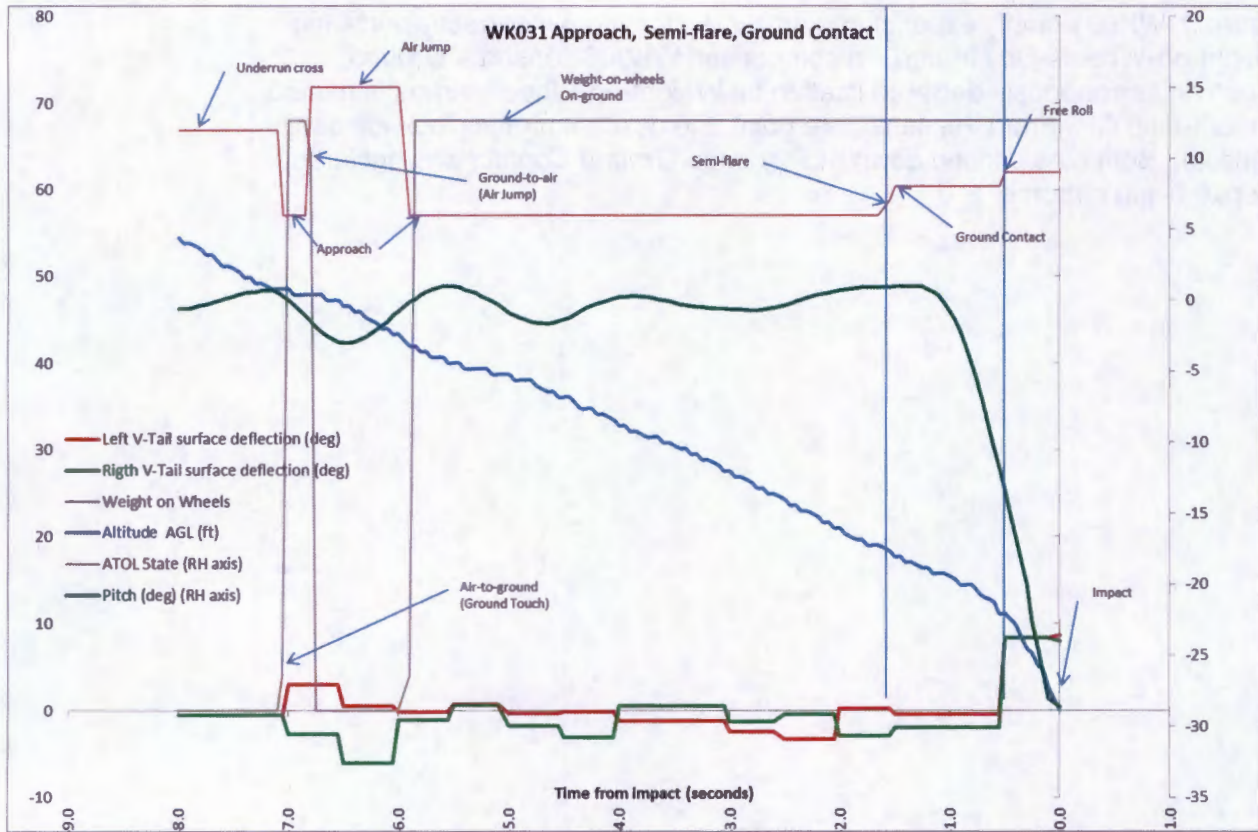
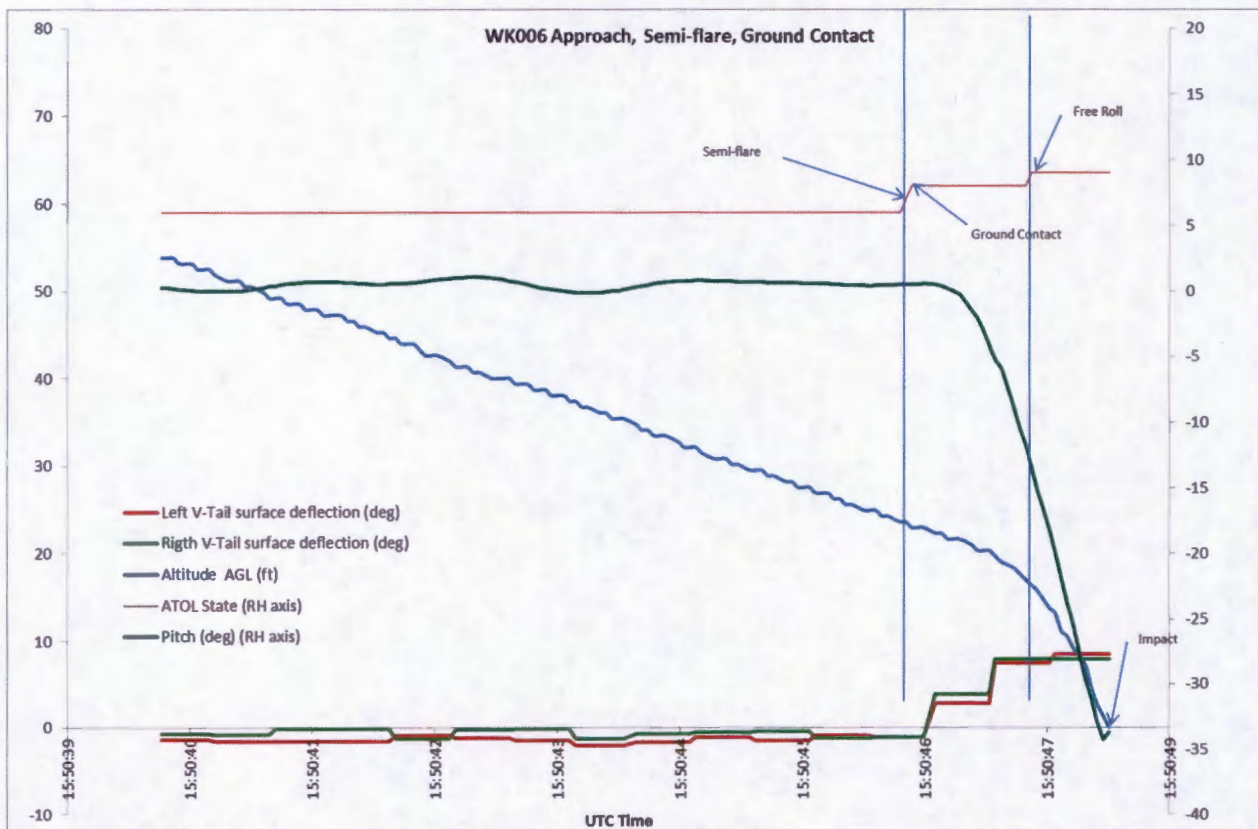
Figure 9 – Comparison of final 8 seconds of flight

1.4.1.83. **Technical comparison.** Figure 9 shows a subset of the recorded VMSC data for the final 8 seconds of both flights. WK031 was pitching up and down in response to a gust of wind, which caused the UA to sense a *Ground Touch*. This is further corroborated by the motion of the V-tails which suggested it may have been correcting for gusty conditions. As also shown in

Figure 9, WK031 briefly experienced an *Air Jump* before incorrectly declaring Weight-on-Wheels *On Ground*. In comparison WK006 sensed a *Ground Touch* and erroneously declared itself to be Weight-on-Wheels almost a minute earlier at the CP. From the semi-flare point, the descent profiles look almost identical. Both UAs pitched down rapidly once *Ground Contact* was declared, despite being airborne.

- b. **Sensing Ground Touch.** WK031 sensed a *Ground Touch* as a result of the difference between pitch rate and acceleration induced by a gust of wind. WK006 sensed a *Ground Touch* as a result of pitch rate and acceleration difference caused by a valid and normal manoeuvre at the CP.

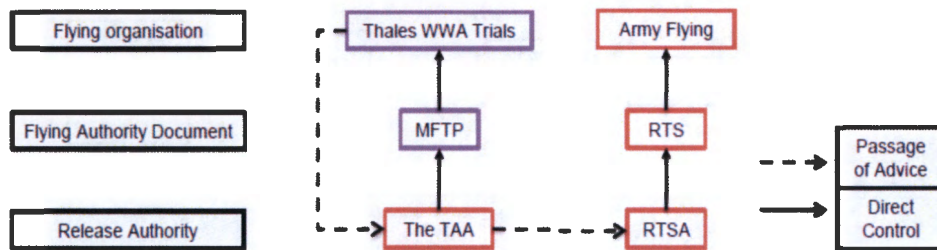
Figure 10 – Overview of TAA control of WK flying

1.4.2.6. **MAA RA5202 – Military Flight Test Permit (MFTP).** WK031 was operated by Thales UK under a MFTP. RA5202 provided the regulation for the MFTP. RA 5202 detailed that the authorisation of flights ‘shall be conducted using a MFTP if all of the following conditions exist: Where the design standard is not reflected in an extant RtS or flying outside the service environment, ie outside the recognised and agreed flight envelope’. The TAA authorised the initial WK MFTP and its subsequent amendments, which enabled Thales UK to undertake test and evaluation sorties at West Wales Airport (WWA). The Guidance Material stated that ‘following an occurrence, the Applicant or the TAA may withdraw the MFTP’. Therefore, the TAA had ‘direct control’ over WK flying at WWA as is illustrated in Figure 10.

who were responsible for the delivery of the WK capability. As shown in the above diagram, the TAA had no direct control over Army WK operations. The TAA provided SQEP advice to the RTSA, WK ADHs and CDCS.

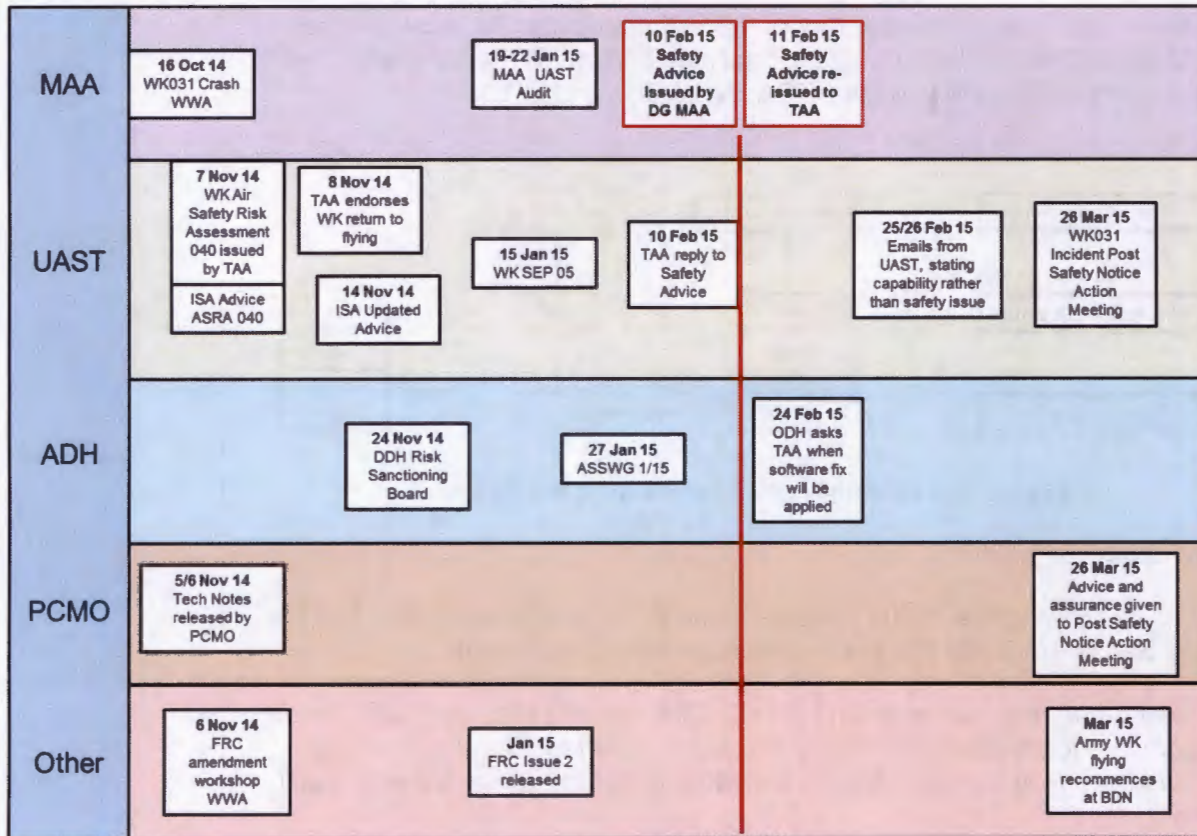
Figure 11 - Chronological Overview of the document trail analysed by Panel

In considering the level of awareness and application of the Safety Advice, the WK006 SI Panel found it necessary to consider the actions taken following the WK031 crash as it became clear to the Panel that they shaped opinion and influenced the direction of travel following the issue of the Safety Advice. Therefore, the next group heading analyses the actions taken following the loss of WK031 to provide context for the actions taken following the Safety Advice. An overview of the documents reviewed by the Panel, prior to and after the issue of the Safety Advice, is shown in Figure 11.

'The Panel recommends that the DES UAS TAA ensures that the VMSC landing mode software logic when MO is selected is corrected to prevent a Ground Touch and Free Roll command being activated whilst the Aerial Vehicle is still airborne'.
