Fire and Solar PV Systems – Investigations and Evidence

Prepared for: Penny Dunbabin, Science and Innovation, BEIS

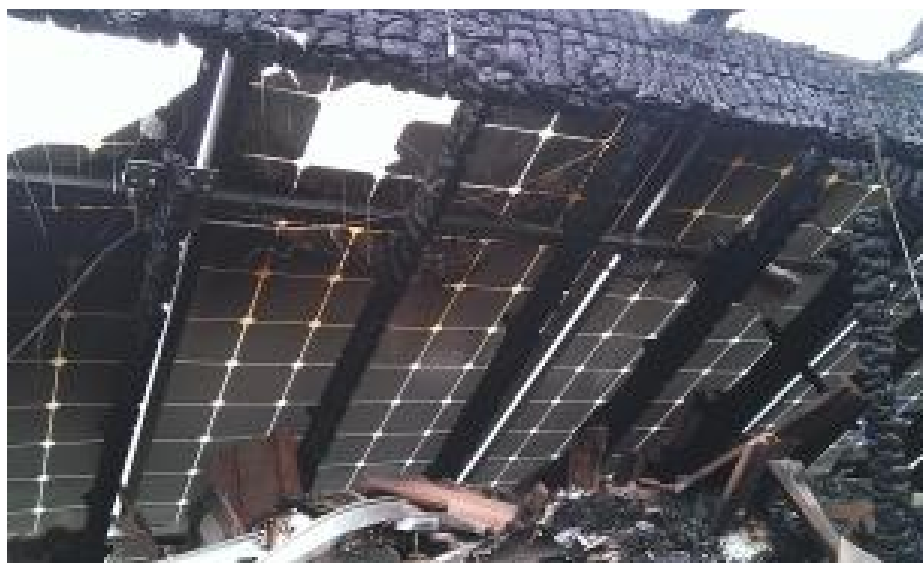
Figure 3: Example burnt-out roof with parts of the PV system intact.

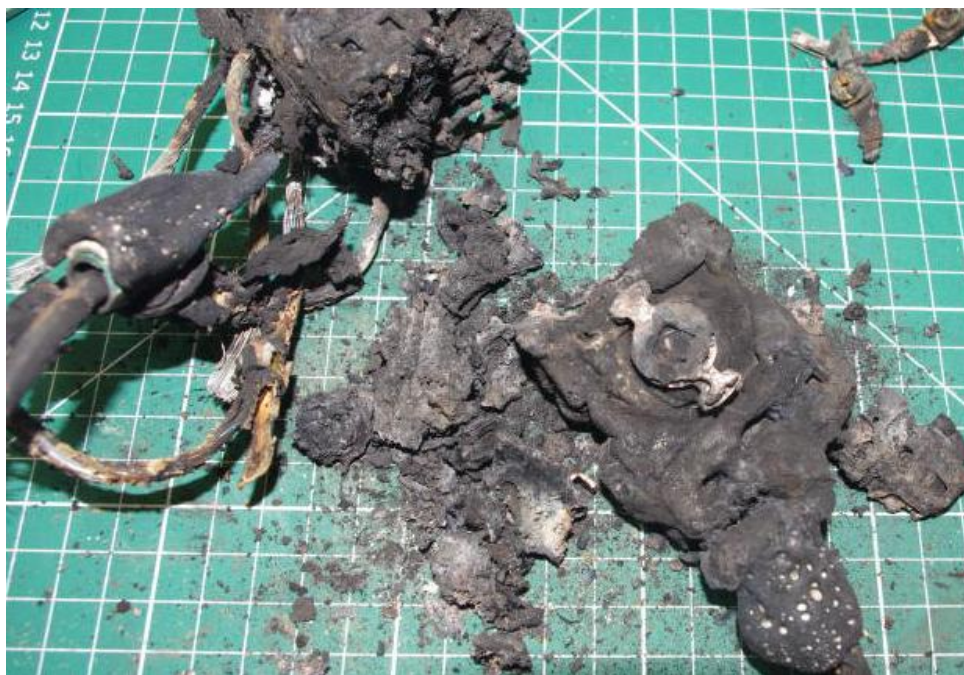
Figure 4: Remains of a DC isolator being disassembled and inspected in the laboratory
(Photo courtesy of Fire Investigations (UK) LLP)

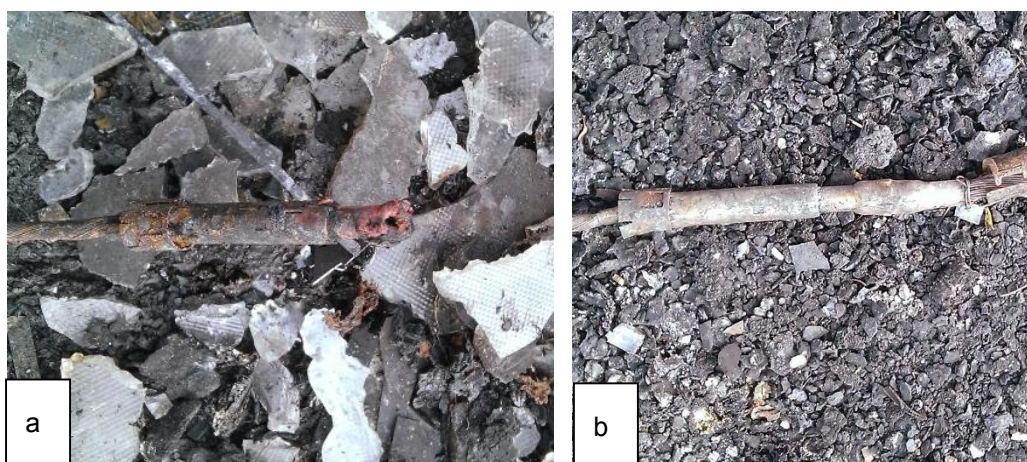
Figure 5: Remains of a DC connector ablated by arcing (a), and by contrast, a connector with contacts still intact and engaged, merely damaged by the surrounding fire (b). In both cases, the insulating body of the connector has been burnt off.

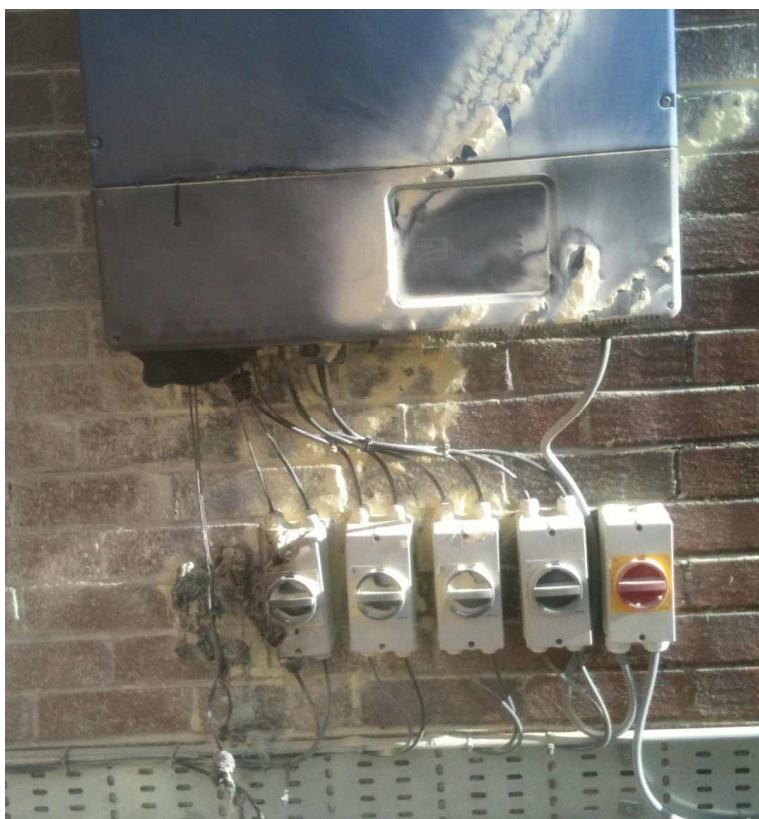
Figure 6: Localised fire in which the left hand DC isolator is completely missing, destroyed by a fire, with collateral damage to the adjacent isolator and inverter above.

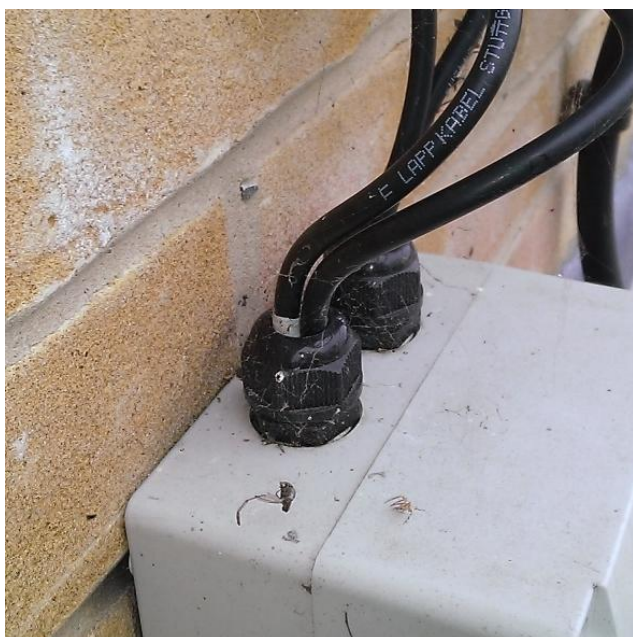
Figure 7: More than one cable passing through an upward-facing sealing gland on a DC isolator enclosure mounted on an outside wall.

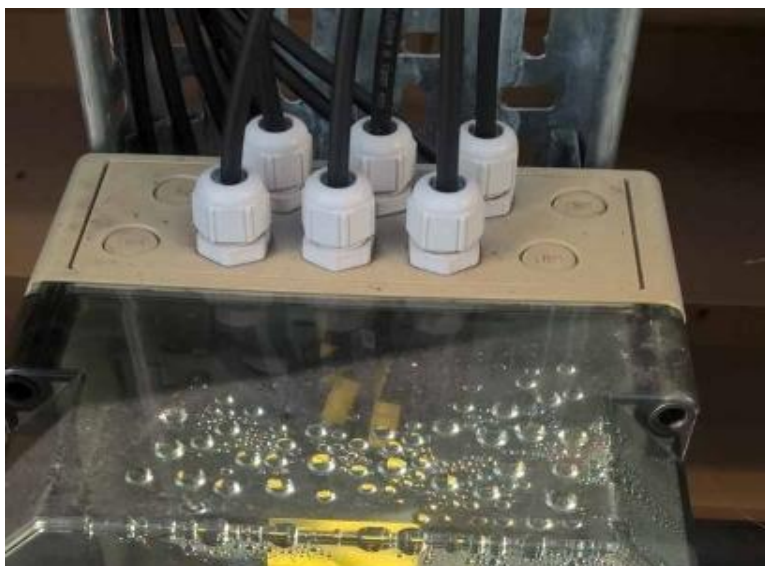
Figure 8: Water can be seen inside this enclosure, even though only one cable passes through each gland.

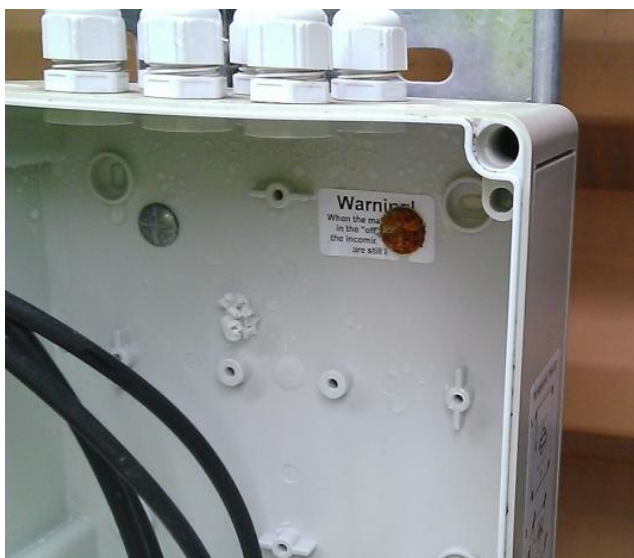
Figure 9: Rear of isolator enclosure drilled through for mounting screws. Note that the screw on the right hand side is rusty, indicating water ingress.

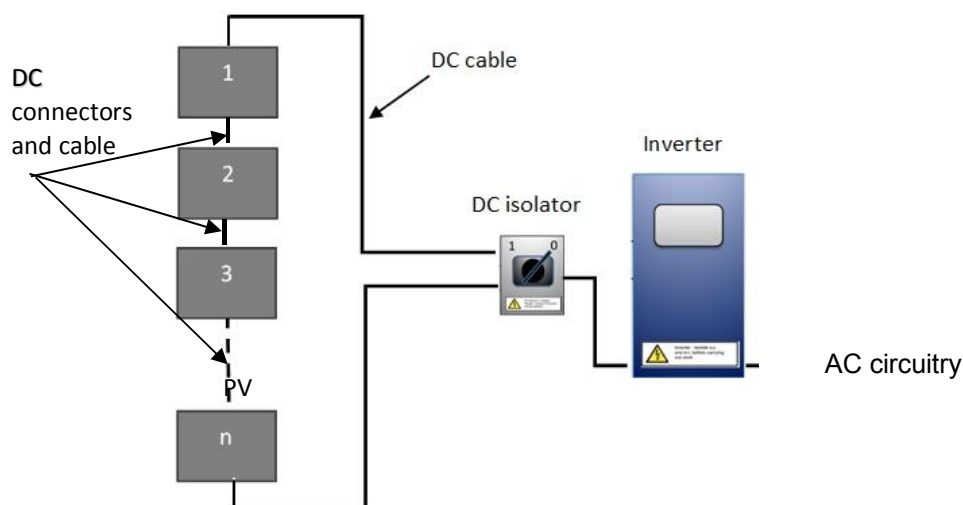
Figure 10: Simplified schematic diagram of DC components in a typical domestic PV system

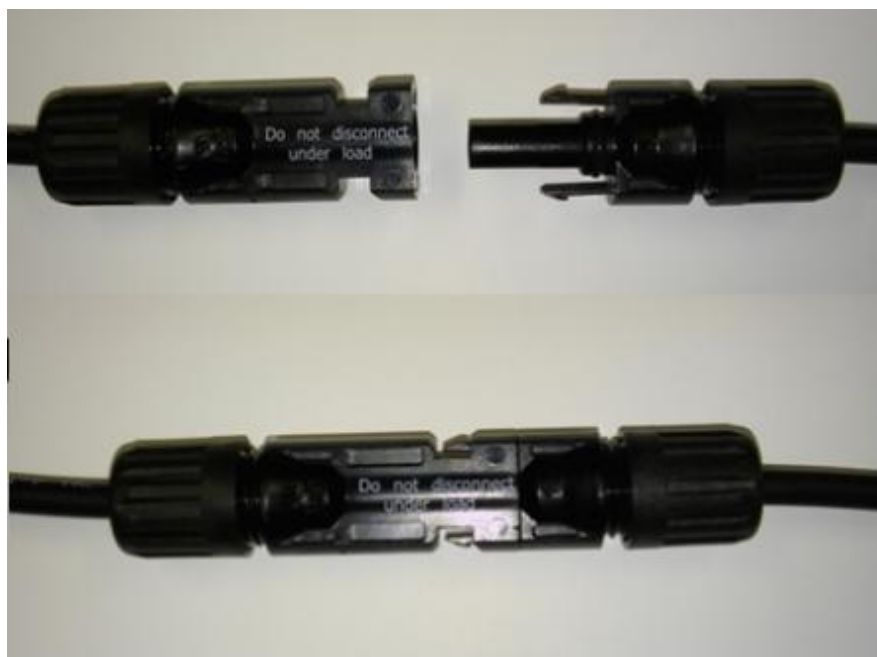
Figure 11: Typical (undamaged) DC connectors, separated (top image) and coupled (bottom image)

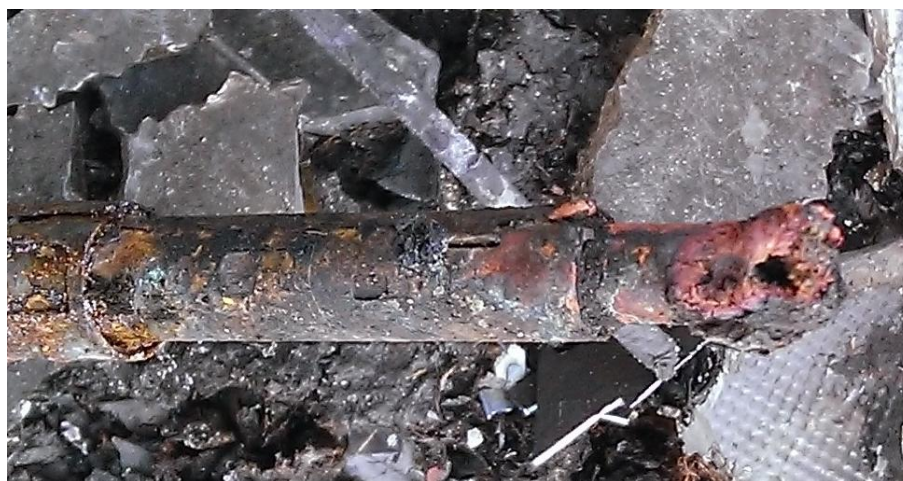
Figure 12: Example of DC connector contact that has been subject to electrical arcing. The right hand end has been melted.

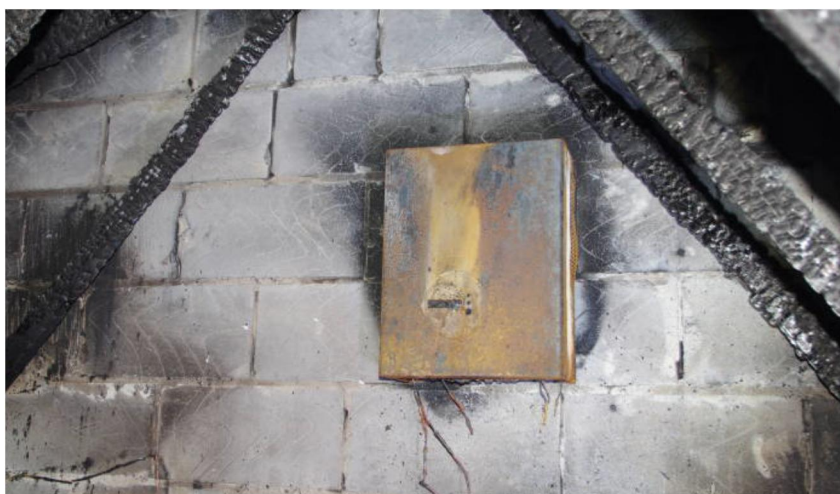
Figure 13: Inverter fire with clear burn patterns showing this as the source of the fire.

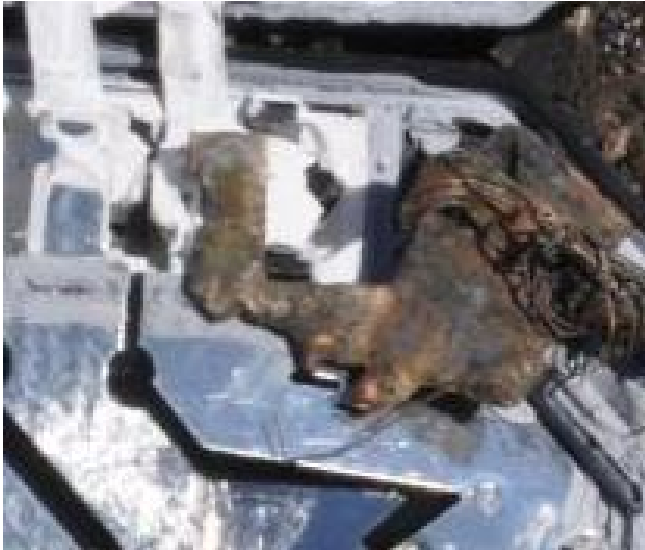
Figure 14: Damaged part of a PV module junction box laid over an identical undamaged component, showing where material has been ablated through arcing.

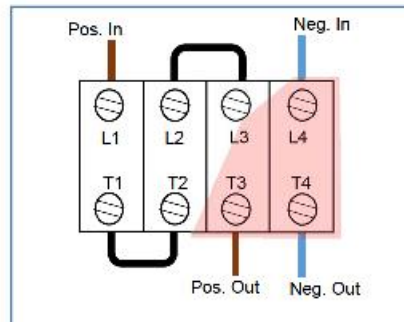
Image 1: Schematic showing the configuration and terminal designation of the switch mechanism inside the DC Isolator.
