AAIB Bulletin: 3/2018	G-OHCP	EW/C2017/03/02
ACCIDENT		
Aircraft Type and Registration:	Airbus Helicopters A G-OHCP	S355F1 Ecureuil II,
No & Type of Engines:	2 Allison 250-C20F t	urboshaft engines
Year of Manufacture:	1982 (Serial no: 524	9)
Date & Time (UTC):	29 March 2017 at 11	55 hrs
Location:	Summit of Rhinog Fa	awr, Snowdonia
Type of Flight:	Private	
Persons on Board:	Crew - 1	Passengers - 4
Injuries:	Crew - 1 (Fatal)	Passengers - 4 (Fatal)
Nature of Damage:	Aircraft destroyed	
Commander's Licence:	Private Pilot's Licence	ce
Commander's Age:	56 years	
Commander's Flying Experience:	3,650 <sup>1</sup> hours (of whic Last 90 days - 9.0 ho Last 28 days - 1.5 ho	ch 102 were on type) ours ours
Information Source:	AAIB Field Investiga	tion

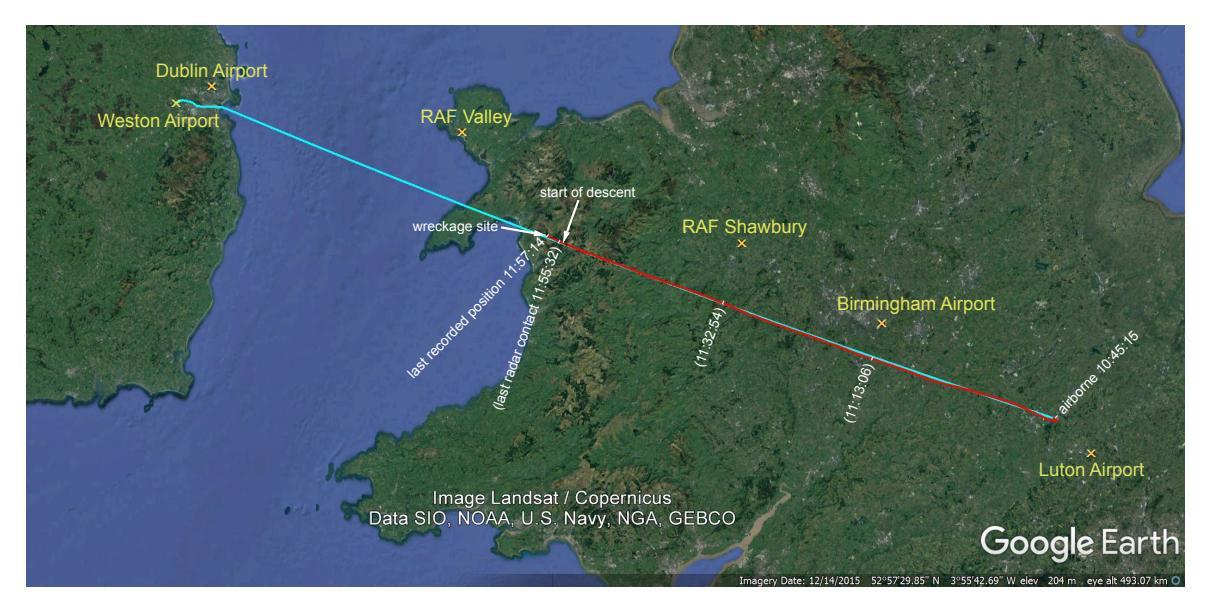
Figure 1 Planned route (blue) and actual track (red)

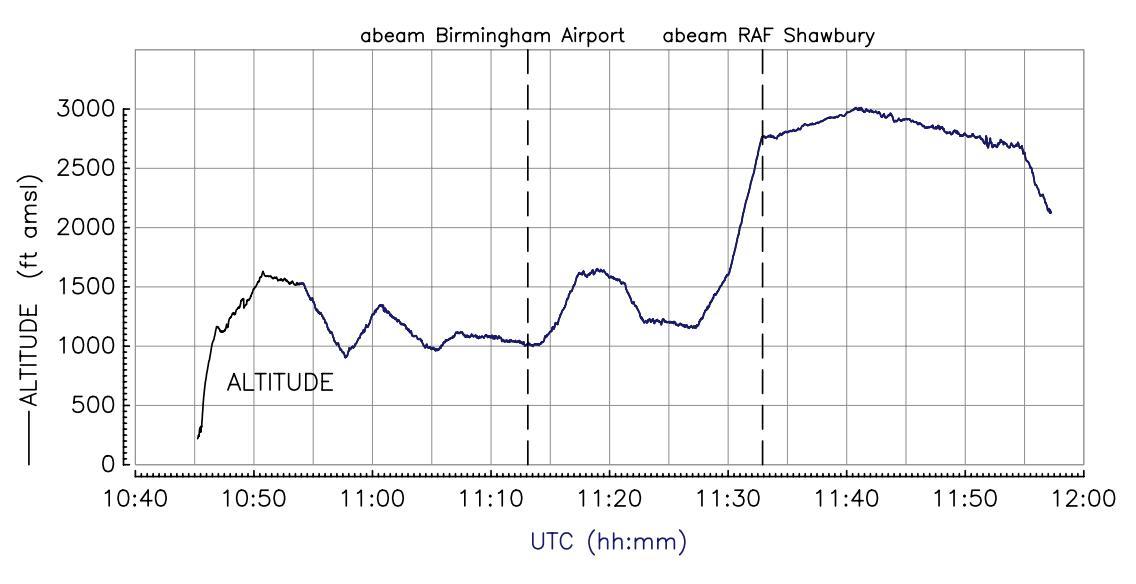
Figure 2 GPS derived vertical profile of the accident flight

The helicopter had been in a gentle descent from its maximum height to 2,500 ft before descending to 2,060 ft when it struck the east side of Rhinog Fawr Mountain, at about 1157 hrs. At the moment of impact, the auto pilot was engaged with the heading (HDG), turn coordinator (T/C) and vertical speed (V/S) modes active. This was consistent with a pilot-managed, autopilot-flown descent.

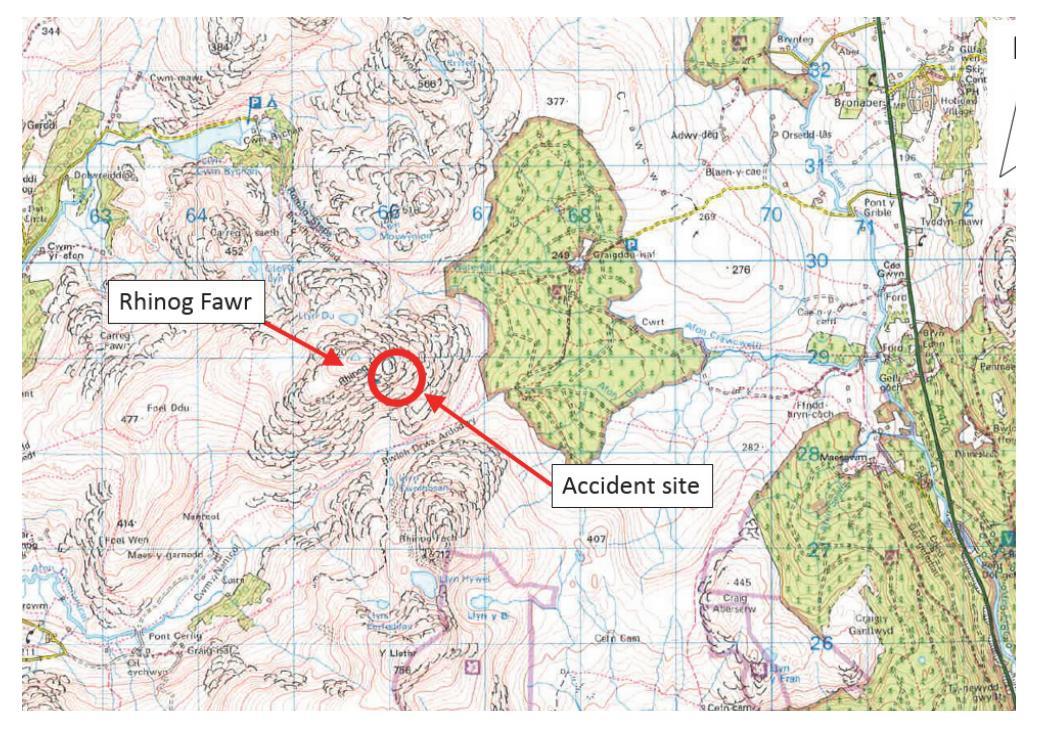
The accident site was located on the south-east face of Rhinog Fawr in southern Snowdonia, at an elevation of 2,060 ft amsl, approximately 300 ft below the summit shown in Figure 3. The helicopter had struck a rock outcrop (Figure 4), completely destroying the cabin section and depositing wreckage along a trail 150 m in length, oriented on a heading of 280°M. The helicopter's main rotor, gearbox and engines had separated from the fuselage and continued over the rock outcrop, coming to rest 140 m from the initial impact. The degree of disintegration of the cabin indicated that the helicopter had been flying at cruising speed immediately prior to impact. Witness marks made by the cabin, right skid and right horizontal stabiliser on the rock outcrop showed that the helicopter was in an approximately level pitch and roll attitude at impact.

Figure 3 Location of the accident site

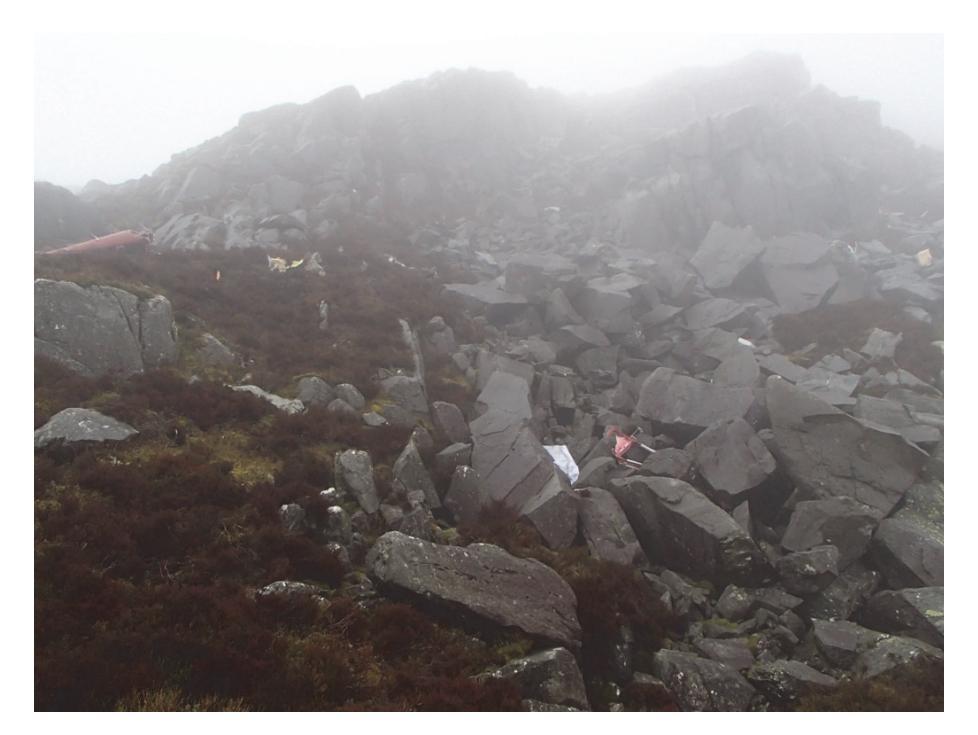
All major parts of the helicopter were identified at the accident site. A number of wreckage parts were burned and a small part of the impact area also exhibited evidence of burning, indicating that an intense, short-duration fuel fire had occurred after impact. There was a strong smell of unburned aviation fuel at the base of the rock outcrop, immediately below the impact area.

Figure 4
Section of the accident site wreckage trial

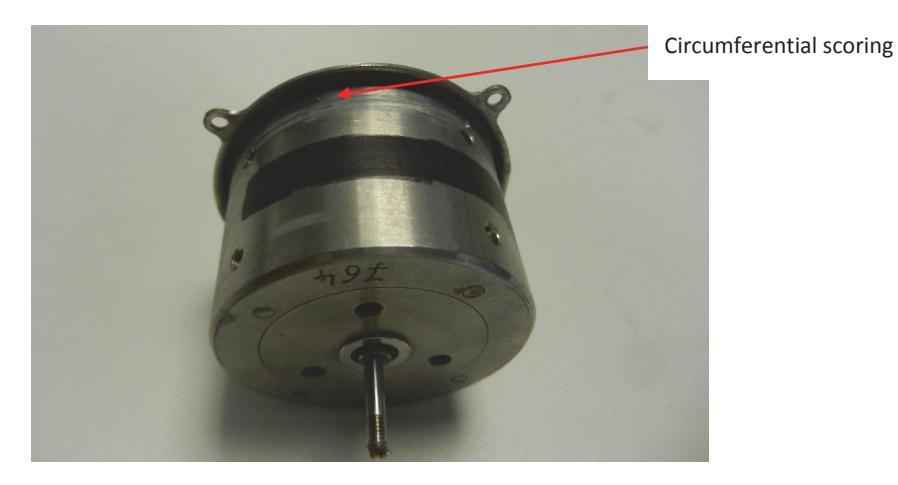
All the helicopter's flight instruments had been severely damaged during the impact sequence. The pilot's artificial horizon and the standby artificial horizon were disassembled and examined in detail. Both units had suffered from significant internal damage. Circumferential scoring was identified on the gyroscope of the pilot's artificial horizon and rotational damage was observed on the cooling fins of the standby artificial horizon gyroscope wheel (Figure 5), indicating they were both operational at the time of impact.

Figure 5 Pilot's artificial horizon gyroscope exhibiting circumferential scoring

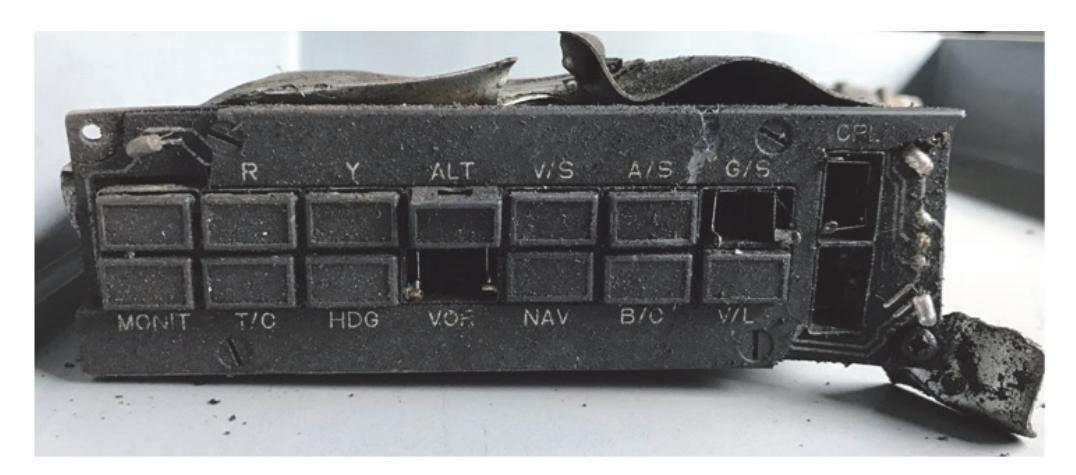
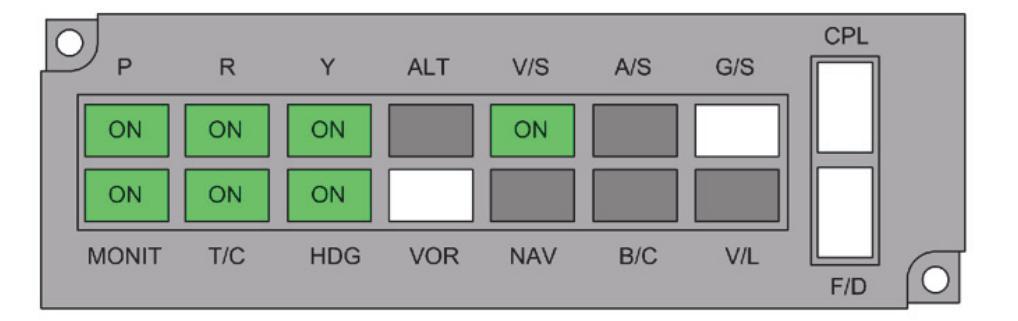
# Figure 6

The autopilot mode control panel (Figure 6) was recovered from the wreckage trail. The control panel was substantially intact apart from the *'VOR', 'G/S', 'CPL'* and *'F/D'* buttons, which had separated during the accident and were not located.

Autopilot mode control panel recovered from the accident site (top), and assessment of the control panel buttons illuminated at impact by light bulb filament analysis (bottom)

The lightbulb filament analysis indicated that the autopilot was switched ON, and was engaged at impact. The pitch ('P' button), roll ('R') and yaw ('Y') channels were available and engaged, the pitch and roll monitor<sup>2</sup> ('MONIT') was engaged and the turn coordination mode<sup>3</sup> ('T/C') was ON. The analysis also showed that the heading hold ('HDG') and vertical speed ('V/S') modes were also engaged.

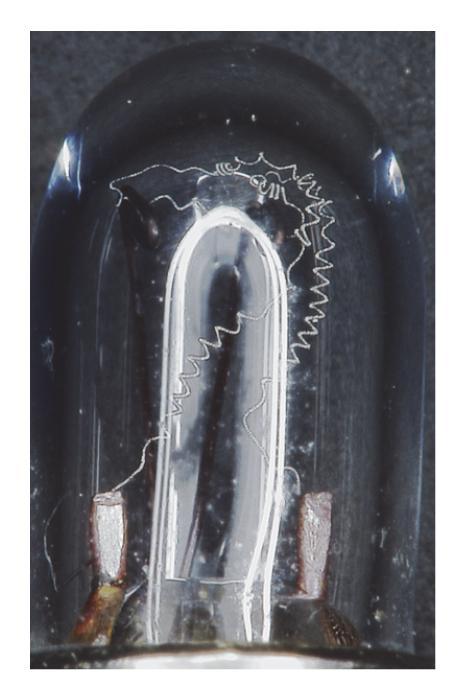
The push-button switches were disassembled and their lightbulbs removed for visual examination by microscope. This examination showed that a number of bulbs' filaments were stretched, with the double-helix coils elongated, consistent with bulb illumination at impact. By contrast, the remaining bulbs examined did not exhibit any evidence of filament hot-stretching, indicating that those bulbs were unlit at impact (Figure 7).

V/S button (right bulb), lit at impact

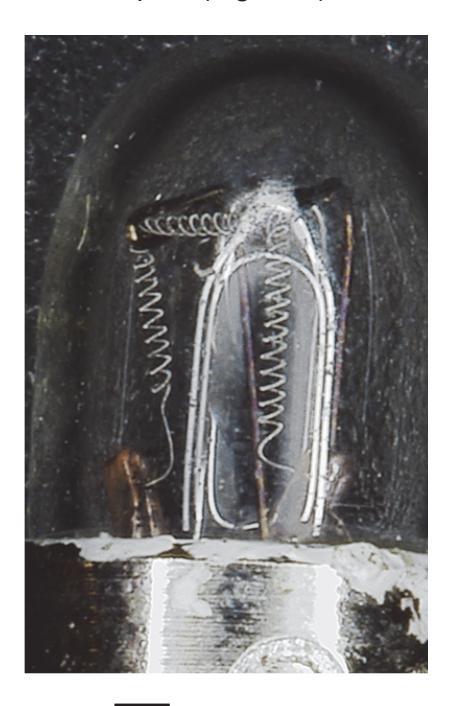
ALT button (right bulb), unlit at impact

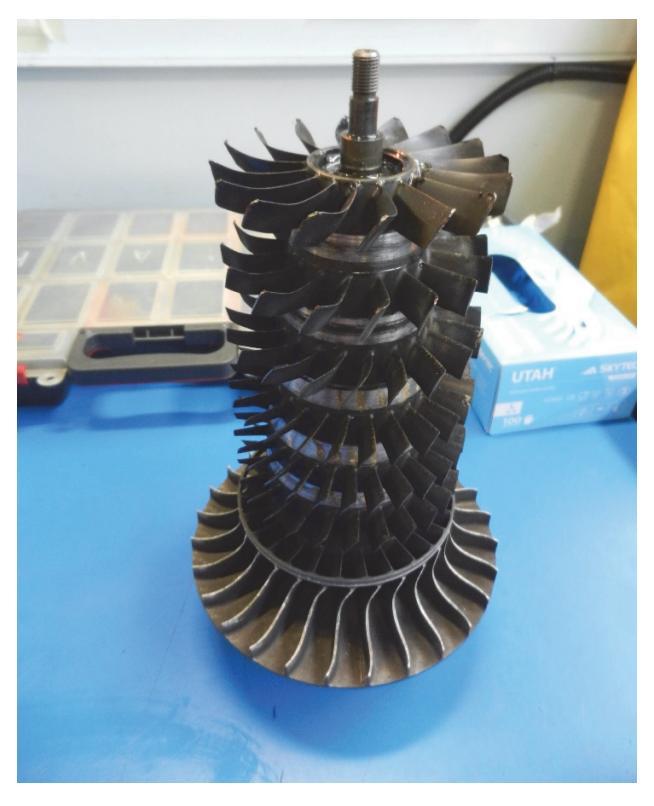
During the removal of the compressor from the gearbox, it was found that the retaining feature of the impeller drive coupling shaft had failed, allowing the shaft to be released. Examination of the remains of the shaft showed evidence of bearing impact marks on the shaft consistent with forces experienced during the impact sequence. Disassembly of the compressor and impeller module revealed that all the compressor vanes and stators were present. However there was clear evidence of rotational damage to the forward stages of the axial compressor (Figure 8), with associated loss of the compressor abraidable liner. There was also evidence of rotational contact between the impeller and the impeller shroud.

**Figure 8** Left engine axial compressor and impeller assembly

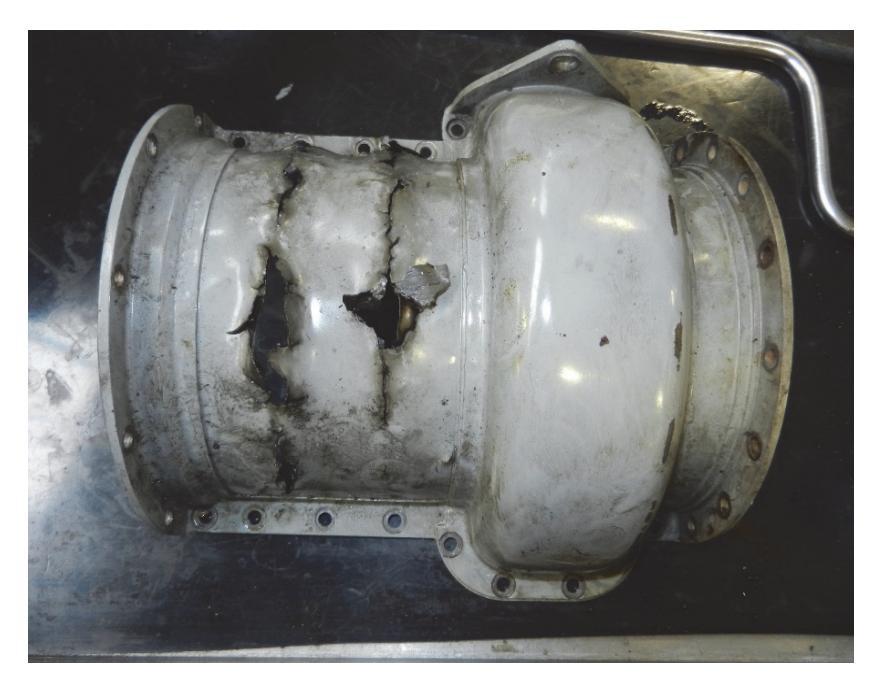
The compressor case exhibited multiple penetrations (Figure 9) typical of significant axial compressor blade release.

**Figure 9** Right engine compressor case showing case penetration

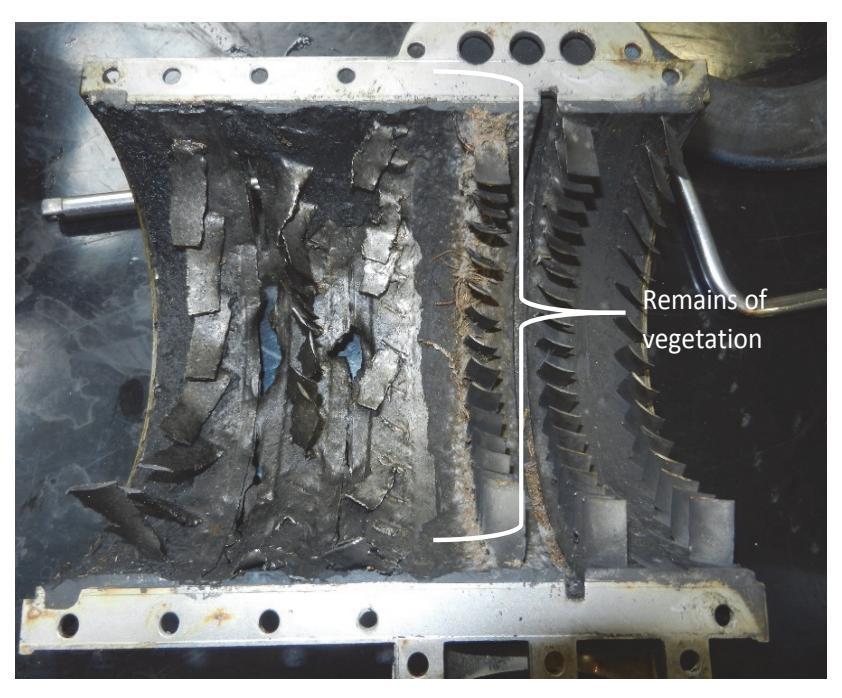
Disassembly of the compressor assembly revealed significant damage to all the stator vanes in the first three stages of the axial compressor, and the remains of vegetation was observed on the fourth stage stator vanes (Figure 10).

**Figure 10** Damage to the right engine axial compressor stator vanes

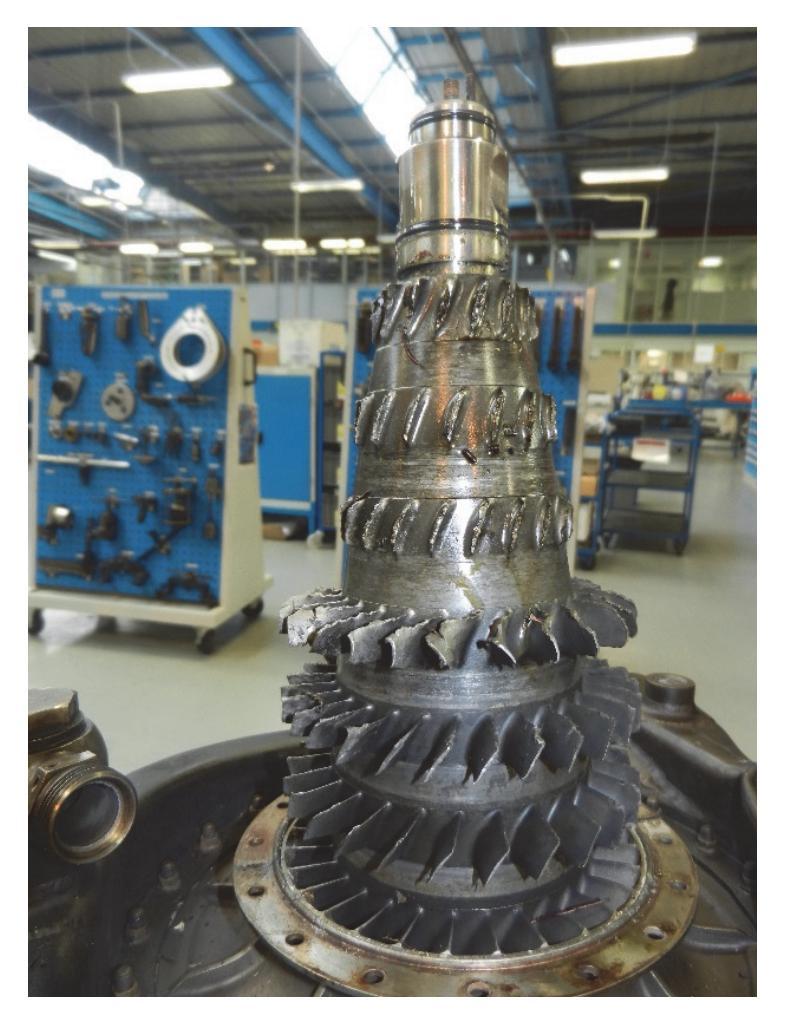
The compressor spool was heavily damaged, all the first three stages of compressor blades had been released, and the blades on the fourth stage exhibited significant impact damage (Figure 11). The impeller and impeller shroud also showed signs of rubbing. Small particles of vegetation were also found within the impeller.

Figure 11 Right engine axial compressor

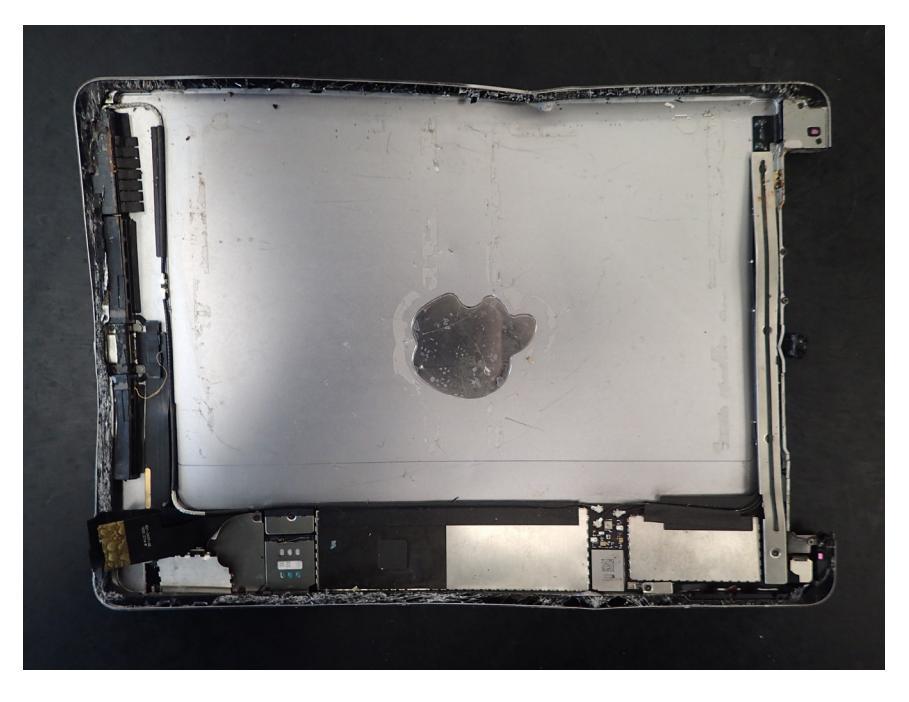
## Figure 12

The logic board (containing the memory) and battery were still attached to the base of the iPad, which was slightly bent and dented (Figure 12). The logic board was removed from the iPad base and slaved into a similar iPad mini whose own logic board had been removed. The memory was downloaded using a commercially available data extraction and analysis software tool.

Base of iPad mini containing logic board (battery has been removed)

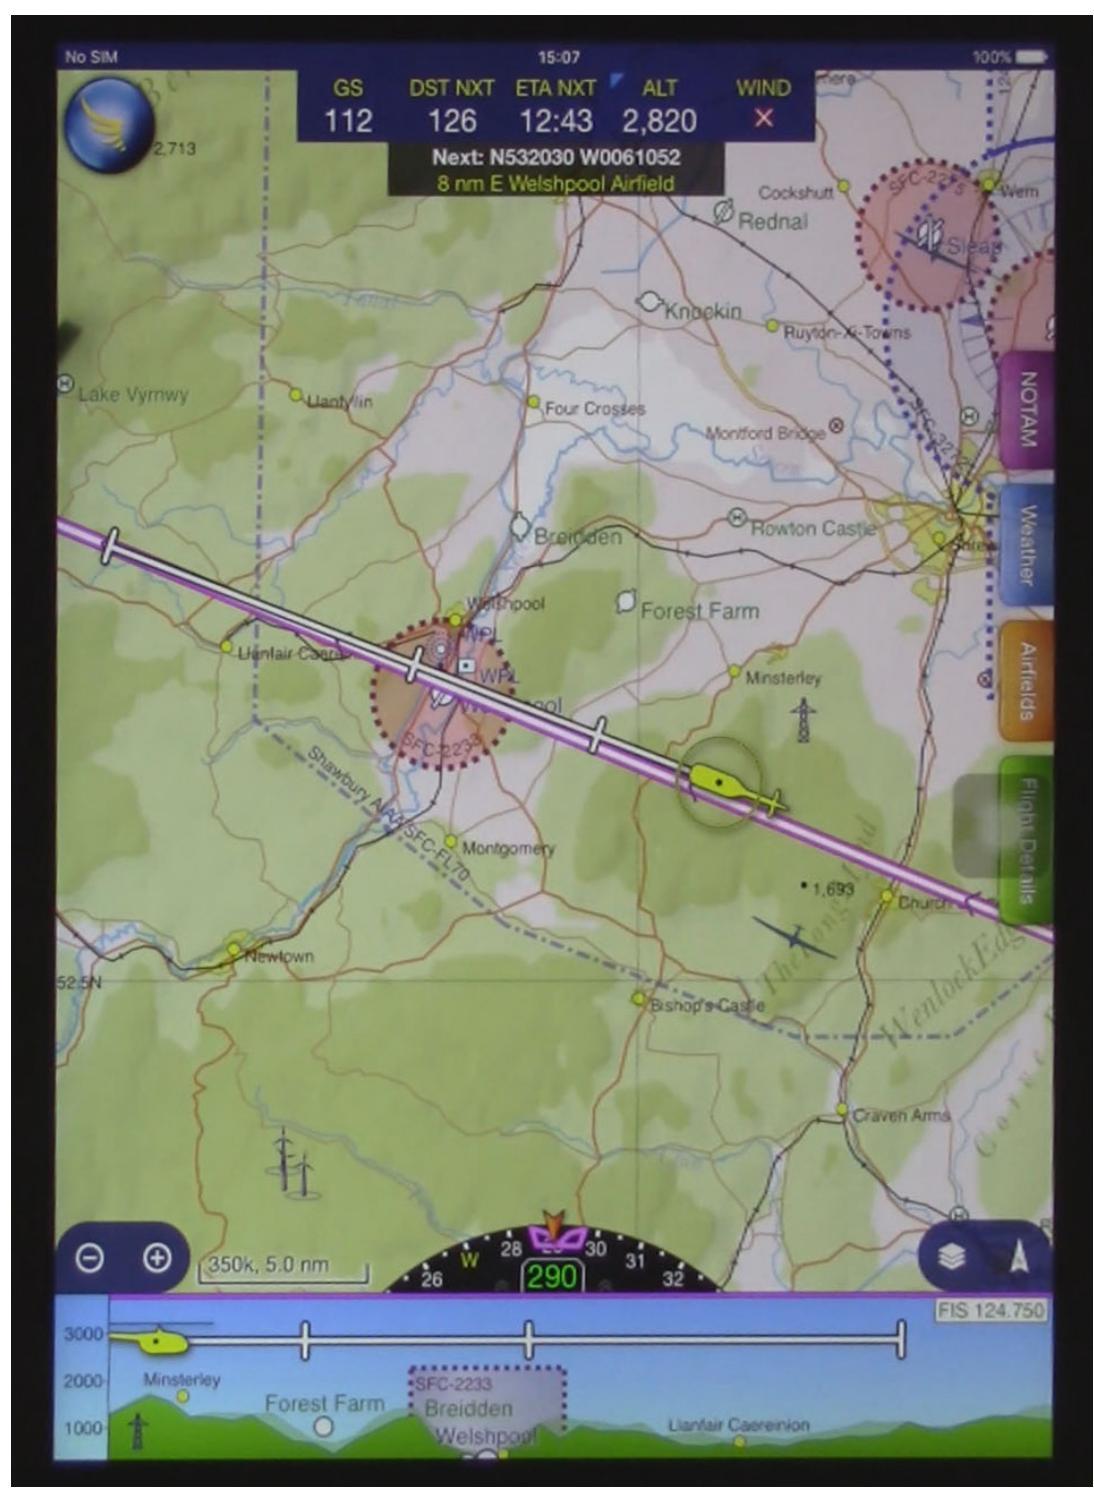
# Figure 14 Stored screenshot of app (SkyDemon) running in the background at the time of the accident

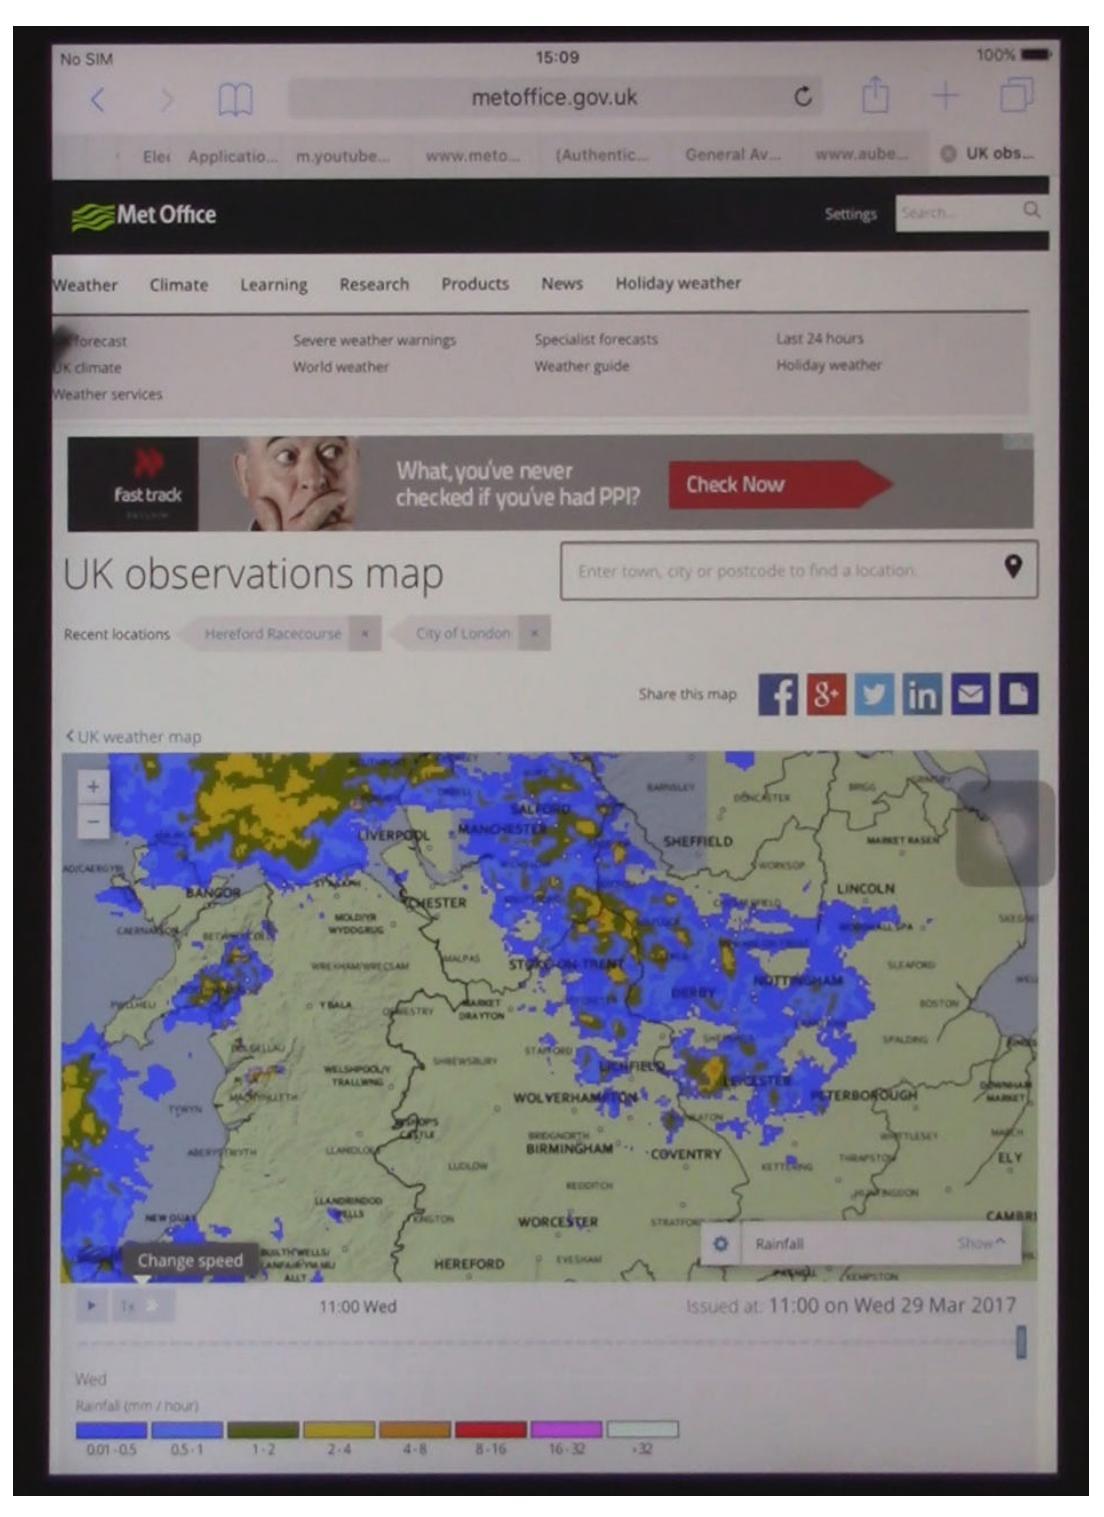
# Figure 15

Stored screenshot of app running in the background at the time of the accident

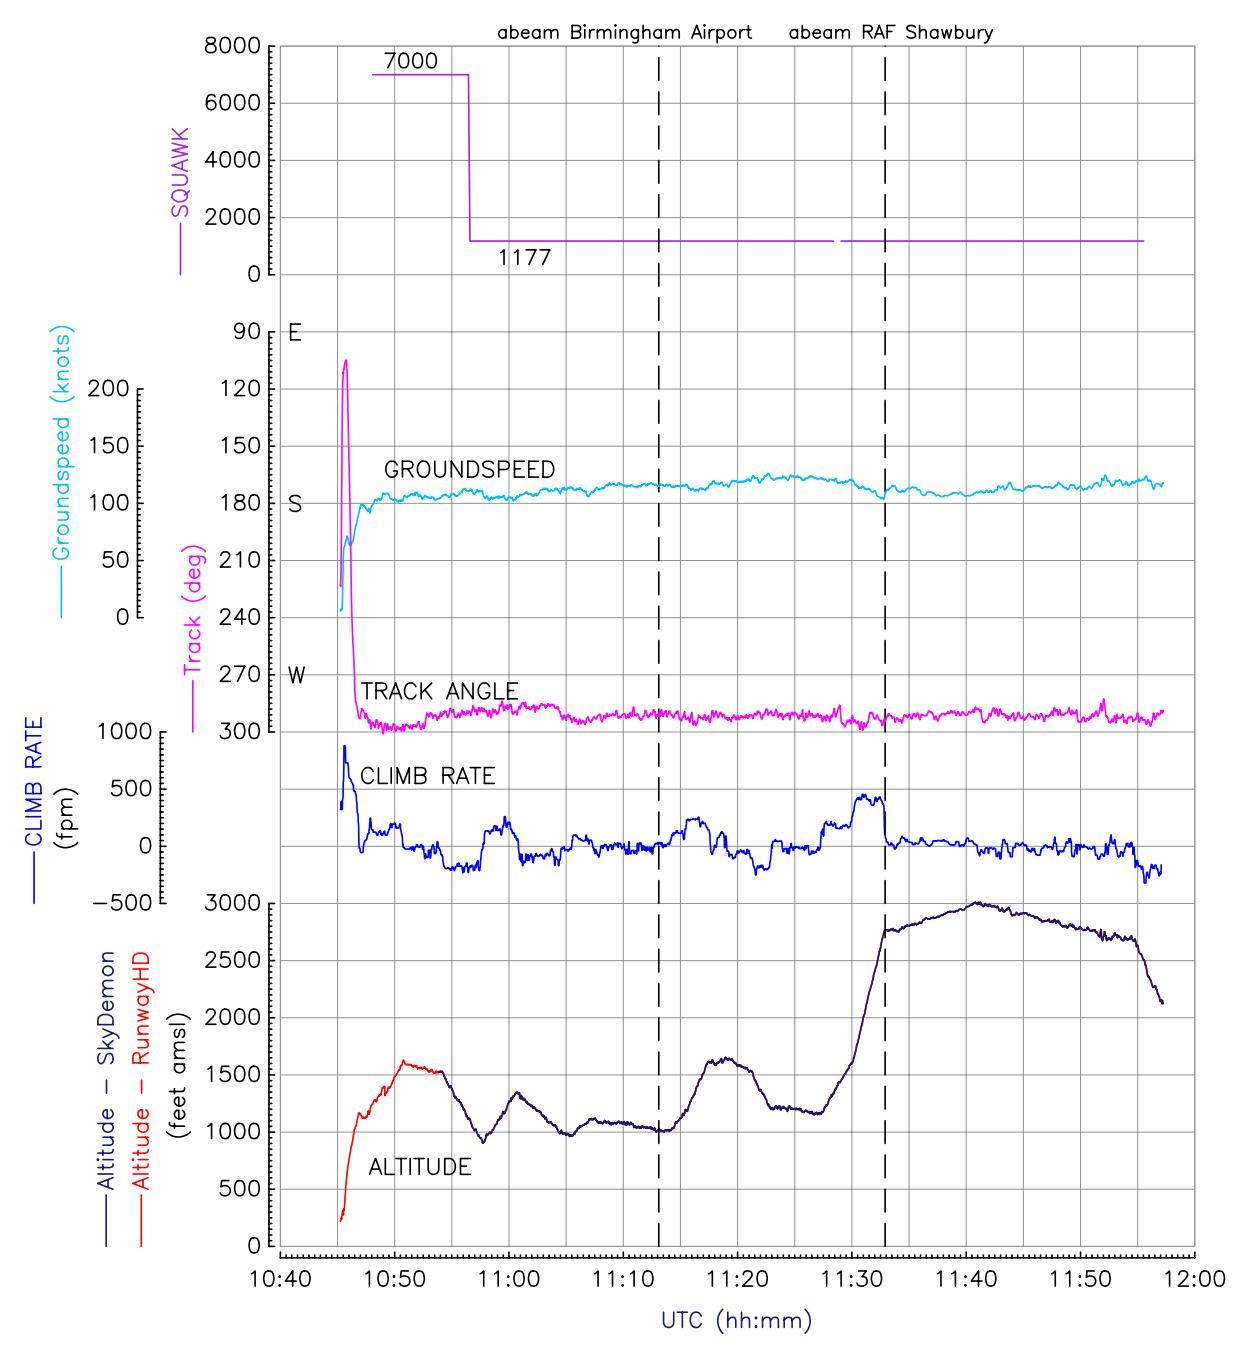
The planned route and actual track flown is illustrated in Figure 1, and the altitude and groundspeed profile for the flight in Figure 16 with other GPS derived and transponder information. The helicopter lifted around 1045 hrs; the last point, approximately 0.5 nm from the accident site, was recorded shortly after 1157 hrs. Figure 1 shows the helicopter flew close to the planned route, the maximum deviation being 0.7 nm in the early stages of the flight. The altitude profile in Figure 16 indicates that the first part of the route was flown between 1,000 and 1,500 ft amsl before climbing to 2,750 ft abeam RAF Shawbury at around 1133 hrs. Eight minutes later it climbed to a maximum of 3,000 ft before descending at approximately 25 ft/min to 2,700 ft. Shortly before 1155 hrs, the descent rate increased to 185 ft/min, after which radar contact was lost. The altitude of the last recorded point on the RunwayHD and SkyDemon apps was 2,125 ft. The calculated groundspeed for the flight varied between 100 and 120 kt.

Recorded data from RunwayHD and SkyDemon with radar Mode A squawk

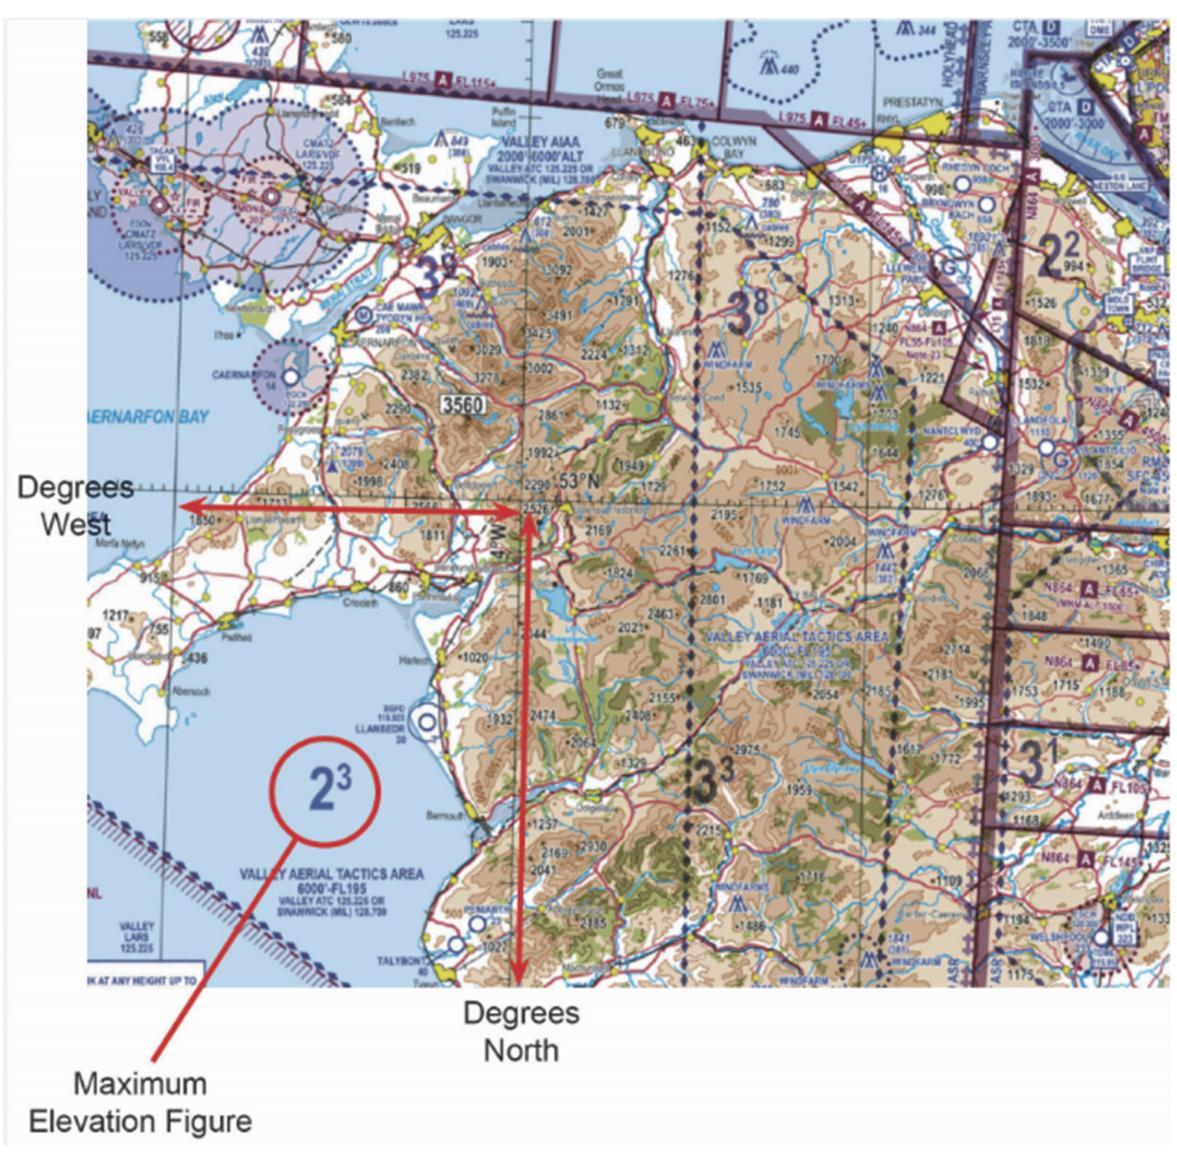
Figure 18 shows part of an aeronautical chart including the area in which the accident occurred. MEF are located in quadrangles bounded by graticule lines for every half degree of latitude and longitude. MEFs are represented in thousands and hundreds of feet above mean sea level. Each MEF is based on information available concerning the highest known feature in each quadrangle, including terrain and obstacles and allowing for unknown features. A note printed on the complete chart states that this is not a safety altitude. The MEF provides an instant figure on which to base the Minimum Safe Altitude (MSA) for a given area. MSA is based on the MEF plus 1,000 feet, below 5,000 feet. Thus, the MSA in the quadrangle containing the accident mountain would have been MEF 3,300 ft plus 1,000 ft terrain clearance giving an MSA of 4,300 ft. MSA is applied on IFR flights but is not required for VFR flights.

Figure 18 1:500,000 Chart with Maximum Elevation Figures shown
