AAIB Bulletin: 3/2018	G-CKLR	EW/C2017/04/01
ACCIDENT		
Aircraft Type and Registration:	SZD-55-1, G-CKLR	
No & Type of Engines:	None	
Year of Manufacture:	1993 (Serial no: 551193056)	
Date & Time (UTC):	8 April 2017 at 1045 hrs	
Location:	Currock Hill Airfield, Northumbria	
Type of Flight:	Private	
Persons on Board:	Crew - 1	Passengers - None
Injuries:	Crew - 1 (Fatal)	Passengers - N/A
Nature of Damage:	Extensive	
Commander's Licence:	Private Pilot's Licence	
Commander's Age:	62	
Commander's Flying Experience:	18,800 hours (of which 39 were on type) Last 90 days - 1 hour Last 28 days - 0 hours	
Information Source:	AAIB Field Investigation

Synopsis

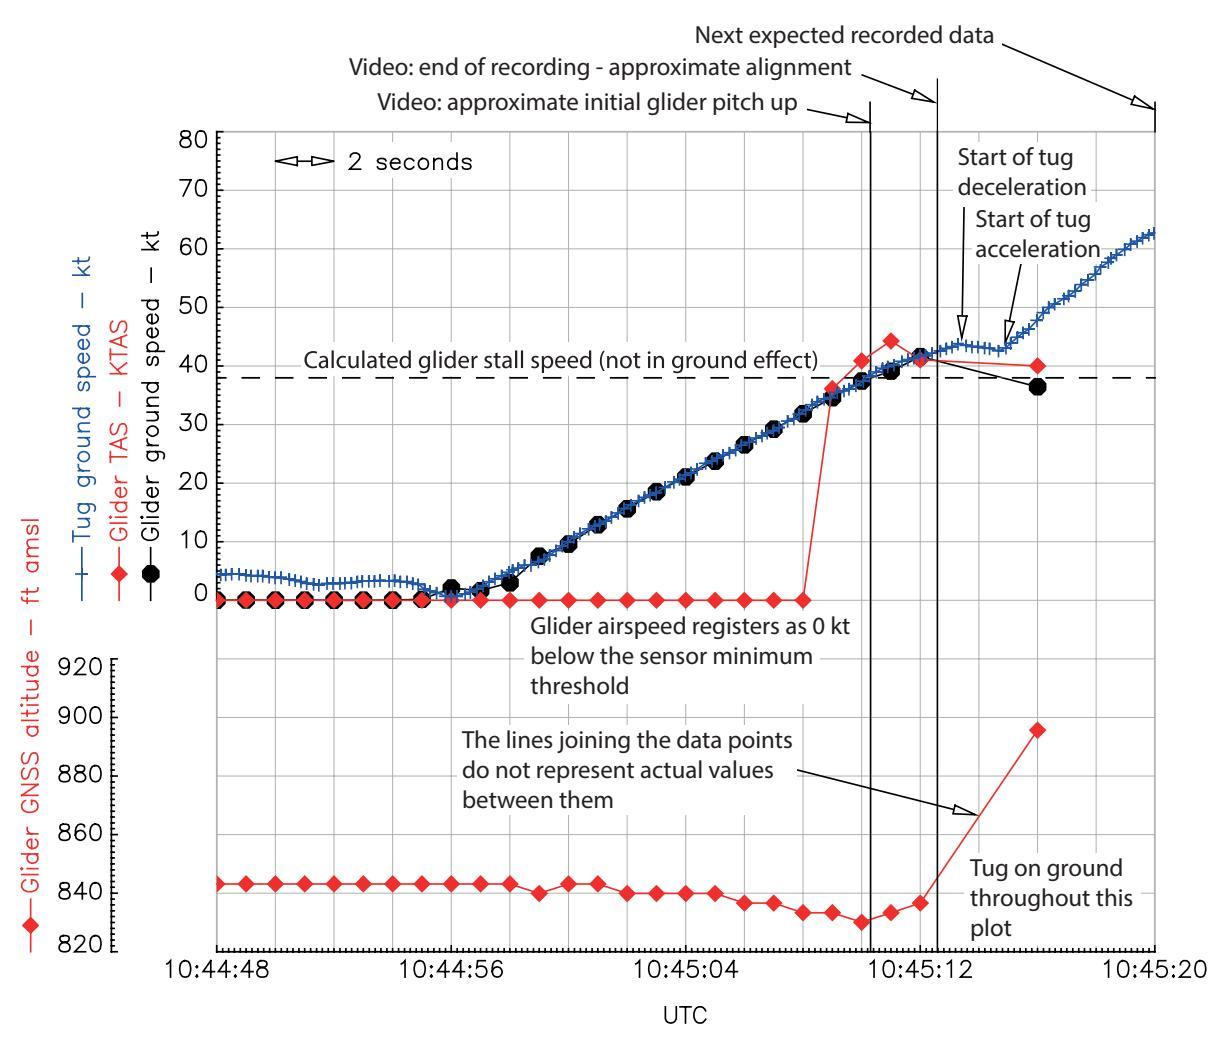
Figure 2

Data recovered from the tug (Figure 2) indicates that in the four second period between the glider's last two data points, the tug, which was still on its takeoff ground roll, experienced a short period of deceleration. Thereafter the tug's acceleration was higher than that evident earlier in the takeoff roll.

Recorded data from the glider and tug

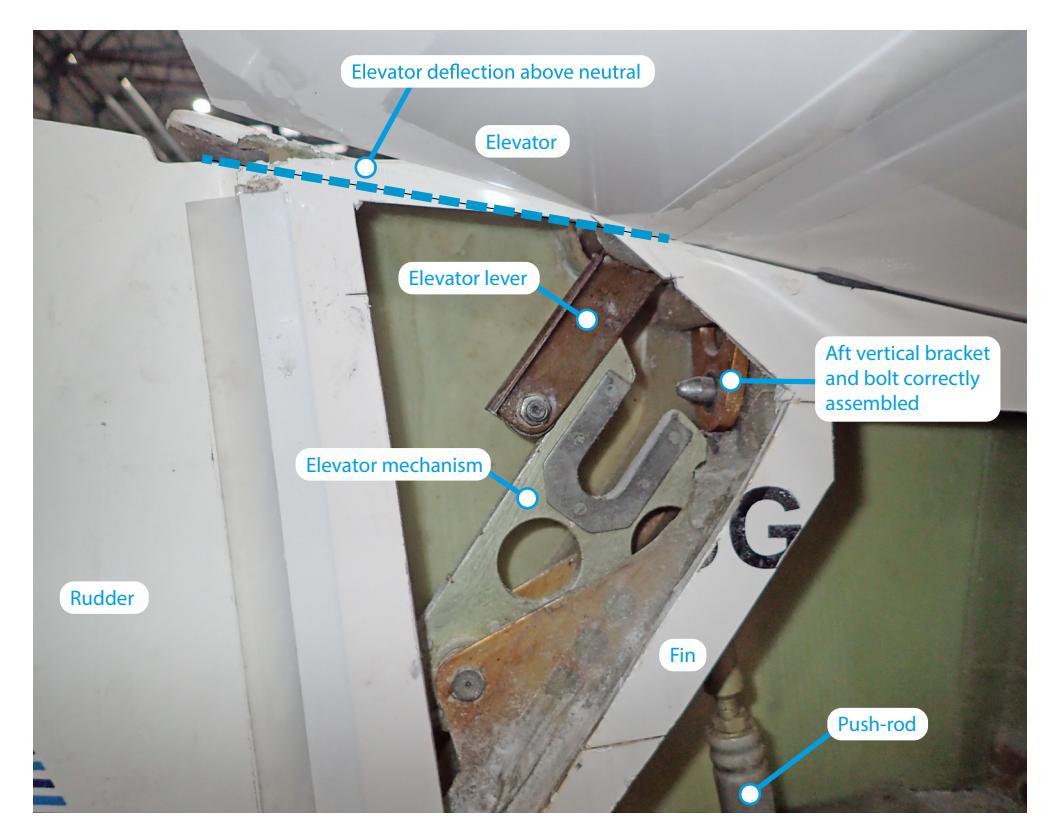
Figure 6

The tailplane was correctly seated on top of the tail fin with no obvious gap between the tailplane and the fin. Access panels were cut in the tail fin to inspect the elevator control connection. It was observed that the tailplane structural connections were correctly made, and the securing bolt correctly inserted. However, the elevator lever was not engaged in the elevator mechanism, but was instead sitting aft of the mechanism (Figure 6).

Position of elevator lever as found on G-CKLR (Note: elevator lever not engaged in elevator mechanism)

Disruption to the elevator control system, caused by the impact, meant that the control stick was no longer connected to the elevator control mechanism, and the position of the mechanism was therefore not restrained. Consequently, as shown in Figure 6, the elevator mechanism, under its own weight, is resting against a small wooden block, which forms the forward stop of the elevator control system. This corresponds to a position slightly forward of full forward control stick. In normal circumstances, control stops on a bracket at the base of the control stick limit its range of movement and, when the control stick is in the fully forward position, there should be a 0.5 mm gap between the elevator mechanism and the wooden block.

During examination of the wreckage, the horizontal elevator push-rod was moved forward and aft to simulate movement of the control stick. It was demonstrated that in this mis-rigged condition, the elevator surface could be driven upwards by moving the control stick (push-rod) aft. Forward movement of the control stick (push-rod) resulted in the elevator surface moving downwards under gravity, but only to a position above neutral and not into the normal downwards range of elevator deflection. The available range of elevator deflection in the mis-rigged condition was measured as 5° UP to 30° UP; the normal range of elevator deflection is 20° DOWN to 30° UP.

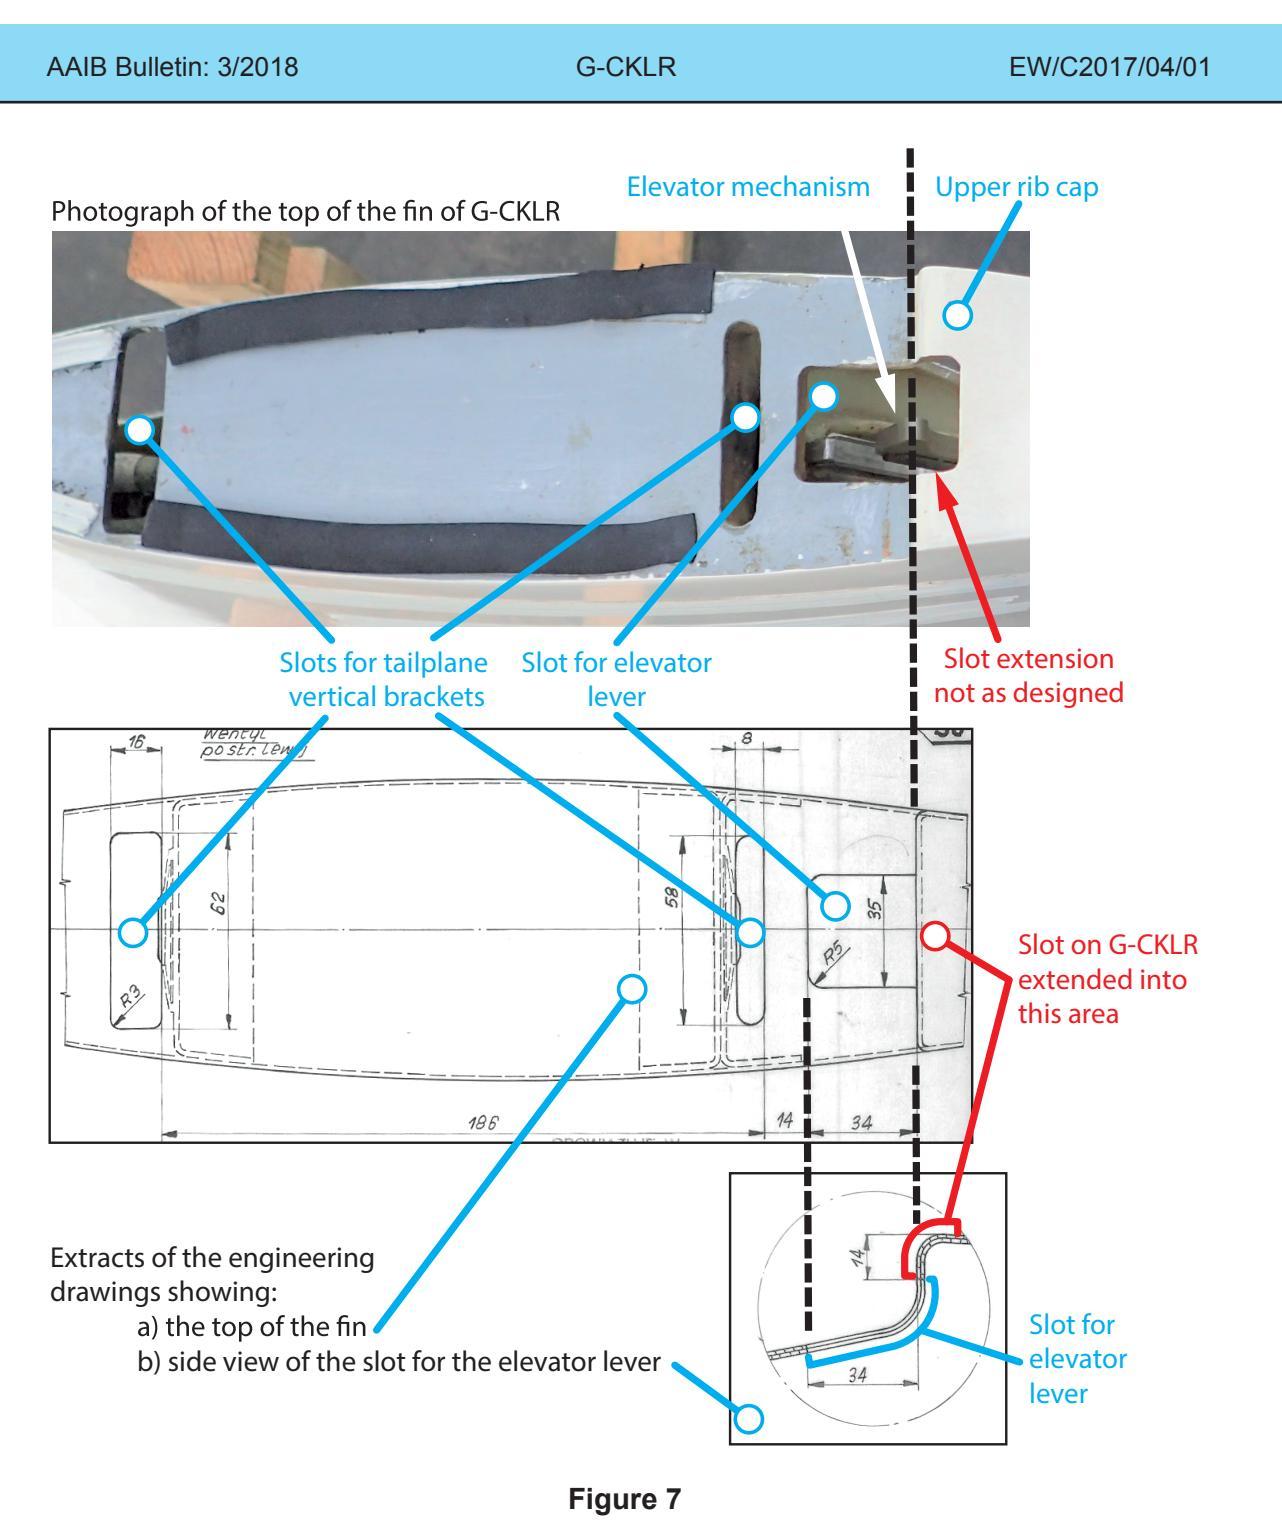
The rigging pin was removed from the fin and it came out smoothly, with no resistance. When the tailplane was removed, it was evident from examination of the horizontal rib of the tail fin, that the elevator lever slot was substantially larger than the original design dimensions. The appearance of the edge of the slot was rough and unfinished and was of uneven thickness. The manufacturer considered that the finish did not correspond to original production standard.

Figure 7 shows a plan view of the horizontal rib from the tail fin of G-CKLR compared with extracts from an engineering drawing provided by the manufacturer.

The design dimensions of the elevator slot in the horizontal rib of the tail fin should be 34 mm x 35 mm. The horizontal rib exhibits an approximately vertical step-change in profile towards its aft end. The design drawings indicate that the elevator lever slot should extend only partially up this vertical step, to a position which is approximately indicated by the dashed line in Figure 8. However, on G-CKLR this slot extends up the entirety of the vertical step and onto the upper rib cap.

G-CKLR tail fin horizontal rib comparison with extracts from engineering drawing showing design dimensions

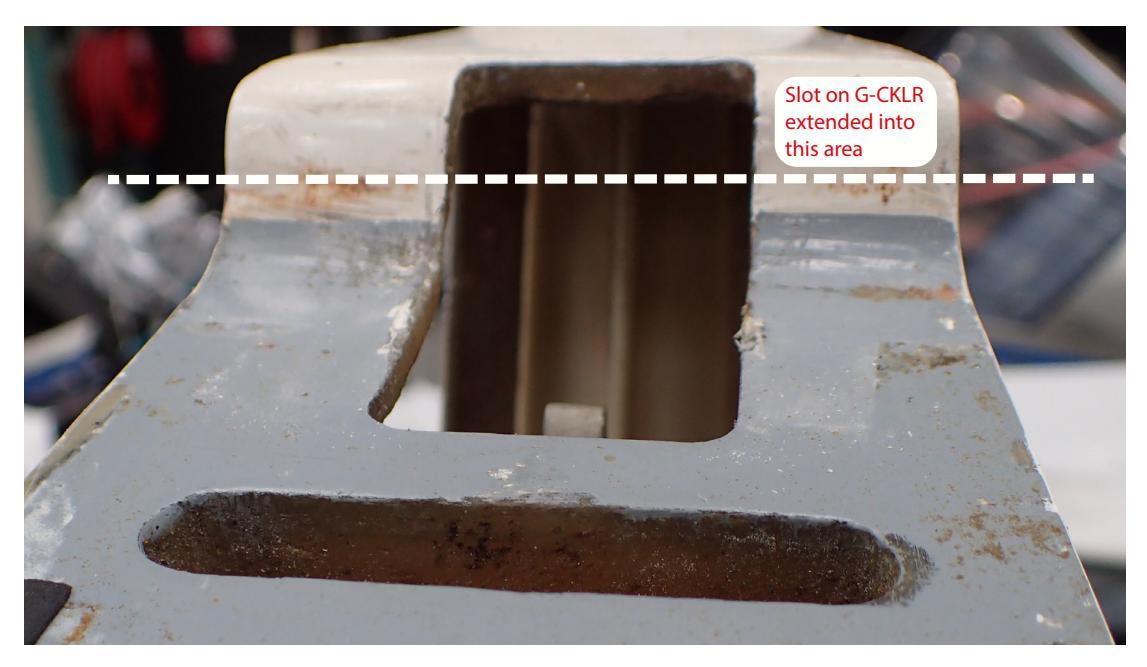
Figure 8 Rearwards view of elevator slot in G-CKLR's tail fin
