Report on the investigation of the

Ocean Prefect

Umm Al Qaywayn, United Arab Emirates

REPORT NO 8/2018

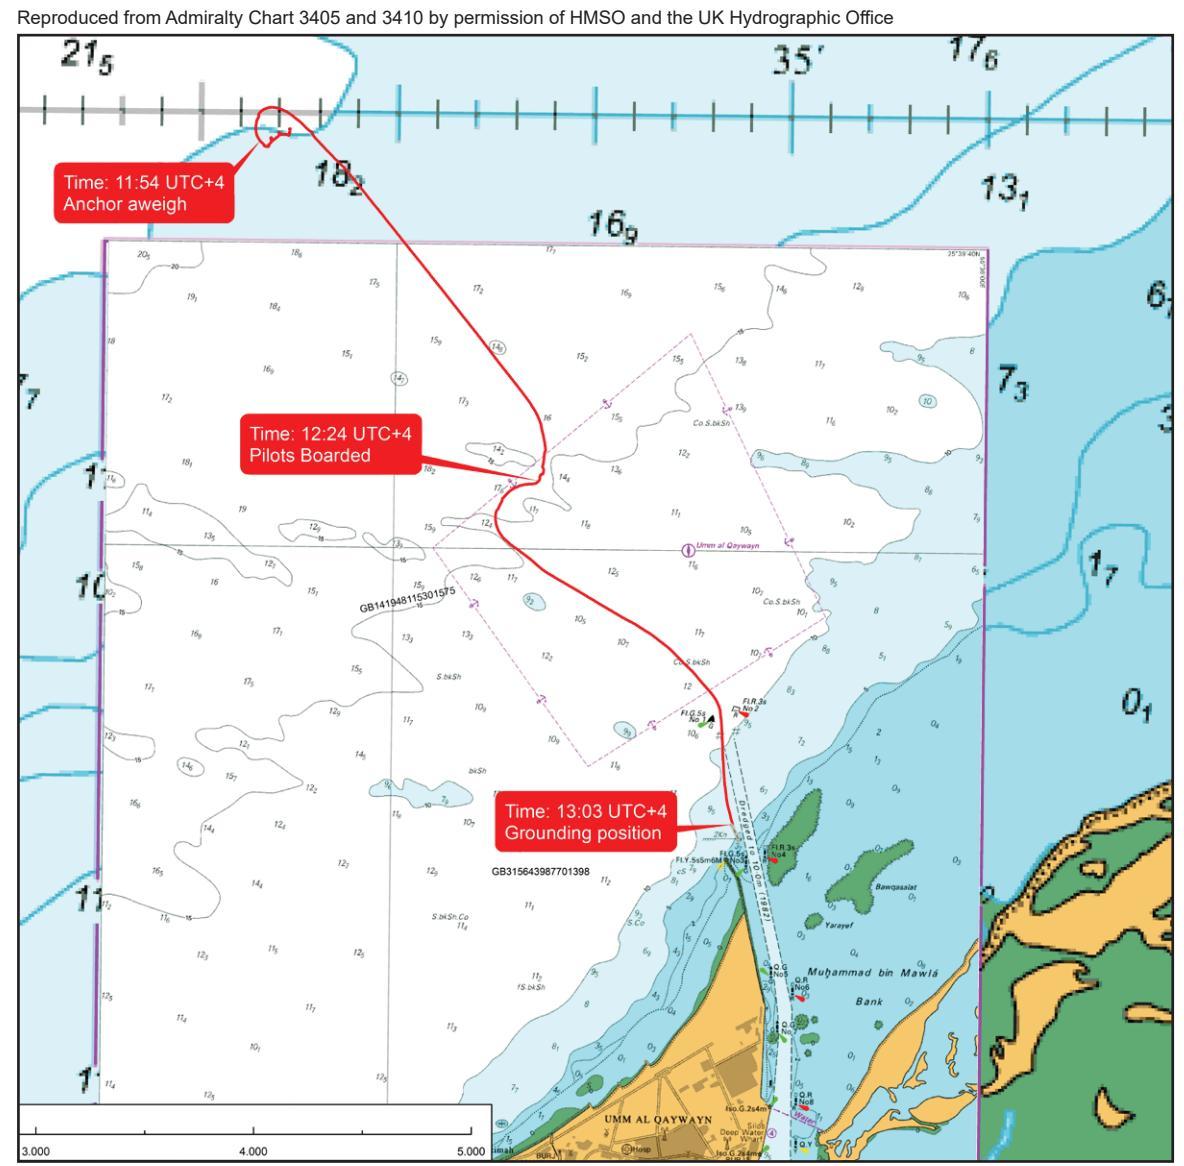
Figure 1: Extracts of Admiralty charts 3405 and 3410 showing the approaches to Umm Al Qaywayn and track to first grounding on 10 June 2017

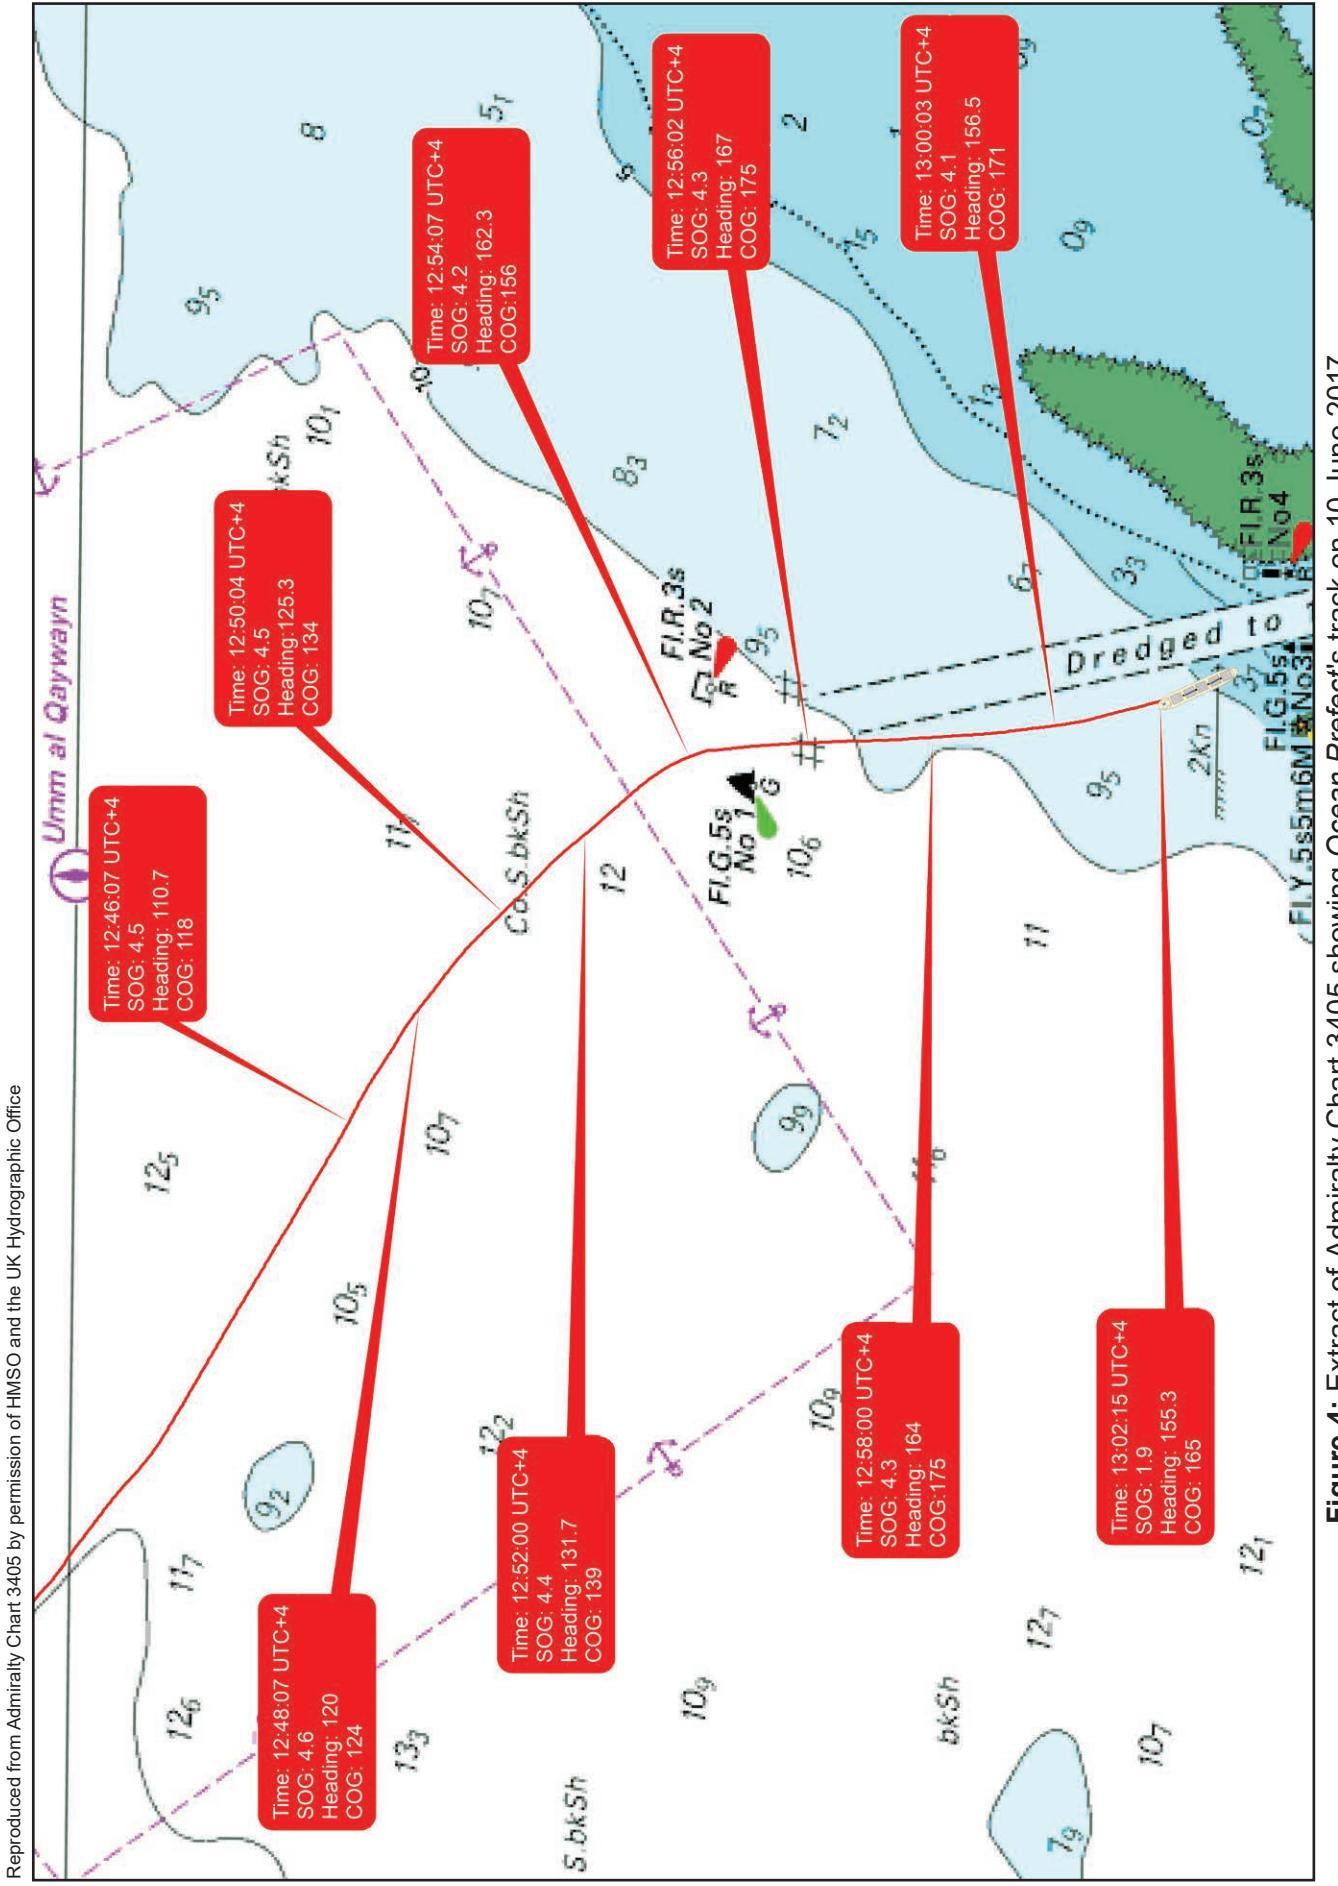
At 1254, *Ocean Prefect* passed between No.1 and No.2 buoys (Figure 4) and the pilot steadied the vessel on a heading of 167°. The engine telegraph was at 'slow ahead' and the vessel was making good 4.2kts⁵. At 1255:42, the echo sounder alarm activated. The depth displayed on the echo sounder, which was set to show 'depth below the keel', was 1.8m.

At 1302:30, the pilot asked for *Ocean Prefect*'s speed and was informed by the second officer that it was 1.1kts. The master added that the vessel was probably aground. The pilot immediately ordered a heading of 150° followed by hard-a-port and 'full ahead'.

Figure 4: Extract of Admiralty Chart 3405 showing Ocean Prefect's track on 10 June 2017

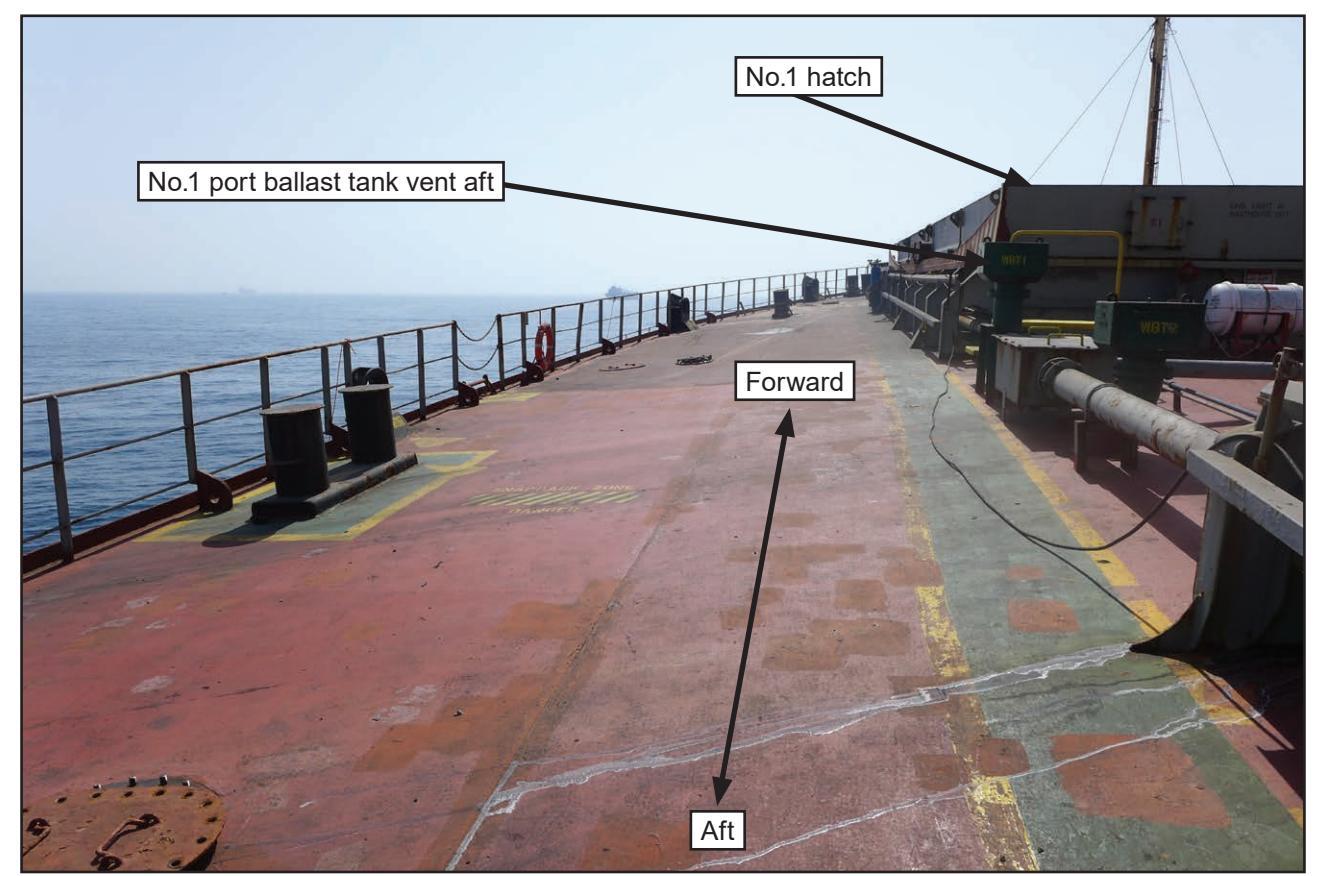
'full ahead' and steered the vessel towards the centre of the channel. At the same time, the chief officer, who was on the port side of the main deck adjacent to the accommodation, investigated an unusual loud noise and found air rushing from the ballast tank vent 'number 1 port aft' (**Figure 6**).

Figure 6: Ocean Prefect's main deck, port side

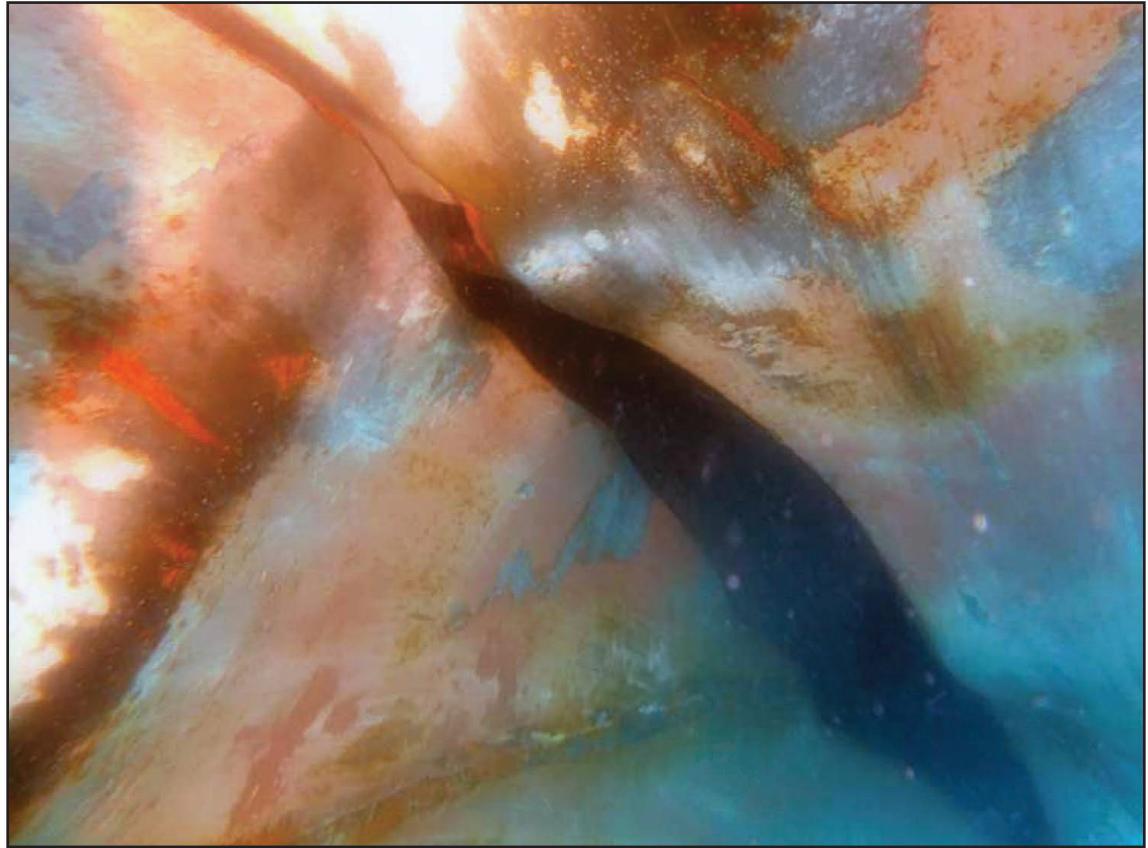
Ocean Prefect's cargo discharge in Umm Al Qaywayn was completed on 16 June 2017. The vessel then sailed and anchored off Dubai, UAE. On 18 June, a dive inspection identified a series of splits, deep indentations and buckling of the shell plating between frames 184 and 109 on the port side. The largest split was 9100mm in length and 200mm wide (**Figures 7** and **8**). Inspection of the starboard side identified only abrasion damage to paintwork. With Lloyd's Register's approval, *Ocean Prefect* proceeded to dry dock in Dubai for repair.

Figure 7: Split in shell plating between frames 169 and 178

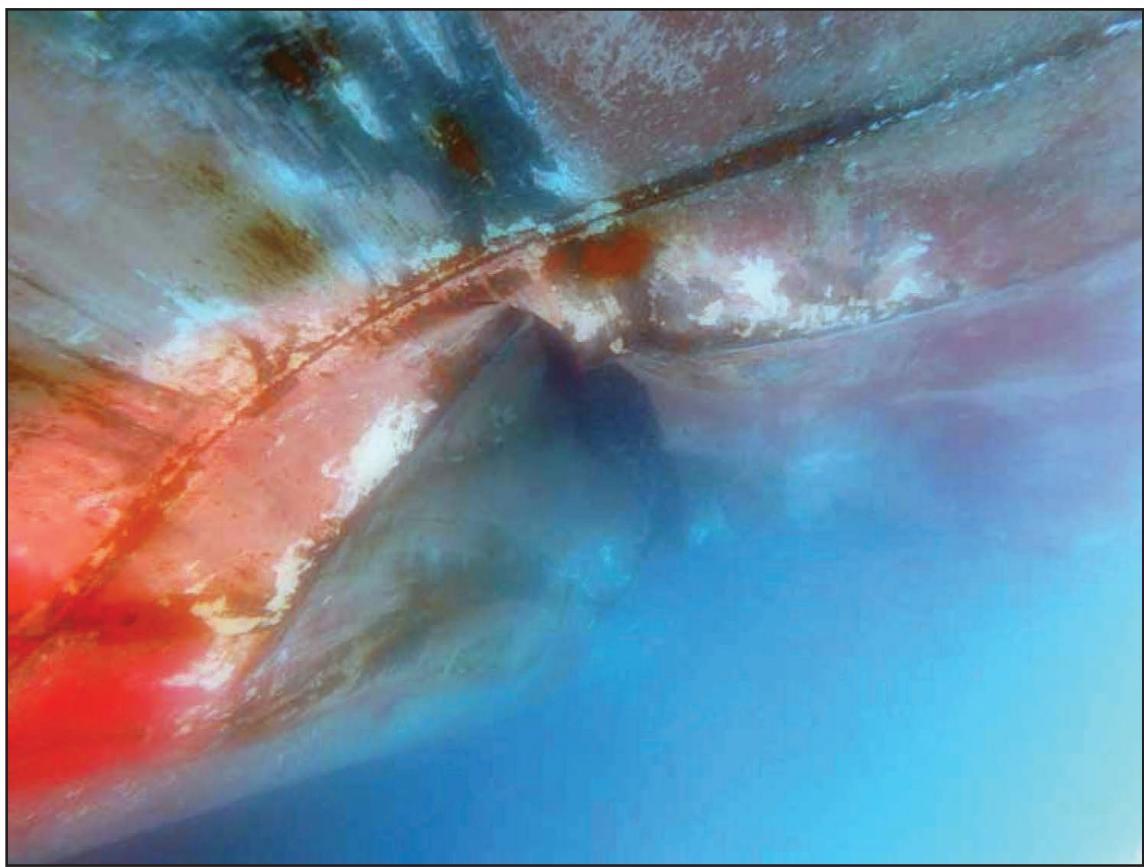
Figure 8: Shell plating deformation between frames 183 and 184

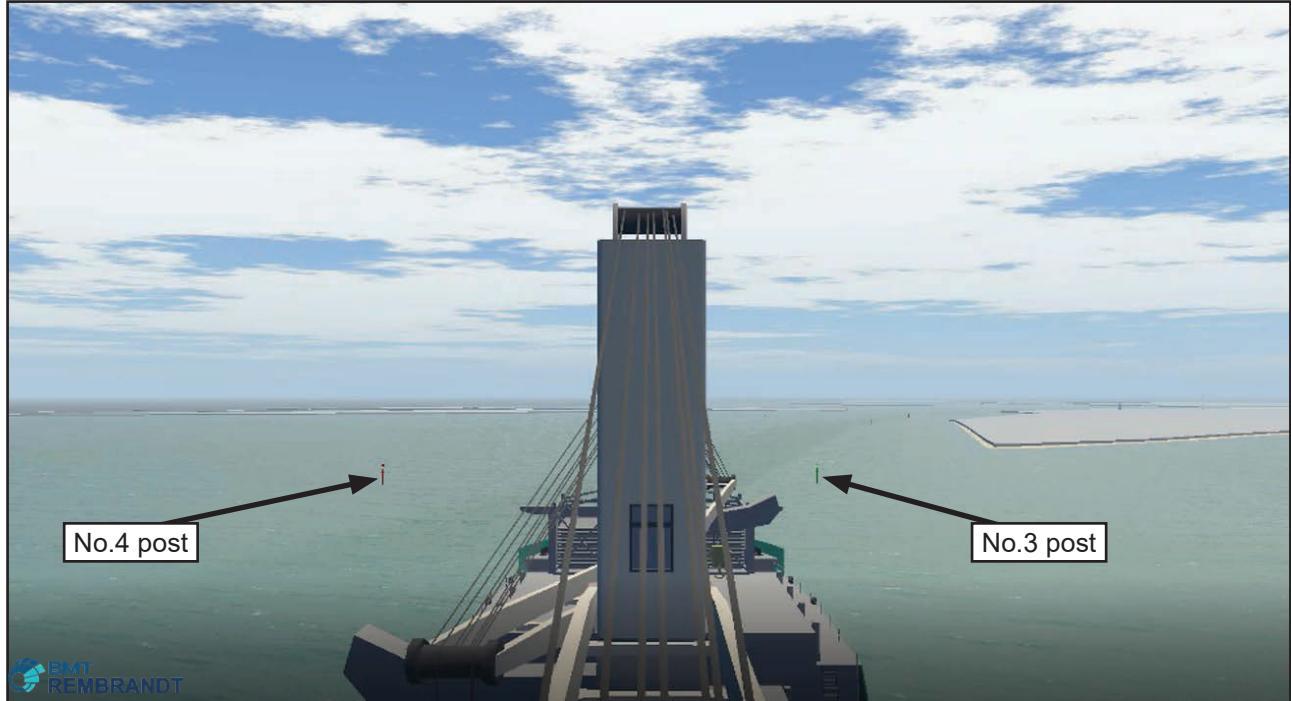
Figure 9: Simulated view from the bridge at 1300 (heading 155°)

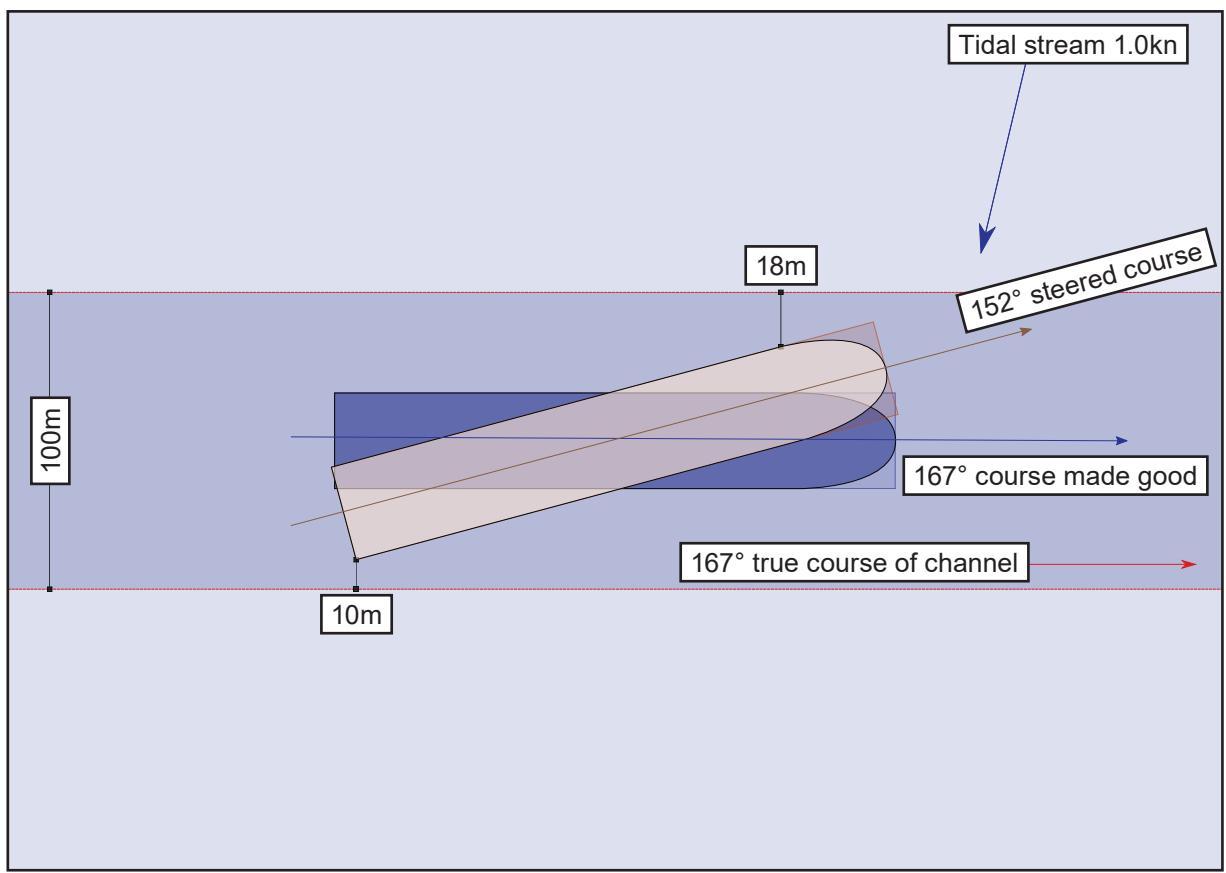
The importance of accurate tidal stream data in the approaches to Umm Al Qaywayn is increased by the narrowness and depth of the dredged channel, the length and breadth of larger vessels and their speed restrictions due to squat. As the channel is only 100m wide, the extent to which a vessel can safely deviate from the base axis of 167°/347° is determined by its length and its position relative to the channel's centre. During *Ocean Prefect*'s entry on 10 June, at a speed of 4kts, the vessel would have had to steer approximately 152° to counter the 1kt tidal stream and make good a course of 167°. As a result, the vessel's extremities would have been perilously close the channel's limits (**Figure 10**). Consequently, for large, deep draught vessels, slack or near slack water is a prerequisite of safe passage.

Figure 10: Bow and stern clearances of a 189m x 32.3m vessel in a 100m wide channel
