AAIB Bulletin: 6/2018	9H-BBJ an	d G-CISK	EW/G2018/01/02	
SERIOUS INCIDENT				
Aircraft Type and Registration:	1) 2)	Boeing 737, 9H-BBJ Embraer 145LR, G-CISK		
No & Type of Engines:	1) 2)	2 CFM 56-7 turbofan engines 2 Rolls-Royce AE3007A1 turbofan engines		
Year of Manufacture:	1) 2)	2000 (Serial no: 2002 (Serial no: 2002)	30791) 145570)	
Date & Time (UTC):	10 .	January 2018 at 1	238 hrs	
Location:	Bris	Bristol Airport		
Type of Flight:	1) 2)	Private N/A		
Persons on Board:	1) 2)	Crew - 6 Crew - None	Passengers - None Passengers - N/A	
Injuries:	1) 2)	Crew - None Crew - N/A	Passengers - None Passengers - N/A	
Nature of Damage:	1) 2)	Minor damage to left winglet Damage to tail section		
Commander's Licence:	1) 2)	Airline Transport Pilot Licence N/A		
Commander's Age:	1) 2)	54 years N/A		
Commander's Flying Experience	: 1)	11,700 hours (of Last 90 days - 11 Last 28 days - 5	which 5,200 were on type) 1 hours 55 hours

Synopsis

Whilst taxiing under guidance from a marshaller and wingman, the winglet of a Boeing 737 struck the tail of a parked Embraer 145. The airport authority and operator conducted separate investigations which identified several contributory factors that had combined

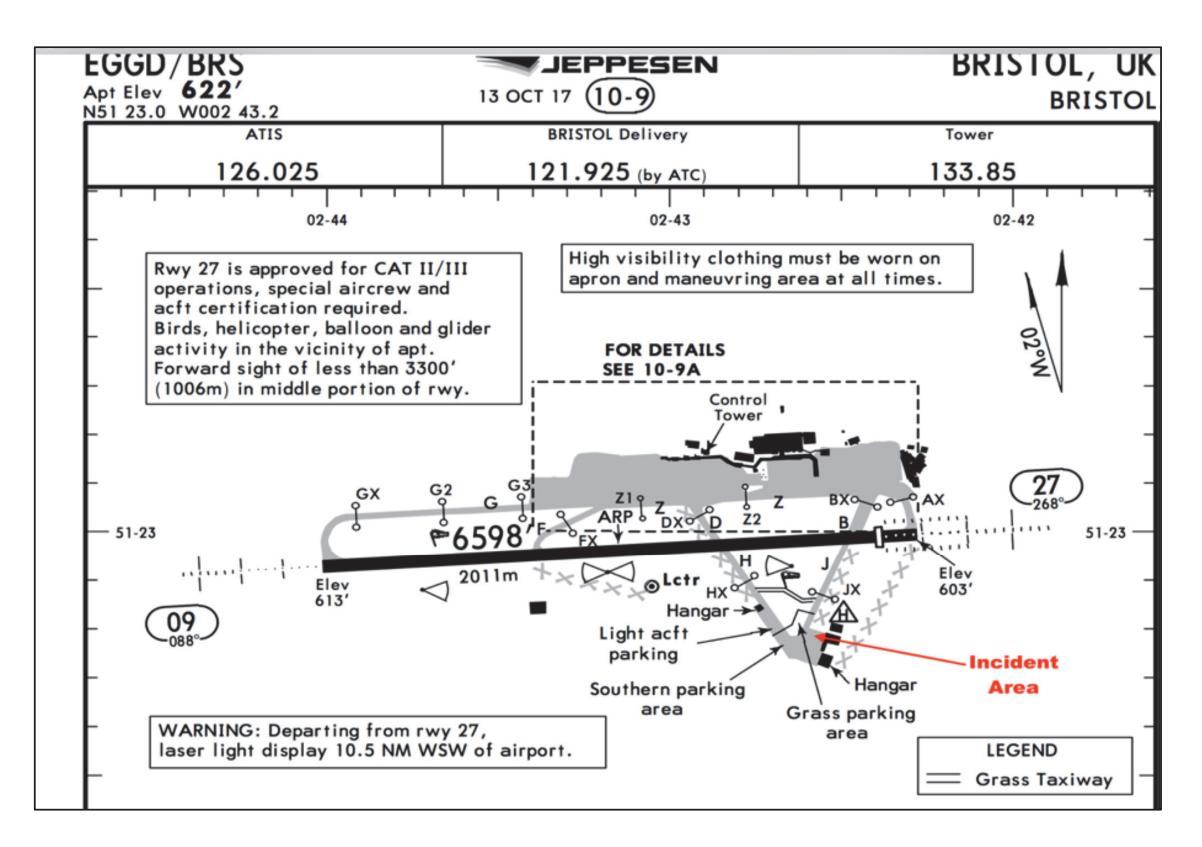
Figure 1

who provided a marshalling service. The commander reported that after crossing the Juliet X-Ray holding point (Figure 1), the aircraft was met by a wingman who stood on the left of the aircraft behind the tail of a parked Embraer 145 and a marshaller located just in front of the grass verge where the aircraft was to be parked (Figure 2). The marshaller then signalled to the flight crew to continue to move forward.

Layout of the airport showing the JX hold point and the Southern parking area

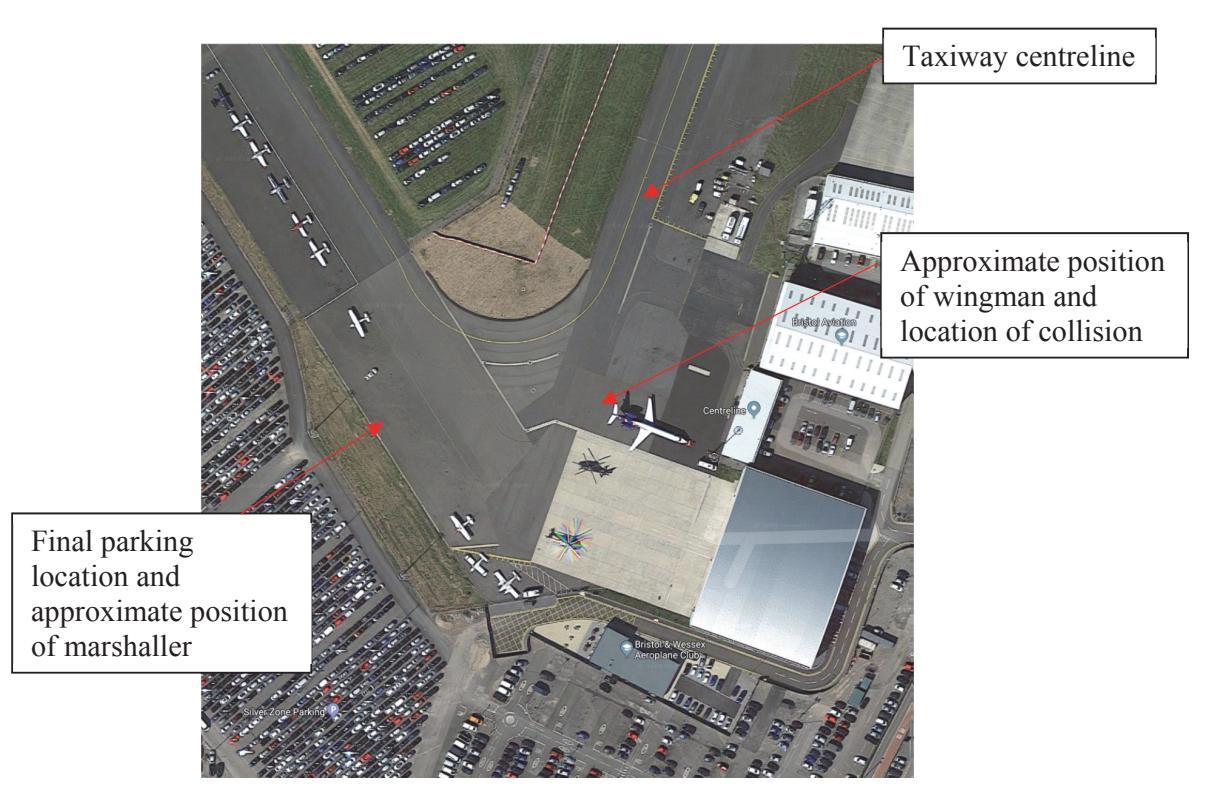
Figure 2

Accident location

Image showing the taxiway and a parked aircraft in the same position as the accident aircraft in front of the hangar

The accident was recorded by one of the airport's CCTV cameras located on the southern corner of the large silver building shown in Figure 2, looking north towards the taxiway.
