6/2018

AAIB Bulletin

Published 14 June 2018

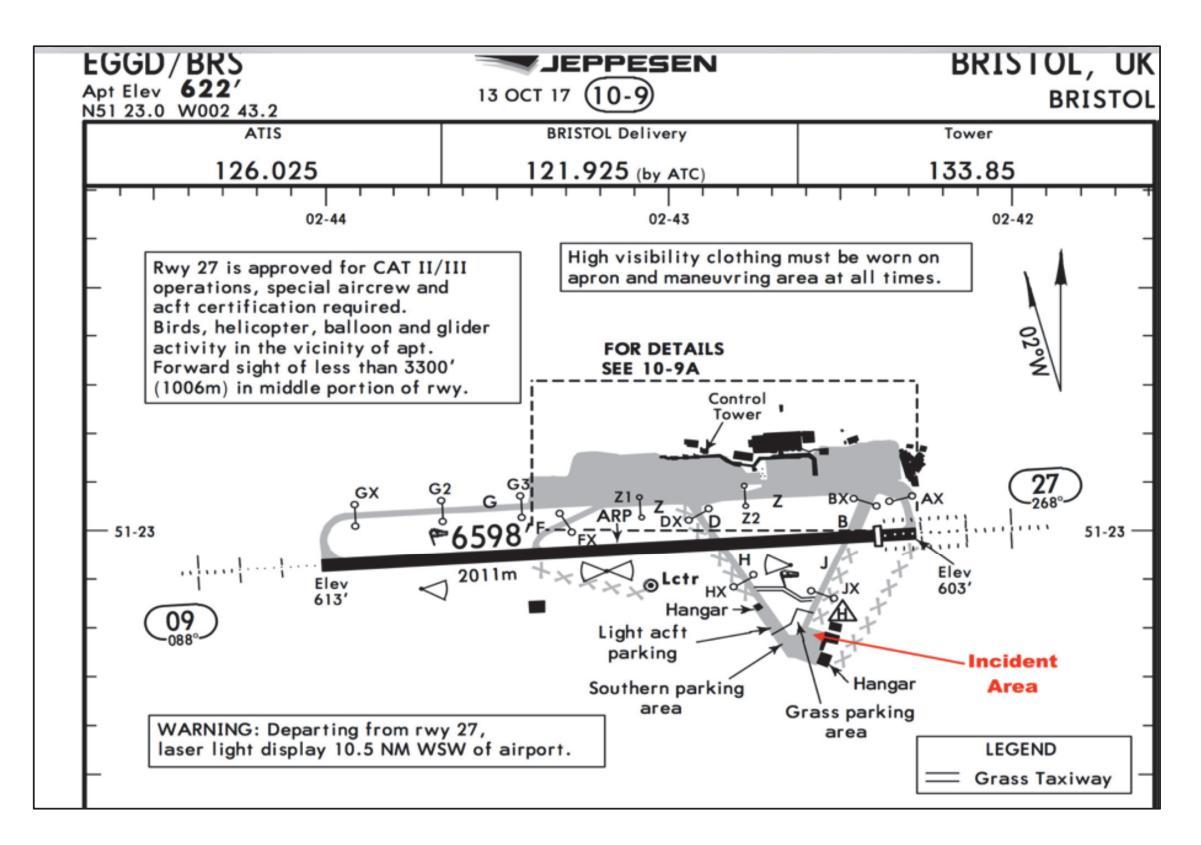
Figure 1

who provided a marshalling service. The commander reported that after crossing the Juliet X-Ray holding point (Figure 1), the aircraft was met by a wingman who stood on the left of the aircraft behind the tail of a parked Embraer 145 and a marshaller located just in front of the grass verge where the aircraft was to be parked (Figure 2). The marshaller then signalled to the flight crew to continue to move forward.

Layout of the airport showing the JX hold point and the Southern parking area

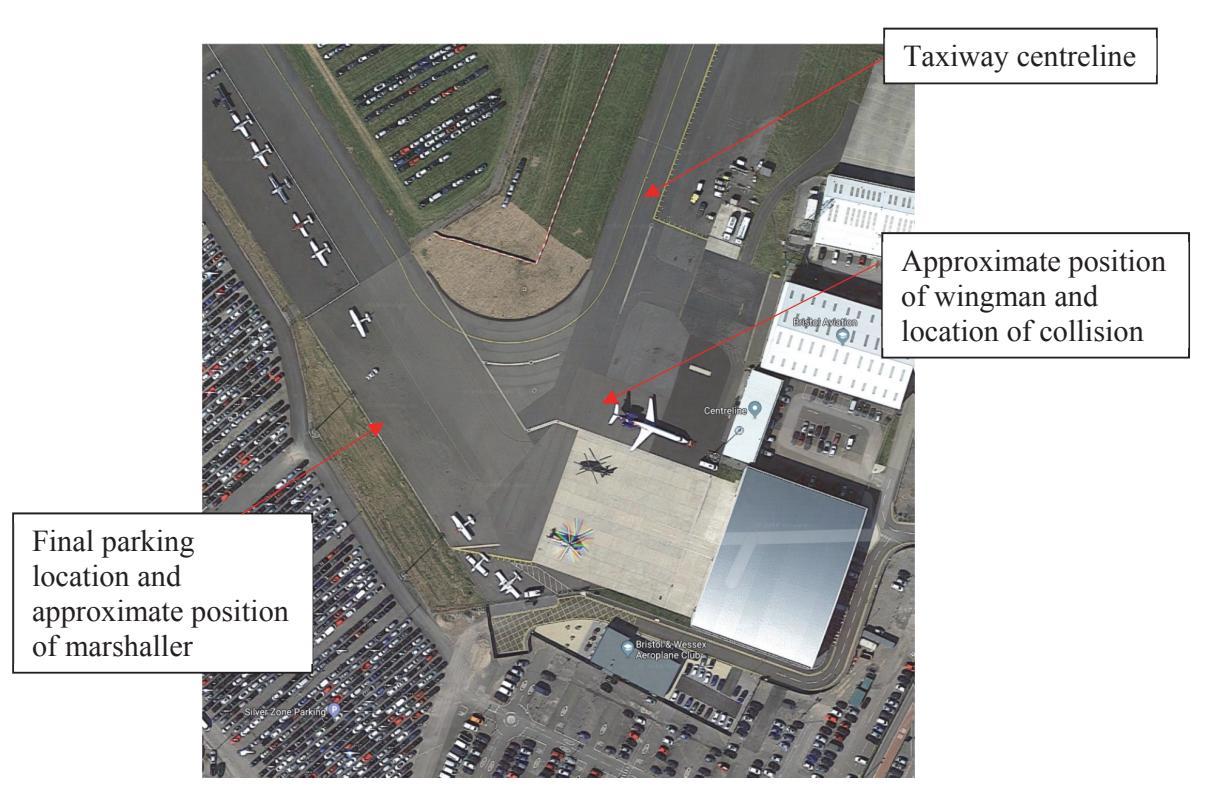
Figure 2

Image showing the taxiway and a parked aircraft in the same position as the accident aircraft in front of the hangar

The accident was recorded by one of the airport's CCTV cameras located on the southern corner of the large silver building shown in Figure 2, looking north towards the taxiway.

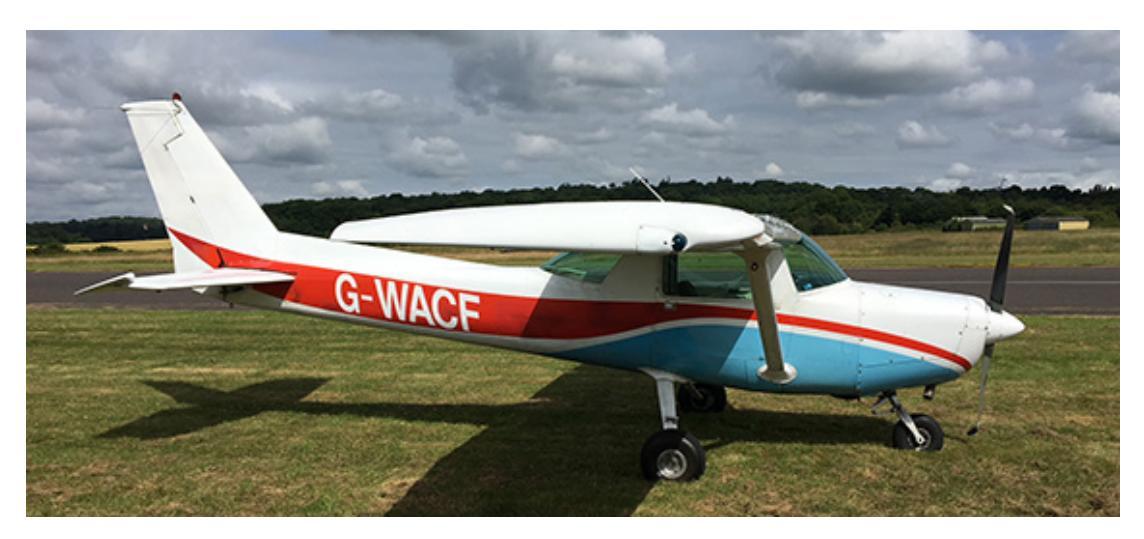
Figure 1

The approach appeared stable until, at approximately 100 ft aal, the student started to make over-corrections to the aircraft's pitch attitude, while trying to achieve the correct airspeed. The instructor observed the aircraft pitching up and down and saw the mainwheels touchdown before the aircraft bounced, in a nose-up attitude, to approximately 15 ft aal. However, the nose then dropped, the aircraft landed nosewheel-first and it porpoised along the runway while the groundspeed reduced.

G-WACF, with damage to the propeller and to the nose landing gear apparent

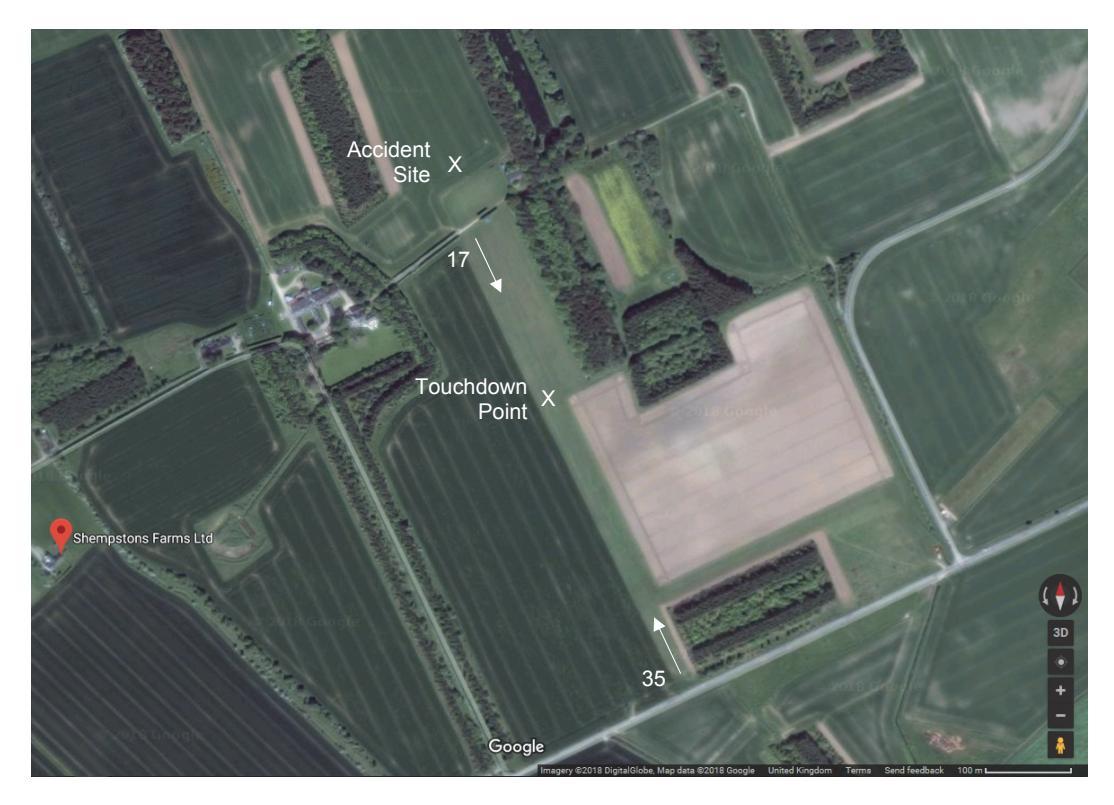
During the flight the wind increased to about 13 kt and the pilot made three approaches followed by go-arounds. The touchdown on the fourth approach was later than normal (Figure 1) and at 60 KIAS which, combined with the tailwind component, resulted in a high ground-speed. The aircraft wheel brakes are not normally used for landing deceleration and the pilot was unable to stop before running off the end of the runway. The aircraft entered a rough ploughed field causing the main landing gear to dig in and it came to rest inverted. The pilot required assistance to vacate the aircraft and suffered a minor back injury. The engine and propeller suffered shock loading and the structure of the canopy, upper fuselage and right main landing gear was damaged.

Figure 1 Accident site - Shempstons Field, near Lossiemouth

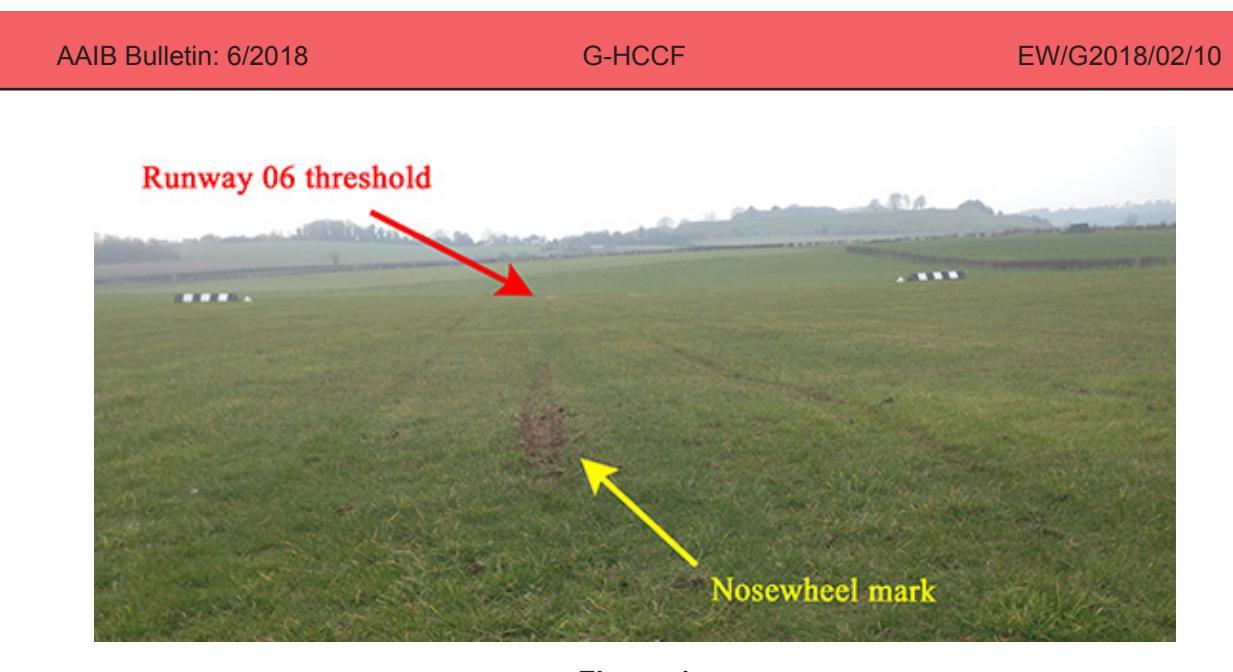
A third approach was flown, for another 'short field' landing, and the aircraft touched down on a part of the runway close to the threshold that felt "bumpy" and had an uphill gradient. The aircraft bounced and both occupants believed that only the mainwheels had touched, but subsequent examination of the ground markings indicated the nosewheel had also made firm contact (Figure 1). This was substantiated by a witness, who described the third landing as heavier than the first two, and who believed the aircraft was in a relatively flat attitude when it bounced.

Figure 1 View of initial ground marks; the aircraft having touched down moving towards the camera position and then bounced

After examining the ground marks and damage, the passenger, who was also the aircraft's constructor and owner, observed that the nose landing gear had bent rearwards as a result of "digging in" to the soft ground during the landing; there was significant damage to the nose landing gear fork unit. The pilot commented, that prior to the aircraft inverting, there was no jolt and no noise was heard that could have warned him the nose landing gear was sustaining damage.

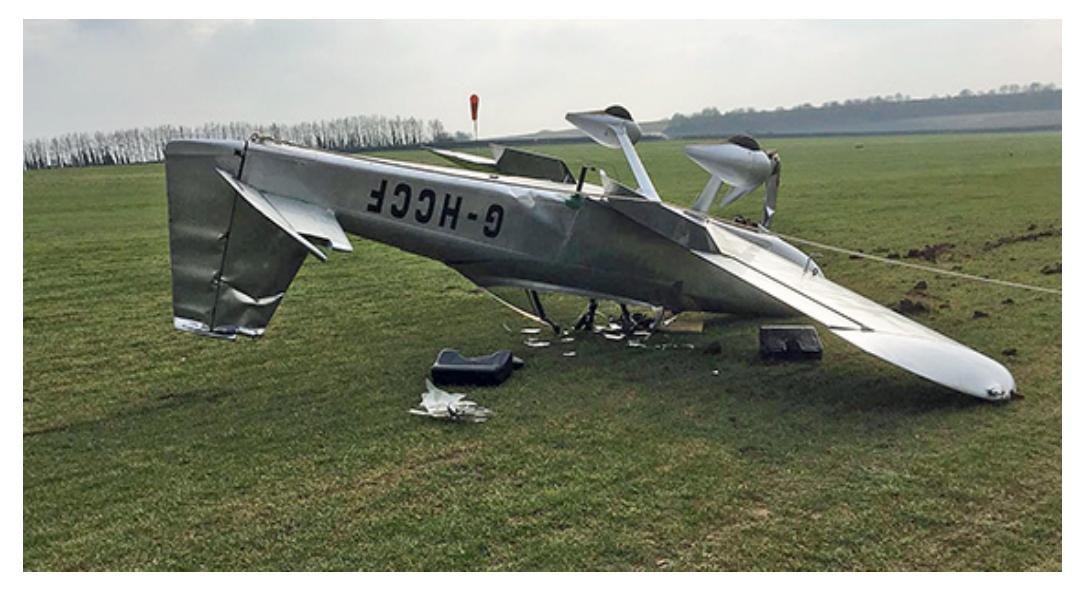
After the bounce, when the aircraft touched down again, the pilot asked the passenger to apply the brakes "more firmly" than he had during the previous landings. The aircraft ran straight and slowed quickly, but the nose dropped and, although the pilot moved the control stick fully aft, the propeller made ground contact. According to the passenger, the aircraft then "flipped over quite slowly" and came to rest inverted, with the canopy broken into several pieces (Figure 2).

Figure 2 G-HCCF inverted and with a line attached in preparation for righting

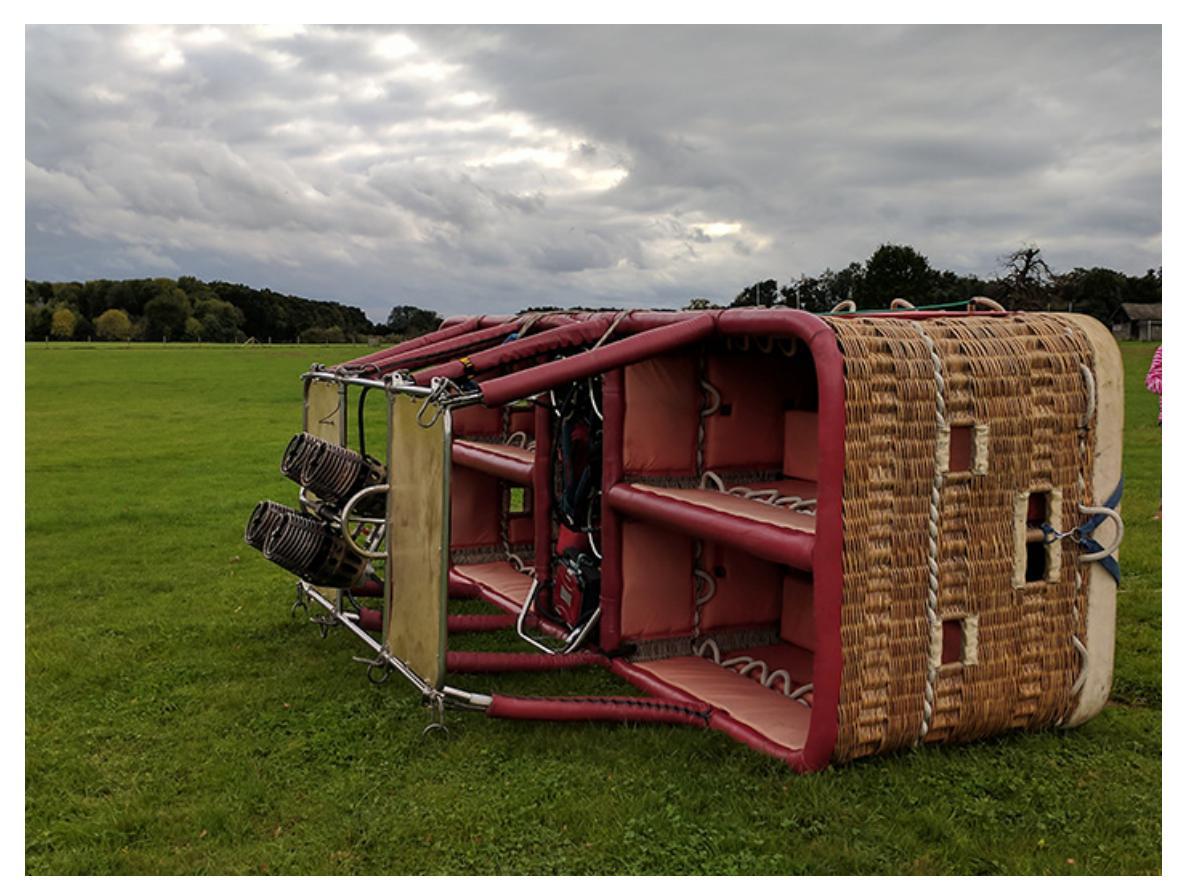
G-VBFO is a Cameron Z-375 hot air balloon. The basket has a central area for the pilot and four passenger compartments, two either side of the pilot (Figure 1). The operator's operations manual specifies that G-VBFO may carry a maximum of 18 occupants.

Figure 1 G-VBFO Basket before the flight

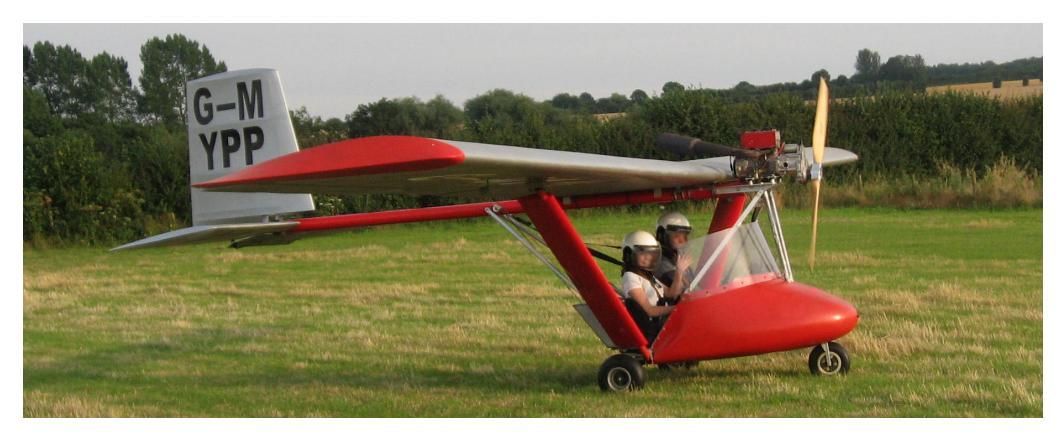
Figure 1 G-MYPP pictured prior to a previous flight

After the accident, the pilot discovered that a nipple on the throttle cable had detached, causing the engine to throttle back to idle. He noted that the aircraft (Figure 1), which had last flown four weeks previously, is a low inertia microlight and "does not have a great glide ratio". He estimated that the elapsed time from the loss of power to impact was 10 seconds.
