## **Air Quality and Dust Monitoring Monthly Report – June 2018**

**Three Rivers District Council**

A report prepared by Osborne on behalf of HS2 Ltd.

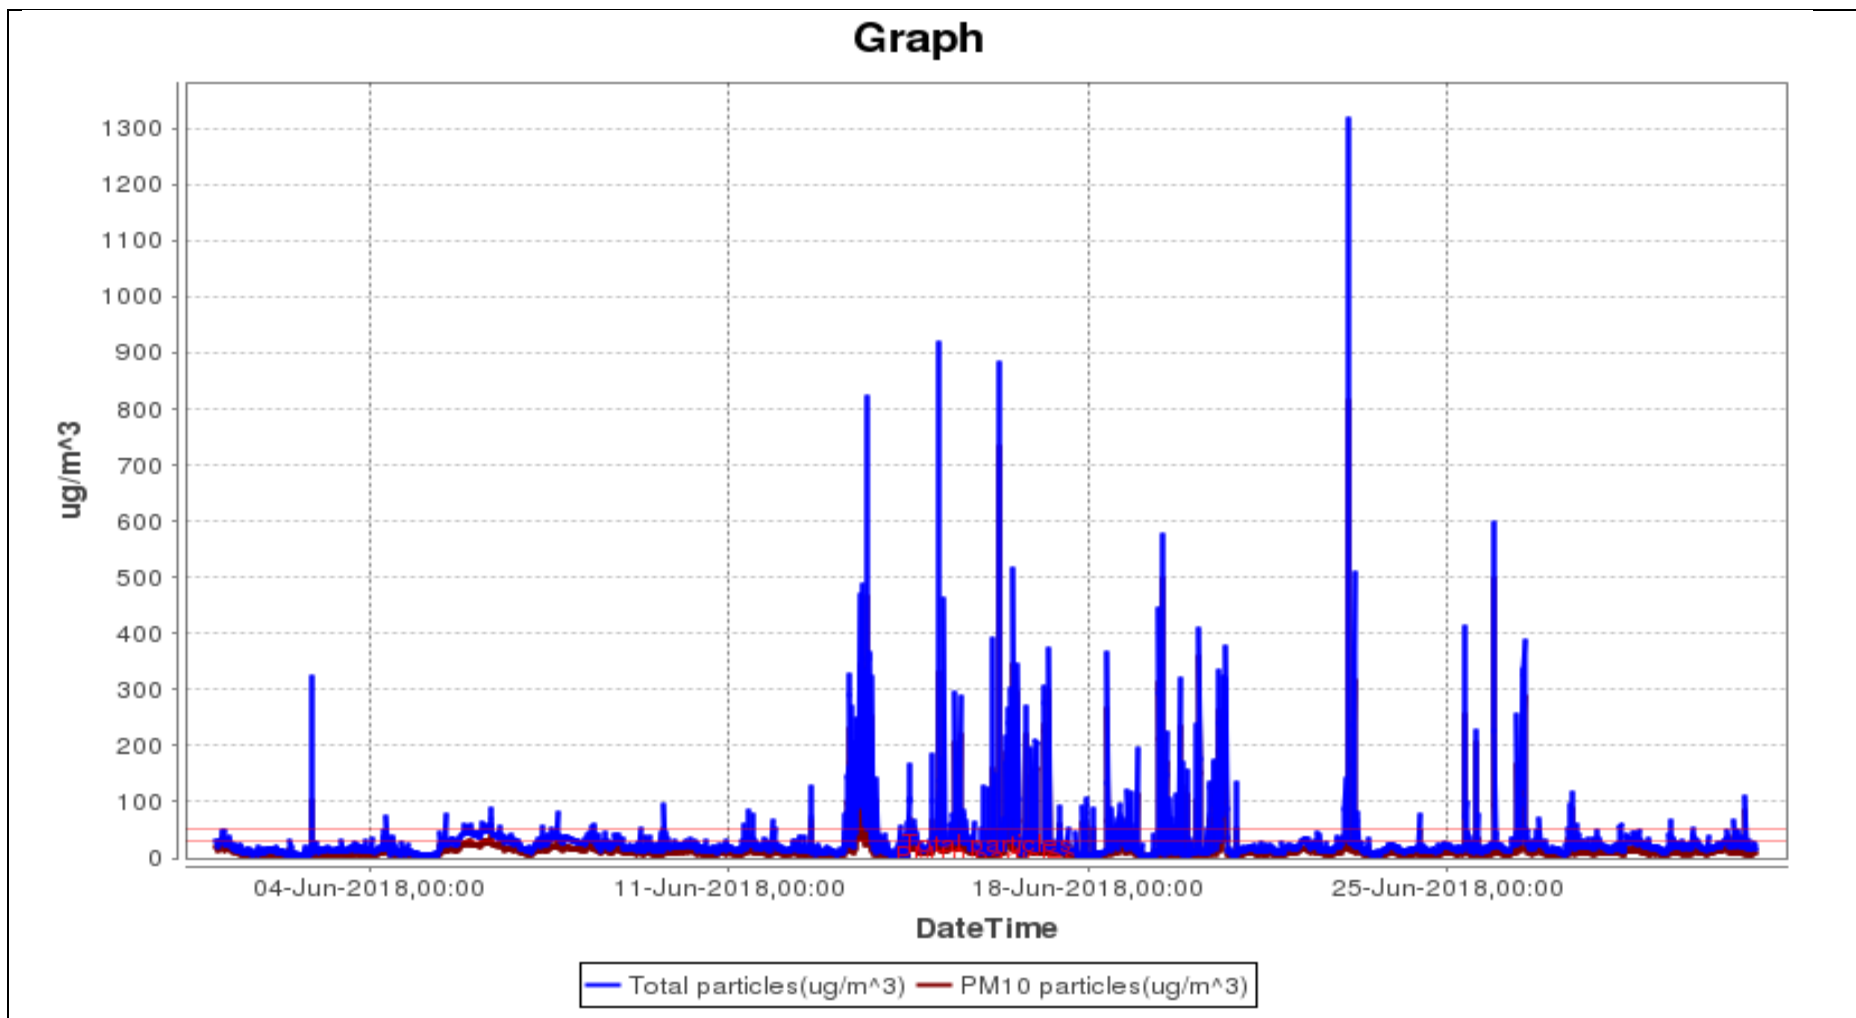
Figure 3: Construction dust 15-minute mean indicative PM<sub>10</sub> concentration for dust monitors

- 1.1.7 Twenty-two (22) exceedances of the dust trigger level were recorded during the month of June 2018. Eight (8) of these triggers occurred outside of construction site hours. For the remainder of alarm triggers, investigations determined that exceedances were not resultant

from HS2 site activities as dust-generating activities were either not programmed or performed at the time of the alert.

- 1.1.8 A neighbouring contractor Kier, working on behalf of Affinity Water, were undertaking construction works near the monitoring location at Chalfont Lane. Kier construction activities included: water main commissioning and steel fixing operations.

- 1.1.9 Following an initial alert and subsequent HS2 investigation, correspondence was issued to Kier for additional investigations and a request for the implementation of mitigation measures if works were the source of the dust origination. Kier investigations considered the majority of triggers to have resulted from prevailing winds and weather-related conditions which facilitated the movement of dust particles from neighbouring rural properties.

- 1.1.10 A haul road was also recognized as a source of dust on the Keir construction site. As a result, Kier implemented a reduced vehicle speed limit of 5 miles/hour and undertook localized dust suppression measures where an alerts were associated with construction activities. HS2 contractors and personnel also possessed rights of access to the haul road Bellmouth throughout the duration of June works.

1.1.14 Osborne have continued to dampen-down the haul road as required during the unseasonably dry weather. Kier have continued to dampen grounds at the localized construction site to reduce dust generation.
