HS2

Air Quality and Dust Monitoring Monthly Report – September 2019

London Borough of Ealing

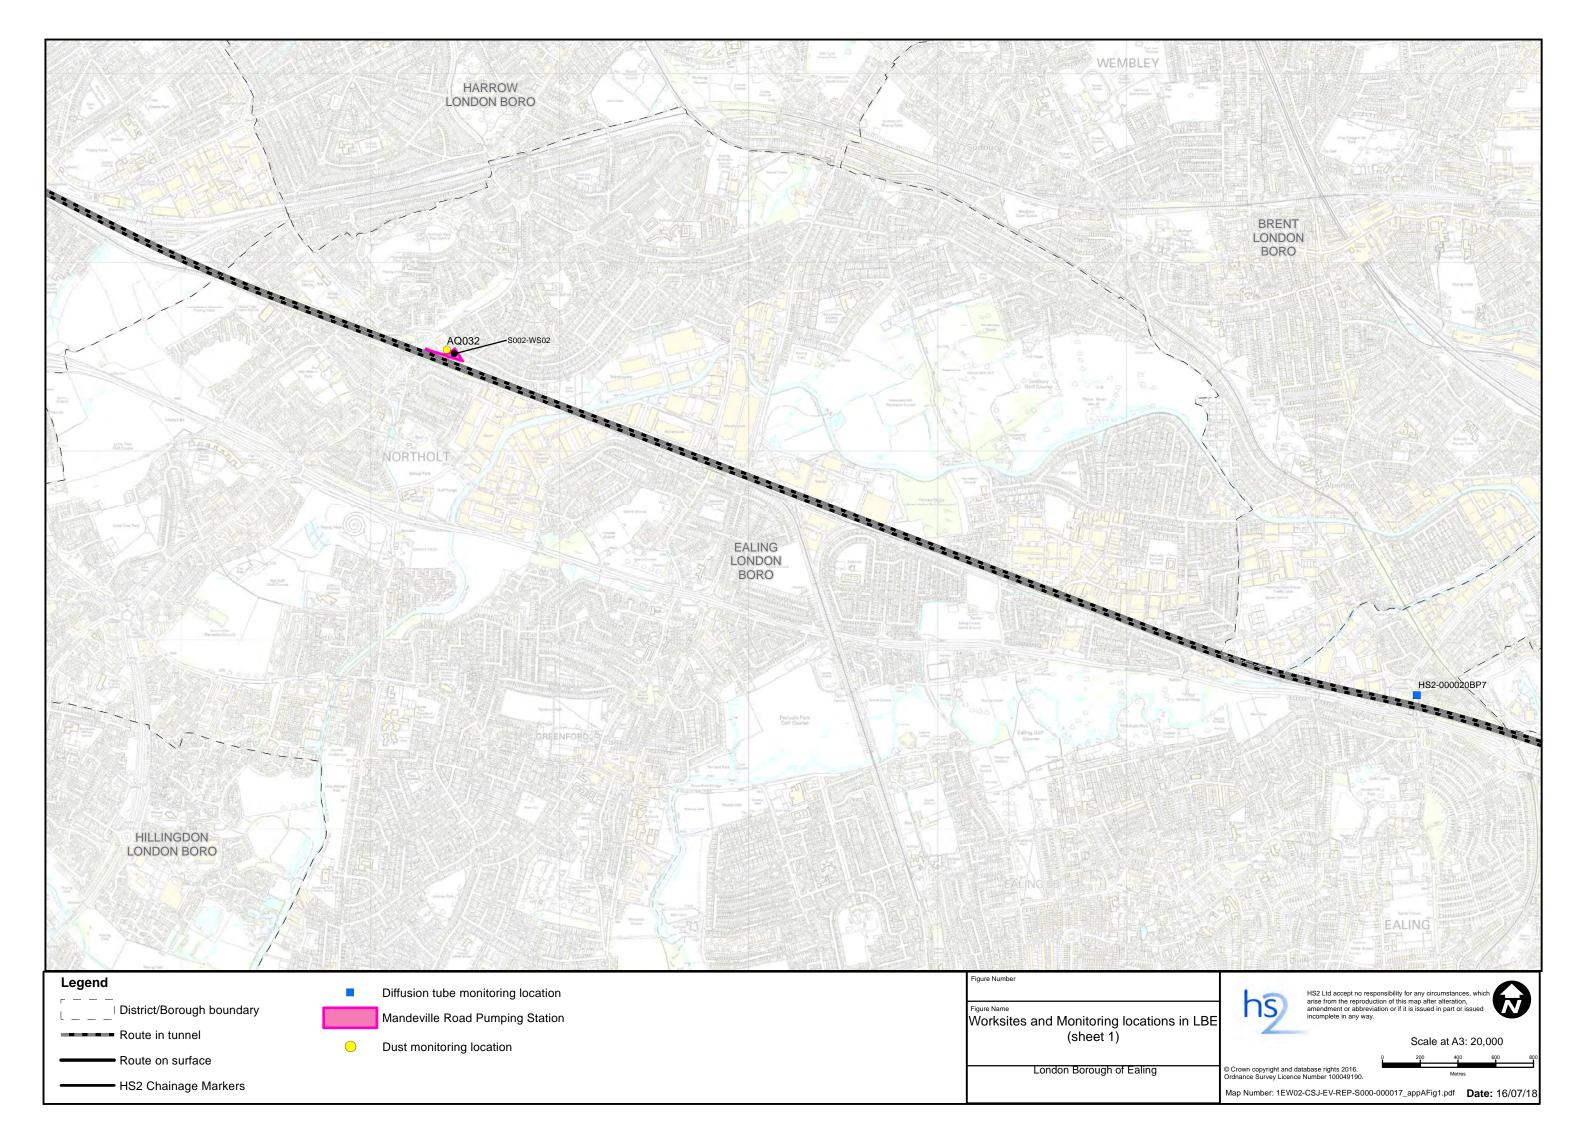
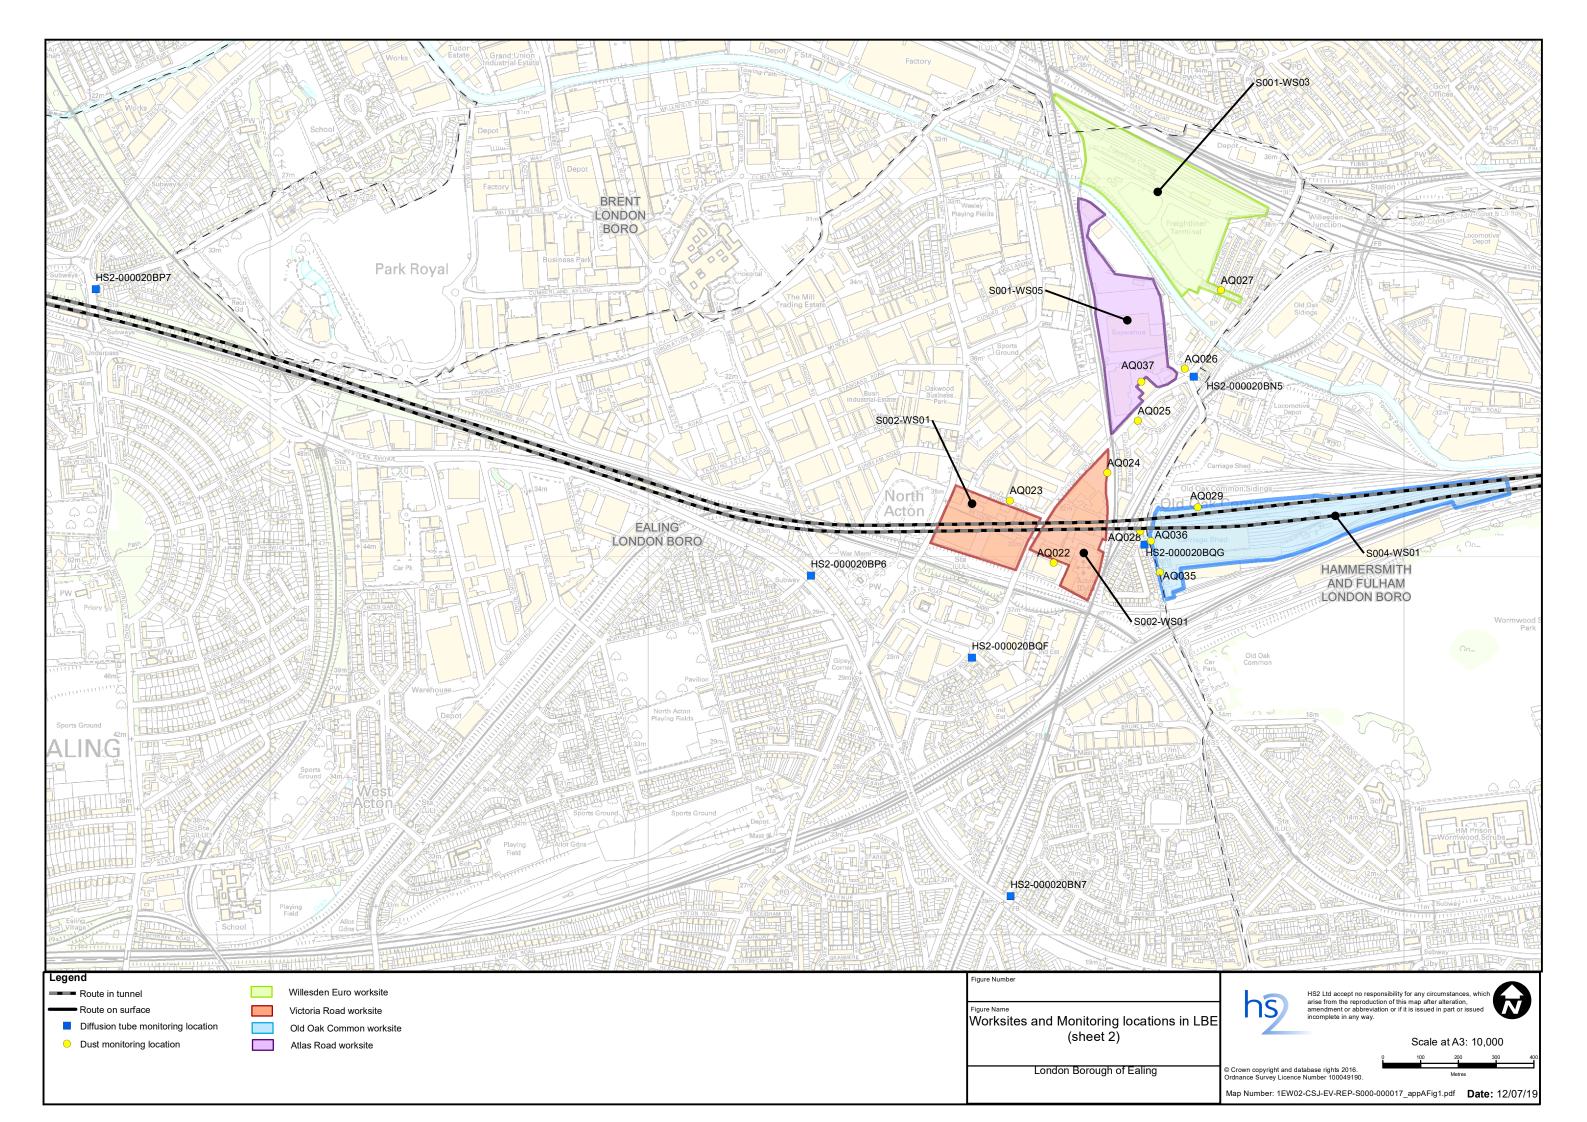
Figure 1 and 2: Worksites and monitoring locations within the LBE

- 1.1.2 Figure 1 and Figure 2 in Appendix A indicate the current worksites together with air quality and dust monitoring locations.
- 1.1.3 This summary should be read in conjunction with the overview monitoring report available from www.gov.uk/government/collections/monitoring-the-environmental-effects-of-hs2, which highlights: the applicable standards and guidance, as well as the air quality and dust monitoring methodologies to be implemented by nominated undertakers throughout construction.

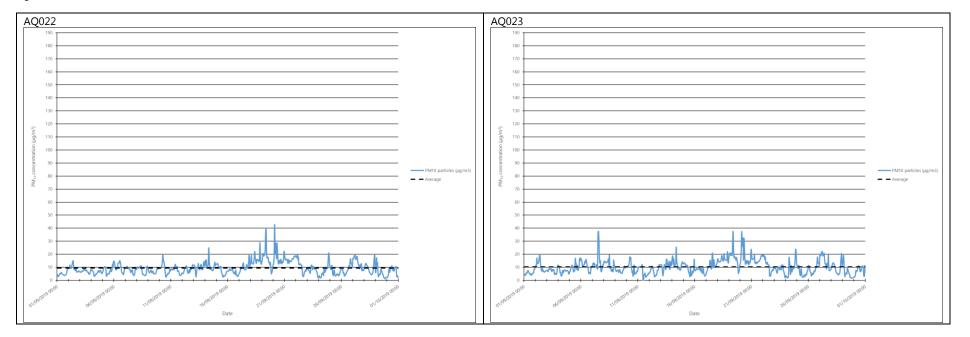
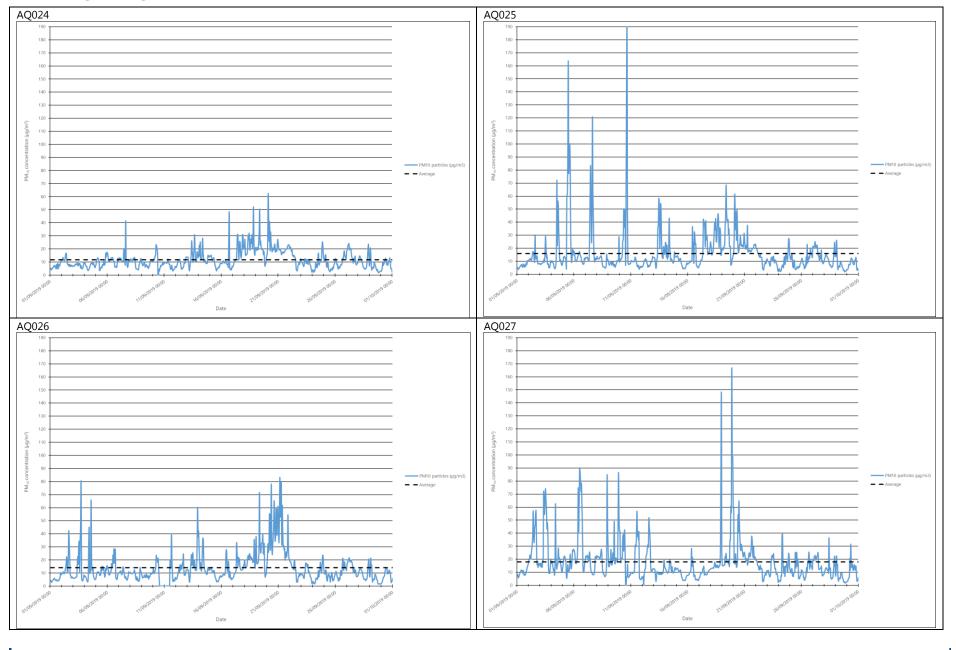
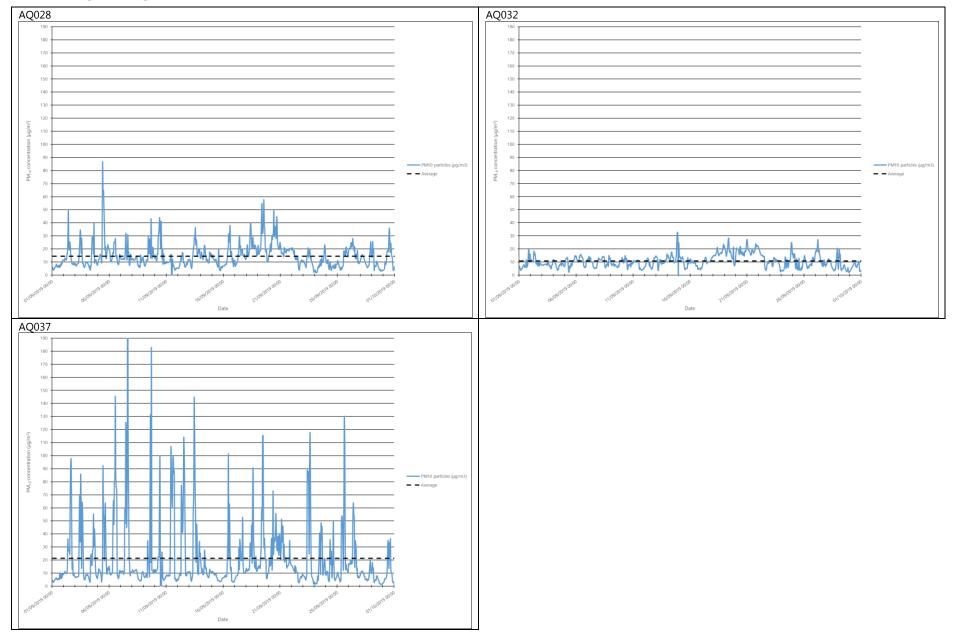
Figure 1: Construction dust 1-hour mean indicative PM₁₀ concentration for dust monitors

- 1.1.8 There were two (2) dust trigger alerts recorded during this monitoring period (September 2019). Dust trigger alerts are presented in Appendix B, Table 2. All other results were in line with expected ranges.
