## **Air Quality and Dust Monitoring Monthly Report – December 2019**

**Three Rivers District Council**

A report prepared by Align JV on behalf of HS2 Ltd.

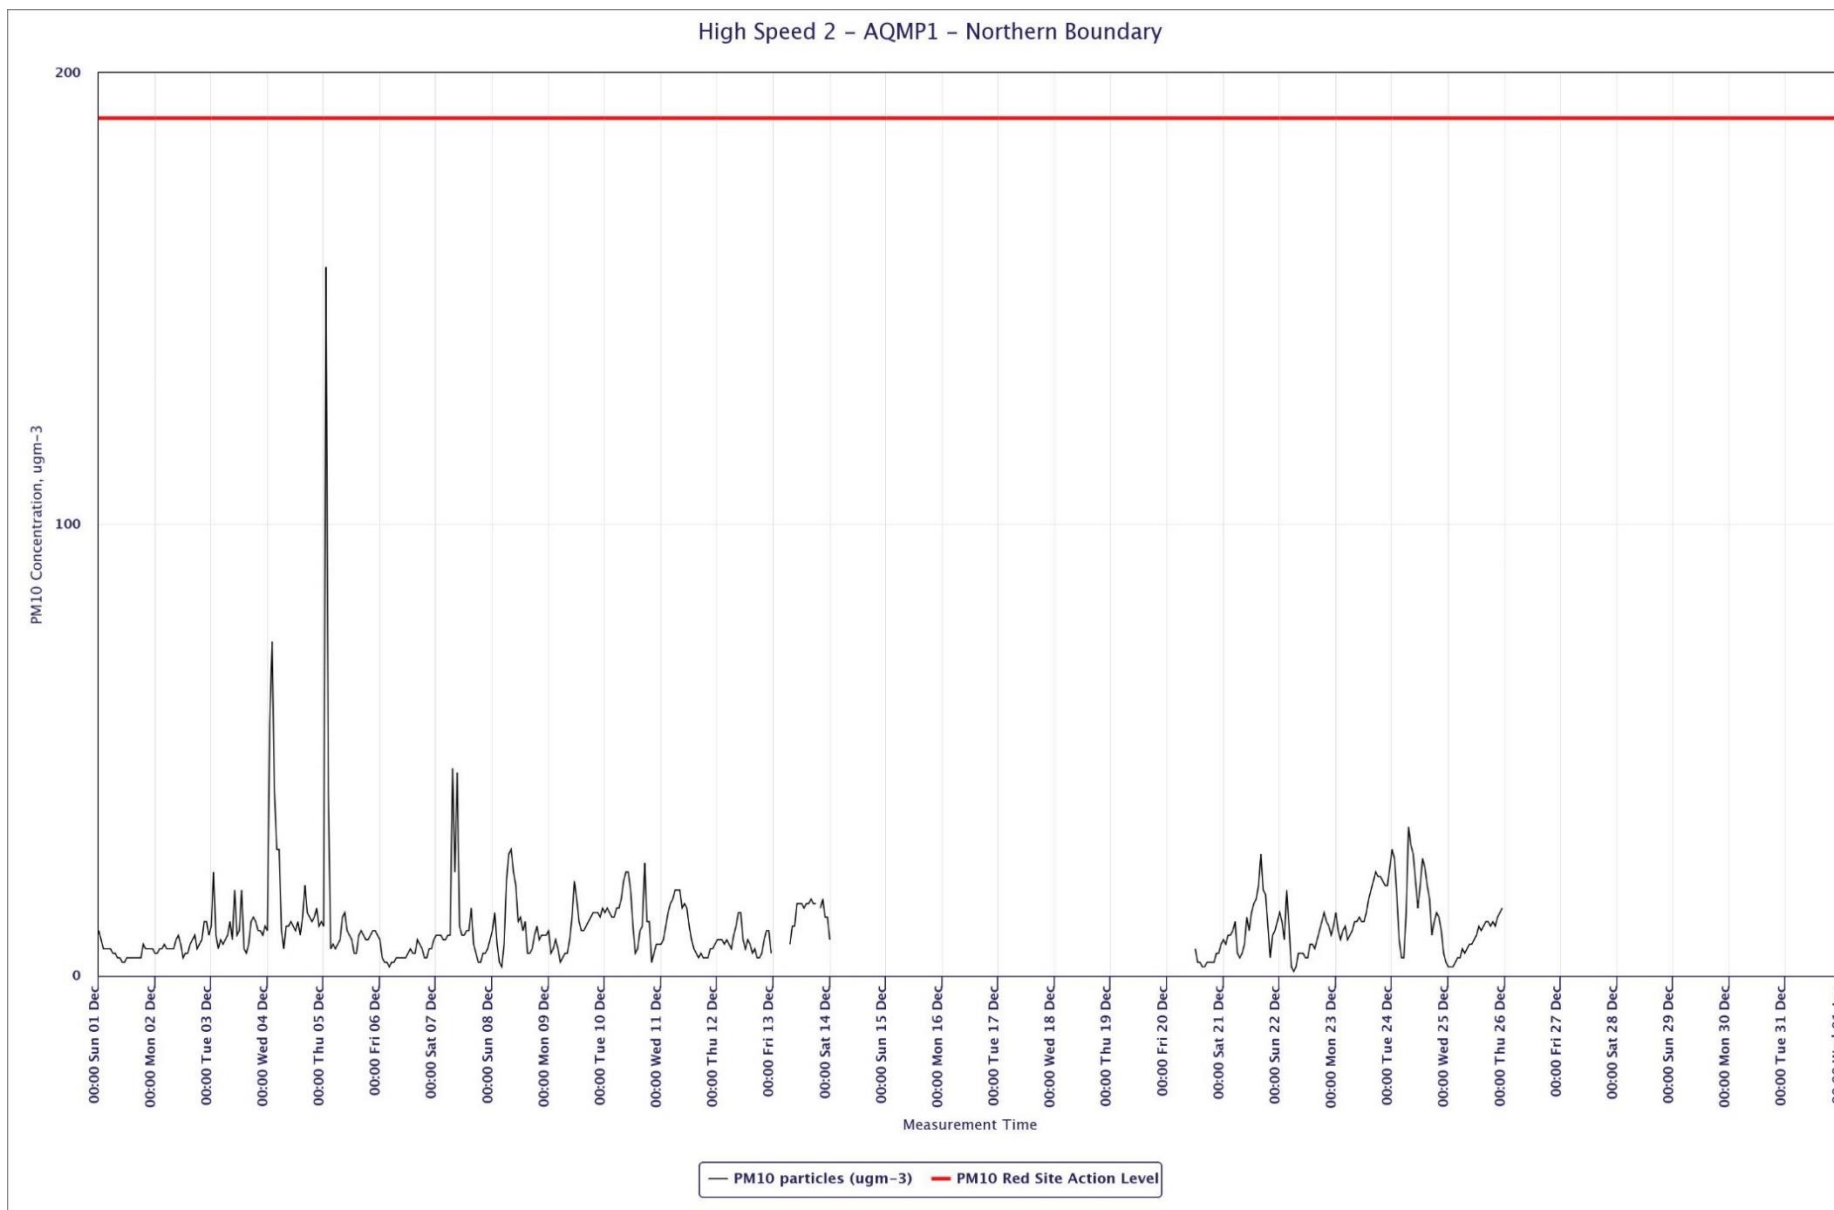
Figure 2: Continuous dust 1-hour mean indicative PM<sub>10</sub> concentration for AQMP1 for December 2019

- 1.1.9 There were a number of dust trigger alerts recorded at AQMP1 during this monitoring period (December 2019). These were recorded between 26<sup>th</sup> December and 31<sup>st</sup> December. Following an investigation, it was noted that these were false triggers caused by a faulting heating inlet on the monitor. The heating inlet was replaced on 3<sup>rd</sup> January and regular maintenance inspection will continue to be carried out to avoid reoccurrence.

- 1.1.13 Missing data from AQMP1 from Friday 13<sup>th</sup> to Friday 20<sup>th</sup> December 2019 was caused by interruptions to continuous power from the solar and wind power pod, likely as a result of calm and overcast conditions. The interruptions in continuous power resulted in an internal battery charging circuit component failure of the AQMP1 unit (TNO4199) which was retrieved from site and replaced with TNO3427 on Friday 20<sup>th</sup> December.

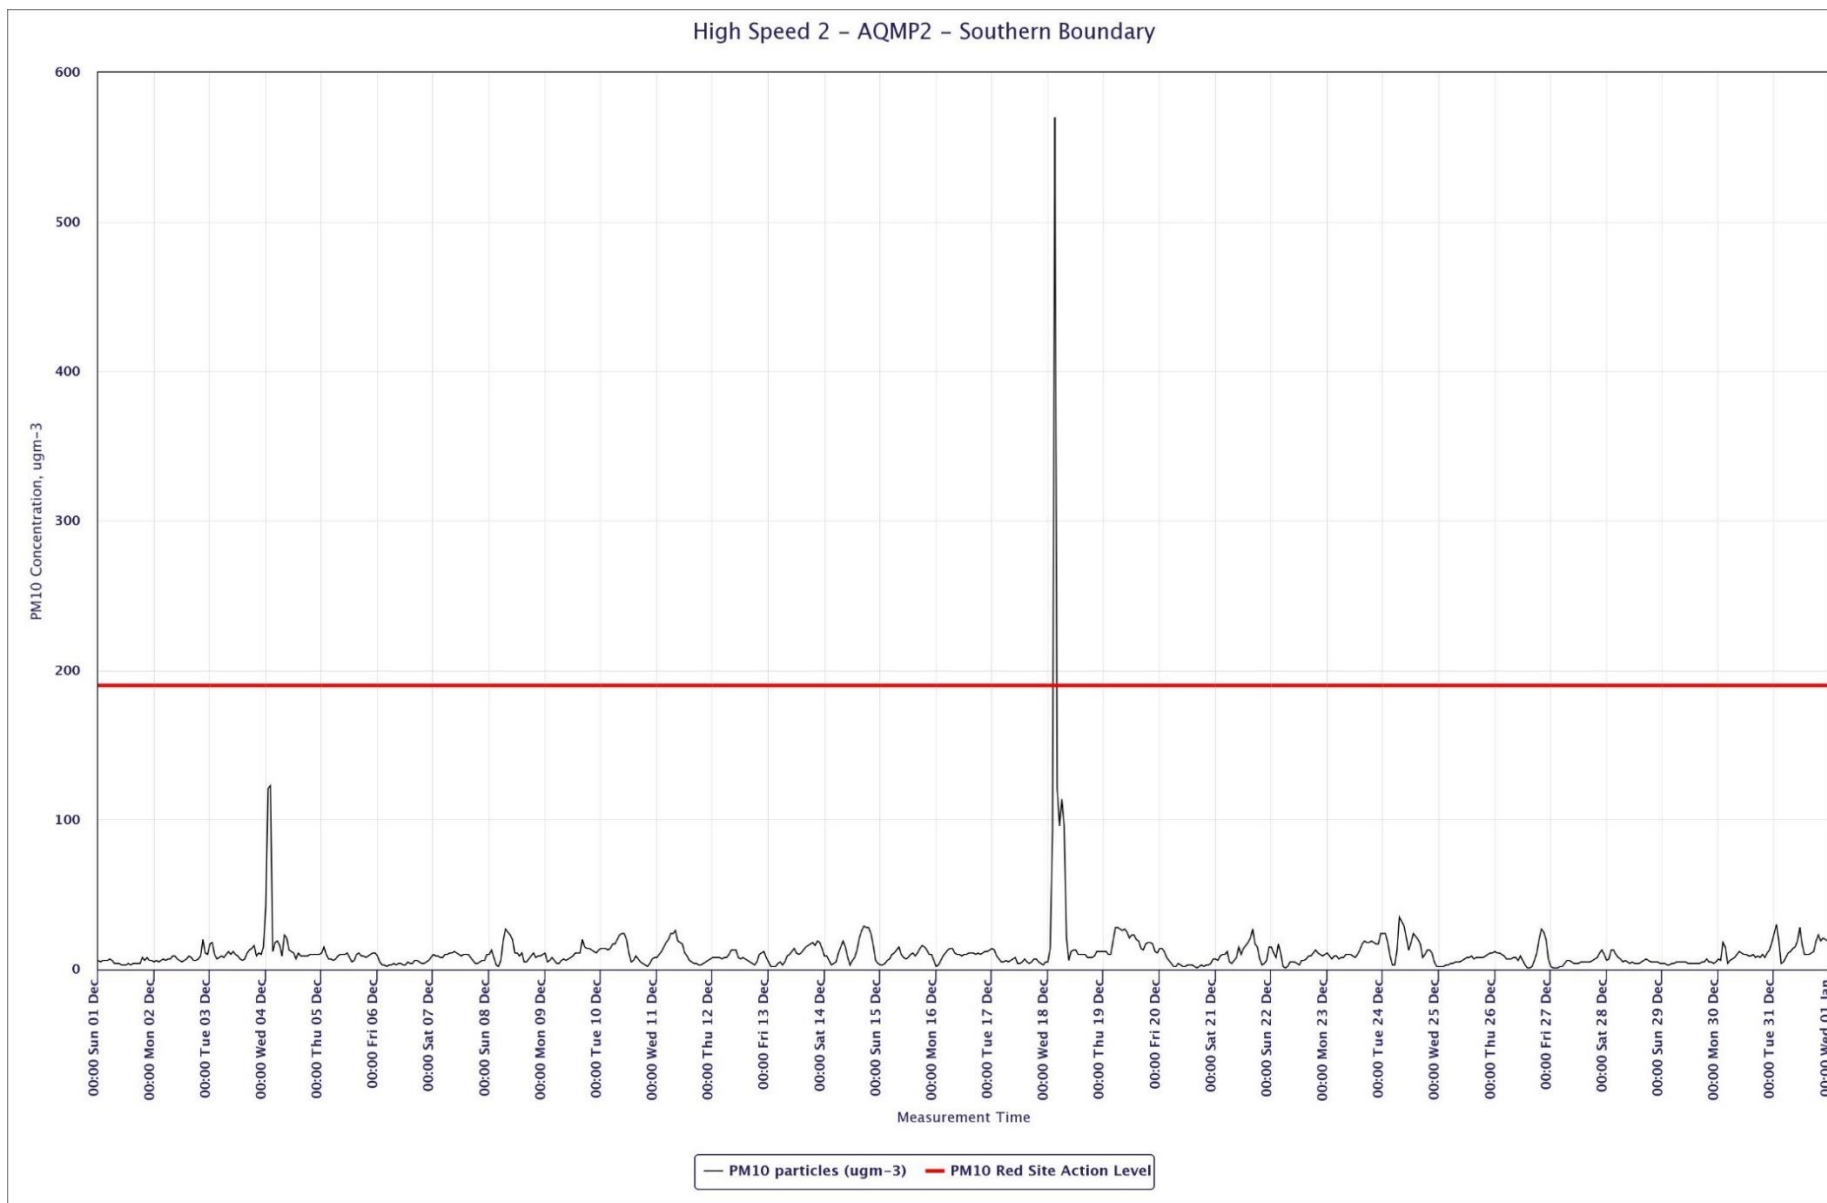
Figure 3: Continuous dust 1-hour mean indicative PM<sub>10</sub> concentration for AQMP2 for December 2019

- 1.1.10 There was one (1) dust trigger alert recorded at AQMP2 during the December 2019 monitoring period. The exceedance of the  $190 \mu\text{g}/\text{m}^3$  dust trigger level at AQMP2 was measured on Wednesday 18<sup>th</sup> December at 03:00 - 04:00 hrs. The cause of this exceedance has been identified as being attributable to power loss which affected the functionality of the heated inlet and are not considered to be associated with site activities.

Monitoring Site ID	Period of trigger alert & Concentration recorded	Investigation	Outcomes / Resolution / Remedial measures implemented
AQMP2	<u>18/12/2019</u>	Due to number of exceedances occurring outside of working hours suggests possible issue with the heated inlet.	Engineer attended site 03/01/2020. Heated inlet connection damaged and replaced on 03/01/20. Unit left functioning, operation continuing to be monitored.
AQMP1	<u>26/12/2019 – 31/12/2019</u>
