MARINE ACCIDENT INVESTIGATION BRANCH

Summary of Investigations No 3/90

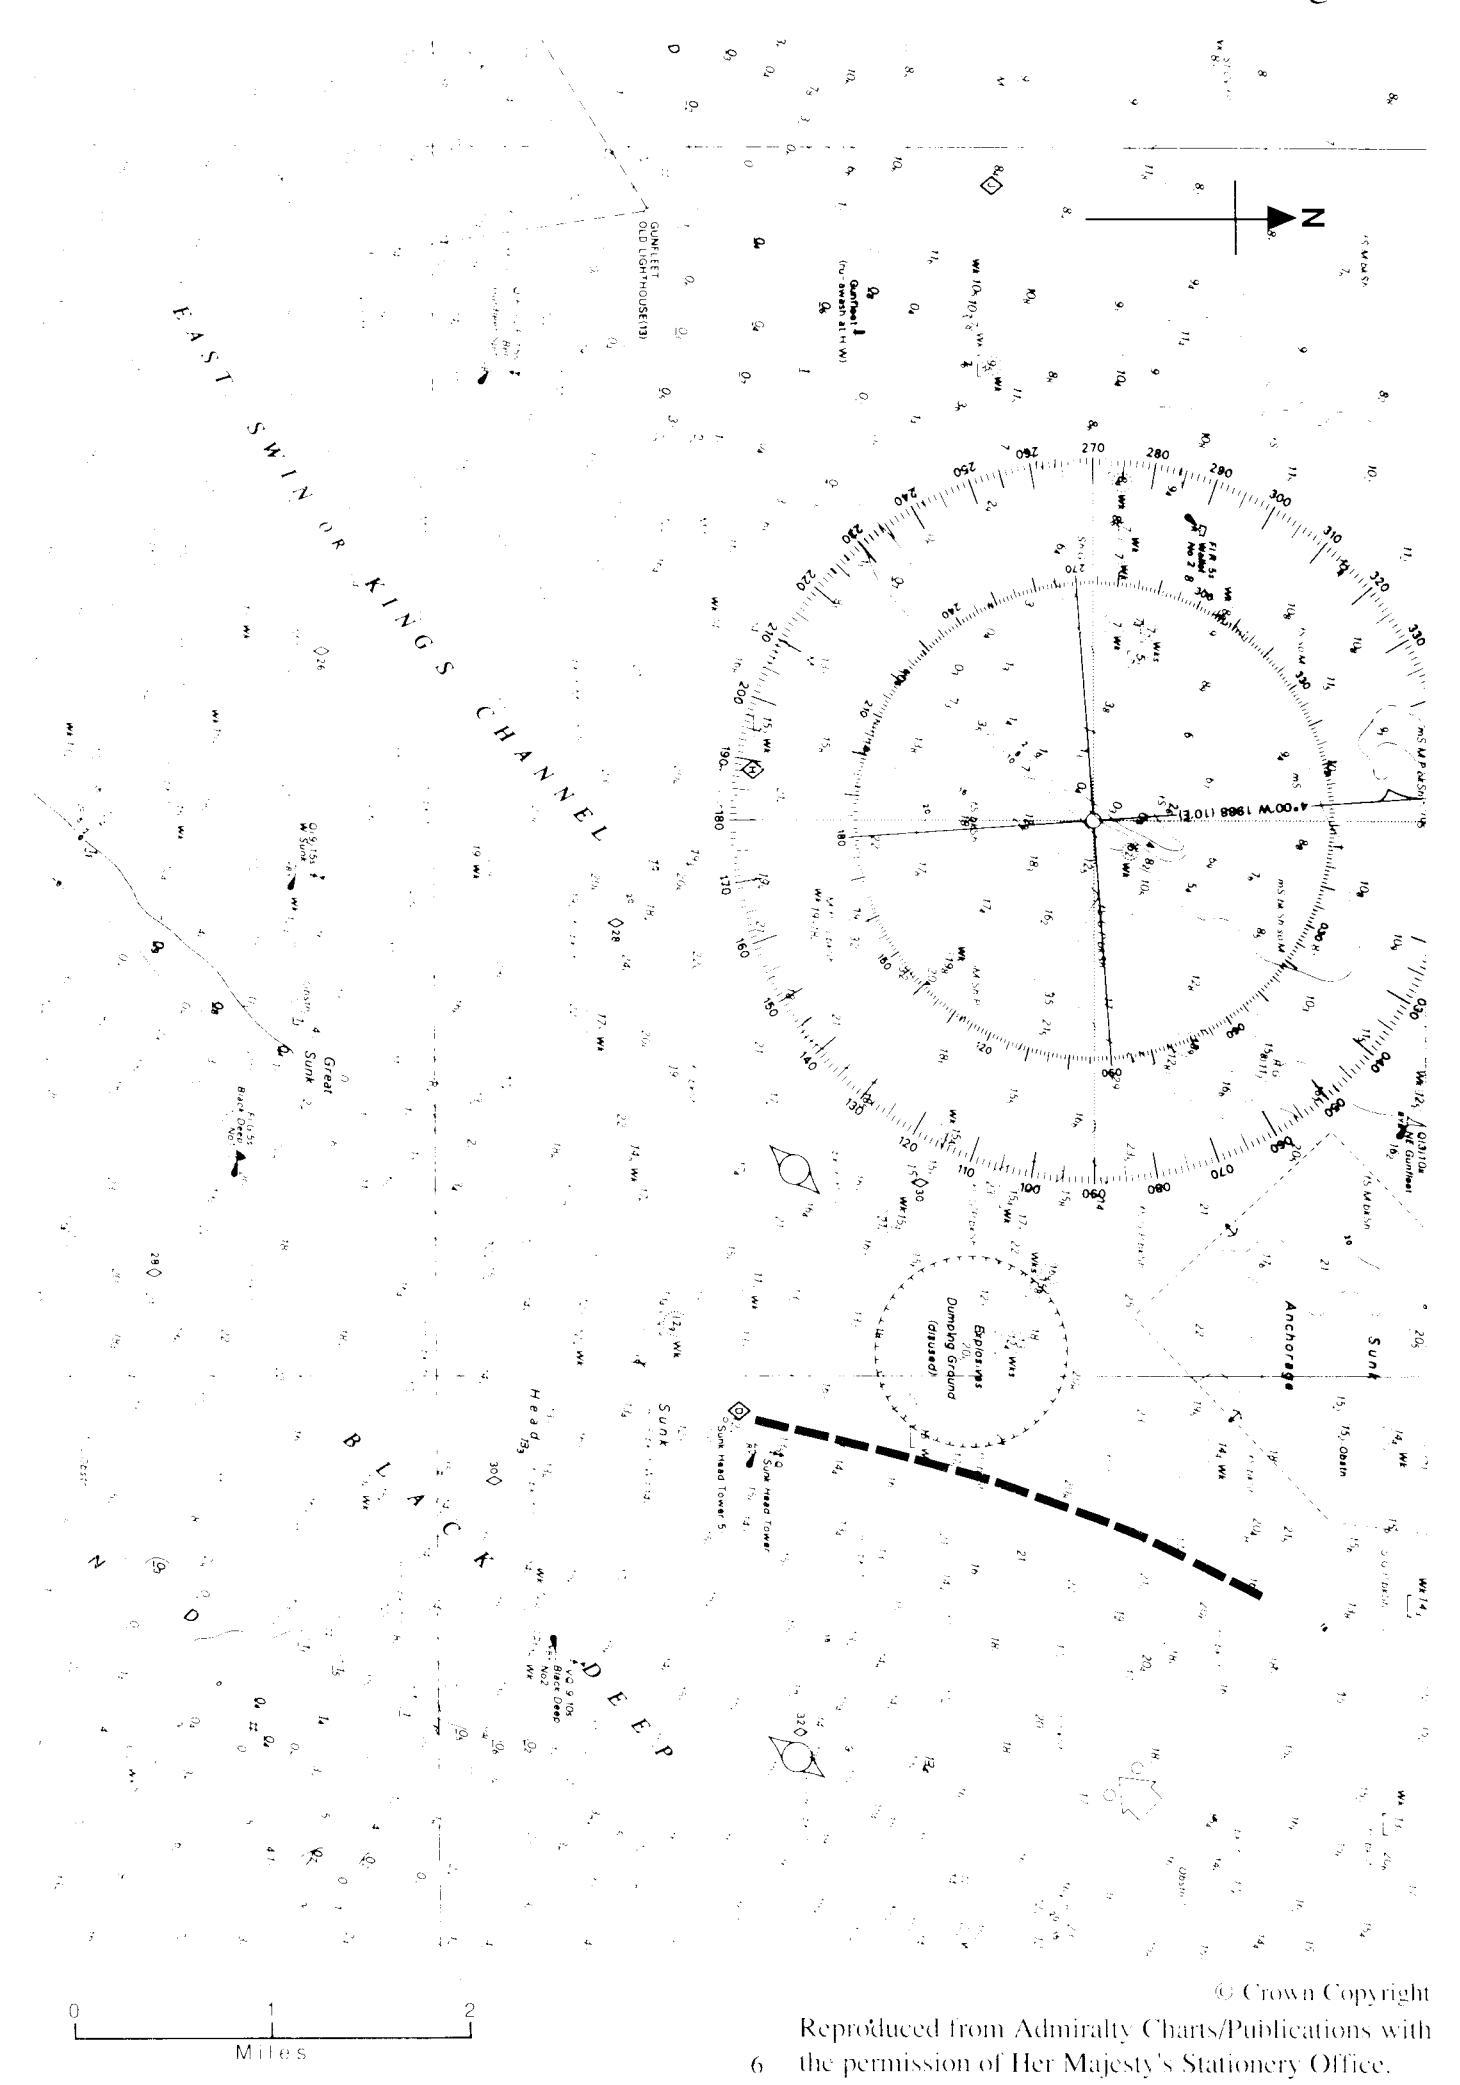
Figure 1

A 26,802 gross registered tonnage liquified gas carrier with a cargo of Propane and Butane was proceeding under pilotage inward bound on the River Thames. (See Figure 1). The wind strength was force 7; it was cloudy with good night visibility. Approximately 20 minutes after embarking the Pilot, the ship struck Sunk Head Tower. There were no injuries but the ship sustained fractures to the hull plating which opened the Forward Deep Tank to the sea. However, the cargo containment was not affected.

- 1. The Master had anticipated taking the Kings Channel and the ship was in a position inward of the designated pilot boarding position; this was at the request of the pilot cutter.
- 2. The initial Pilot/Master exchange of information was incomplete and an adequate pilotage passage plan was not formulated.
- 3. Although the progress of the ship was monitored, the course was not projected ahead on the chart and, therefore, the imminent risk of collision with Sunk Head Tower was not appreciated.
- 4. Plotted charted positions were disregarded in favour of assessing the position of the ship by visual observation of the relative bearings of lights of buoys. The misinterpretation of the light of a distant buoy for a reported erratic flashing of the light of a closer buoy resulted in the ship being in a position different from that assumed.

- 1. Merchant Shipping Notice No M.854 and the Department of Transport publication "A Guide to the Planning and Conduct of Passages" contain guidance on navigation safety and proper passage planning.
- 2. When a Pilot is to be taken, he should ideally be embarked as early as possible. This would enable the necessary initial Pilot/Master exchange of information and passage planning to be conducted prior to the ship entering an area where navigation was potentially hazardous.

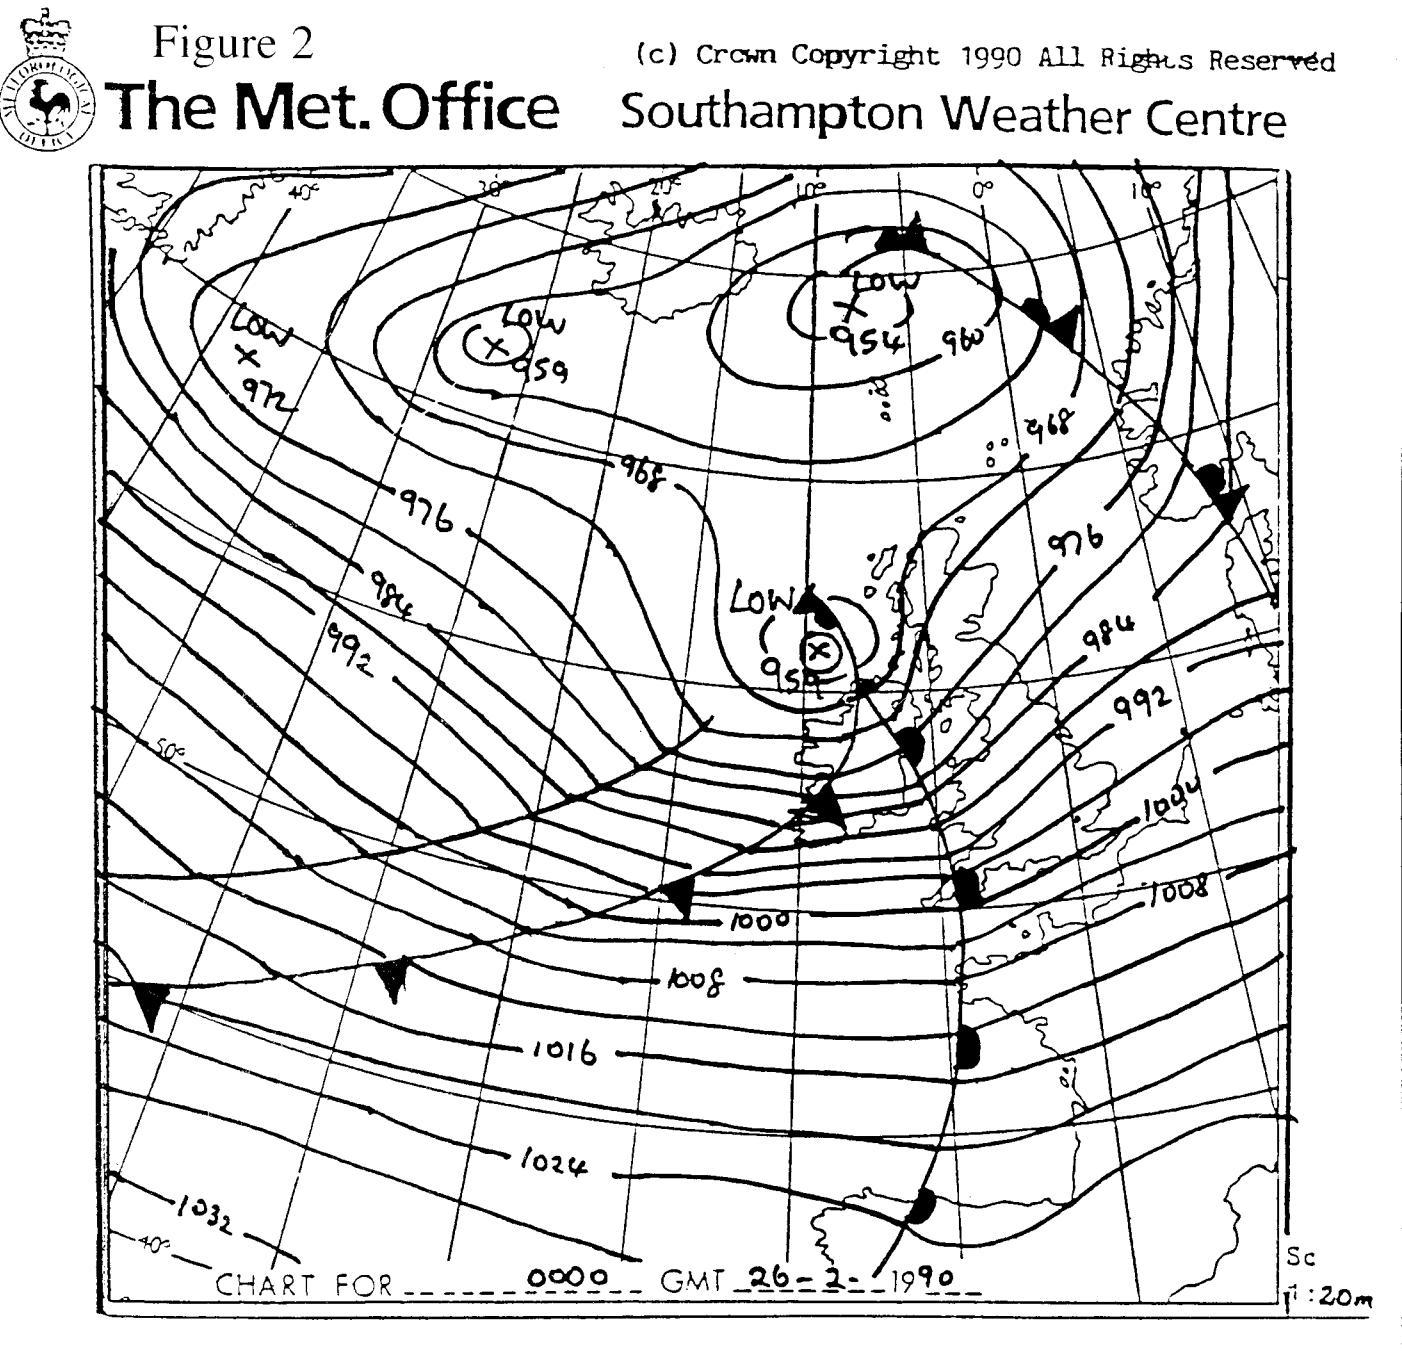
The ship had sailed from Falmouth at about 1600 hours and throughout that day there had been gale warnings in force for all sea areas except Trafalgar. The following are extracts from transcripts of the shipping forecasts broadcast on BBC Radio 4 which are reproduced, together with the synoptic chart at Figure 2, with the permission of the Met. Office.

Seafarers should never under estimate the power of the sea in a gale, irrespective of the size of the ship and should take early action, whenever possible, to minimise the effects it might have on a ship.

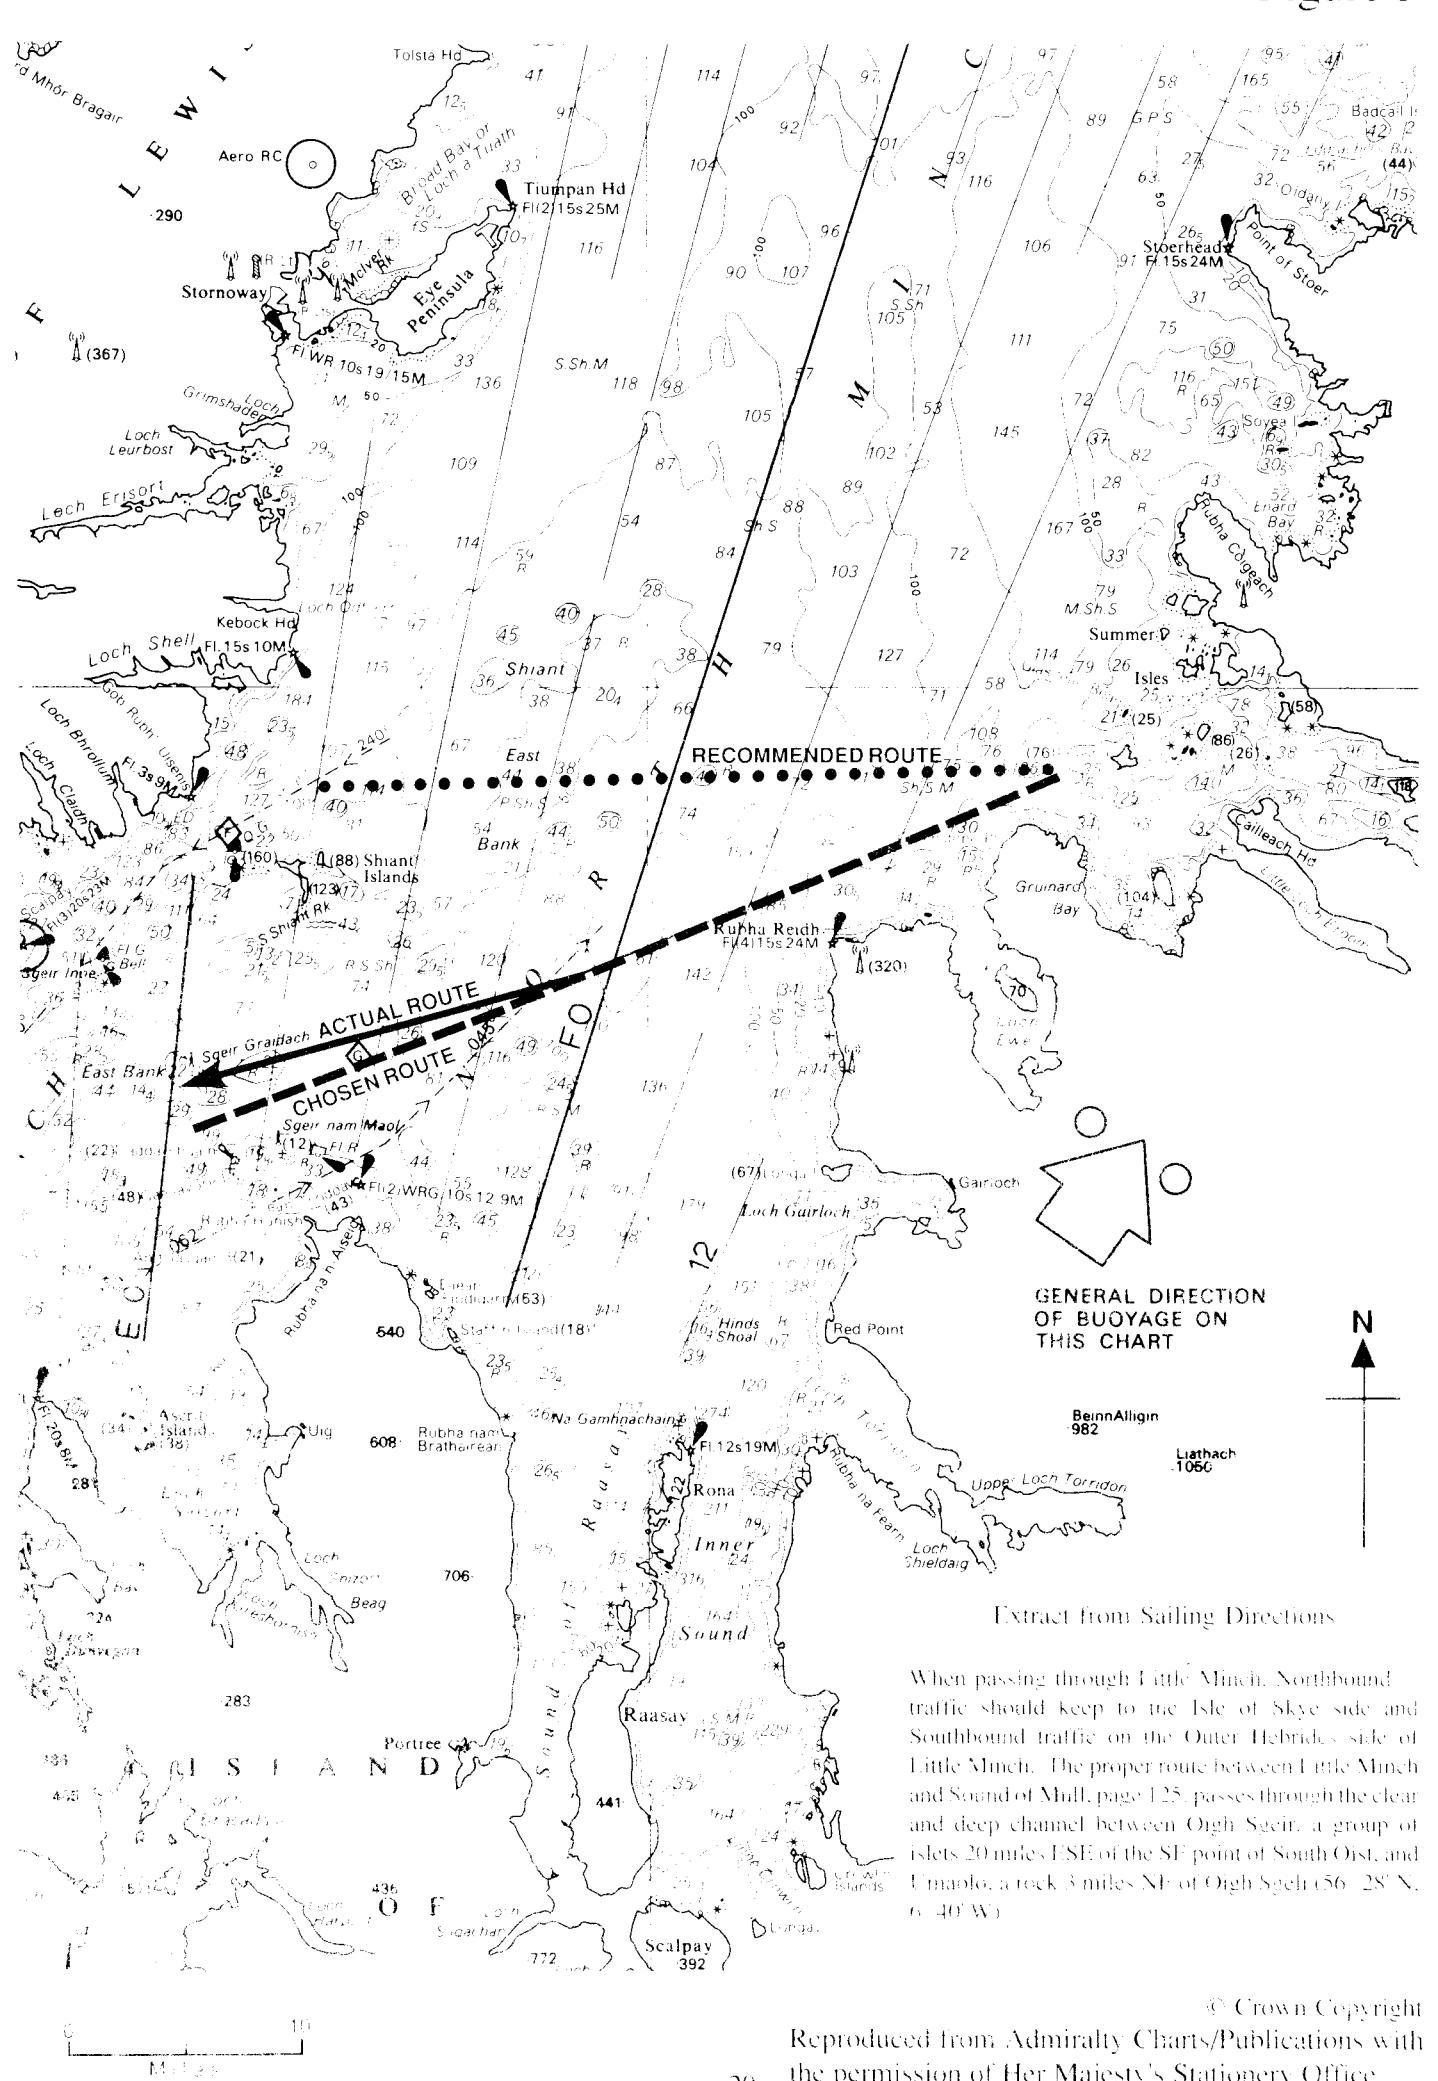
Figure 3

The vessel was holed and the consequent flooding could not be stemmed. Later the weather deteriorated and the ship was abandoned, and (despite attempted salvage) became a total loss. There was some pollution from the factory ship's fuel oil tanks, but this was successfully treated with dispersants from a Marine Pollution Control Unit aircraft.

- 1. There was a failure to produce and follow a safe passage plan. The recommended route had not been followed and the one chosen passed too close to charted dangers.
- 2. No account had been taken of the prevailing tidal stream. In fact there was a current of about 1 knot which set the vessel to the north, and to the west, towards the rocks.
- 3. Total reliance had been placed on the radar. When this failed no attempt was made to fix positions by other means.
